**OUTBUILDING AT MEADOW VIEW,
 EARSHAM STREET,
 WINGFIELD**

STRUCTURAL APPRAISAL

JA/R/19/179
 15th August 2019

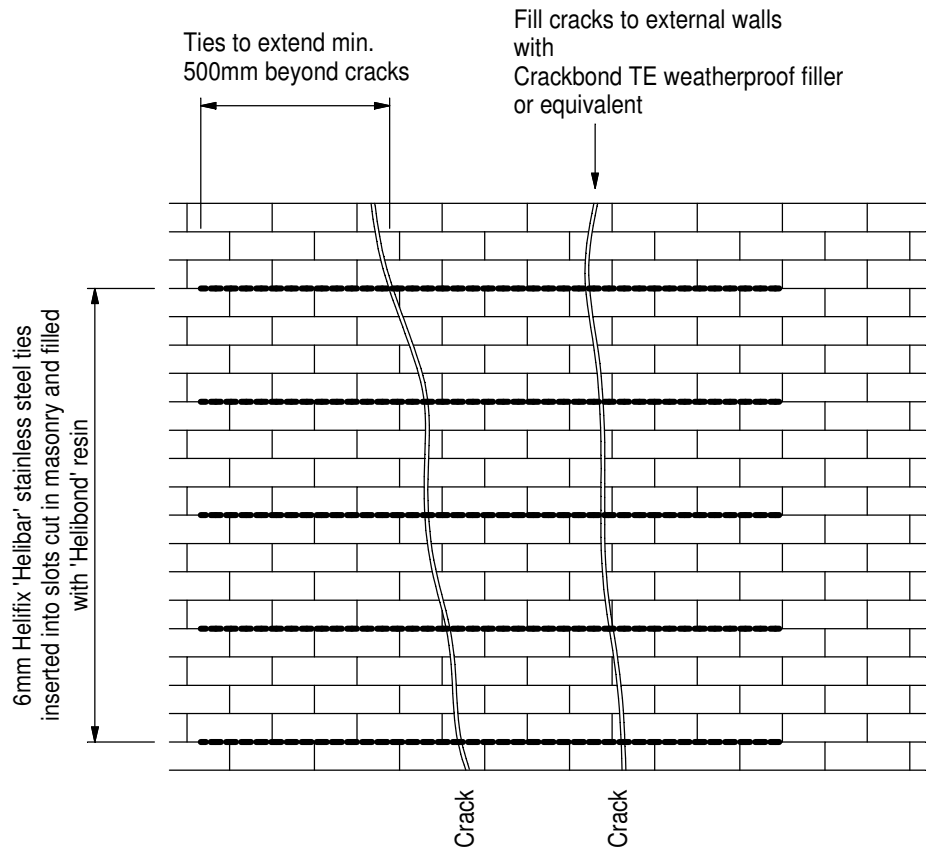
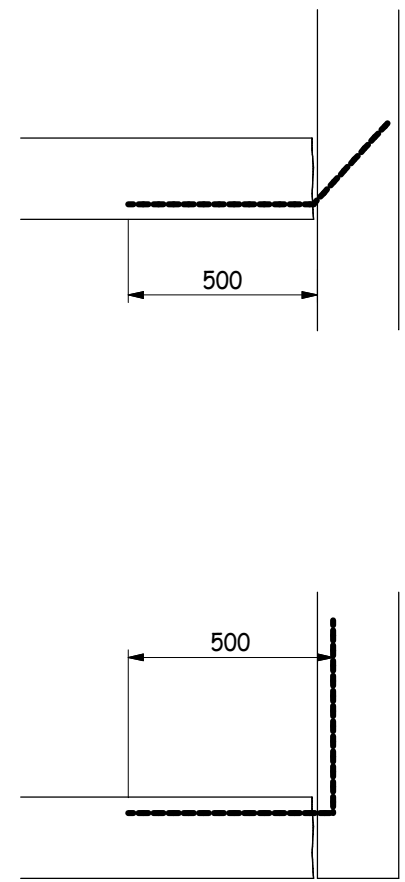
Detail for Re-Connecting Corners

Element	Description	Recommendations
		<p>not present a problem structurally, and future movement will be prevented by the introduction of a new roof designed to modern standards.</p> <p>The north and central bays are not toothed together and have subsequently prised apart. Tie the central bay external walls back into the north bay external walls and internal dividing wall using Helifix bars (SK-01).</p> <p>The south bay timber frame is in good condition and no improvements are necessary.</p>
Ground floor	<p>There is an exposed concrete floor to the north bay. The central bay has a mixture of uneven brick weave flooring, and crude concrete oversite. The south bay has a modern, level concrete floor slab throughout</p>	<p>The floor slabs to the north and south bays are in good condition where visible and no improvements are necessary. A new floor slab will be required to the central bay.</p>
Foundations	<p>Trial holes were excavated on the north and central bays, exposing 400mm deep straight brick footings, founded on moist, firm, mottled slightly sandy clay subsoil.</p>	<p>Shallow foundations in clay subsoils are susceptible to movement through seasonal variations in moisture levels in the clay causing heave and shrinkage. There is a risk of movement of the existing foundations if prolonged drought conditions were to cause desiccation/shrinkage of the clay soil.</p> <p>The existing footings to the north and central bays have performed satisfactorily to date. It is acceptable to leave the existing foundations as they are because they bear onto the clay subsoil, however there is a degree of risk to this as explained above, which would have to be accepted by the client.</p> <p>The south bay footings were not surveyed however this area is of modern construction and has clearly performed in a satisfactory manner to date.</p>

NOTE - Where cracks are less than 500mm from an external corner or an opening the bars should be bent at least 100mm round the corner and bonded into the return wall or bent and fixed into the reveal

Single skin or cavity wall	Solid wall
Tie bar vertical spacing	300mm	300mm
Depth of slot	30mm	40mm
