**SCHEDULE OF REPAIRS TO  
THE STUDIO  
POUND FARM  
HADLEIGH ROAD  
HIGHAM  
COLCHESTER  
CO7 6LF**

**Date:** May 2022

**Reference:** PV/BBR/20385~srep rev 0

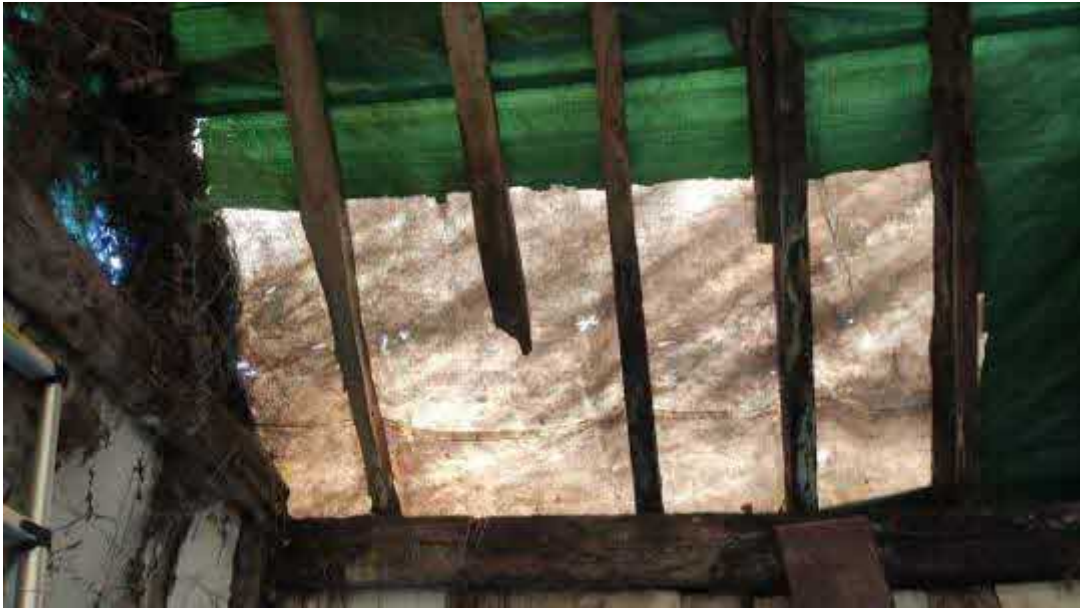
Photograph 01 – Snapped rafter on NE side.

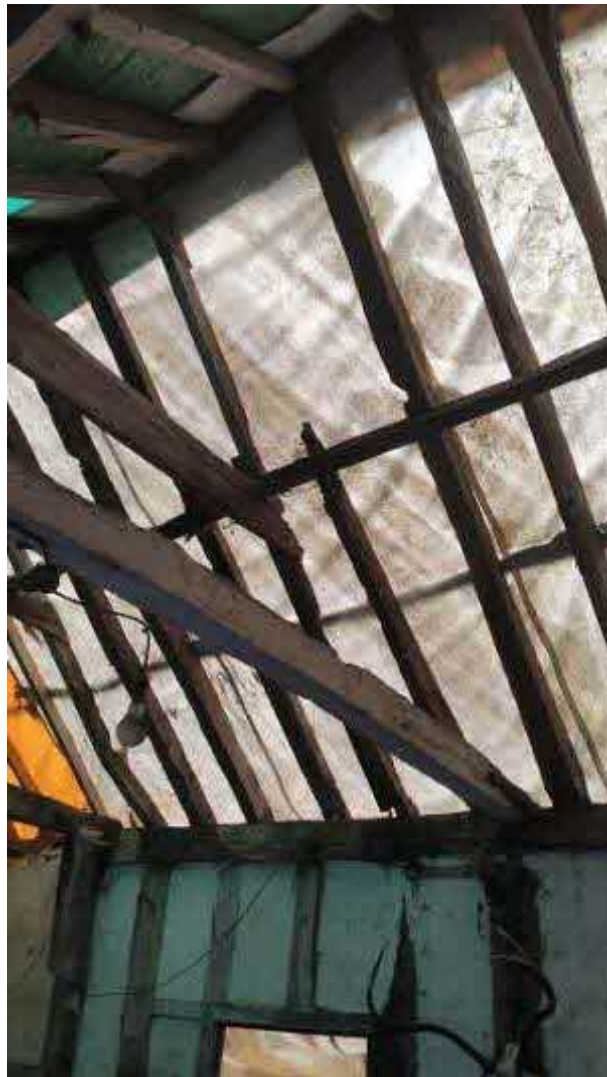
Photograph 02 – Damage to the west side of the roof.

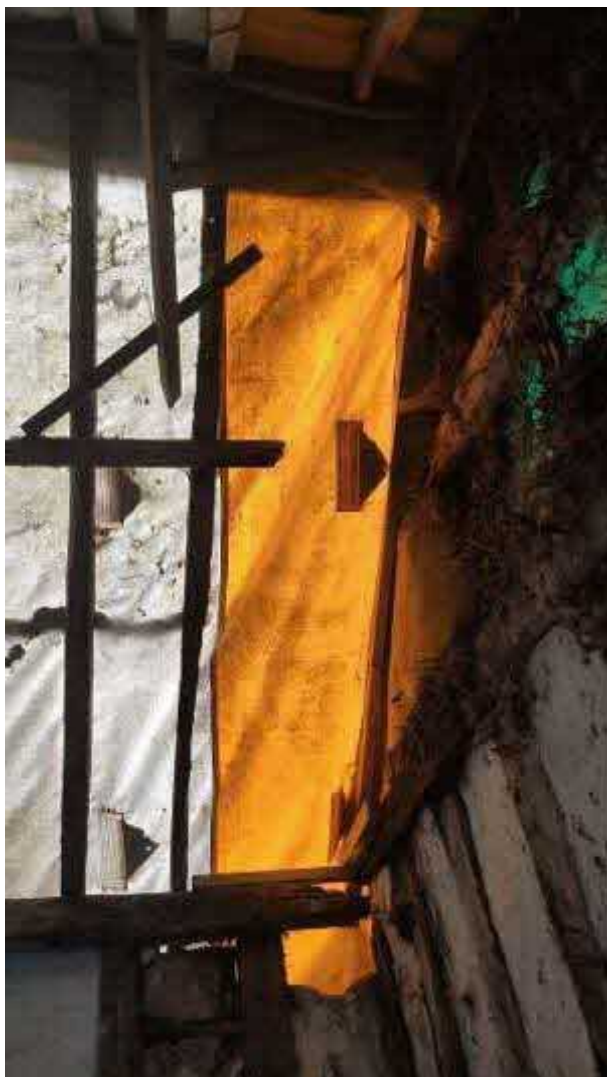
**Photograph 03 – Missing rafter and purlin end. Also damage to joint between top rail and eaves plate, NW corner.**

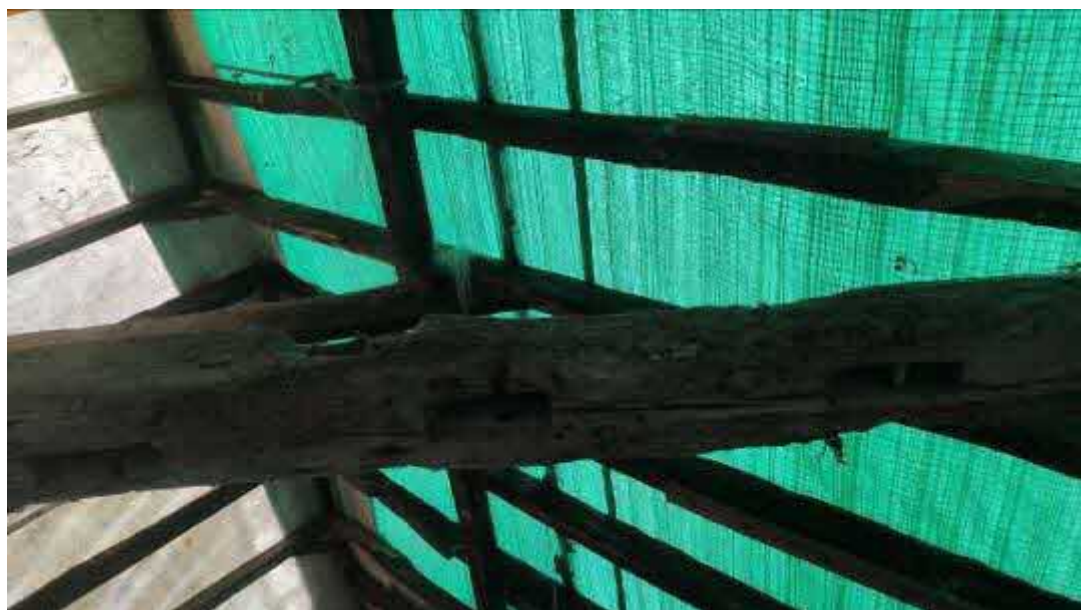
**Photograph 04 – Split in tie beam nearest the south end.**

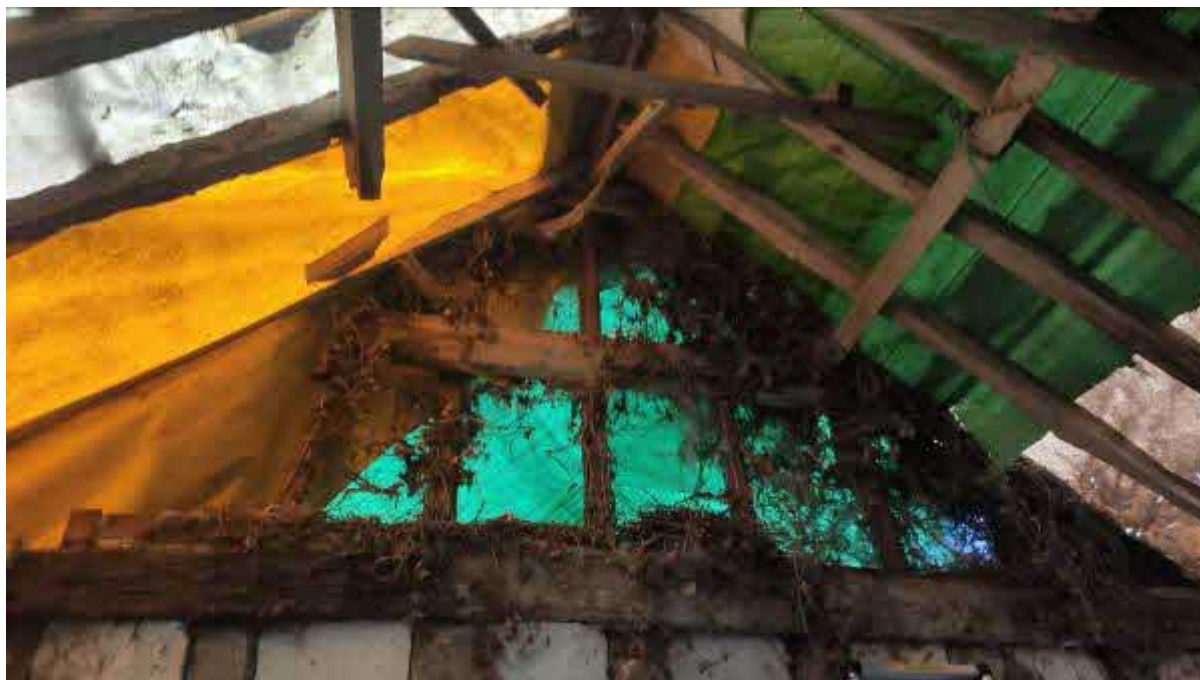
Photograph 05 – Spandrel panel at the north end.

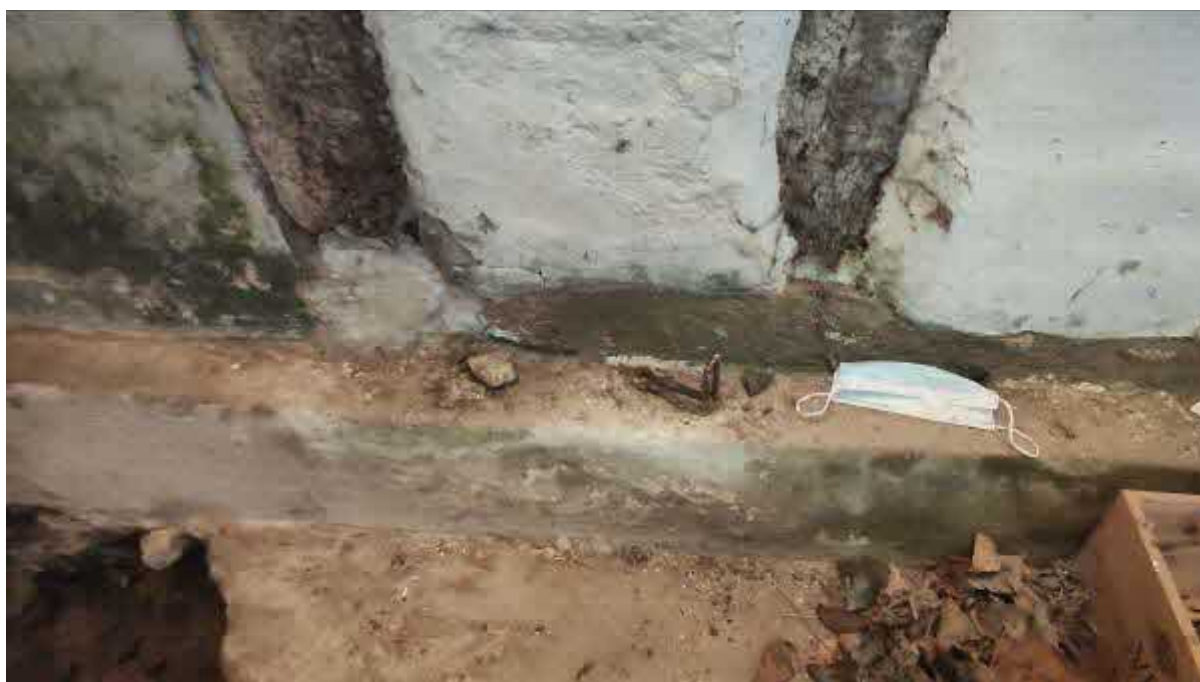
Photograph 06 – Concrete covered brick plinth wall and previous cement repair to bottom timber wall plate, north gable.

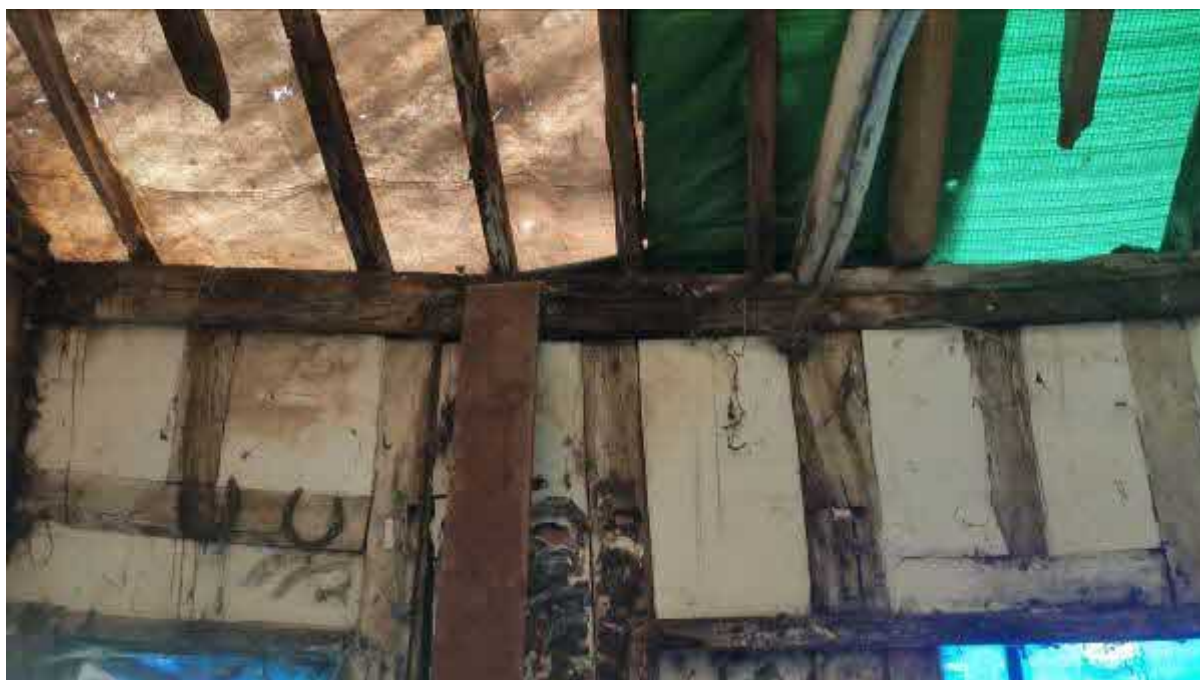
Photograph 07 – Condition of eaves plate/top rail, east facing elevation.

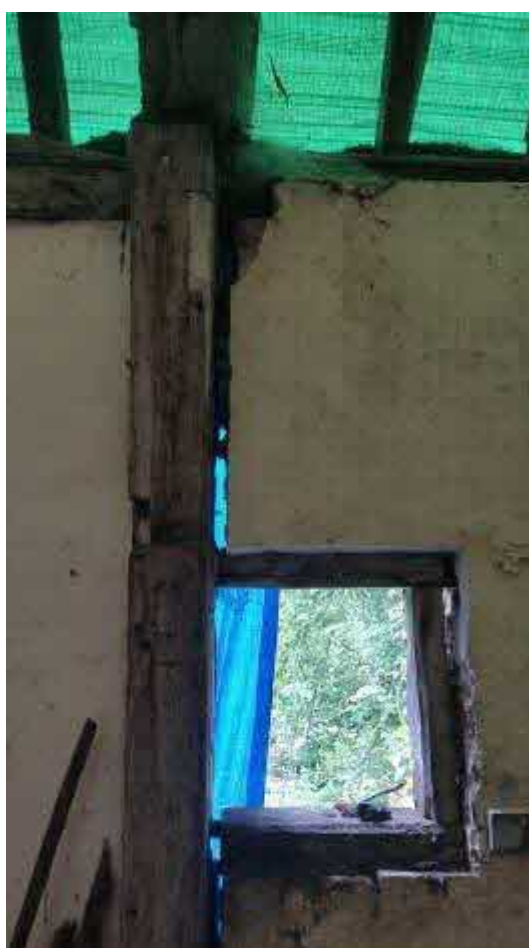
Photograph 08 – Principal post on east facing elevation at junction with later brick extension.

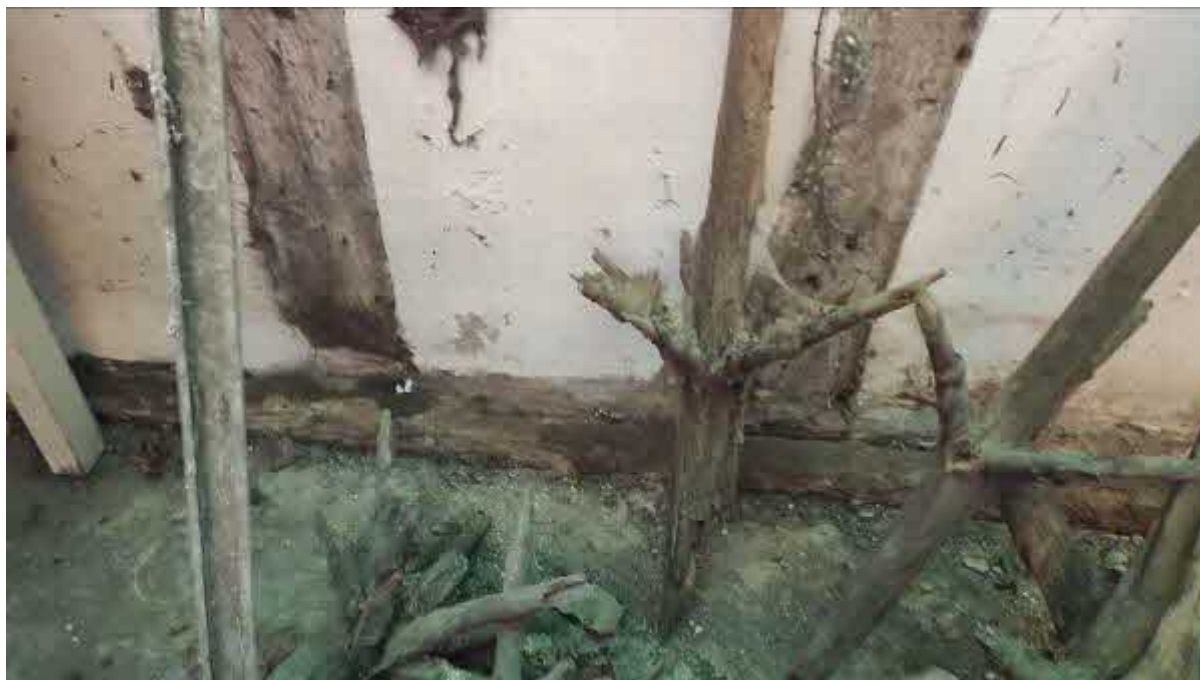
**Photograph 09 – Previous cement repair to bottom timber plate, east facing elevation.**

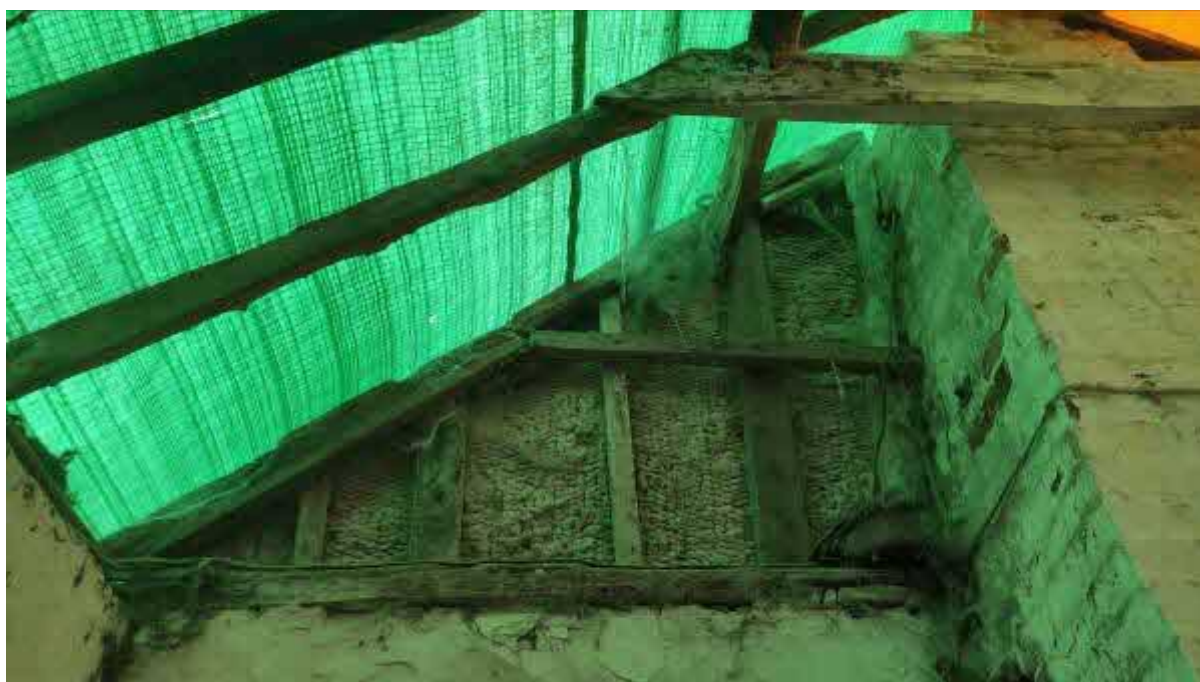
**Photograph 10 – Left hand spandrel panel at the south gable.**

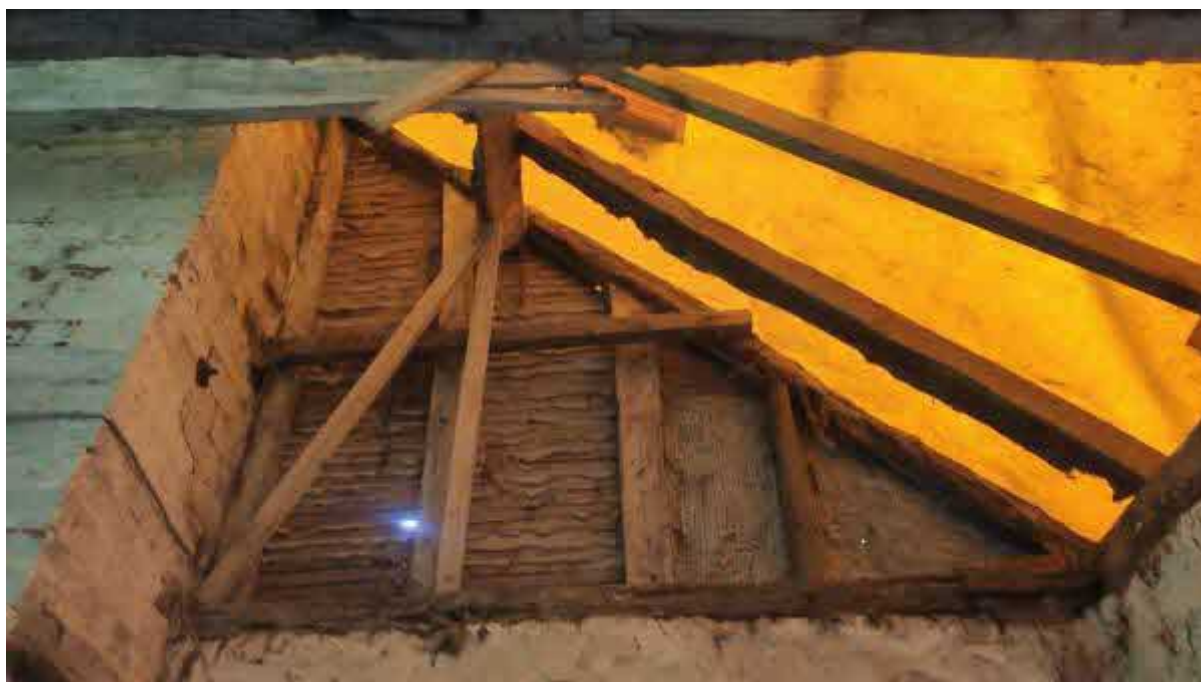
Photograph 11 – Right hand spandrel panel at the south gable.

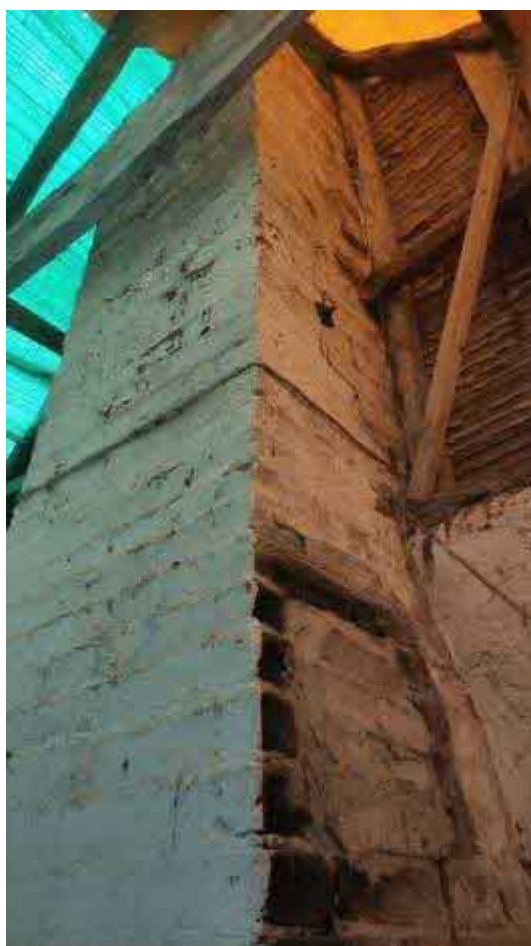
Photograph 12 – Existing steel tie through the stack at the south end.

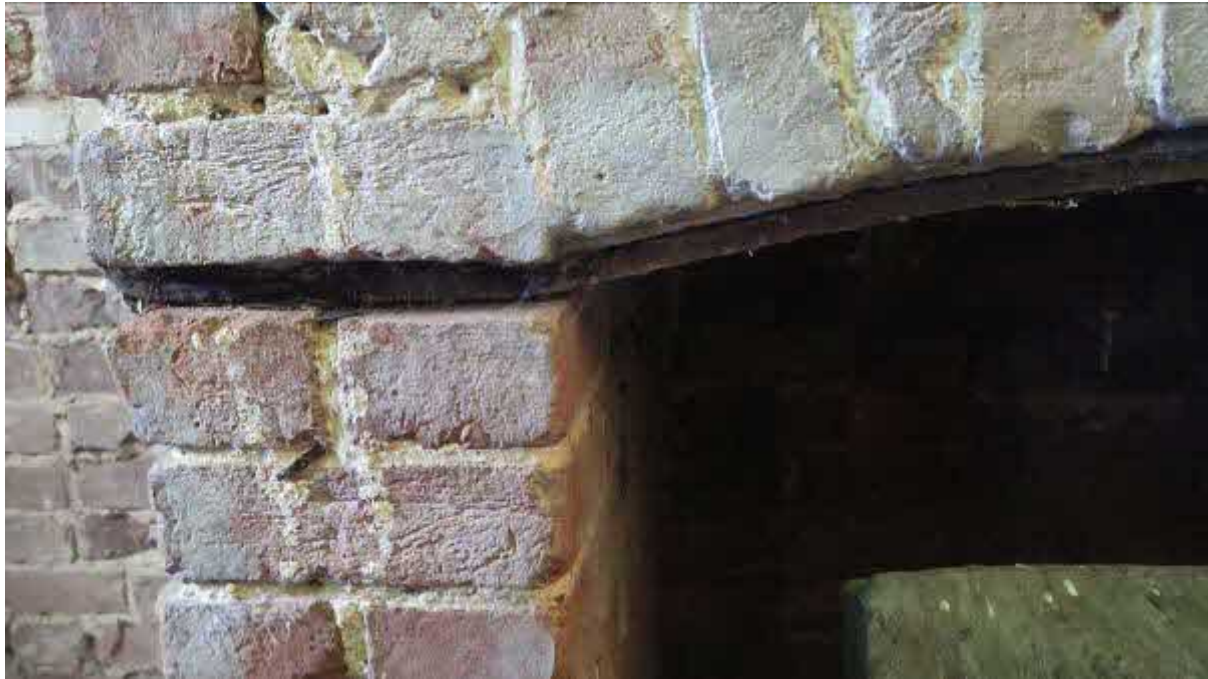
Photograph 13 – Rust jacking caused by the fireplace lintel.

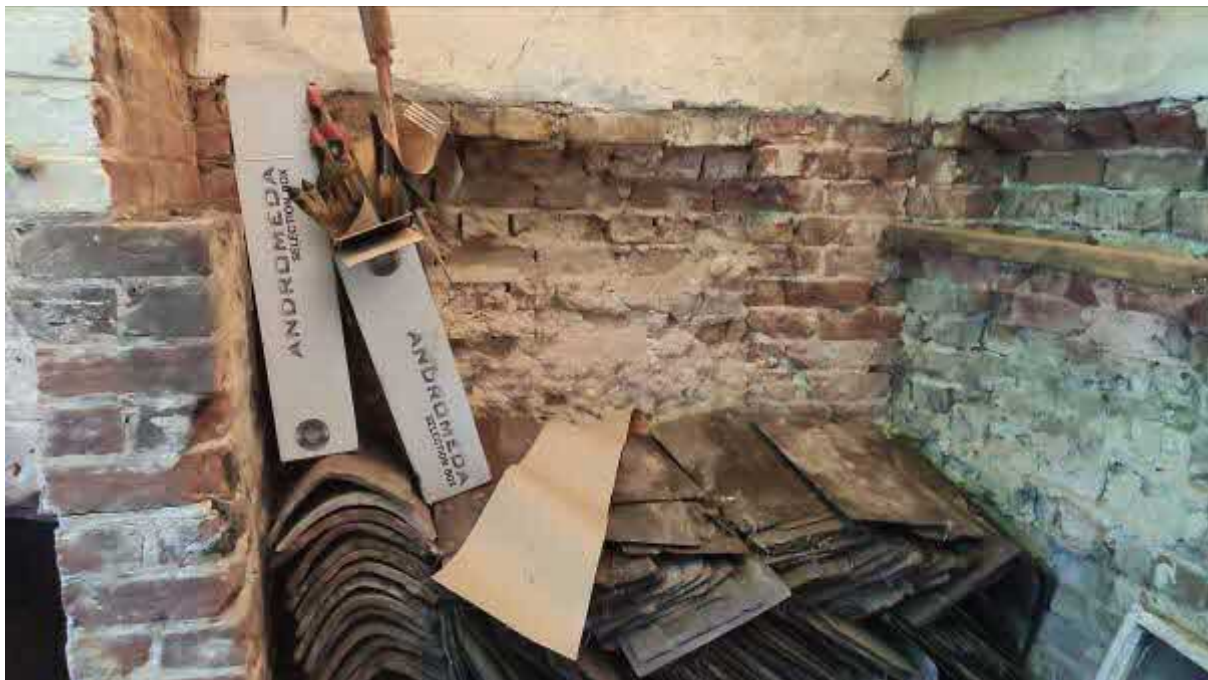
Photograph 14 – Pocket cut into the south gable wall.

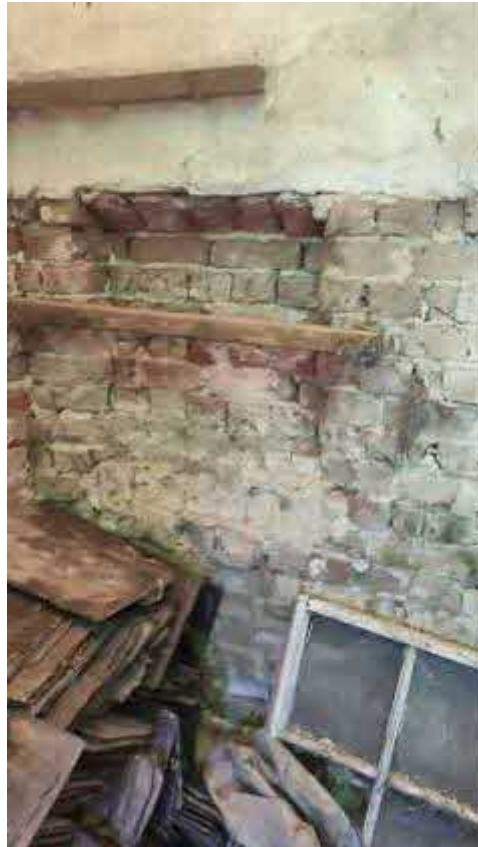
**Photograph 15 – Pocket cut into the brick wall on the west facing elevation.**

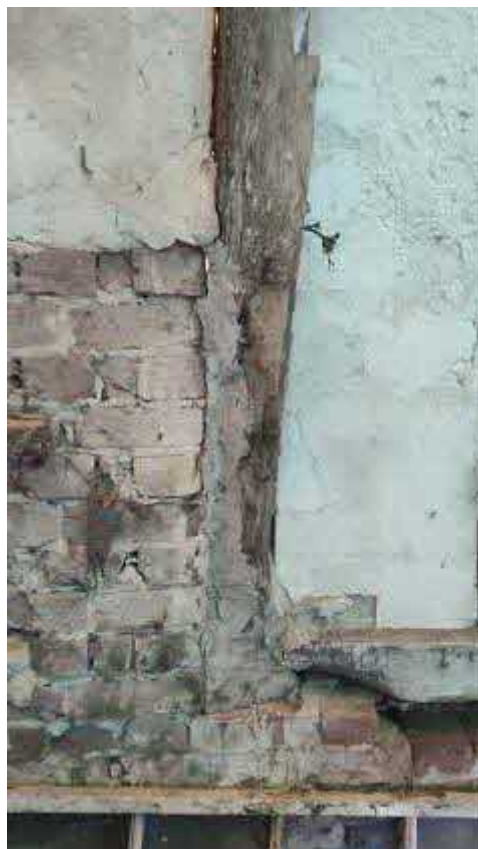
**Photograph 16 – Previous cement repair to base of principal post, west facing elevation towards the south end.**

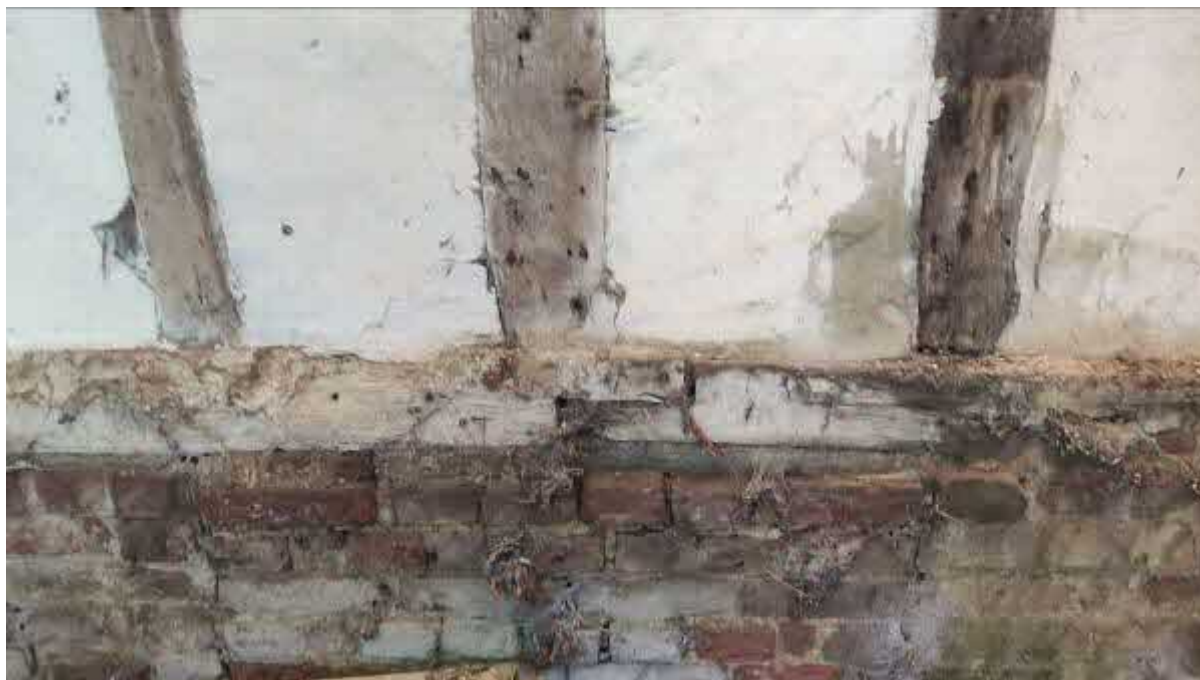
Photograph 17 – Bottom wall plate on west side showing the half lapped joint.

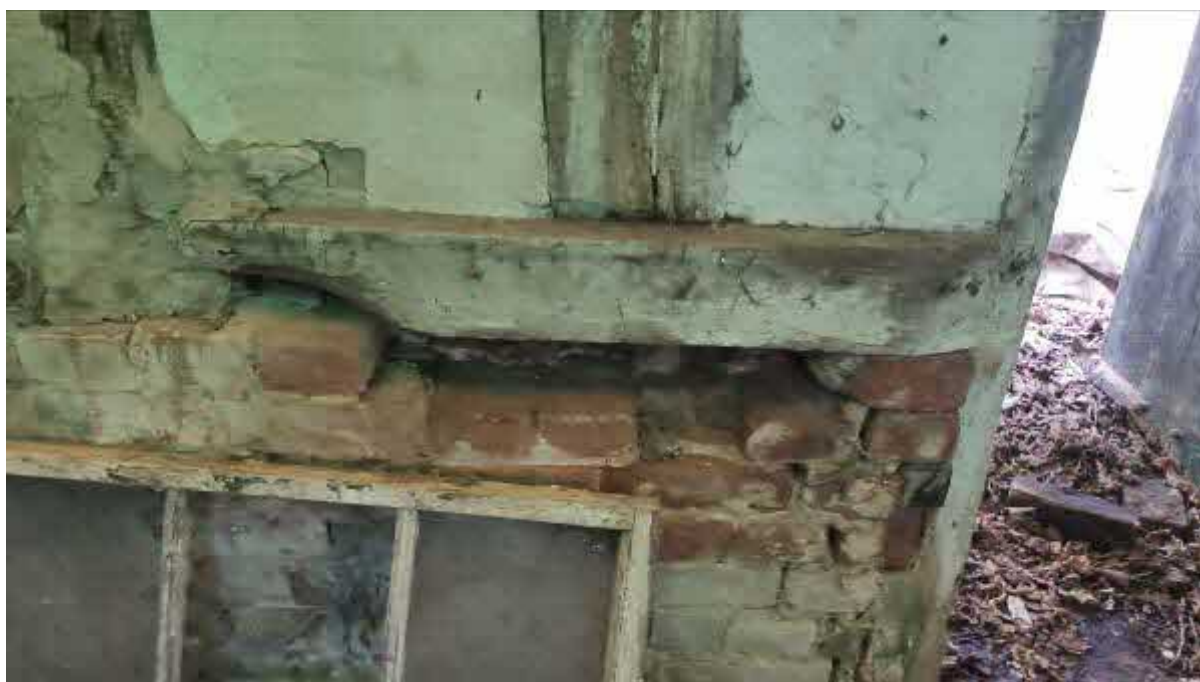
Photograph 18 – Missing bricks in plinth wall, west facing elevation.
