87 Woolverstone Close
Ipswich
IP2 9RX

Structural Inspection Report

- 1.1 J P Chick & Partners Limited were appointed by Orwell Housing to undertake a structural inspection to report on crack damage. Our initial report IG22/340 dated 15 November 2022 refers. This is contained within Appendix A for completeness.
- 1.2 Within our report we made recommendations with regard to further investigations to be undertaken in order to understand and identify the mechanism of movement and likely cause. We were subsequently appointed by Orwell Housing to undertake these investigations.
- 1.3 Intrusive site Investigations were undertaken Soil Investigation Eastern Limited on 05 June 2023 following an initial aborted attempt on 04 May 2023 where access could not be permitted. The factual Report for the investigations is contained within Appendix B to the rear of this Report.

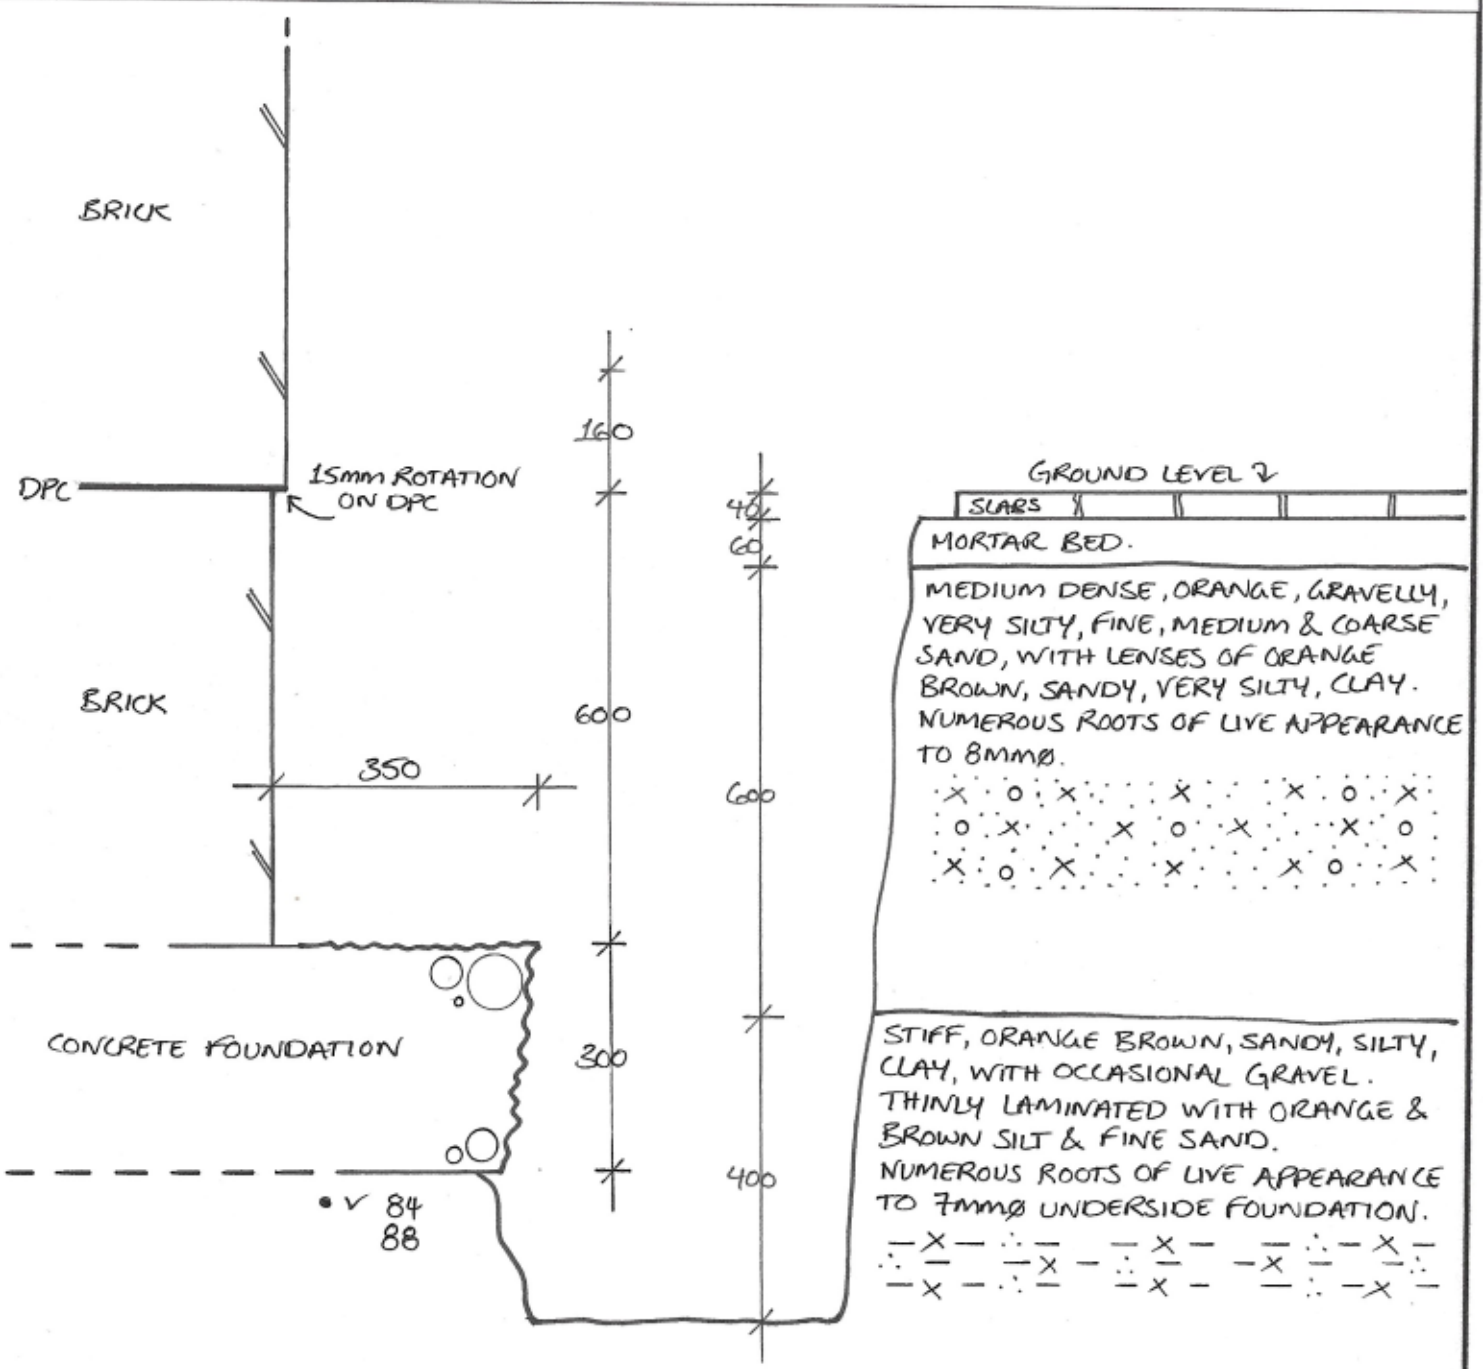
Trial Pit 1

- 3.1 In trial Pit 1, the foundation is a concrete strip footing 300mm thick with a toe projection of 350mm, situated 900mm below existing ground level in a stiff sandy silty Clay. Roots of up to 7mm diameter were noted to the underside of the foundation. This clayey material remained unchanged but became stiffer continuing to 2.8m depth. From 2.8m through to termination at 6m the material was essentially very stiff silty Clay with silt and sand partings and roots continuing into the very stiff material at 3.6m depth. Shear vane readings obtained were consistently high, at or above 150kPa.

FOR STRATA BELOW 1100mm.
 SEE BOREHOLE 1 LOG.

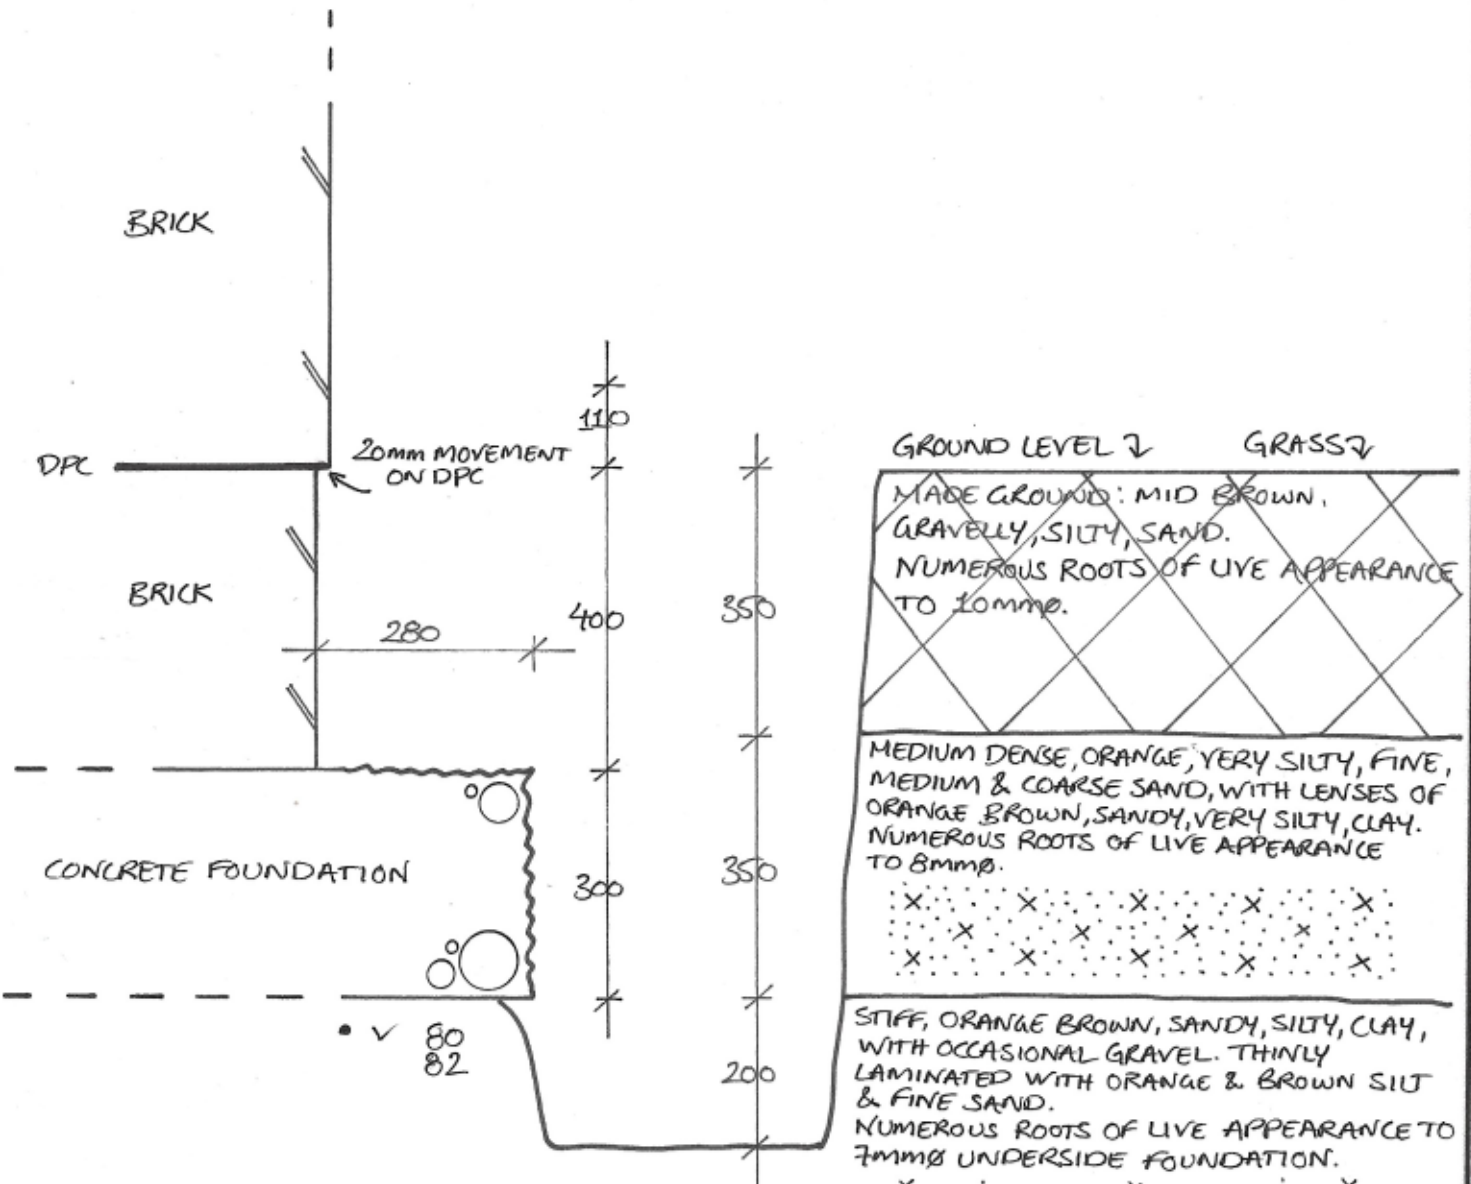
Trial Pit 2A

MADE GROUND: MID BROWN, GRAVELLY, SILTY, SAND. NUMEROUS ROOTS OF LIVE APPEARANCE TO 10mm.

MEDIUM DENSE, ORANGE, VERY SILTY, FINE, MEDIUM & COARSE SAND, WITH LENSES OF ORANGE BROWN, SANDY, VERY SILTY, CLAY. NUMEROUS ROOTS OF LIVE APPEARANCE TO 8mm.

STIFF, ORANGE BROWN, SANDY, SILTY, CLAY, WITH OCCASIONAL GRAVEL. THINLY LAMINATED WITH ORANGE & BROWN SILT & FINE SAND. NUMEROUS ROOTS OF LIVE APPEARANCE TO 7mm @ UNDERSIDE FOUNDATION.

TRIAL PIT ENDS AT 900mm.

Remarks DRY & OPEN ON COMPLETION.

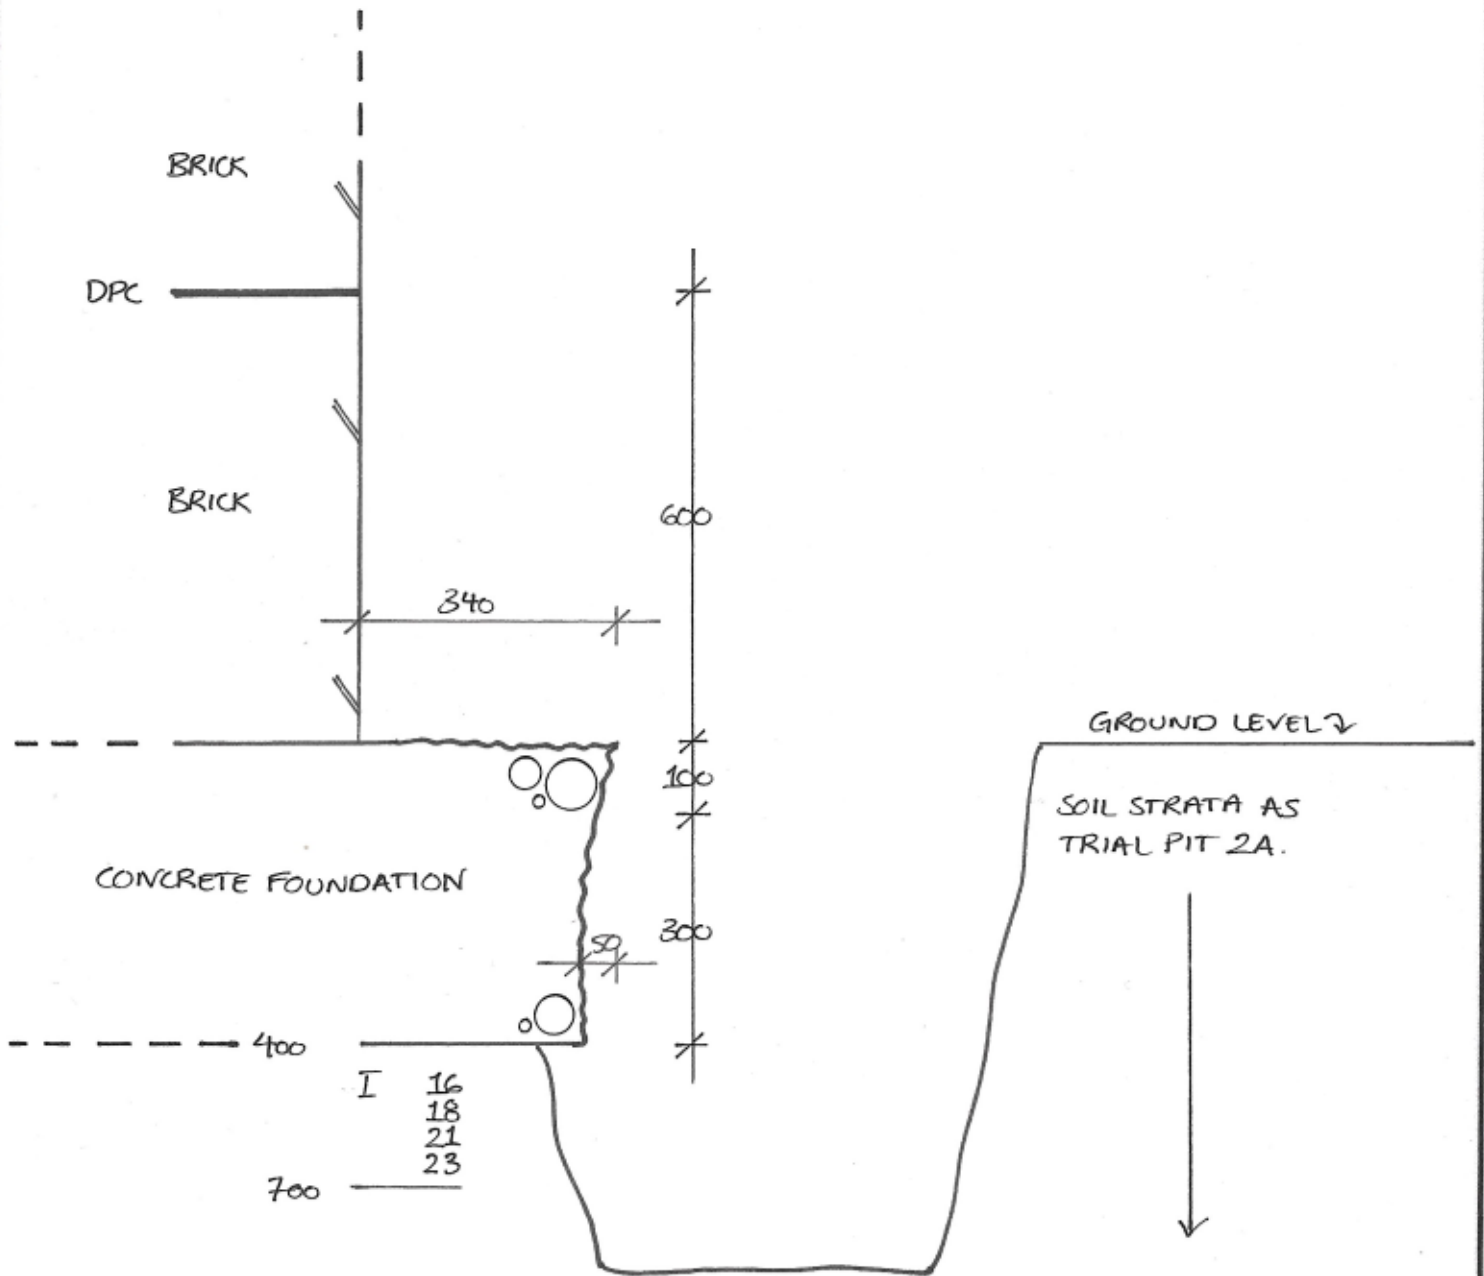
Trial Pit 2B

- 3.2 Trial Pit 2 was undertaken at the junction of number 87 and the rearward right hand flank projection of number 85. Findings are recorded within the Soil Investigation Eastern Limited Report within Appendix B, with details listed as trial pit 2a, showing the foundation of number 87 and trial pit 2b showing the foundation of number 85.

- 3.3 In this location the foundation for number 87 was recorded as concrete foundation situated at an overall depth of 700mm below ground level with a thickness of 300mm and a 280mm toe projection. Foundations recorded for number 85 indicate a concrete foundation and overall depth

of 400mm below ground level with a toe projection of 340mm. The toe projection was noted to be at or very close to existing ground level.

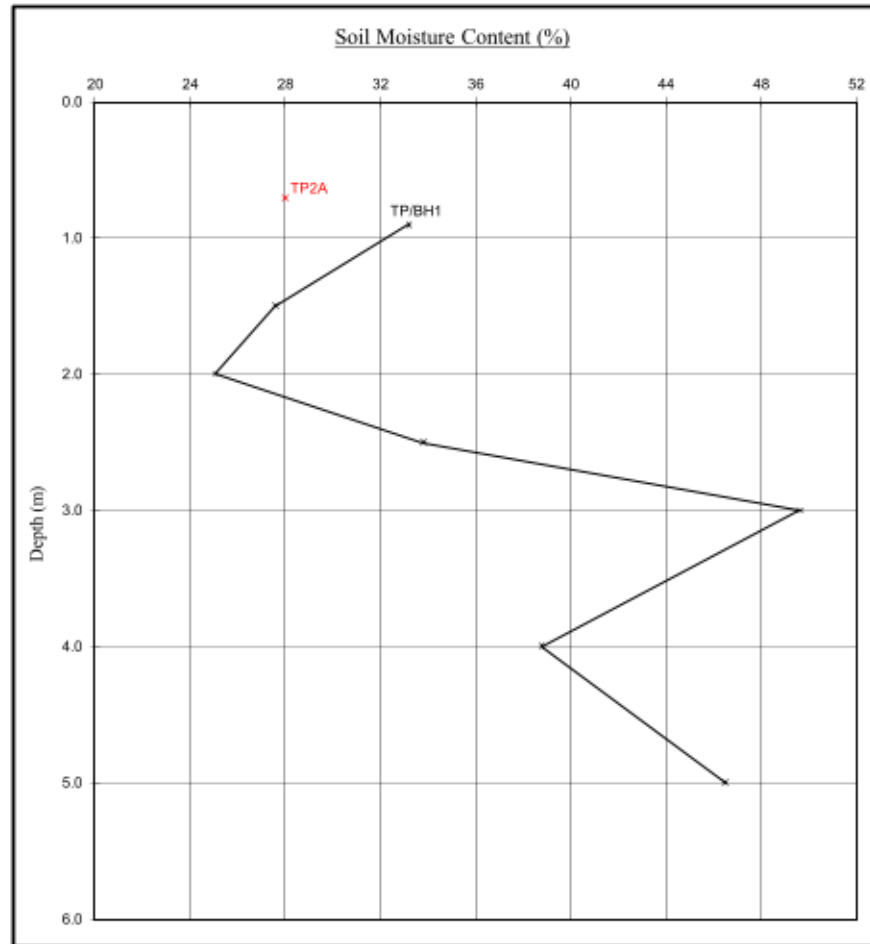
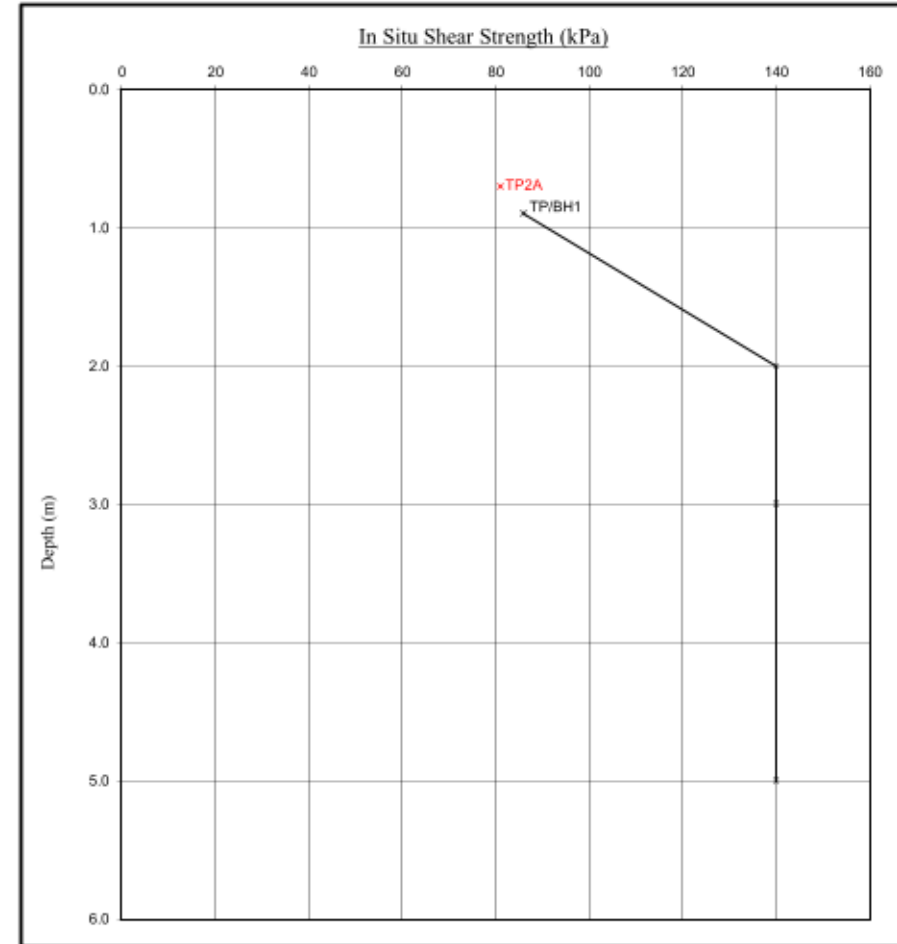
Moisture Content Profiles

4.3.1 Laboratory testing of soils was undertaken by Flawless Soil Testing Limited. Samples taken from directly to the underside of the foundation through to approximately 2.8m depth are considered to provide relative homogeneity. These have been classified as soils being clay with a high plasticity, increasing to very high at the bottom of this layer. The main difference being that the more coarse soil fraction retained on the 425-micron sieve recorded as 19% the underside of the foundation reduces through the layer to 8%, this does have limited impact on the plasticity index which is reduced as a consequence of the coarse fraction. The soil classification with regard to BS 5930 2018 Figure 8, remains as a clay of high plasticity and very high plasticity to the sample from 2.5m.

4.3.2 The clay layer from 2.8m through to 6m appears to provides relative homogeneity. Moisture contents within this layer commence at 50% from 3m before reducing to 39% and 46% at 5m. Roots

4.3.3 When considering the results in conjunction with empirical formulae the high plastic layer down to 2.8m shows moisture contents which reduce through the layer and increasingly have the potential to suffer from negative volumetric change. It is anticipated that volumetric change will occur where the natural moisture content of the soil falls within the envelope of 0.5-0.4 of the liquid limit. In this case soils from 0.9m and 1.5m are both within this envelope with soils recovered from 2m possibly falling below the 0.4 of the liquid limit. This then indicates that volumetric change is very likely. Within the layer below and again considering results with empirical formulae, moisture contents typically exist within the envelope of between 0.4 and 0.5 of the liquid limit, giving the potential that some negative movement may have occurred. This is with the likely exception of that recovered from 3m and at the bottom of the layer at 5m where moisture contents tend to increase.
