Appendix F – Existing Building CCTV Drainage Survey

Project Name: 67C Camlet Way, Barnet, EN4 0NL
Project Description: Pre-build
Project Date: 02/11/2022

Survey Comments & Recommendations

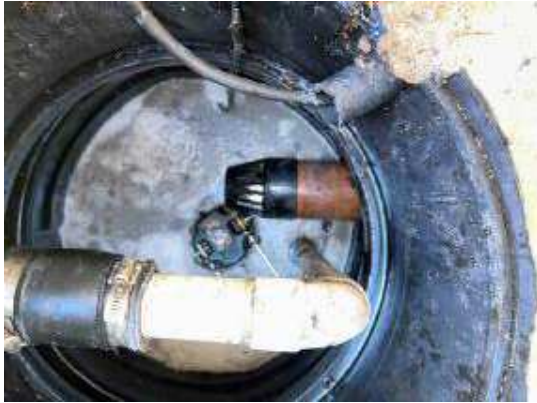
Recommend to remove Birdsnest off MH1 outlet in pump station due to blocking system

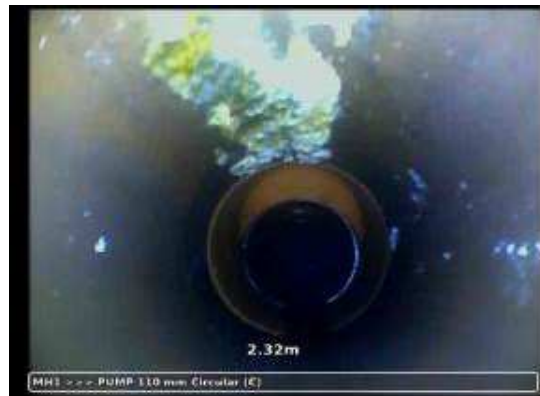
MH1X_d4186610-06ef-45f6-8cd6-e7d7a455cb7f_20221103_101641_060.jpg, 00:00:17, 2.32 m
Attached deposits, grease from 11 o'clock to 1 o'clock, 10%

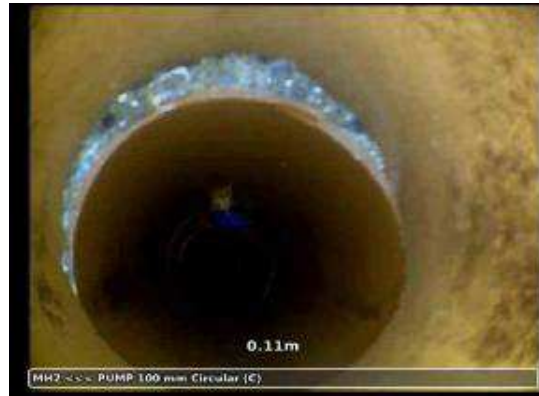
PUMPX_3e4c5767-e416-4097-99d1-cd8b95deb938_20221103_101803_237.jpg, 00:00:07, 0.15 m
Joint displaced, large

Town or Village:	Barnet	Inspection Direction:	Upstream	Upstream Node:	PUMP
Road:	67C Camlet Way	Inspected Length:	4.14 m	Upstream Pipe Depth:	0.000 m
Location:	Other (state in comments)	Total Length:	4.14 m	Downstream Node:	MH2
Surface Type:		Joint Length:		Downstream Pipe Depth:	0.550 m
Use:	Combined	Pipe Shape:	Circular		
Type of Pipe:	Gravity drain/sewer	Dia/Height:	100 mm		
Flow Control:	No flow control	Pipe Material:	Vitrified clay pipe (i.e. all clayware)		
Year Constructed:	Not Specified	Lining Type:	No Lining		
Inspection Purpose:	Sample survey to determine asset condition	Lining Material:	No Lining		
Comments:	Pump station discharges to MH2 - Large displacement and redundant connection noted.				
Recommendations:	Install 1m x 100mm Silicate Patch Liner

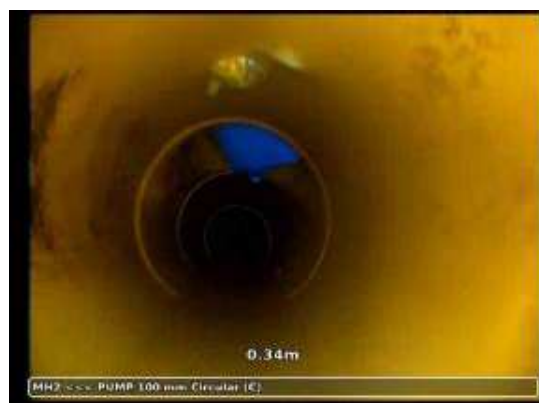
PUMPX_ef7f340b-ff86-48ce-96ff-8cf3af438302_20221103_101830_947.jpg, 00:00:12, 0.34 m
Hole in drain or sewer from 11 o'clock to 12 o'clock

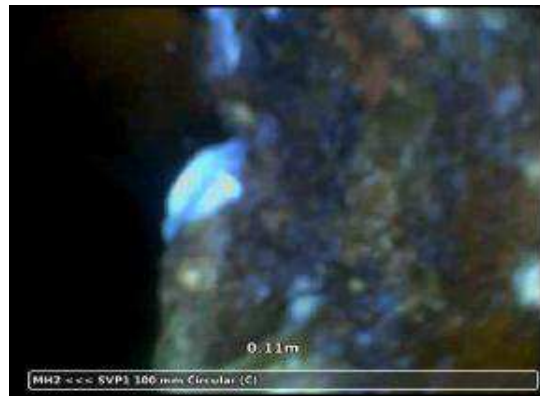
SVP1X_0a8c1da8-9521-43ca-ba49-016bff673e7c_20221103_1
 02335_573.jpg, 00:00:16, 0.11 m
 Attached deposits, encrustation at joint from 12 o'clock to 7

Comments: Survey abandoned due to intruding mortar into joint connection
Recommendations: Picote cut obstruction & Re Survey - Patch Lining repair will likely be required

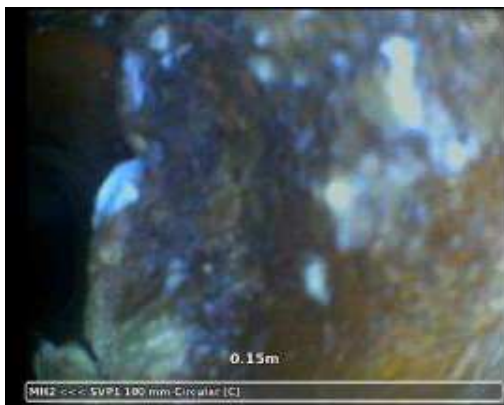
20221102-091513-snap0001.jpg, 00:00:21, 0.15 m
 Survey abandoned, Concrete obstructing

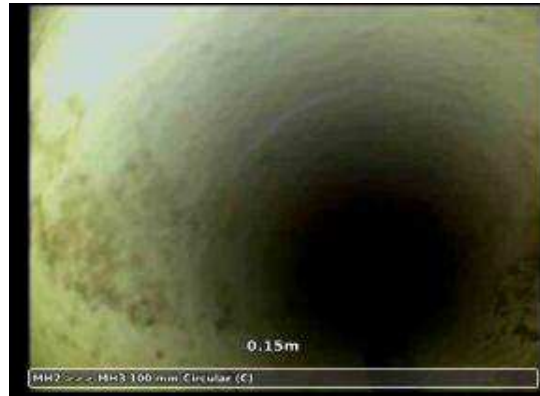
MH2X_d1e2fe50-4e31-4e78-b6c6-037906ac171f_20221103_102714_032.jpg, 00:00:05, 0.15 m
 Crack, circumferential from 9 o'clock to 3 o'clock

Town or Village:	Barnet	Inspection Direction:	Downstream	Upstream Node:	MH2
Road:	67C Camlet Way	Inspected Length:	2.85 m	Upstream Pipe Depth:	0.550 m
Location:	Other (state in comments)	Total Length:	2.85 m	Downstream Node:	MH3
Surface Type:		Joint Length:		Downstream Pipe Depth:	0.840 m
Use:	Combined	Pipe Shape:	Circular		
Type of Pipe:	Gravity drain/sewer	Dia/Height:	100 mm		
Flow Control:	No flow control	Pipe Material:	Vitrified clay pipe (i.e. all clayware)		
Year Constructed:	Not Specified	Lining Type:	No Lining		
Inspection Purpose:	Sample survey to determine asset condition	Lining Material:	No Lining		
Comments:	Survey abandoned due to deformed pitch fibre pipe - Survey completed with below section				
Recommendations:	Re-round/re-line up to 5m x 100mm pipework

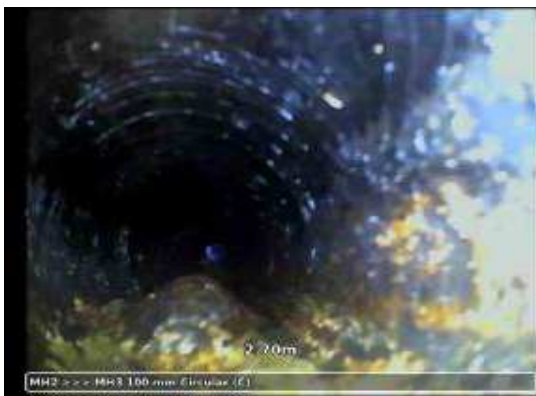
MH2X_f54133c6-7326-4428-b4d8-96821a162e64_20221103_102853_457.jpg, 00:00:36, 2.70 m
 Deformed drain or sewer. 20%

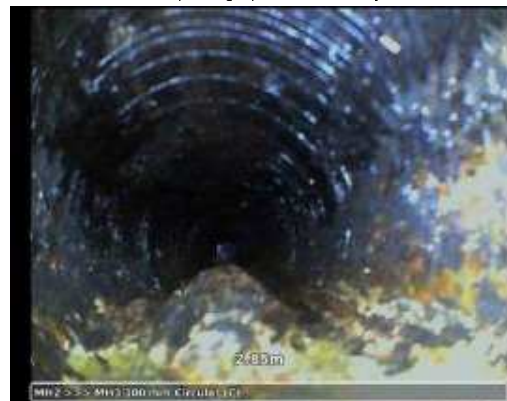
20221102-092005-snap0002.jpg, 00:00:47, 2.85 m
 Survey abandoned, Unable to pass deformed pitch fibre

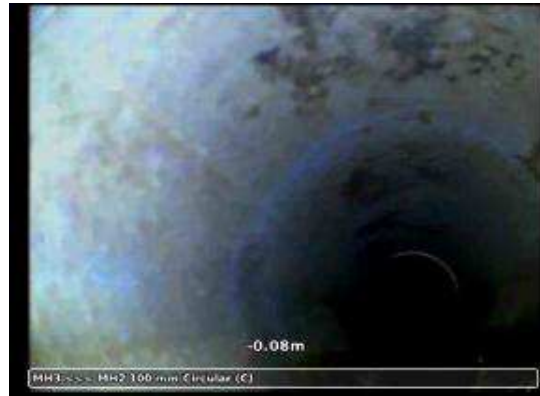
MH2X_263d938a-33ac-4c5d-af43-acc89c52318e_20221103_103027_801.jpg, 00:00:05, 0.08 m
 Crack, circumferential from 12 o'clock to 12 o'clock

Town or Village:	Barnet	Inspection Direction:	Upstream	Upstream Node:	MH2
Road:	67C Camlet Way	Inspected Length:	1.98 m	Upstream Pipe Depth:	0.550 m
Location:	Other (state in comments)	Total Length:	1.98 m	Downstream Node:	MH3
Surface Type:		Joint Length:		Downstream Pipe Depth:	0.840 m
Use:	Combined	Pipe Shape:	Circular		
Type of Pipe:	Gravity drain/sewer	Dia/Height:	100 mm		
Flow Control:	No flow control	Pipe Material:	Vitrified clay pipe (i.e. all clayware)		
Year Constructed:	Not Specified	Lining Type:	No Lining		
Inspection Purpose:	Sample survey to determine asset condition	Lining Material:	No Lining		
Comments:	Survey abandoned due to deformed pitch fibre - Survey overlap from section 9 above				
Recommendations:	As per section 9 above

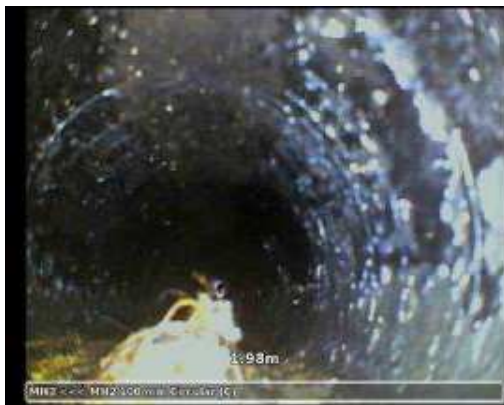
20221102-092526-snap0002.jpg, 00:00:29, 1.98 m
 Survey abandoned, Deformed Pitch fibre

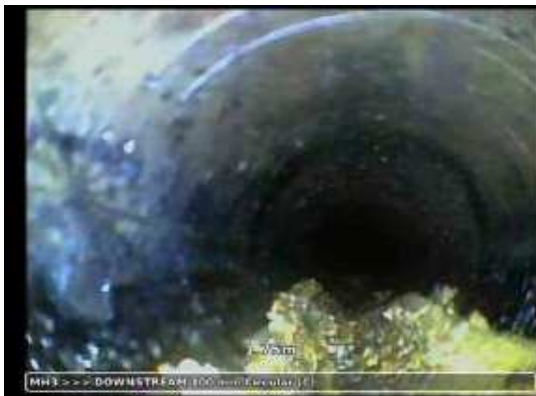
MH3X_eb4fd724-513f-48ce-a001-882928b98f4e_20221103_103640_938.jpg, 00:00:14, 1.75 m
Settled deposits, other, 20% cross-sectional area loss, start

Town or Village:	Barnet	Inspection Direction:	Downstream	Upstream Node:	MH3
Road:	67C Camlet Way	Inspected Length:	12.77 m	Upstream Pipe Depth:	0.870 m
Location:	Other (state in comments)	Total Length:	12.77 m	Downstream Node:	DOWNSTREAM
Surface Type:		Joint Length:		Downstream Pipe Depth:	0.000 m
Use:	Combined	Pipe Shape:	Circular		
Type of Pipe:	Gravity drain/sewer	Dia/Height:	100 mm		
Flow Control:	No flow control	Pipe Material:	Vitrified clay pipe (i.e. all clayware)		
Year Constructed:	Not Specified	Lining Type:	No Lining		
Inspection Purpose:	Sample survey to determine asset condition	Lining Material:	No Lining		
Comments:	Survey abandoned due to deformed pitch fibre - MH4 is buried under the flower bed				
Recommendations:	Raise MH4, Picote clean line & attempt to complete CCTV survey

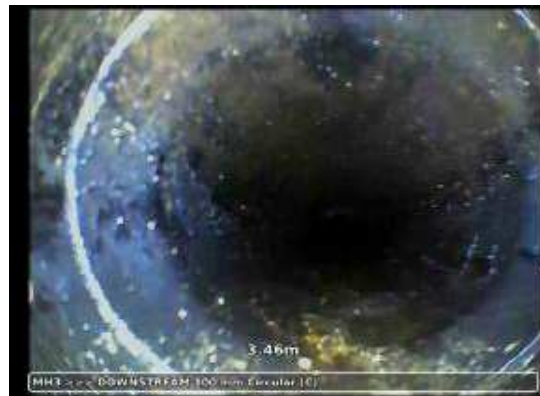
MH3X_ec6b3537-449e-418a-849f-c58954c1dc25_20221103_103658_450.jpg, 00:00:19, 3.46 m
Settled deposits, other, 20% cross-sectional area loss, finish

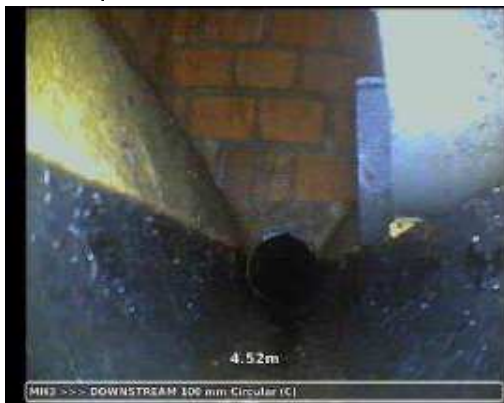
20221102-093611-snap0001.jpg, 00:00:22, 4.52 m
General remark, MH4 Buried under flower bed

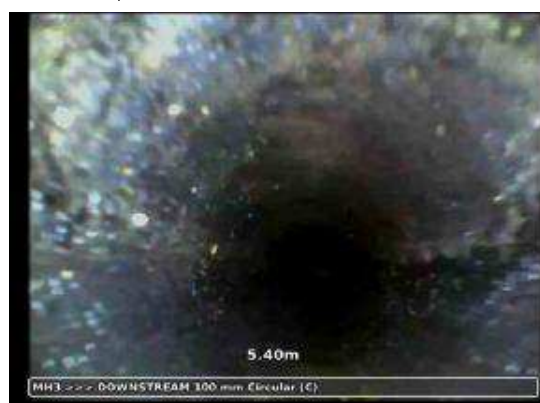
MH3X_bbb910b0-a049-4d7a-94b2-b81635bf3c1a_20221103_103755_390.jpg, 00:00:28, 5.32 m
Deformed drain or sewer, 15%, start

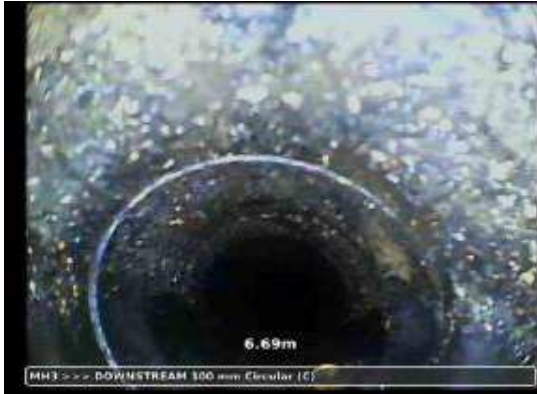
MH3X_e584b10d-6e36-4463-a30e-b638d0b97122_20221103_103825_879.jpg, 00:00:32, 6.69 m
 Deformed drain or sewer, 20%, start

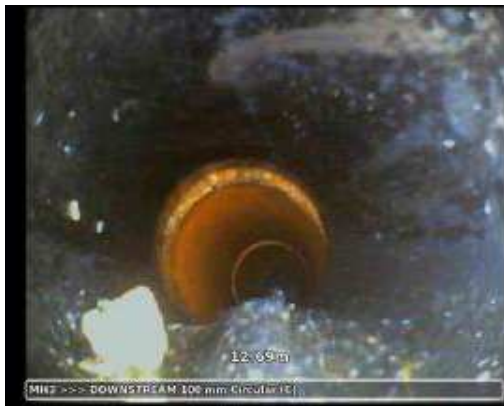
20221102-093611-snap0002.jpg, 00:01:01, 12.77 m
 Survey abandoned, Defect pipe
