Pavilion Gardens

Condition Survey Report

for Allen Scott Ltd

Condition Survey Report 2022

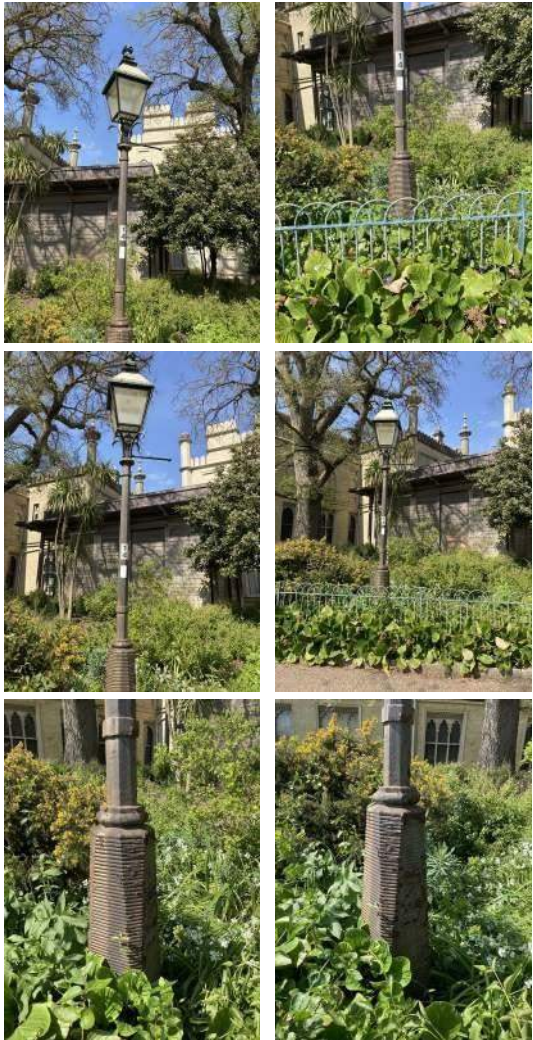
Item	Element & Description	Condition and Recommendation	Repair Category	Photograph
3.1.2	Lamp post 14			
	<p>Cast iron lamp post. This lamp post is not identified within the CBA conservation plan as being listed. Reeded square base with William IV's insignia. Opaque glass to lamp.</p>	<p>a Significant corrosion to reeded base.</p>	<p>A</p>

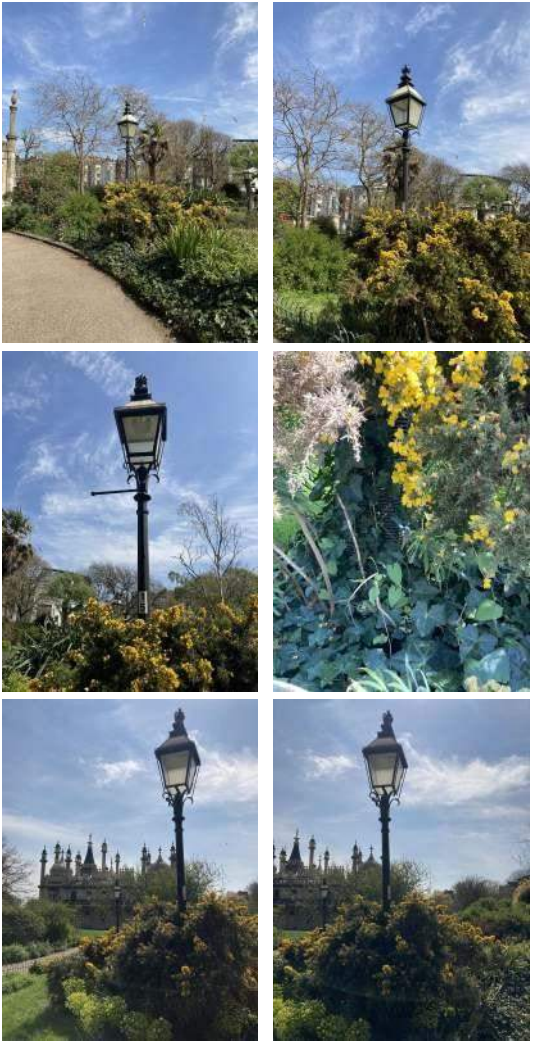
Item	Element & Description	Condition and Recommendation	Repair Category	Photograph
3.1.3	Lamp post 15			
	<p>Cast iron lamp post. Grade II listed. Original gas fittings removed circa late C19 or C20 and now has LED bulb. Reeded square base with William IV's insignia. Clear tinted glass and modern LED bulb.</p>	<p>a Good although partially obscured at base due to planting.</p>	<p>B</p>

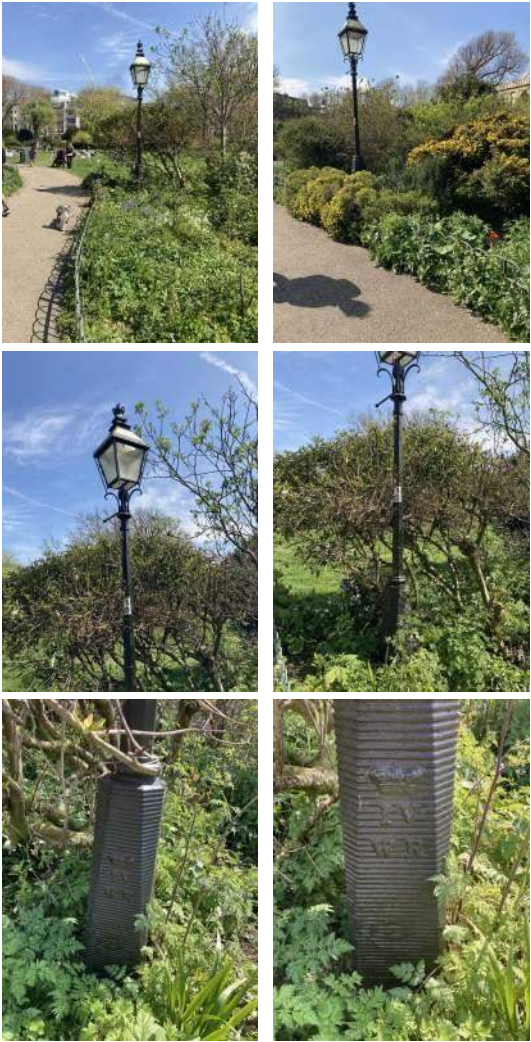
Item	Element & Description	Condition and Recommendation	Repair Category	Photograph
3.1.4	Lamp post 18			
	<p>Cast iron lamp post. Grade II listed. Original gas fittings removed circa late C19 or C20 and now has LED bulb. Reeded square base with William IV's insignia.</p>	<p>a Good. Base partially obscured by planting. Slightly opaque glass and debris/ dirt build up within lamp head.</p>	<p>B</p>

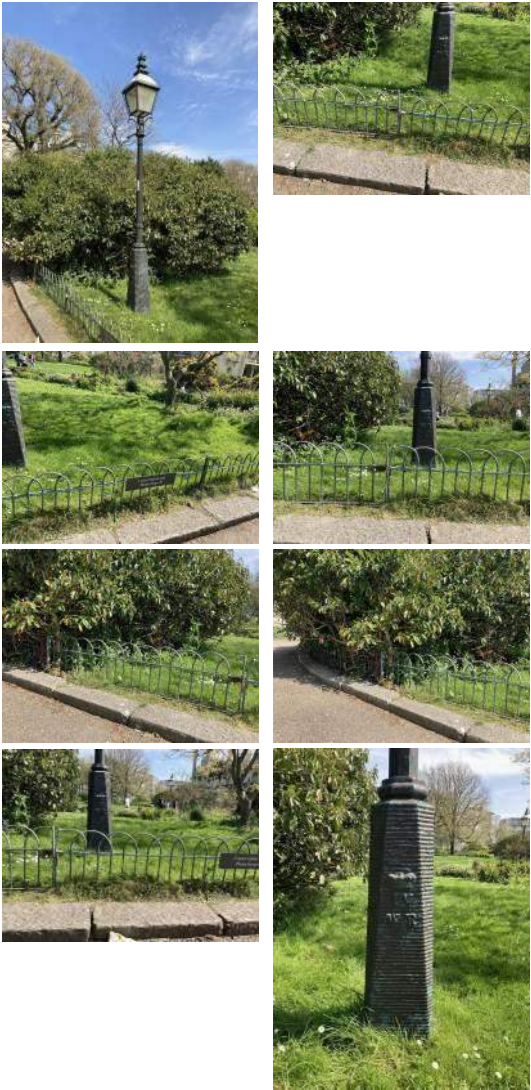
Item	Element & Description	Condition and Recommendation	Repair Category	Photograph
3.1.5	Lamp post 19			
	<p>Cast iron lamp post. Not noted within CBA conservation plan as being listed. Reeded square base with William IV's insignia. Evidence of 2 paint different paint schemes - lighter green below a darker green. Glass is slightly opaque.</p>	<p>a Good but paint flaking.</p>	<p>B</p>

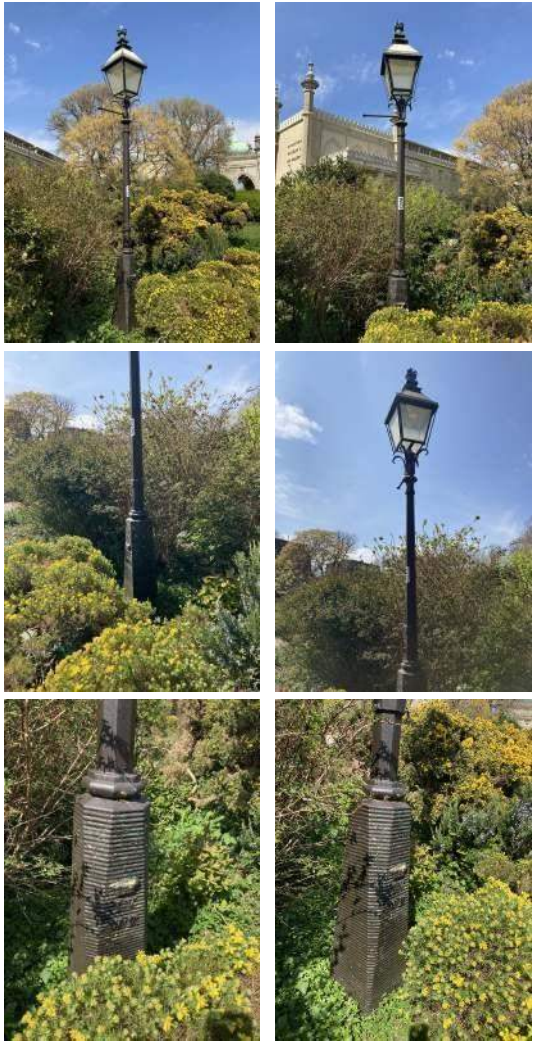
Item	Element & Description	Condition and Recommendation	Repair Category	Photograph
3.1.6	Lamp post 20			
	<p>Cast iron lamp post. Not included within CBA as listed. Reeded square base with William IV's insignia. Appears to have different paint colour scheme to lamp.</p>	<p>a Good. Paint flaking at base exposing different paint schemes - lighter yellow (primer?), light green and darker green.</p>	<p>B</p>

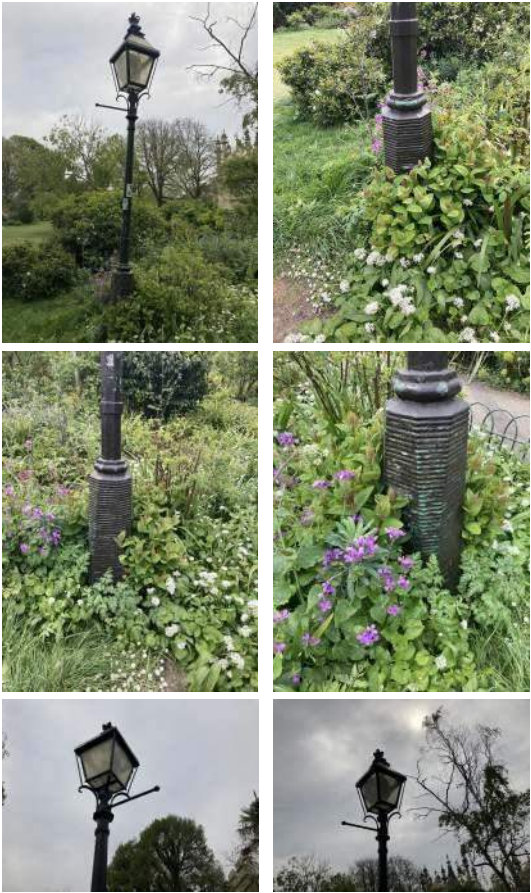
Item	Element & Description	Condition and Recommendation	Repair Category	Photograph
3.1.7	Lamp post 16			
	<p>Cast iron lamp post. Grade II listed. Original gas fittings removed circa late C19 or C20 and now has LED bulb. Reeded square base with William IV's insignia. Clear tinted glass.</p>	<p>a Cast iron components appear sound but bulb damaged. Paint flaking and some corrosion at base.</p>	<p>A</p>

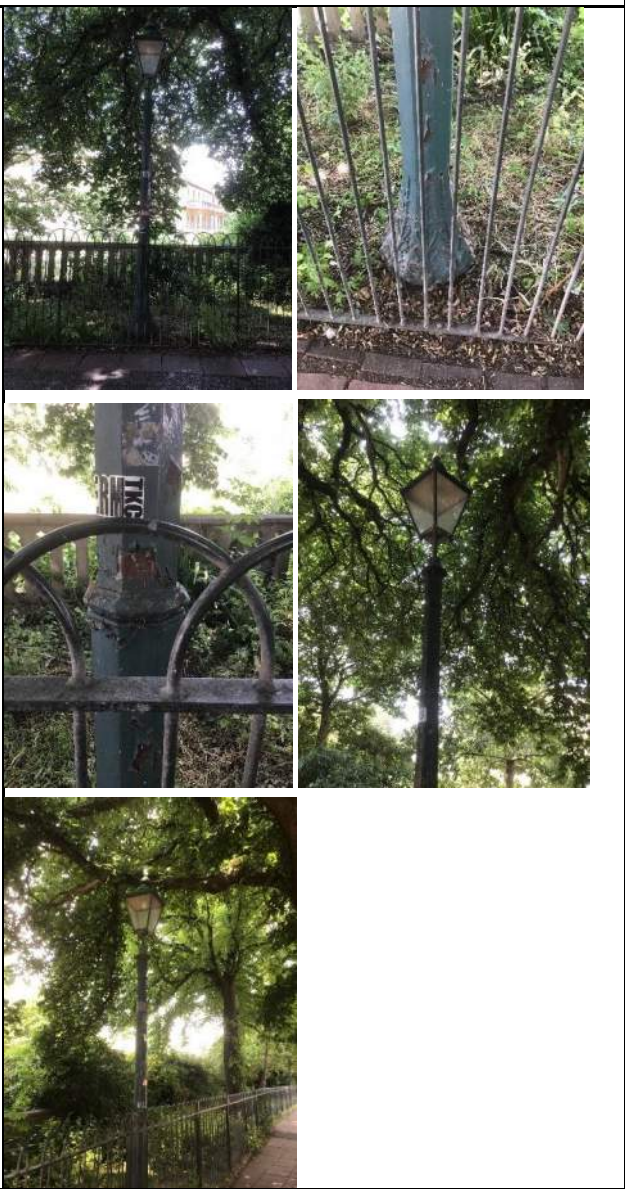
Item	Element & Description	Condition and Recommendation	Repair Category	Photograph
3.1.8	Lamp post 6			
	Cast iron lamp post.	Suitable preparation to remove all corrosion at base (extend preparation below ground level), prime and redecorate with suitable paint finish to provide weather protection.	A

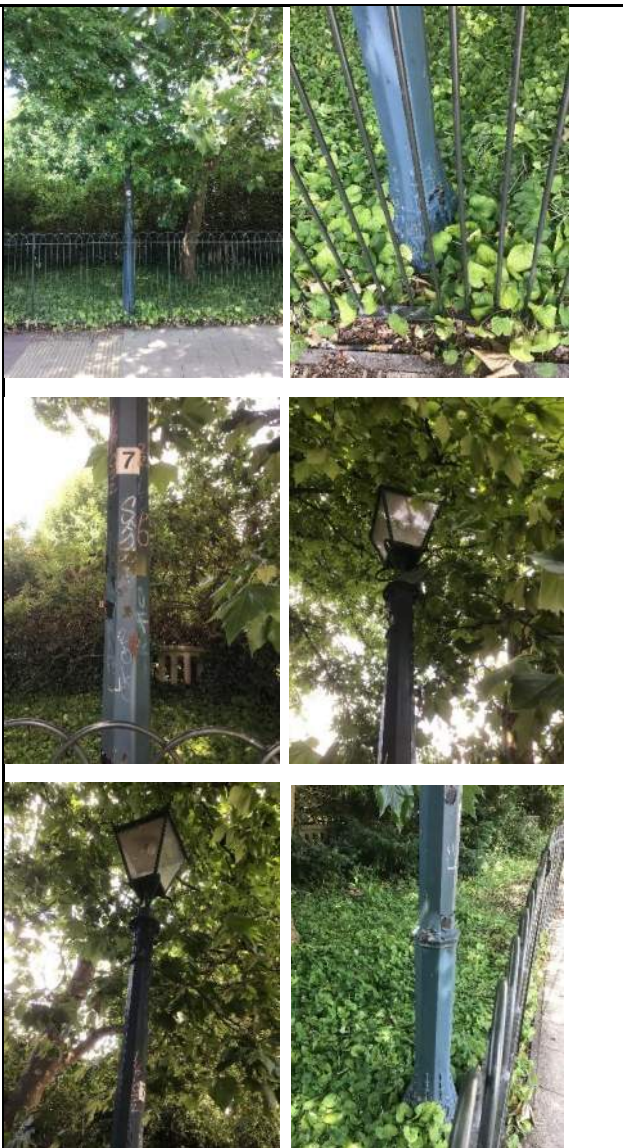
Item	Element & Description	Condition and Recommendation	Repair Category	Photograph
3.1.9	Lamp post 7			
	Cast iron lamp post.	Suitable preparation to remove all corrosion at base (extend preparation below ground level), prime and redecorate with suitable paint finish to provide weather protection.	A

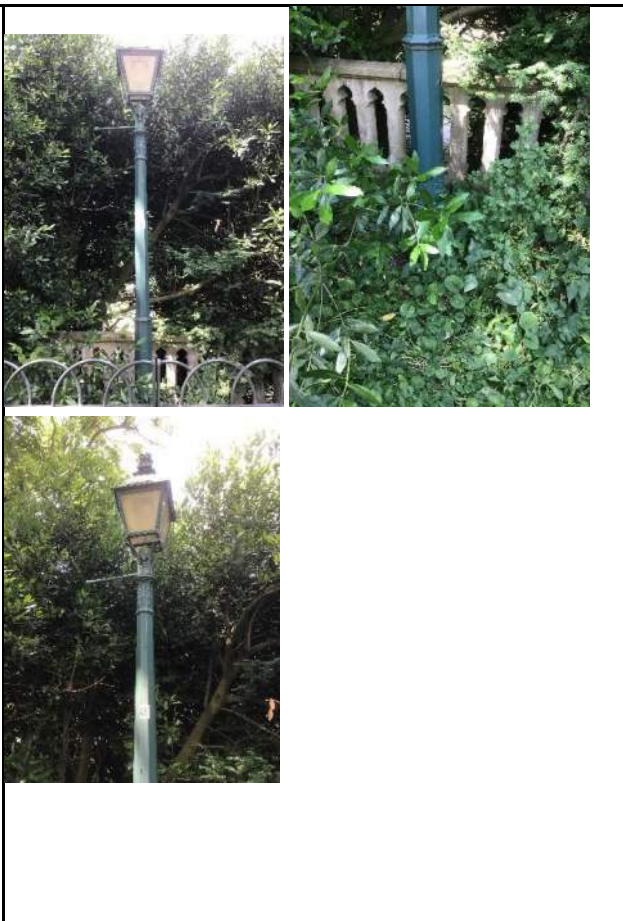
Item	Element & Description	Condition and Recommendation	Repair Category	Photograph
3.1.10	Lamp post 8			
	Cast iron lamp post.	Suitable preparation to remove all corrosion at base (extend preparation below ground level), prime and redecorate with suitable paint finish to provide weather protection.	A

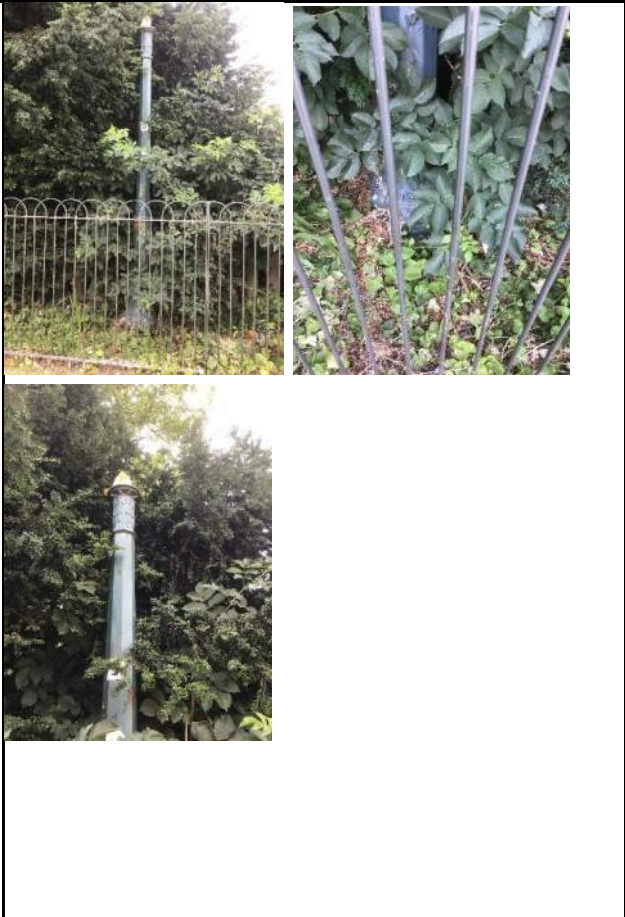
Item	Element & Description	Condition and Recommendation	Repair Category	Photograph
3.1.11	Lamp post 9			
	Cast iron lamp post.	<p>Missing lantern. Suitable preparation to remove all corrosion at base (extend preparation below ground level), prime and redecorate with suitable paint finish to provide weather protection.</p> <p>New replacement lantern to be provided to match existing precedent on site.</p>	A

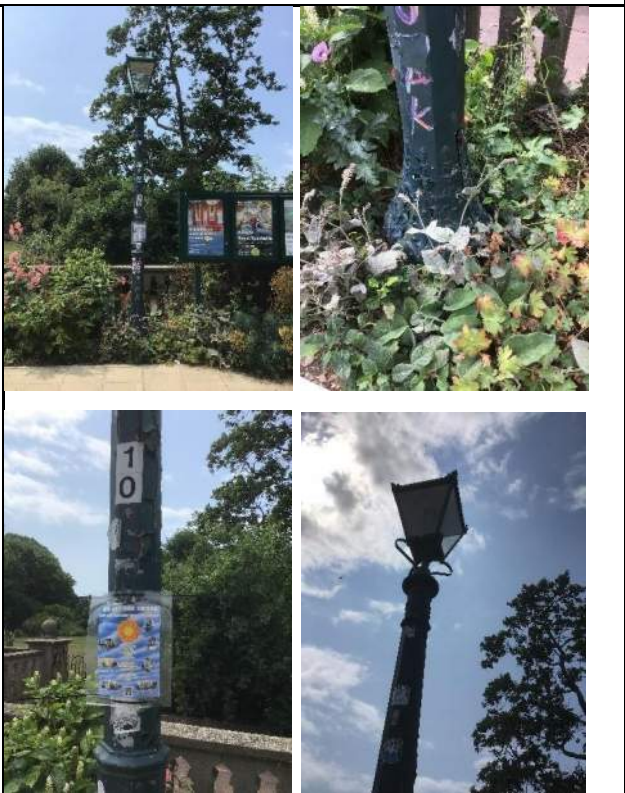
Item	Element & Description	Condition and Recommendation	Repair Category	Photograph
3.1.12	Lamp post 10			
	Cast iron lamp post.	Suitable preparation to remove all corrosion at base (extend preparation below ground level), prime and redecorate with suitable paint finish to provide weather protection.	A

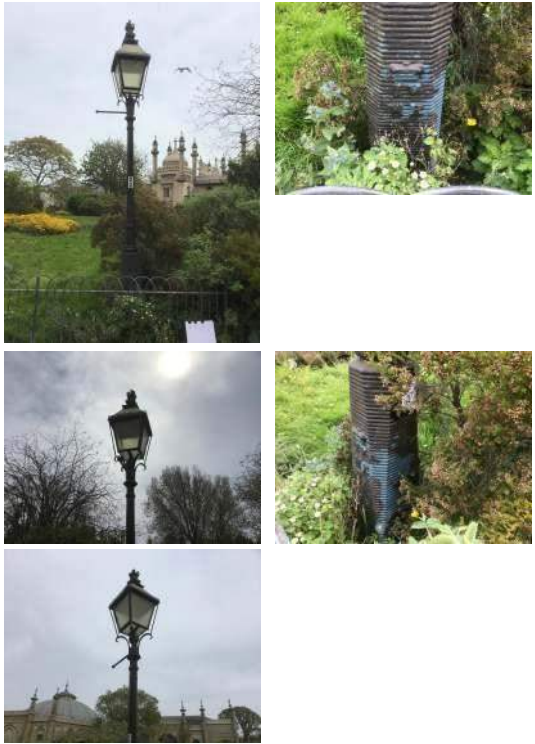
Item	Element & Description	Condition and Recommendation	Repair Category	Photograph
3.2.2	Lamp post 22			
	<p>Cast iron lamp post. Grade II listed. Original gas fittings removed circa late C19 or C20 and now has LED bulb. Reeded square base with William IV's insignia.</p>	<p>a Good. Paint flaking.</p>	<p>A</p>

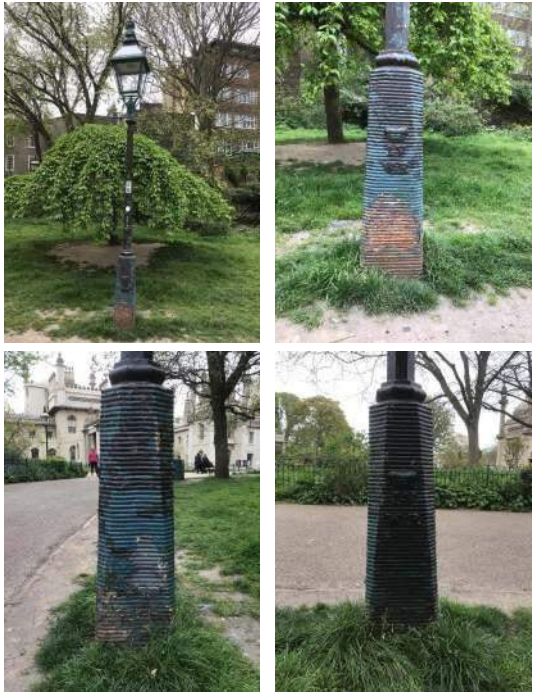
Item	Element & Description	Condition and Recommendation	Repair Category	Photograph
3.2.3	Lamp post 25			
	<p>Cast iron lamp post. Grade II listed. Original gas fittings removed circa late C19 or C20 and now has LED bulb. Reeded square base with William IV's insignia.</p>	<p>a Corrosion at base and paint flaking. Evidence of at least 3 paint schemes, light per green to lamp section compared to base. Clear tinted glass with led bulb. Appears to have been recently repaired?</p>	B

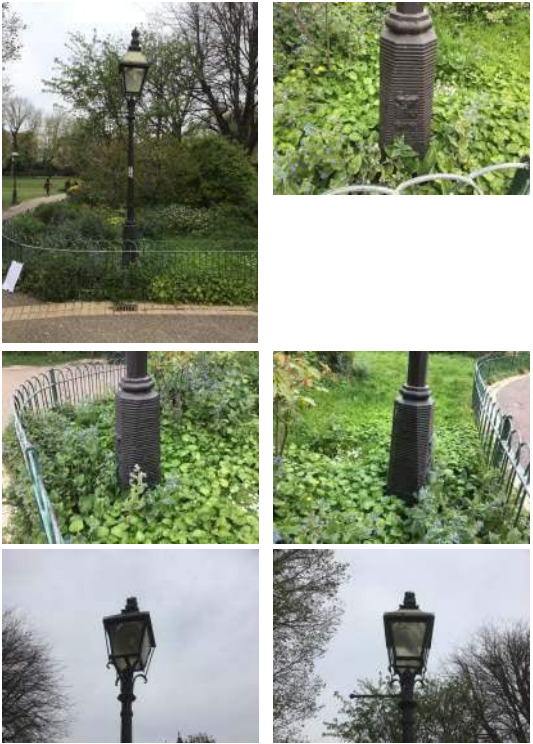
Item	Element & Description	Condition and Recommendation	Repair Category	Photograph
3.2.4	Lamp post 23			
	<p>Cast iron lamp post. Grade II listed. Original gas fittings removed circa late C19 or C20 and now has LED bulb. Reeded square base with William IV's insignia.</p>	<p>a Good. Evidence of previous paint schemes.</p>	<p>A</p>

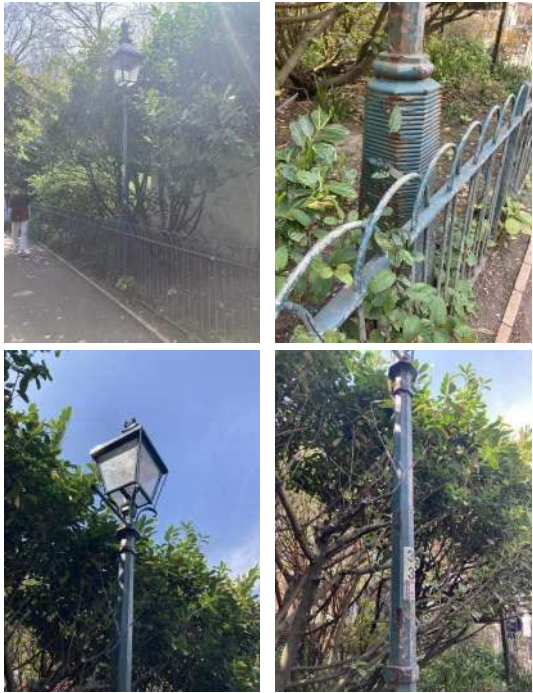
Item	Element & Description	Condition and Recommendation	Repair Category	Photograph
3.3	WESTERN LAWN			
3.3.1	Lamp post 33			
	<p>Cast iron lamp post. Grade II listed. Original gas fittings removed circa late C19 or C20 and now has LED bulb. Reeded square base with William IV's insignia.</p>	<p>a Significant corrosion to reeded base and octagonal post. Light green paint scheme.</p>	<p>A</p>

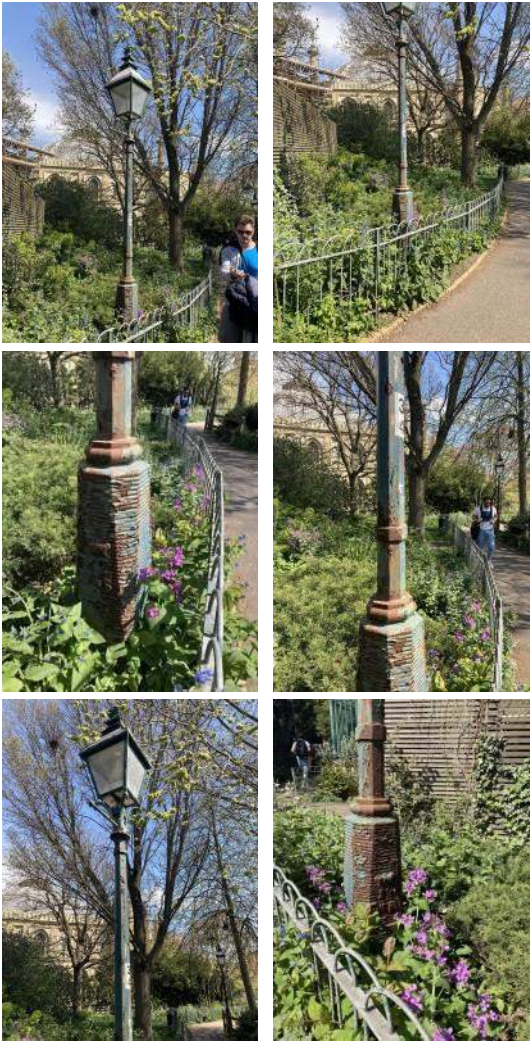
Item	Element & Description	Condition and Recommendation	Repair Category	Photograph
3.3.2	Lamp post 34			
	<p>Cast iron lamp post. Not noted within CBA conservation plan as listed. Reeded square base with William IV's insignia.</p>	<p>a Very poor with significant corrosion to reeded base and octagonal column.</p>	<p>A</p>

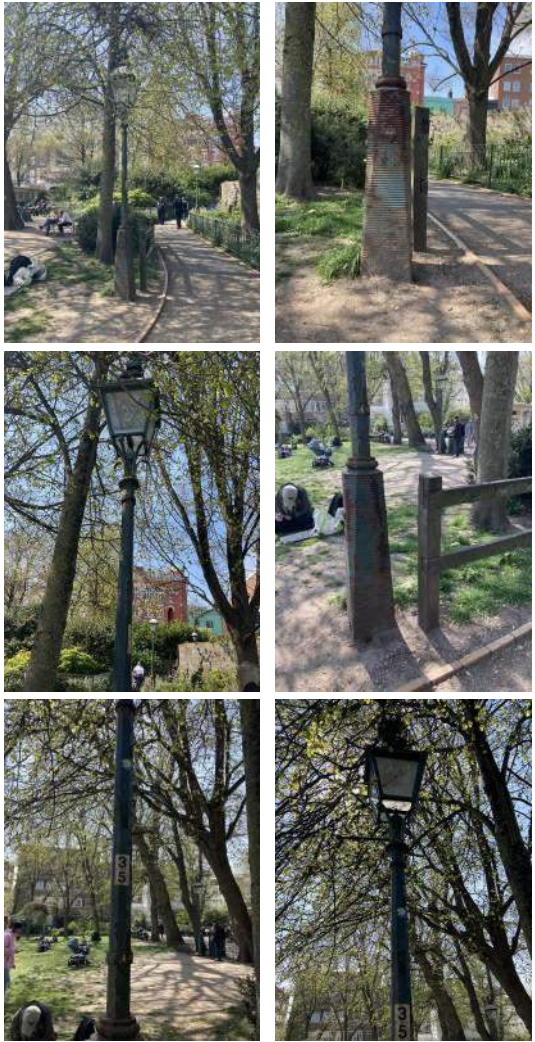
Item	Element & Description	Condition and Recommendation	Repair Category	Photograph
3.3.3	Lamp post 35			
	<p>Cast iron lamp post. Grade II listed. Original gas fittings removed circa late C19 or C20 and now has LED bulb. Reeded square base with William IV's insignia. Clear glass.</p>	<p>a Very poor with significant corrosion to reeded base and octagonal column.</p>	<p>A</p>

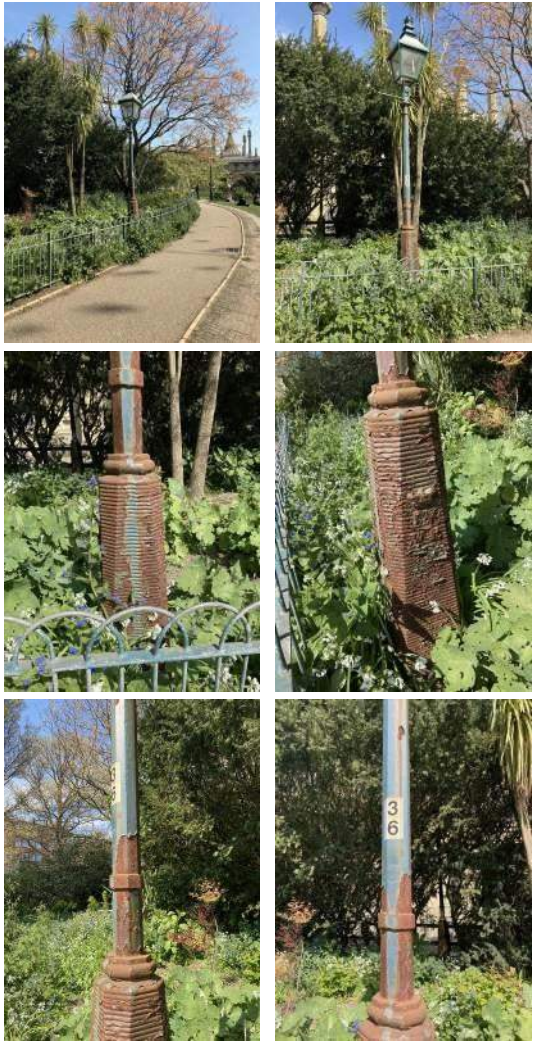
Item	Element & Description	Condition and Recommendation	Repair Category	Photograph
3.3.4	Lamp post 36			
	<p>Cast iron lamp post. Not included in the CBA plan as listed. Reeded square base with William IV's insignia. Light green painting scheme.</p>	<p>a Very poor with significant corrosion to reeded base and octagonal column.</p>	<p>A</p>

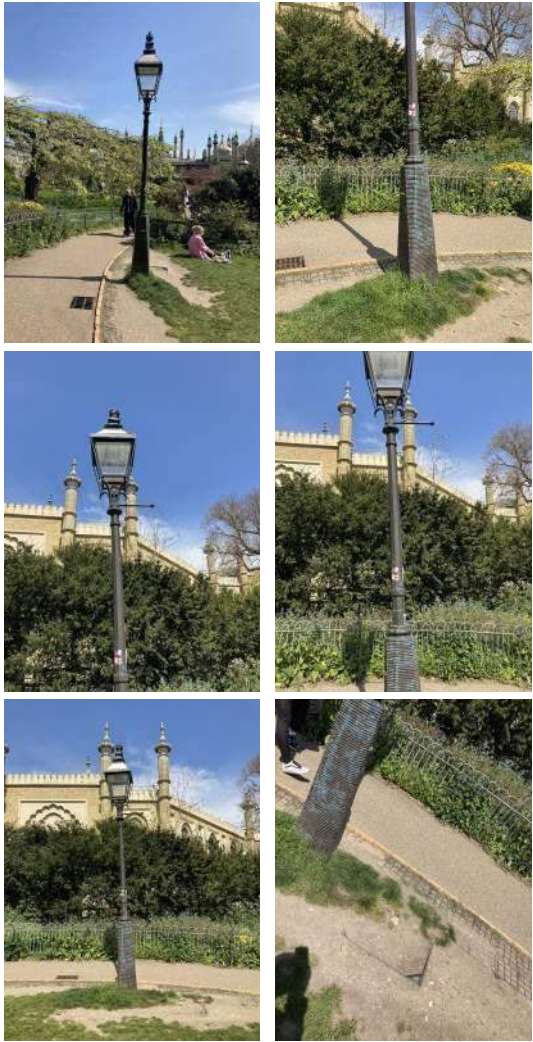
Item	Element & Description	Condition and Recommendation	Repair Category	Photograph
3.3.5	Lamp post 37			
	<p>Cast iron lamp post. Not included in the CBA conservation plan as listed. Reeded square base with William IV's insignia. Evidence of 2 paint schemes, lighter green covered by a darker green.</p>	<p>a Good. Lichen and moss to reeded base.</p>	<p>B</p>

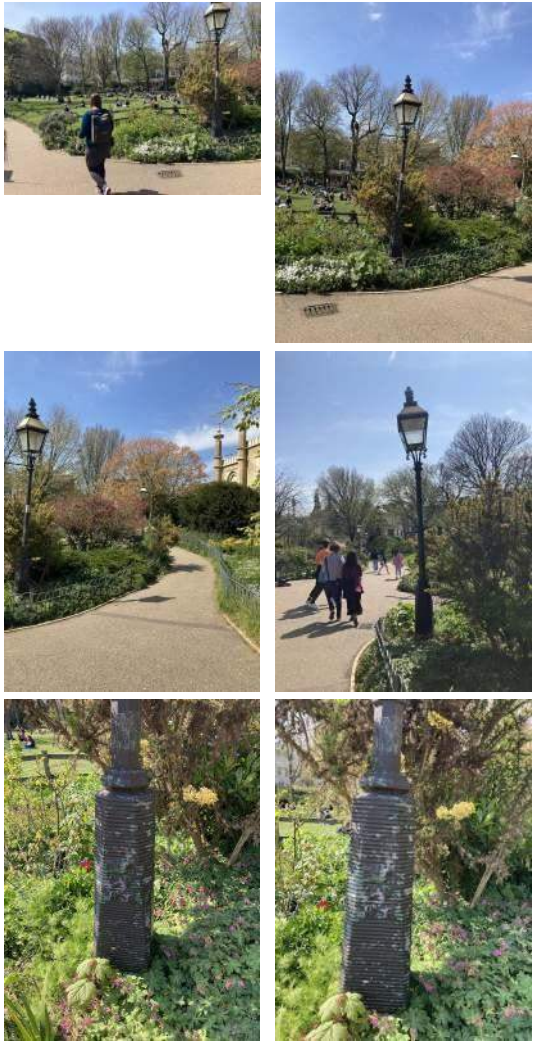
Item	Element & Description	Condition and Recommendation	Repair Category	Photograph
3.3.6	Lamp post 38			
	<p>Cast iron lamp post. Grade II listed. Original gas fittings removed circa late C19 or C20 and now has LED bulb. Reeded square base with William IV's insignia. Evidence of at least 2 paint schemes, lighter green with darker green on top.</p>	<p>a Support of lamp connection to be investigated when high level access available as appears to be sitting out of vertical.</p>	<p>B</p>
