Project
Reawakening Brighton Royal Estate
Phase 2

Drawing
McLaren Boundary Wall Details

Job Ref	Dwg No	Revision	
P1154-RHP-ZZ-00-DR-A-5013 P1			
Scale(s)	Size	Drawn	Checkd
Varies	A1	TP	PN

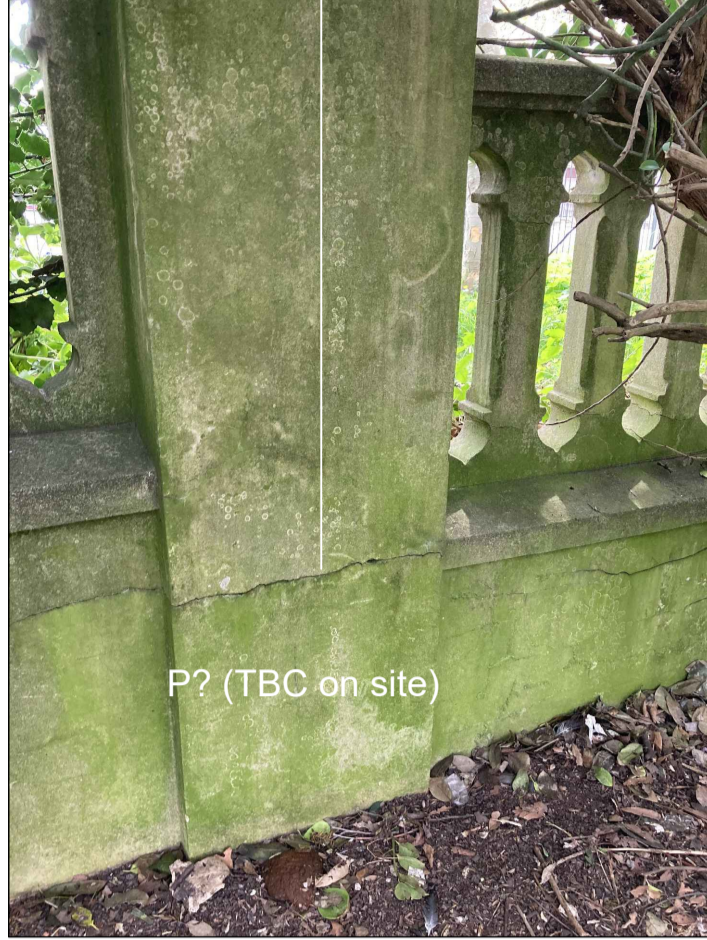
1 Part Elevation of McLaren Wall
5013 NTS

Crack - refer to SE for any remedial works.

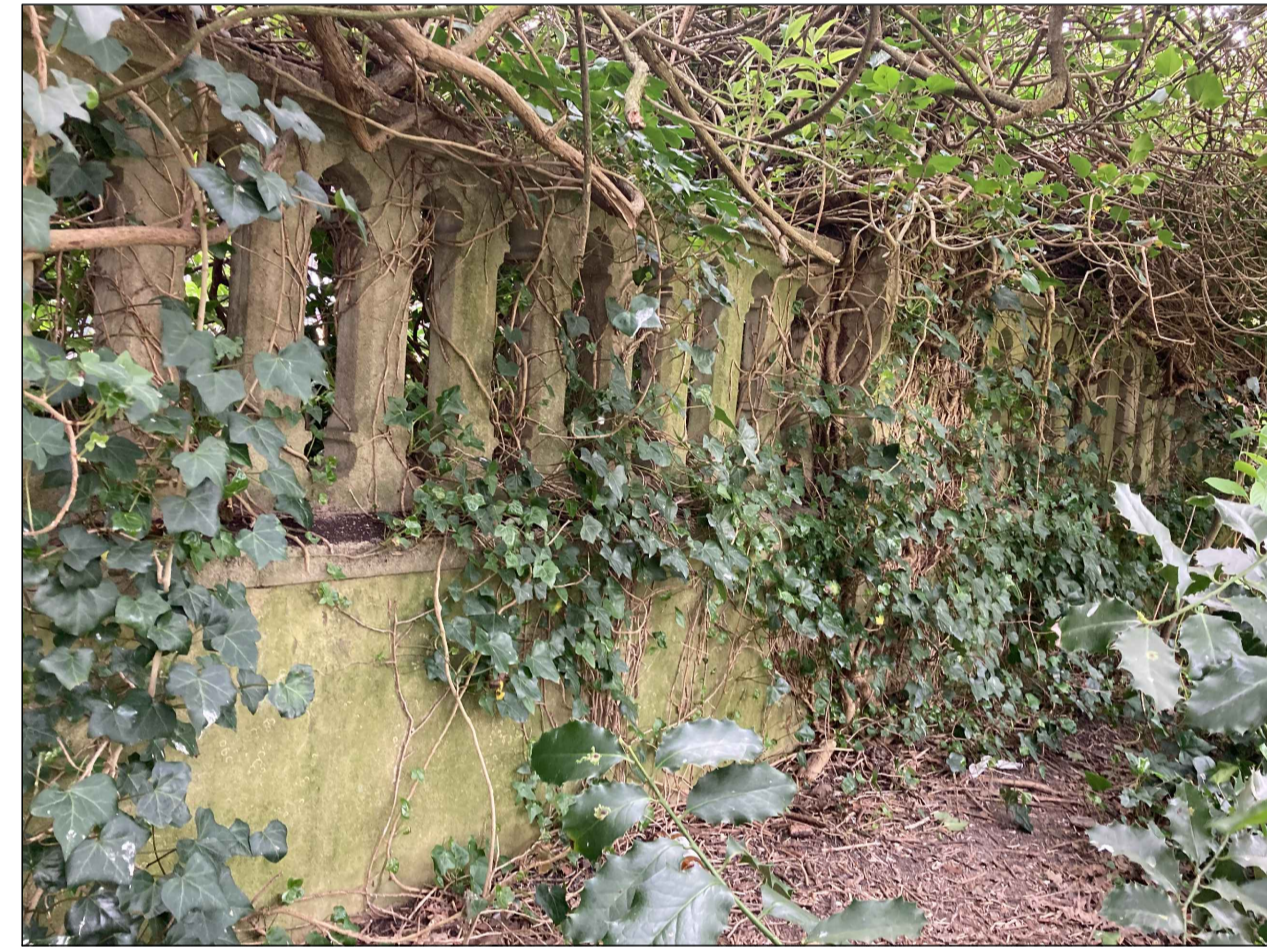
8 Part Elevation of McLaren Wall
5013 NTS

Crack - refer to SE for any remedial works.

Provisionally allow for careful dismantling and rebuilding with stainless steel slip tie to make good crack in conjunction with pier works. Refer to SE details.

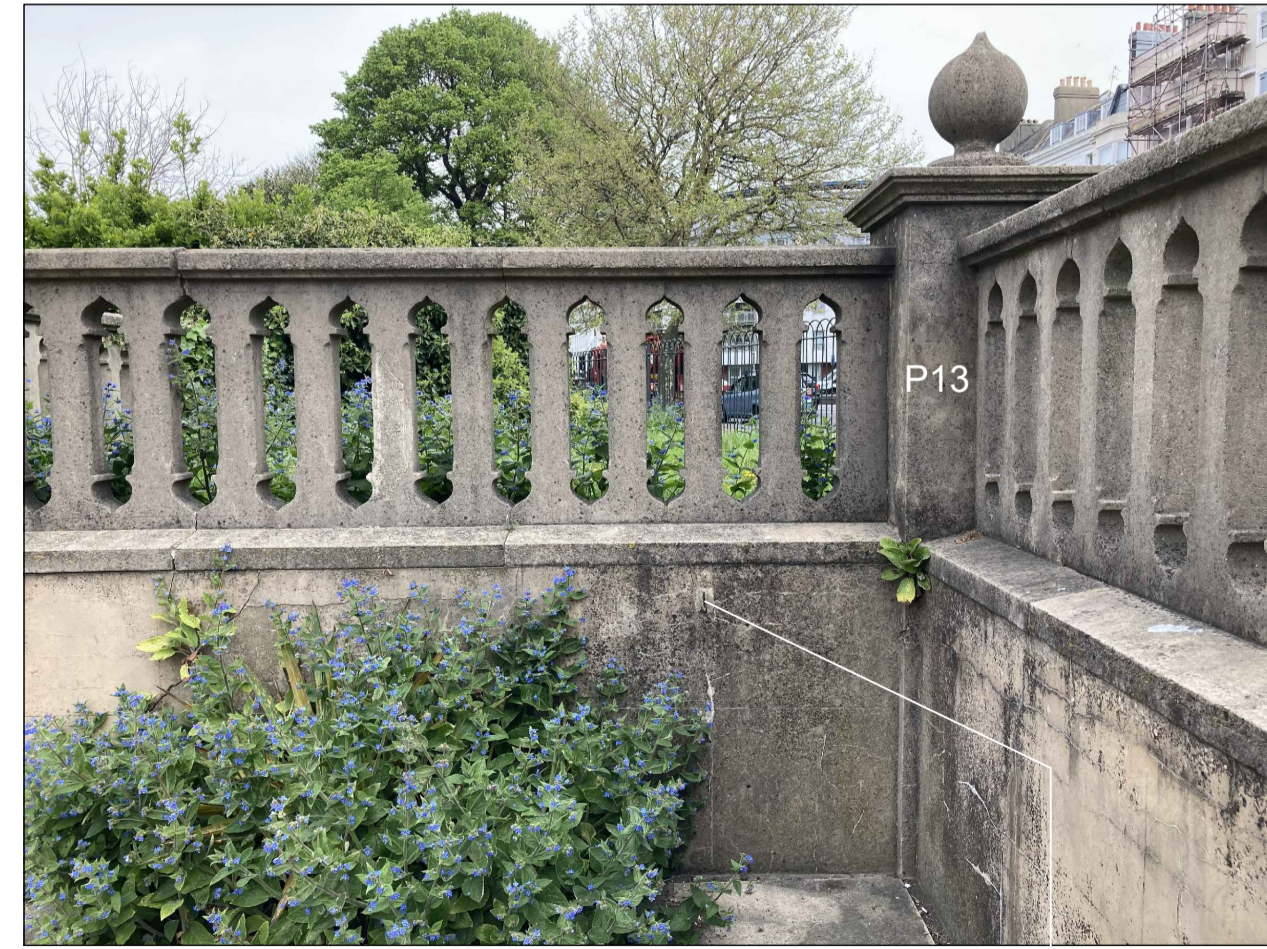
12 Part Elevation of McLaren Wall
5013 NTS

Pier appears to have moved and caused crack to wall adjacent and to investigate foundations and provisionally allow for careful dismantling and rebuilding to same dimensions re-using capstone and new lime render

Remove 4 no. redundant brackets and make good with lime render
