Project
Reawakening Brighton Royal Estate
Phase 2

Drawing
Palace Place Railings Details

P1154-RHP-ZZ-00-DR-A-5051 P1

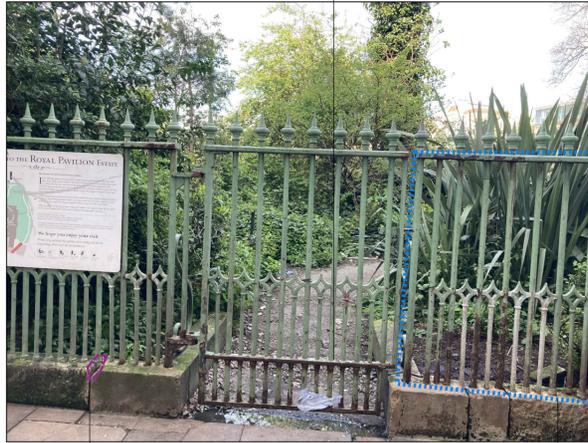
1 Elevation of Type F1 railing
5051 NTS

Existing Gate G11, overhaul ease and adjust lock. Repairs needed to base rails and hinges.

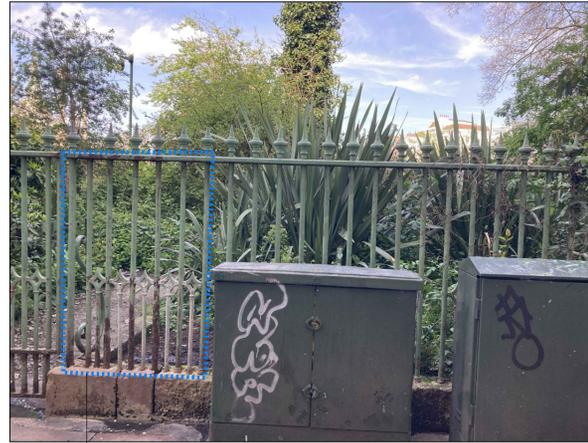
2 Elevation of Type F1 railing
5051 NTS

Significant corrosion to uprights at high and low level. Replacement sections may be require subject to review on site when preparation works are started.

See detail 11 on drawing 5050 for repairs.
