Project
Reawakening Brighton Royal Estate Phase 2

Drawing
McLaren Boundary Wall Details

Job Ref 5014 Dwg No 5014 Revision
P1154-RHP-ZZ-00-DR-A-5014 P1
Scale(s) A1 Size TP PN
Status Preliminary

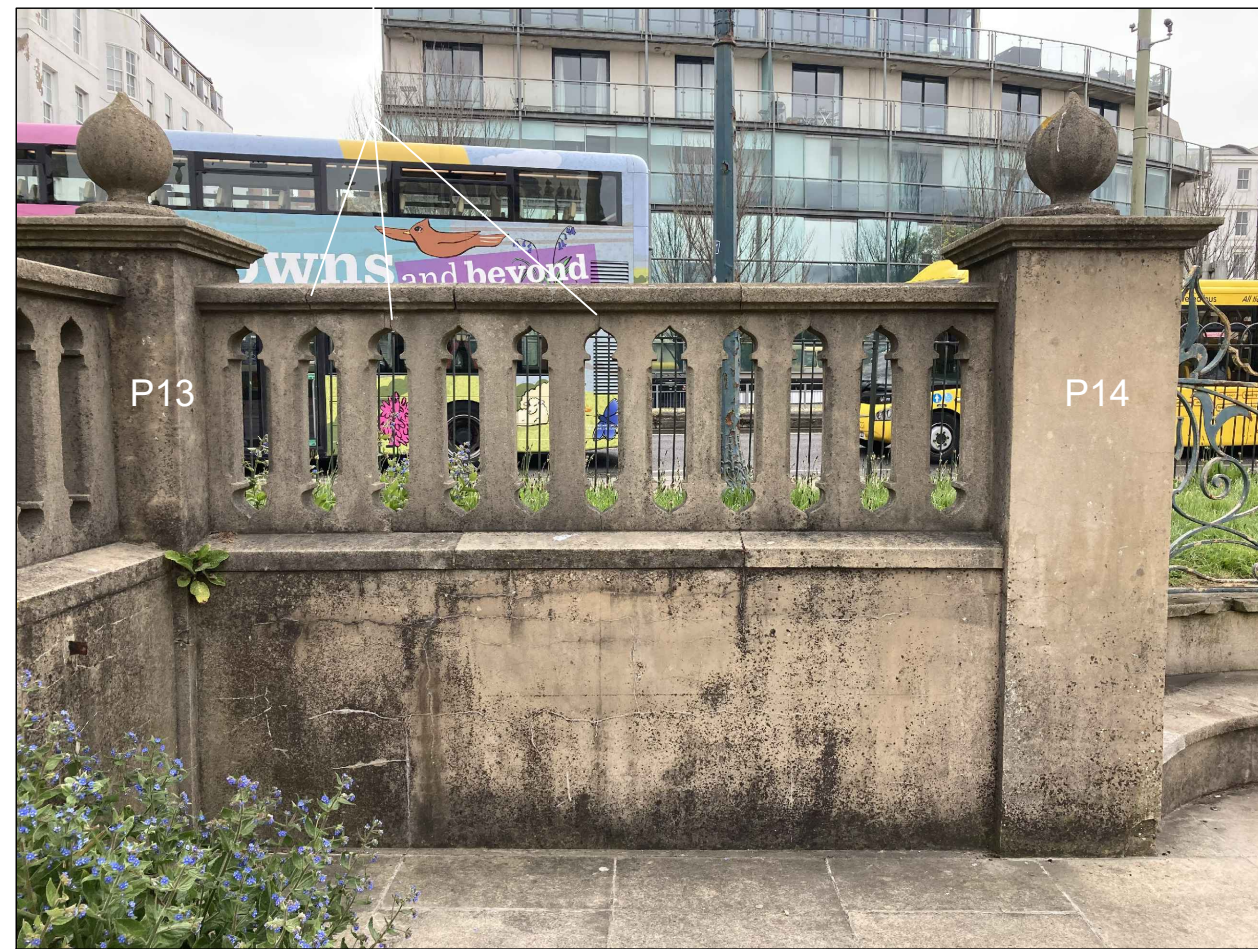
1 Part Elevation of McLaren Wall
5014 NTS

Cracked coping and balustrade

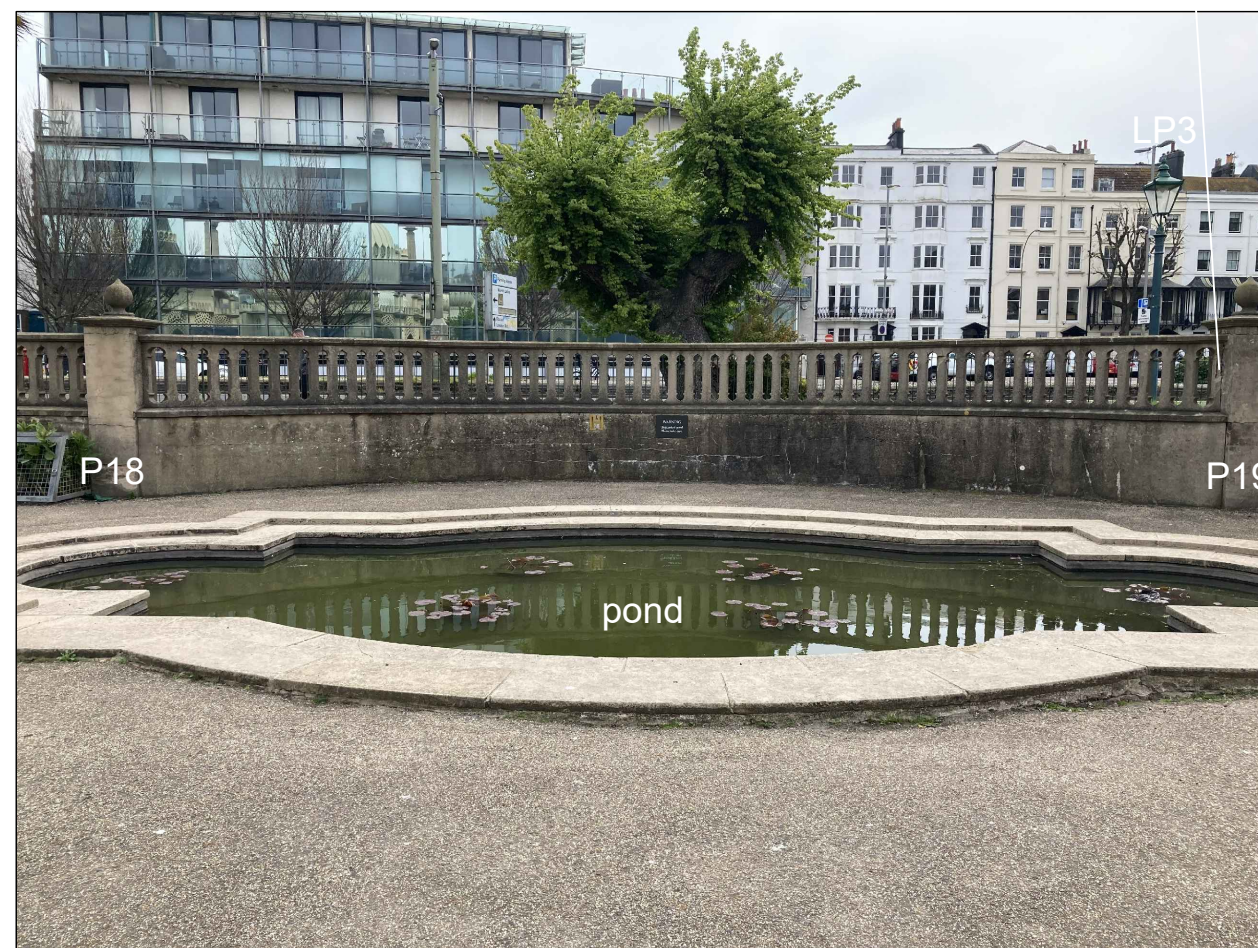
5 Part Elevation of McLaren Wall
5014 NTS

Rebar exposed to balustrade. Carry out localised corrosion treatment and concrete repair to reform profile of baluster and new shelter coat.

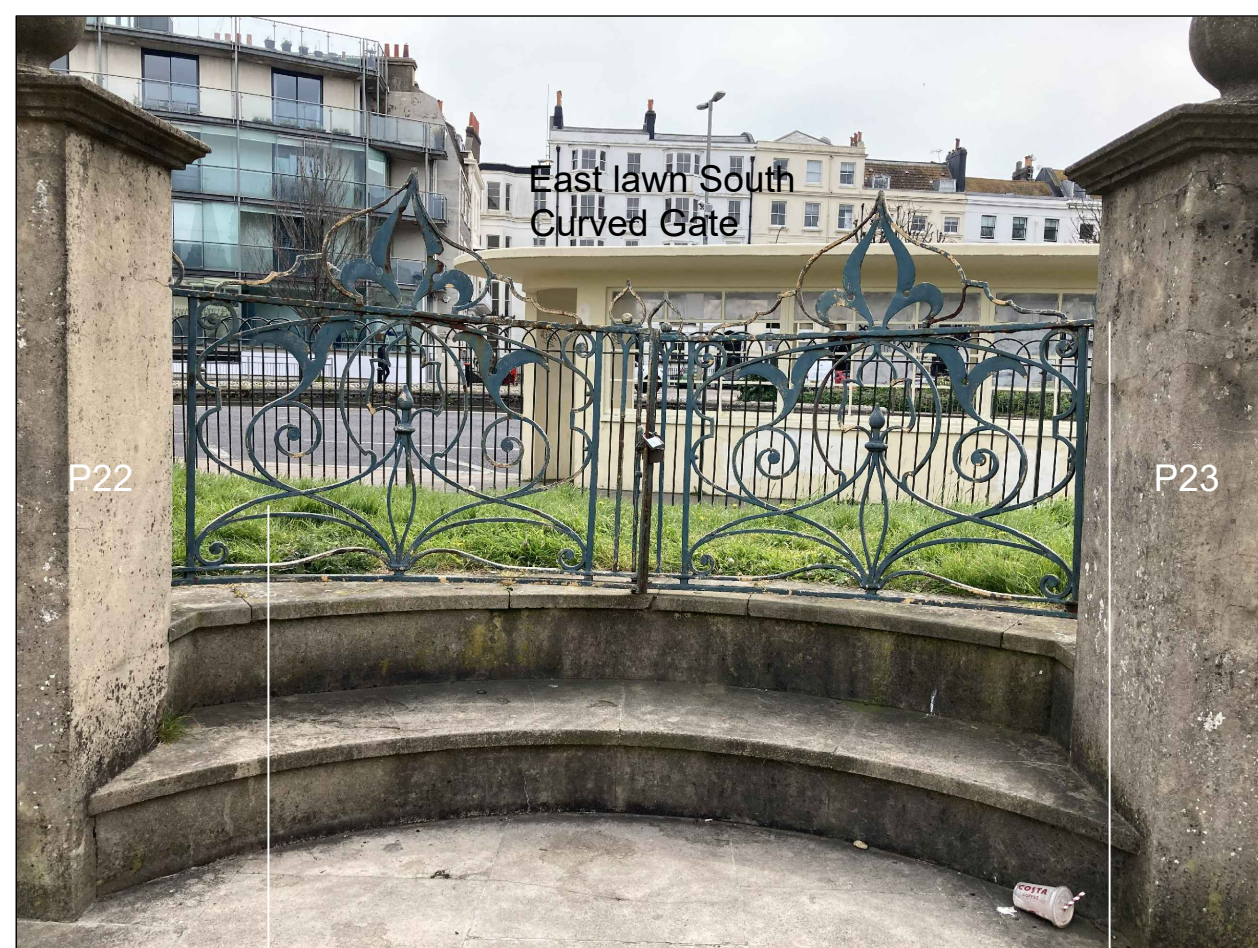
9 Part Elevation of McLaren Wall
5014 NTS

Horizontal crack to Pier and render damaged

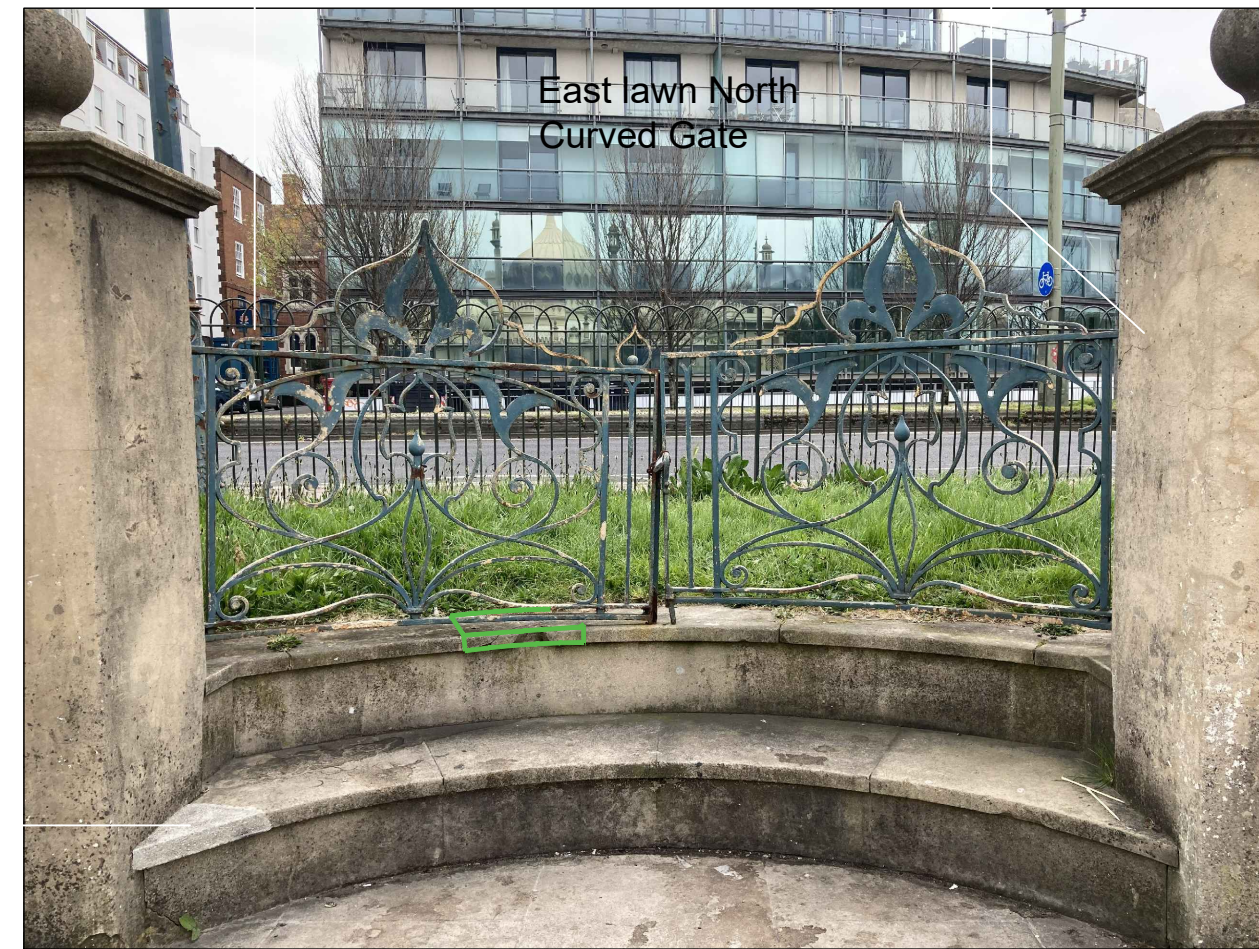
2 Part Elevation of McLaren Wall
5014 NTS

Gate in poor condition with connection to base of gates corroded through causing gate to drop. Gates to be carefully removed off site, prepared, repaired and re-decorated and re-instated by specialist sub-contractor. Re-instate detailing to match.

Gate in poor condition with connection to base of gates corroded through causing gate to drop. Gates to be carefully removed off site, prepared, repaired and re-decorated and re-instated by specialist sub-contractor.

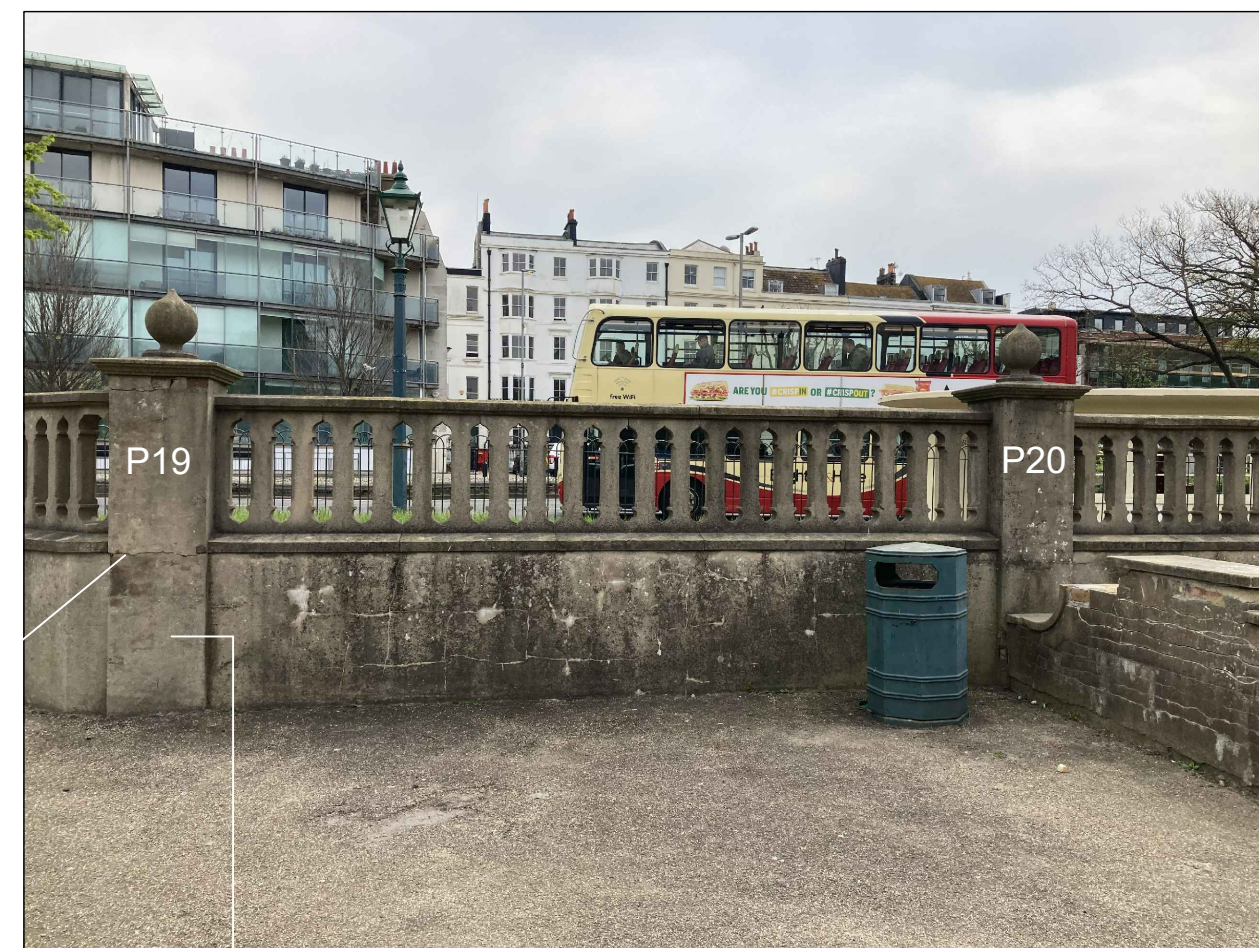
6 Part Elevation of McLaren Wall
5014 NTS

Previous poor repair - retain as appears not to be causing any deterioration

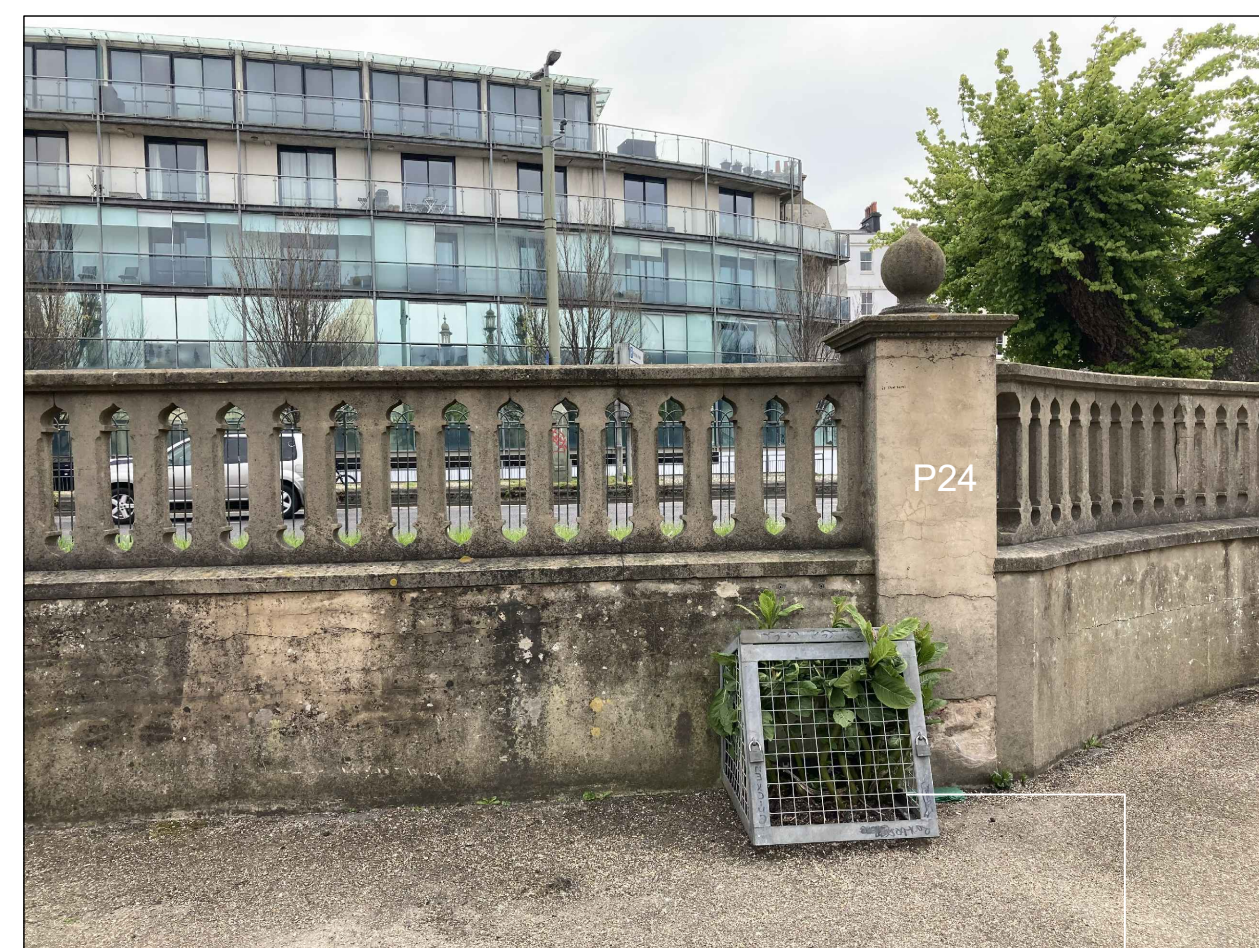
10 Part Elevation of McLaren Wall
5014 NTS

Horizontal crack to Pier and render damaged

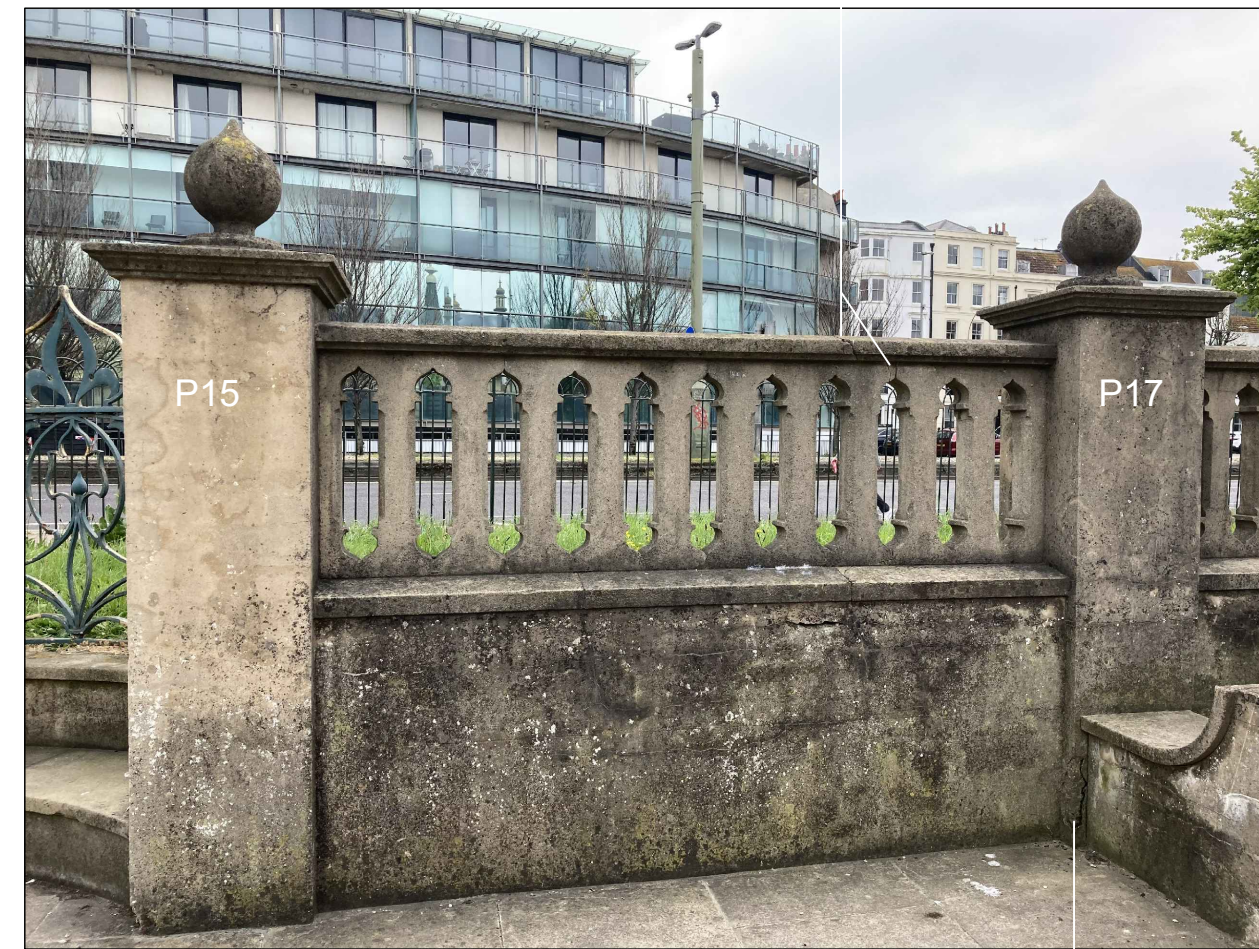
3 Part Elevation of McLaren Wall
5014 NTS

Remove 4 no. corroded fixings into piers. Remake to match connection to pier with new stainless steel fixings.

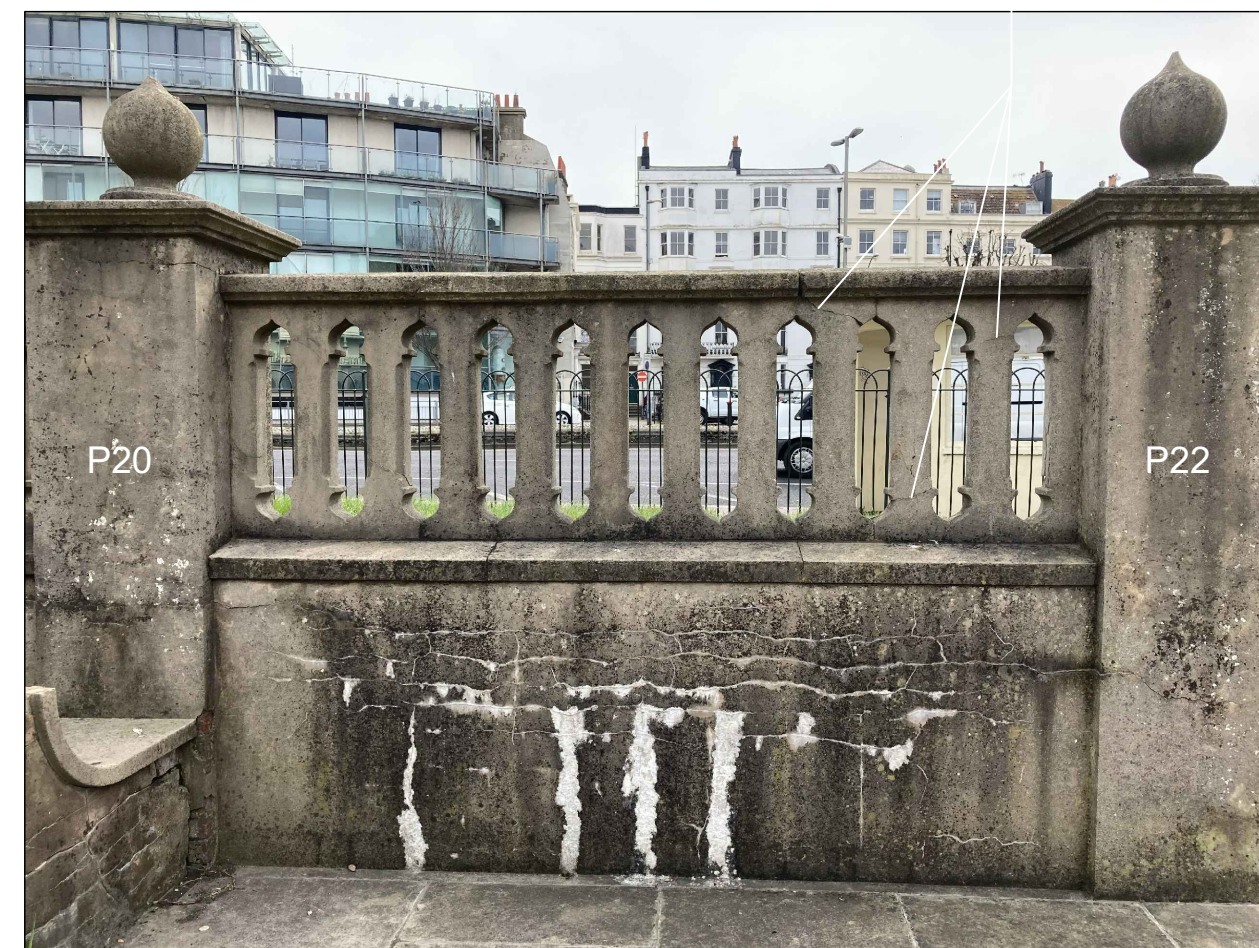
7 Part Elevation of McLaren Wall
5014 NTS

Crack

Cracked balusters - check on site and provisionally allow for lifting capping and implementing SS resin repair subject to CA instruction.

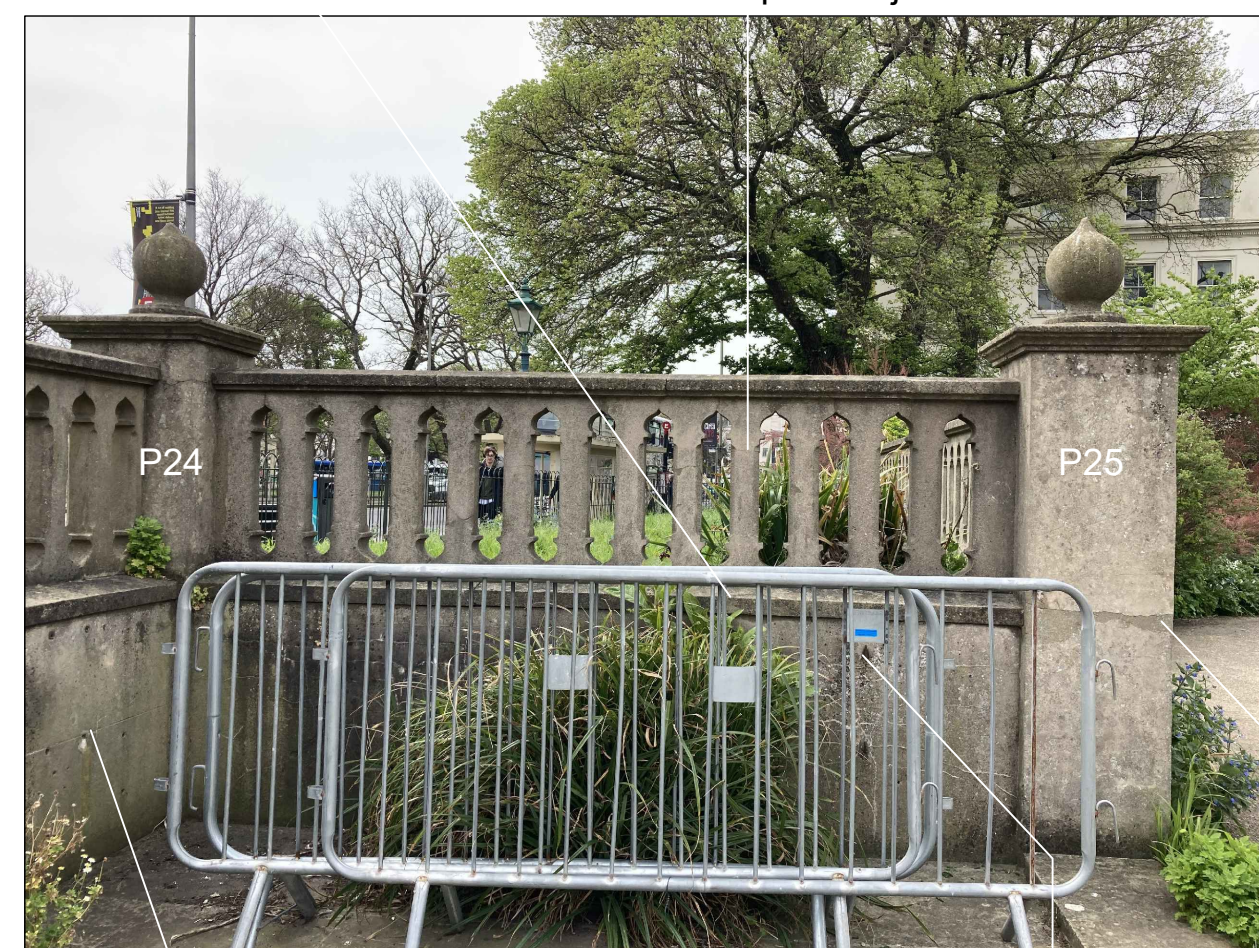
11 Part Elevation of McLaren Wall
5014 NTS

Cracked baluster - check on site and provisionally allow for lifting capping and implementing SS resin repair subject to CA instruction.

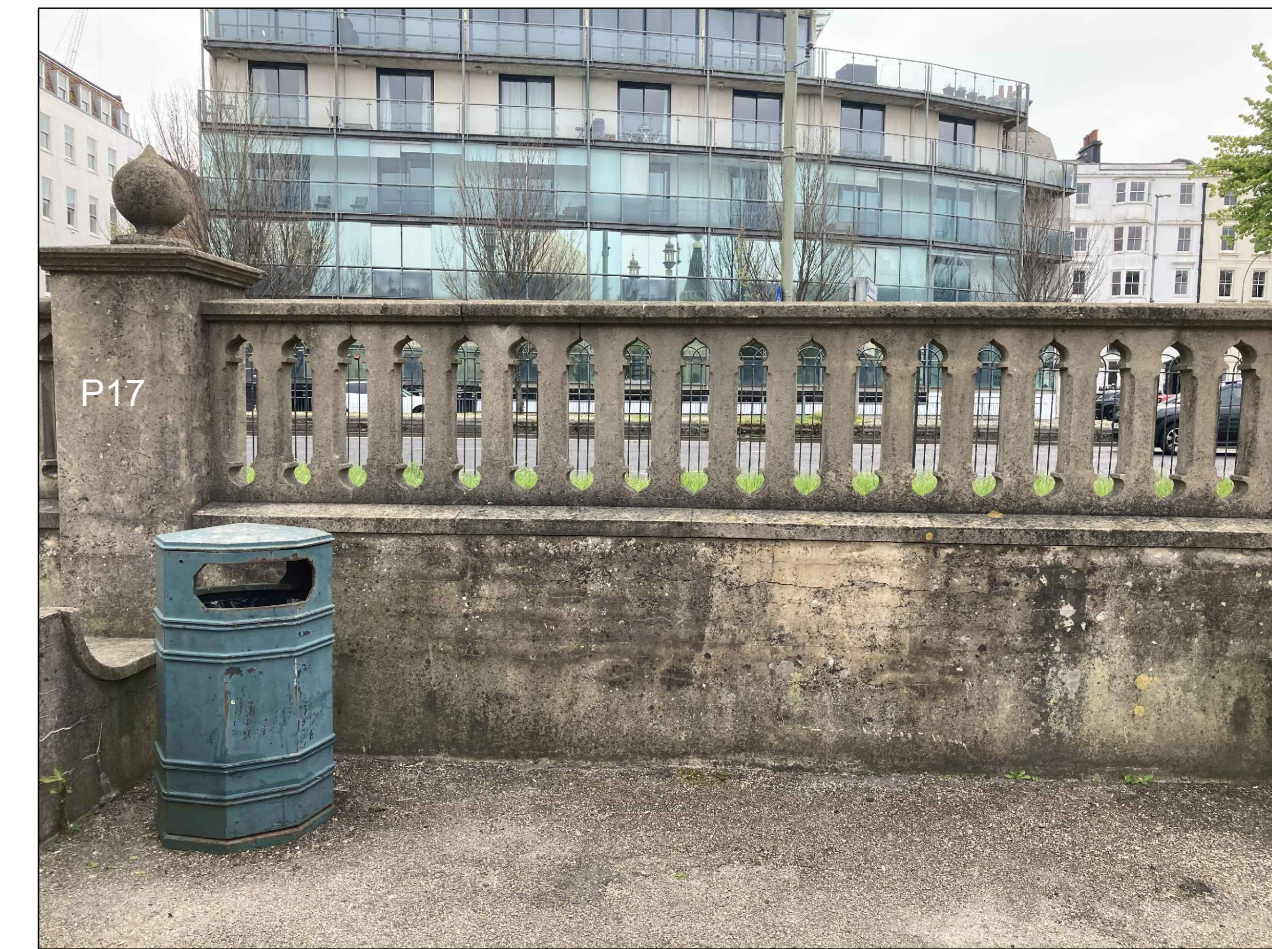
4 Part Elevation of McLaren Wall
5014 NTS

Remove redundant fixings and make good with lime render

Remove 4 no. redundant brackets and make good with lime render

Cracked coping and balustrade

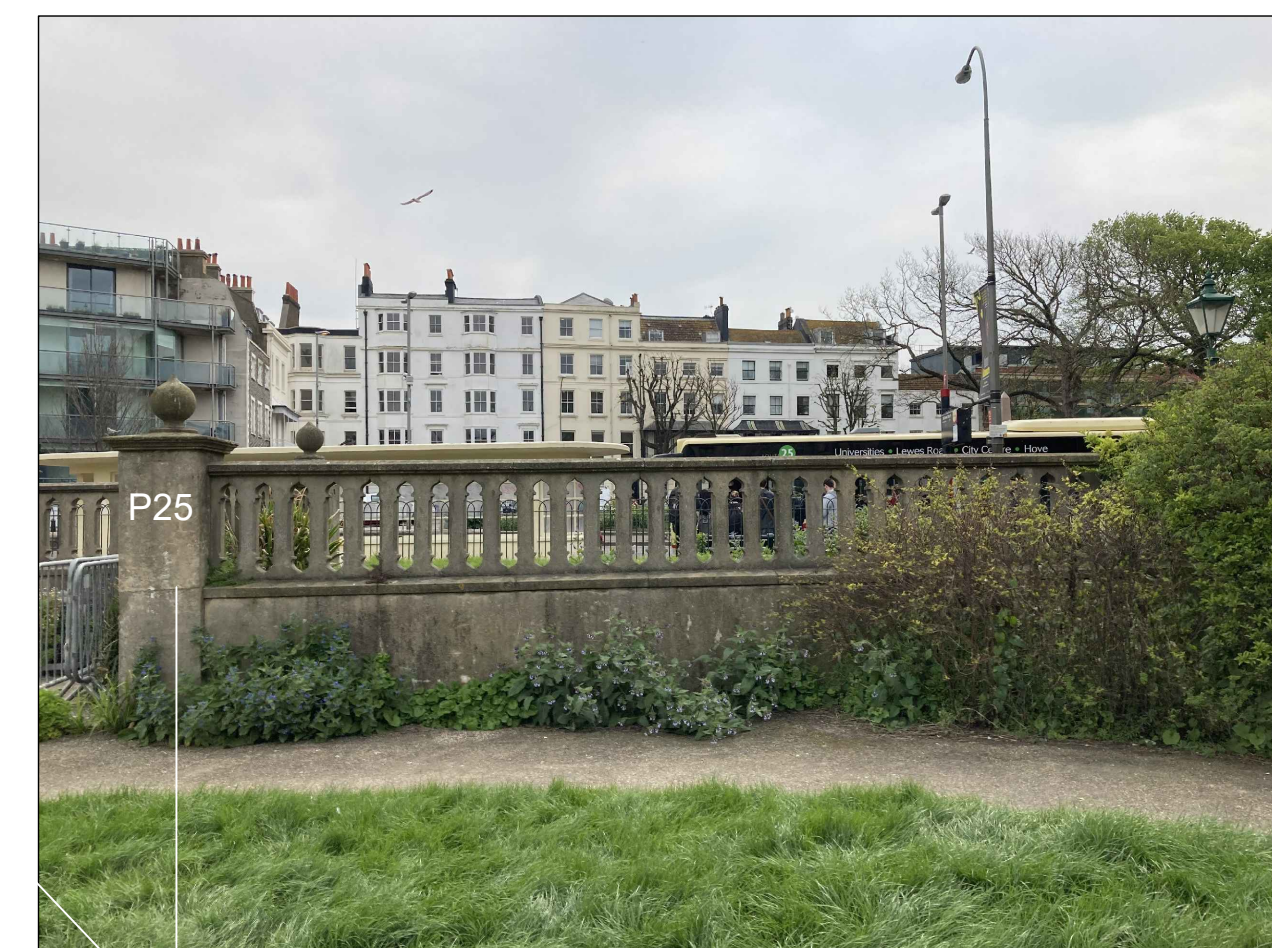
12 Part Elevation of McLaren Wall
5014 NTS

Previous repair to horizontal crack
