3. Original condition survey carried out in April 2022.
4. To be read in conjunction with RHP P1154-RHP-ZZ-SC-A-8200 Brighton Pavilion Gardens Schedule of works.

Project  
**Reawakening Brighton Royal Estate Phase 2**

Drawing  
**Palace Place Railings Details**

P1154-RHP-ZZ-00-DR-A-5050 P1

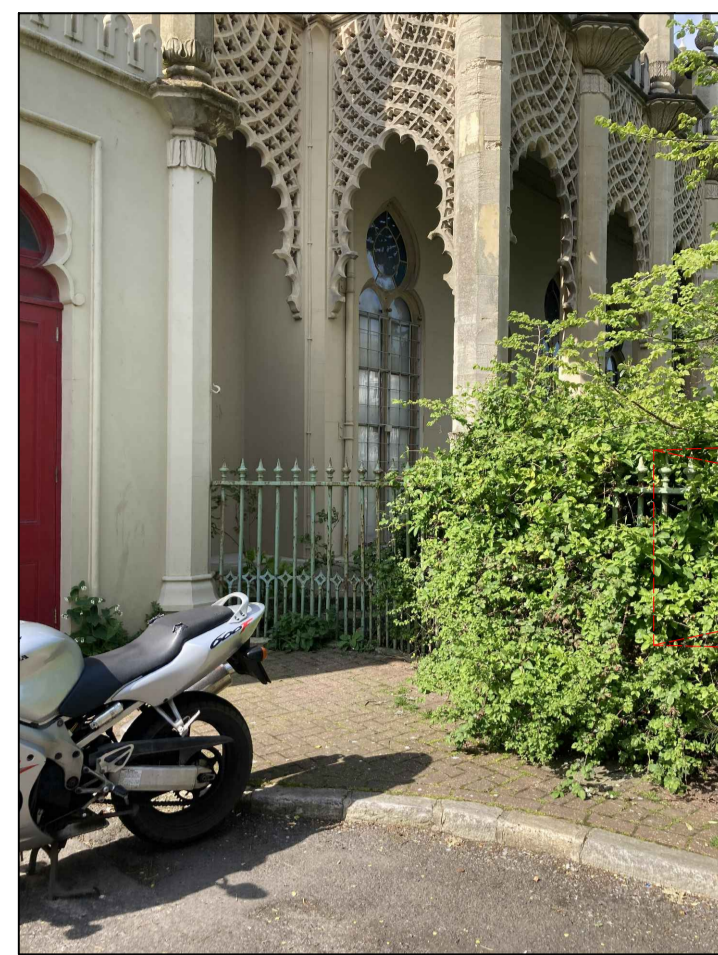
1 Elevation of Type F1 railing  
5050 NTS

Allow for stone repairs to brace sections - limited access available at time of inspection.

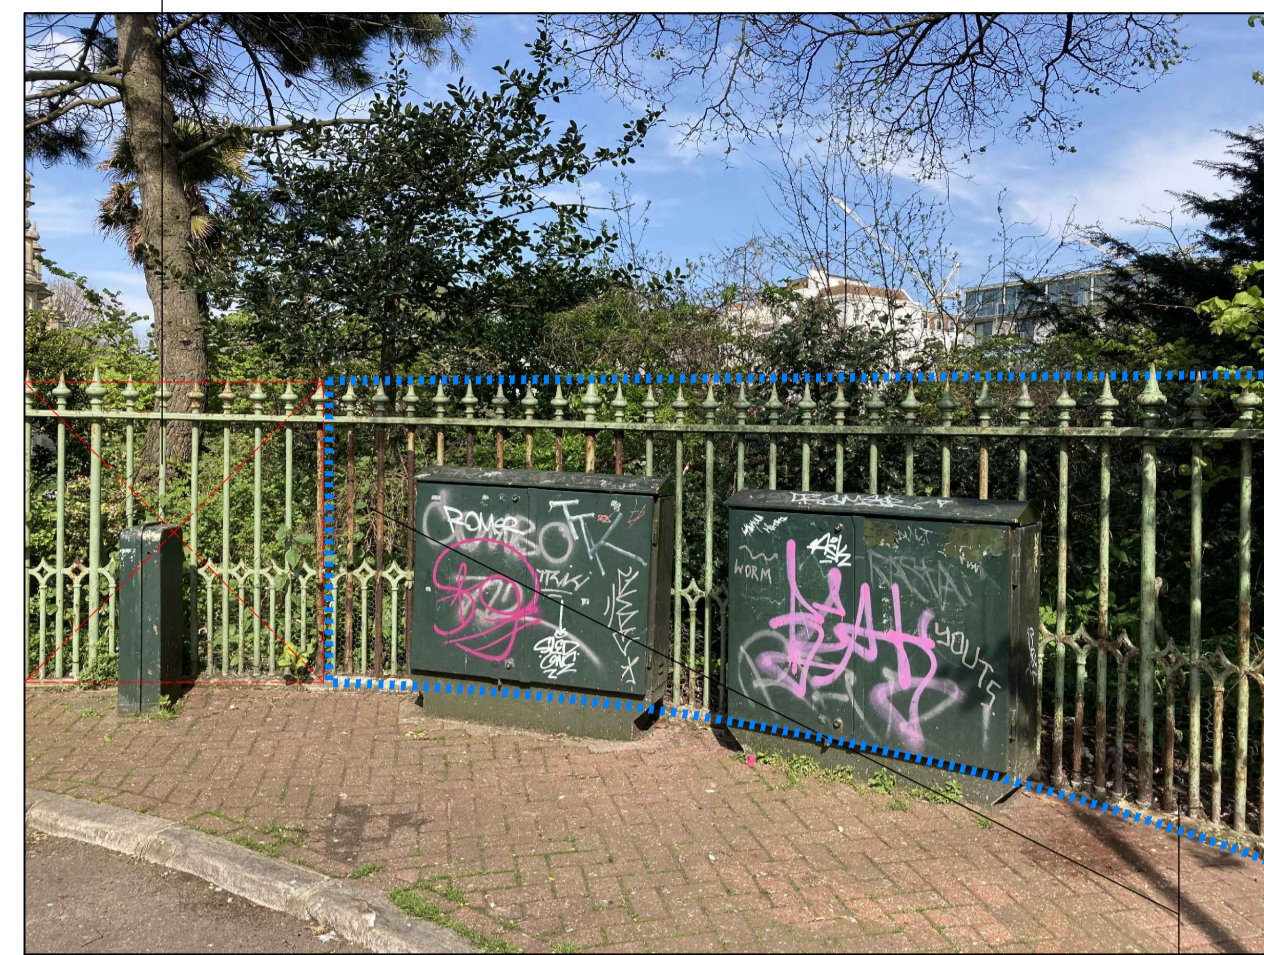
3 Elevation of Type F1 railing  
5050 NTS

Allow for stone repairs to brace sections - limited access available at time of inspection.

Significant corrosion to uprights at high and low level. Replacement sections may be require subject to review on site when preparation works are started.

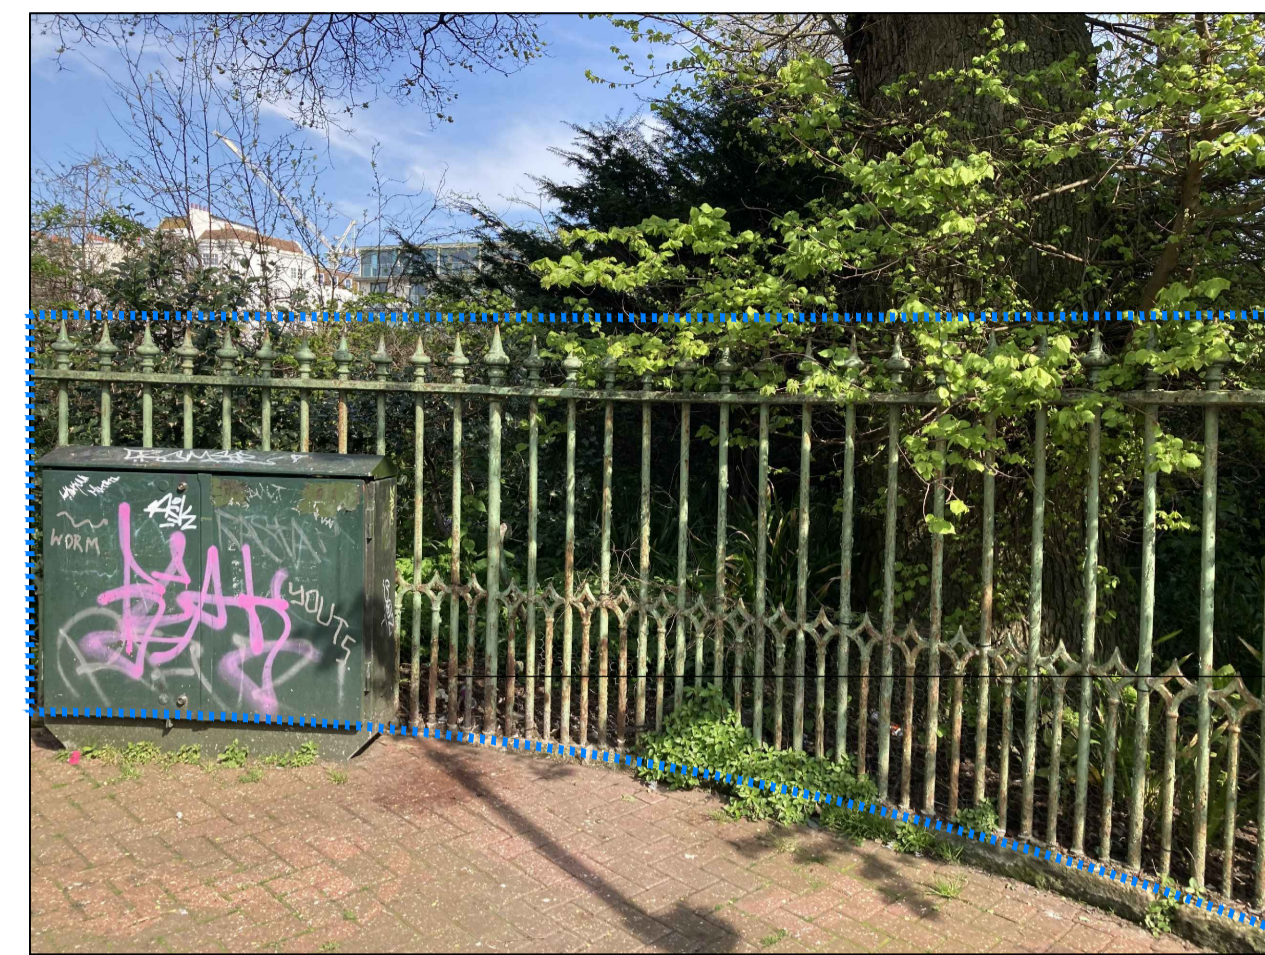
4 Elevation of Type F1 railing  
5050 NTS

Significant corrosion to uprights at low level. Replacement sections may be require subject to review on site when preparation works are started.

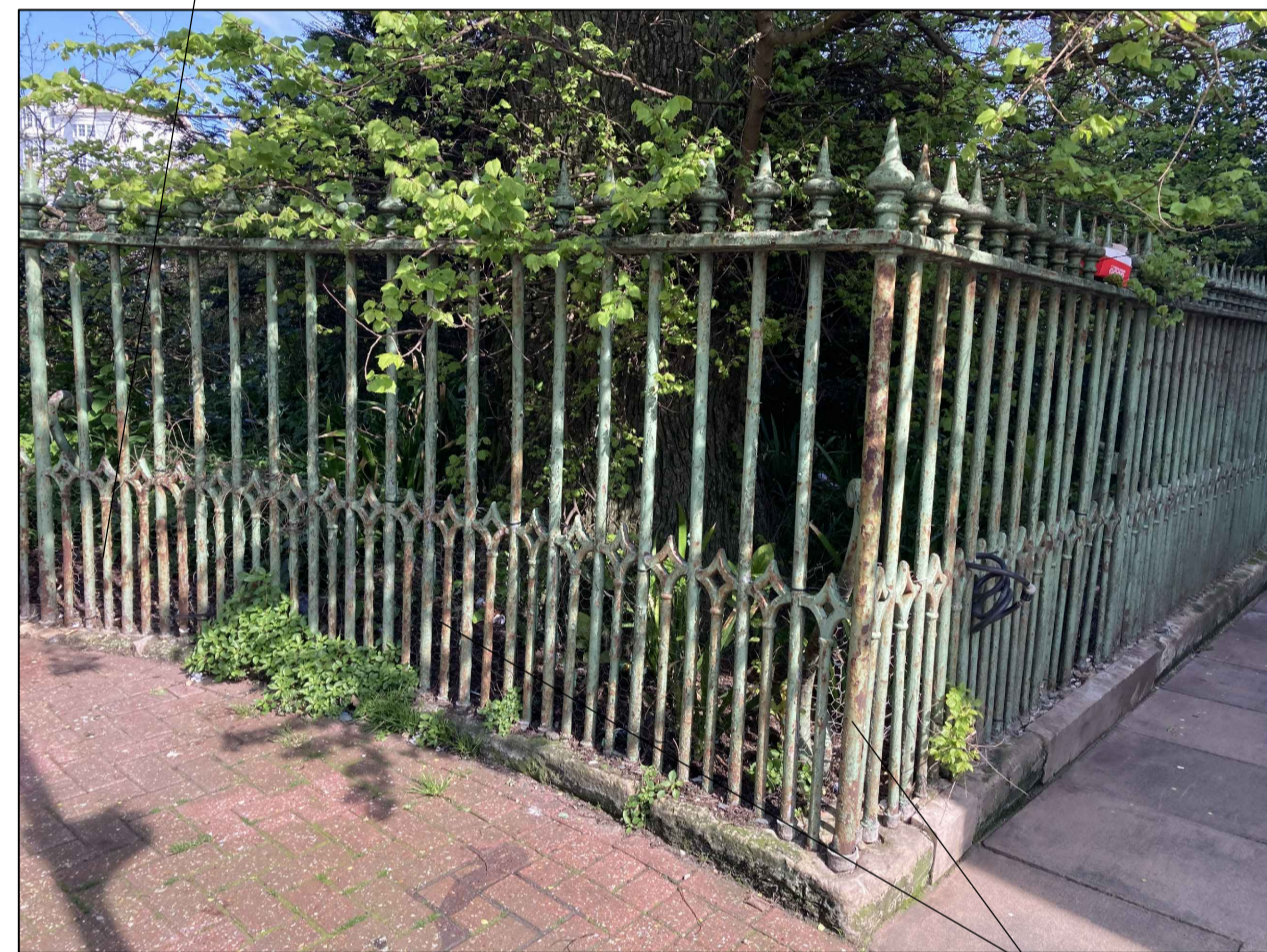
5 Elevation of Type F1 railing  
5050 NTS

Significant corrosion to uprights at low level. Replacement sections may be require subject to review on site when preparation works are started.

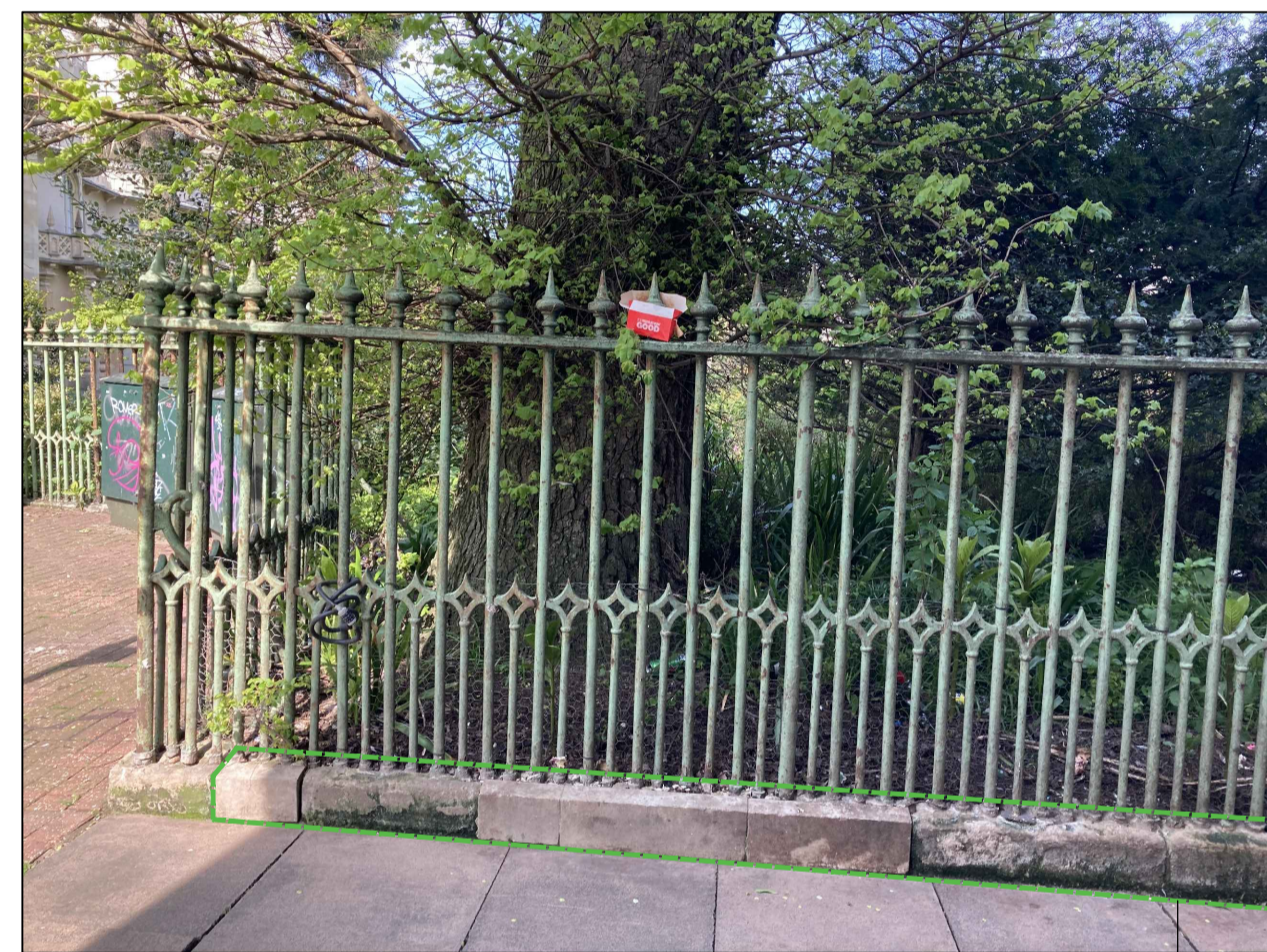
6 Elevation of Type F1 railing  
5050 NTS

Poor face repair carried out. Option of replacement stone by removal and reinstating panels with new lead caulking to be priced.

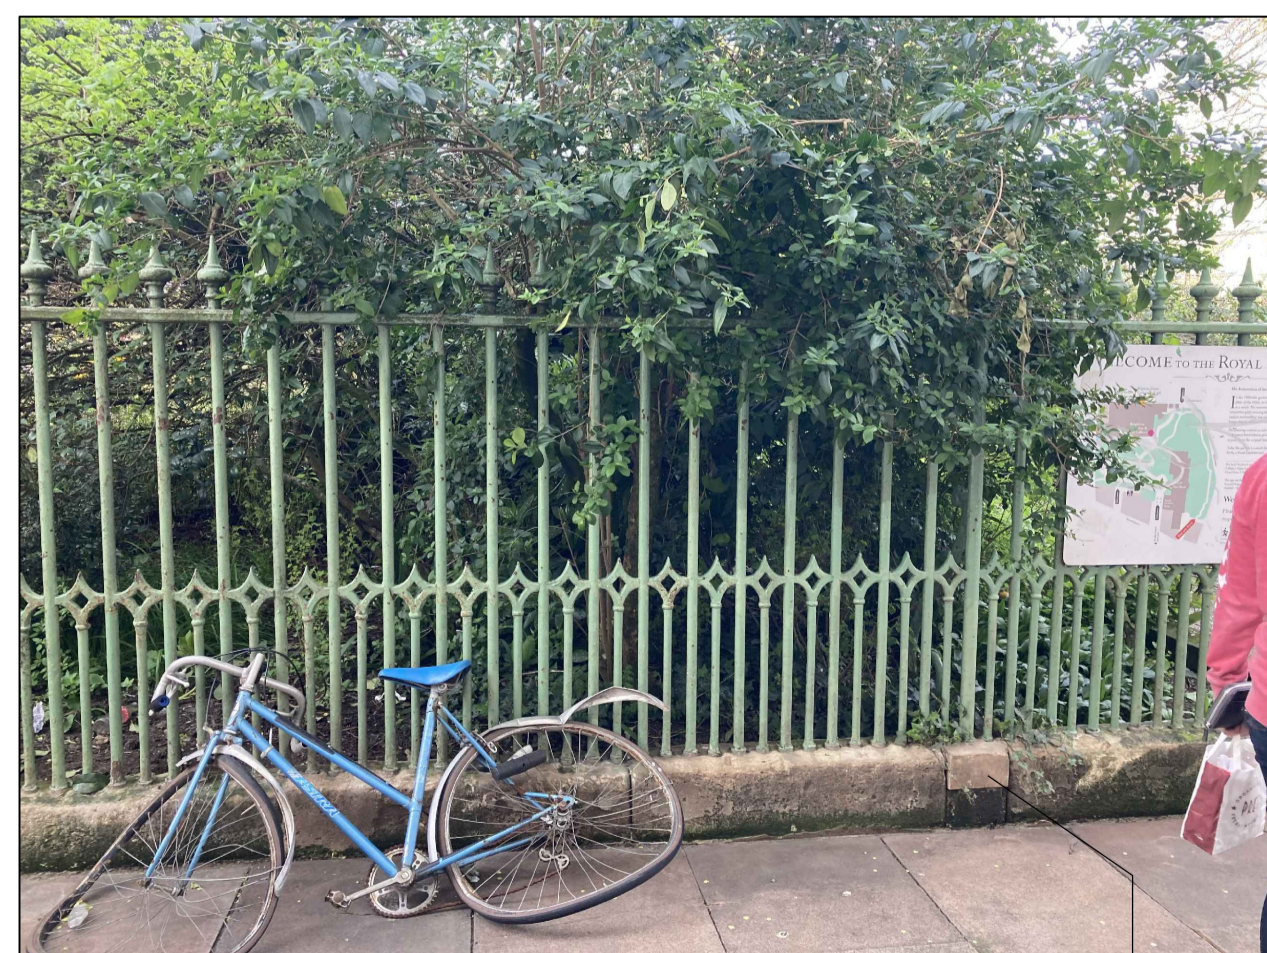
10 Elevation of Type F1 railing  
5050 NTS

Poor face repair carried out. Option of replacement stone by removal and reinstating panels with new lead caulking to be priced.

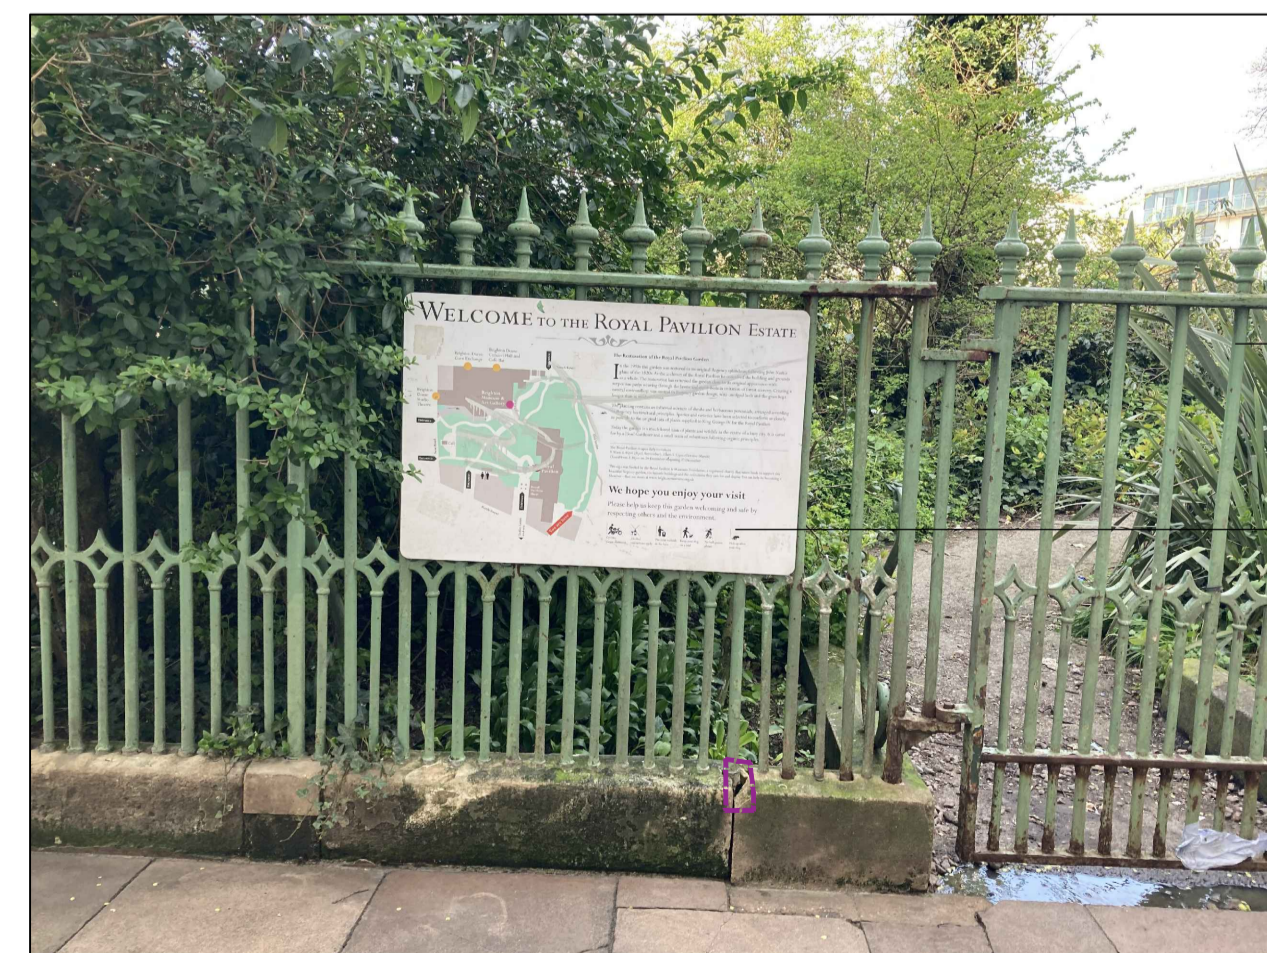
11 Elevation of Type F1 railing  
5050 NTS

Existing Gate G11, see detail 1 on drawing 5051 for repairs.

Remove existing sign, store and re-fix upon completion of works.
