ץ Part Elevation of McLaren Wall

type of stone sample for approval.	Job Ref Dwg No P1154-RHP-ZZ-00-DR-A-5	Revision
F	Localised motar patch repair profiled and colour matched to	Scale(s) Size Drw Varies P1154 A1 TP	n Chkd PN
	existing. Provide sample for approval.	Status Preliminary	SO

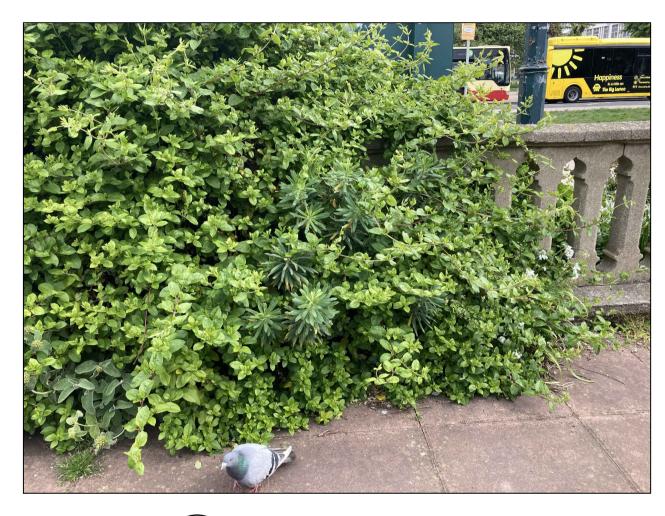
Existing stone boundary wall has been vandalised and removed off site for storage (TBC). Image taken on 28.04.2022.

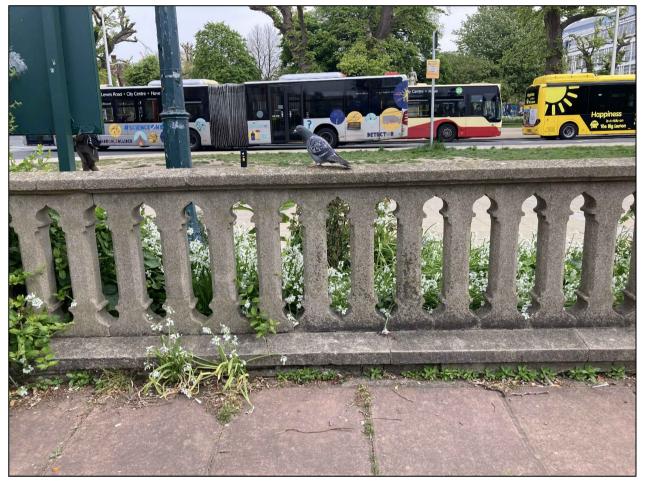
Existing stone boundary wall has been vandalized and removed off site for storage (TBC). CTP Image taken on 17.07.2023. Allow for repairs and reinstatement. Refer to SE details for SS rods resin fixed to existing plinth reinforcement.

New 6 mm dia. SS threaded dowels lime grouted into balustrades and capping/ plinth to reinforce connection

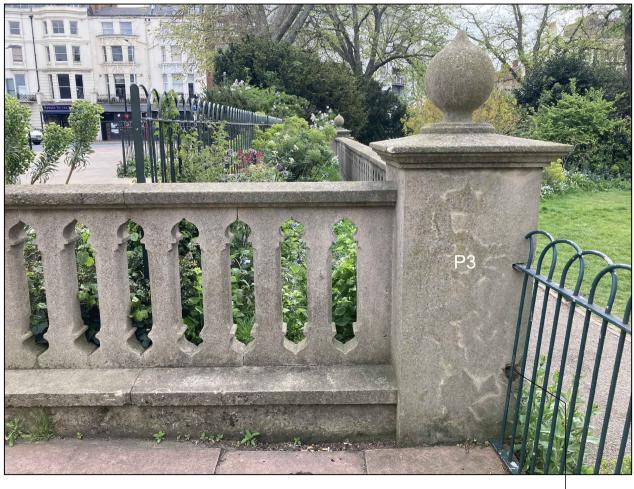
Image of wall panel prior to vandalism. Image taken on 28.04.2022.

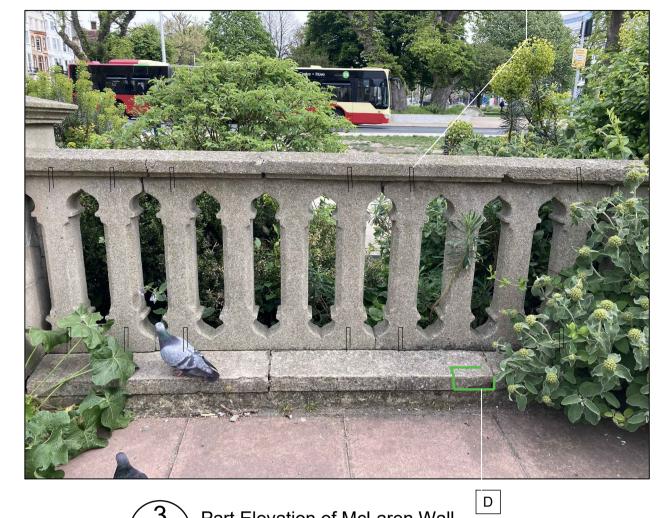
3 Part Elevation of McLaren Wall 5010 NTS

Crack through whole capping. Resin and SS dowel repair.

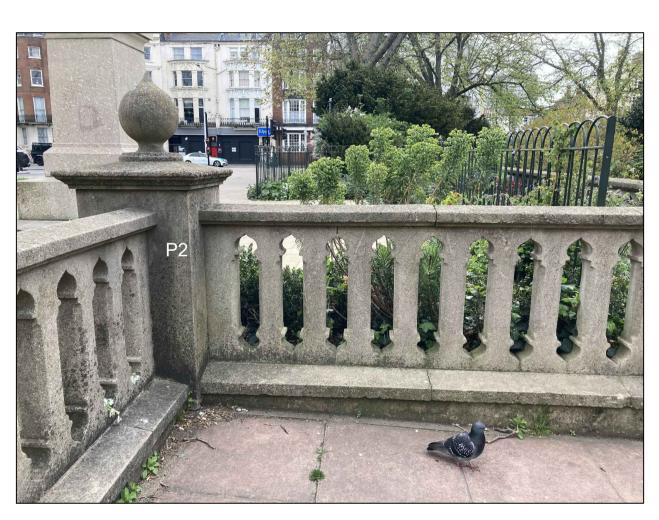
Image of wall panel prior to vandalism. Image taken on 28.04.2022.
