Royal Pavilion Garden, Brighton

Access Review

Rev 1

22.4.22

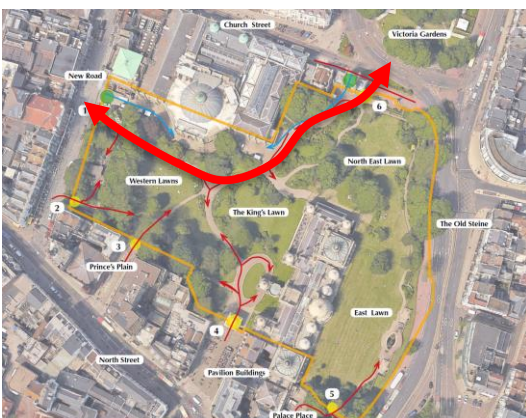
At time of site inspection, it was noted that the path running from New Road entrance 1 down past the Western Lawn towards the North East Lawn is a major route for people cutting through from Old Steine/Church Street Entrance 6. A significant strip of the Western Lawn was worn down on that path edge, presumably due to pedestrian traffic levels. It is therefore recommended that this path is widened to correspond with this usage, and maybe wider than the 2m minimum recommended for two wheelchair users to pass.
