P1154 BRIGHTON PAVILION GARDENS CONSERVATION REPAIRS TO EXTERNAL WALLING,  
RAILINGS, GATES AND LAMP POSTS

**SCHEDULE OF WORKS**

**P1154-RHP-ZZ-ZZ-SC-A-8200-P4 PLANNING & LBC**

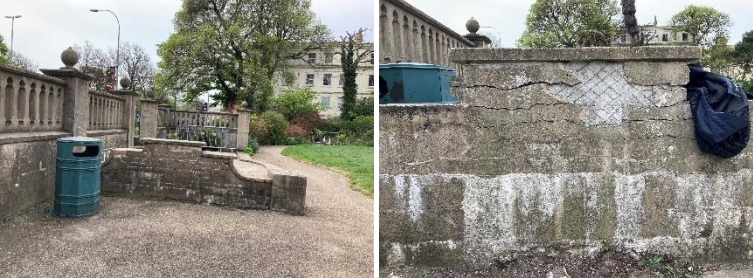
<p>4.2</p>	<p>Example of lime leeching and horizontal cracks to rendered wall.</p> <p>McLaren Boundary wall has failing render. Samples of the render finishes and mortar used in constructing the backing masonry for analysis will be required to determine its composition to inform a suitable repair strategy. A specialist should be approached to carry out this sample analysis and suitable locations agreed on site (allow for 3 no. locations to the east lawn where significant cracks can be observed to the piers by the ornamental ponds). See drawing P1154-RHP-ZZ-00-DR-A-1000 for details of locations to be agreed on site.</p>

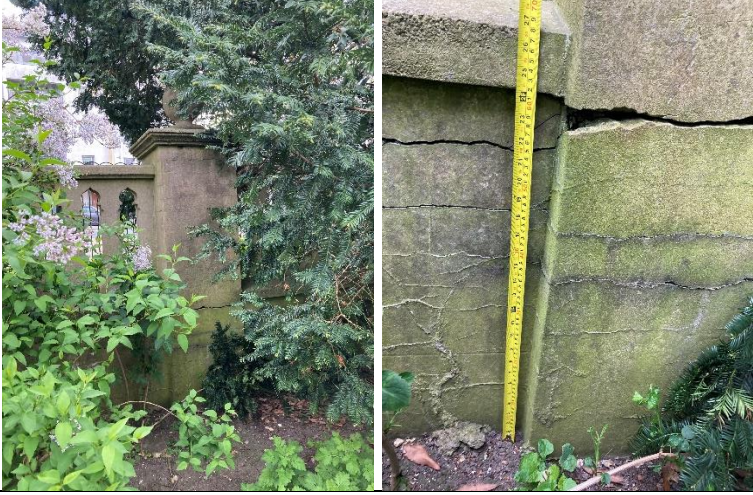
<p>4.3</p>	<p>Investigation of existing foundations to piers adjacent to heavily planted areas to the Old Stein to the east of the site to investigate cause of large horizontal cracks and damaged finish (allow for 3 no. locations to the northeast of the site where existing ground levels vary the most). See drawing P1154-RHP-ZZ-00-DR-A-1000 for details of locations to be agreed on site.</p>

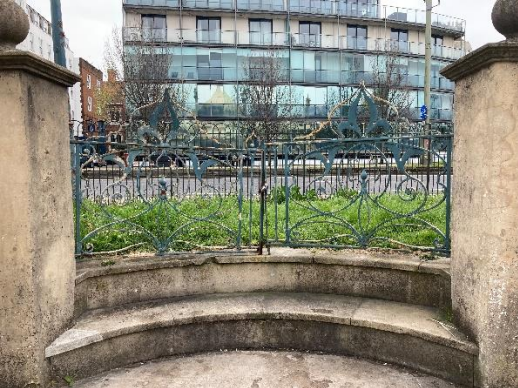
4.5	<p>Metallurgy testing of 2 no. existing curved gates (East Lawn North Gate And East Lawn South Gate) to east lawn.</p>

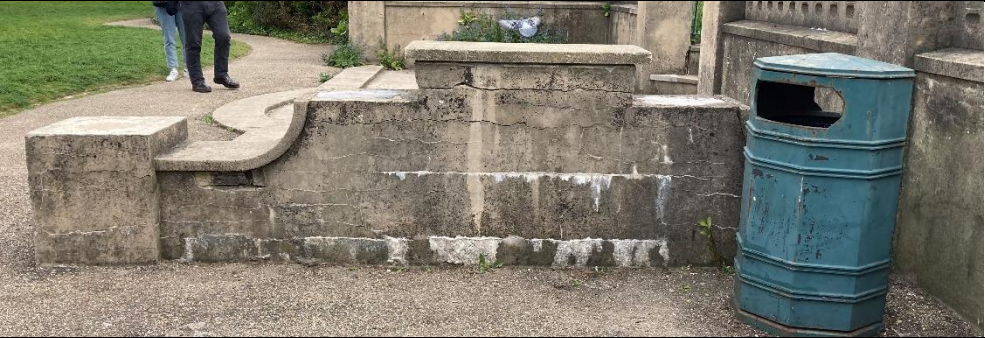
8.6	<p>When railings repaired and re-installed, lead caulk all penetrations to stone plinth.</p>	
	<p>Option B omitted</p>	
<b>9.0</b>	<p><b>Steps below Curved Gates to East Lawn and boundary walls to ornamental ponds</b></p>	
	<p>Render and masonry repairs.</p> <p>Refer to items of render and masonry repair, below, and the drawings referred to for location. All quantities are provisional subject to early inspection and confirmation of the scope of repairs by the Architect and approval of samples as noted above.</p>	
	<p>Drawing 1017 Site Plan 8 North East Lawns and RHP drawing 5016.</p>	
	<p>Existing rendered low level brickwork with missing copings. Lime leeching evident.</p>

9.1	Cut out horizontal cracks to existing cracked render below lower capping, grout and repair and the repair re-integrated with a temporary/sacrificial coating until repair weathers in to full extent of wall (both sides).

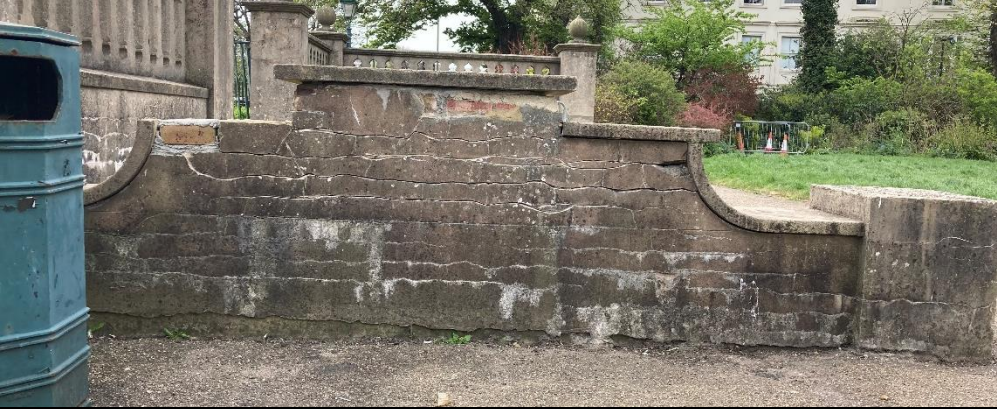
9.2	Provide new replacement copings to missing sections to match.	
	Drawing 1018 Site Plan 9 North East Lawns and RHP drawing 5016.	
	<p>Existing rendered low level brickwork with missing copings. Lime leeching evident.</p>

9.3	Carefully lift and salvage for reuse horizontal copings (to carry out repairs to brickwork below).	
9.4	Cut out and remove poor previous brickwork repairs.

9.5	Cut out horizontal cracks to existing cracked render below lower capping, grout and repair and the repair re-integrated with a temporary/sacrificial coating until repair weathers in to dull extent of wall (both sides).	
<b>10.0</b>	<b>Gates</b>	
	<p>Metal Gate repairs. Refer to items of repair, below, and the drawings referred to for location. All quantities are provisional subject to early inspection and confirmation of the scope of repairs by the Architect and approval of samples as noted above.</p>

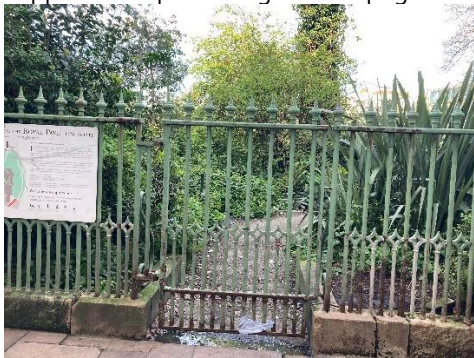
10.21	Carry out repairs as needed to existing stone piers and steps whilst gates are off site. See section 8.0.	
10.22	Carefully protect for transport and re-install to existing stone piers and make fully operational. <b>Gate to Palace Pier Railings</b> (G11 on Allen Scott Landscape Architects drawings). See RHP drawing 1018 for location and detail drawing 5051.	
	Existing cast iron gates with spiked detail to top rail and quatrefoil details to uprights. Supported on pintol hinges with uprights set into stone plinth. Currently in poor condition.

10.23	To be repaired in situ	
10.24	Prepare existing surfaces to carry out repairs.	
10.25	Repair 2 no. bottom horizontal rails which have significant areas of corrosion. Exact repair TBC when surfaces fully repaired and depth of corrosion known.

10.26	Carefully prepare surfaces for new paint finish.	
10.27	Provide new paint system in full accordance with manufacturers recommendation (subject to successful trials – see item 5.8 above)

10.28	Install new bespoke lock box to provide new secure access.	
10.29	Carry out repairs as needed to existing stone plinth whilst gates are off site. See section 8.0.

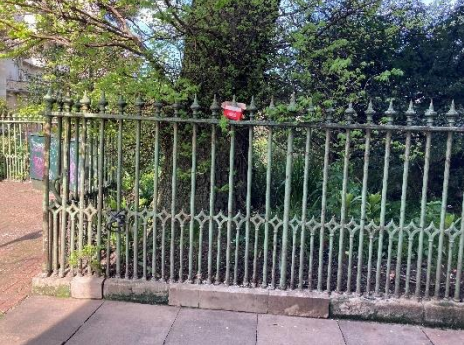
<b>11.0</b>	<b>Green Cast Iron Railings adjacent Palace Pier</b>	
	Drawing 1018 Site Plan 9 and drawings 5050 and 5051	
	Existing cast iron railings with spiked tops and infill uprights. Serpentine braced supports fixed to railings and into stone plinth.

11.1	To be repaired in situ	
11.2	Prepare existing surfaces to carry out repairs. Allow for all suitable protection measures as noted on drawings.	
11.3	Allow to carry out repairs to located areas of significant corrosion to decorative elements, repair extent TBC when corrosion removed. <ul style="list-style-type: none"> <li>• Horizontal top rail in poor condition with previous 1 no. stitch repairs evident.</li> <li>• 7 no. uprights in significant poor condition and may require wholesale replacement including section supporting hinge to Gate G11.</li> <li>• Curved section in poor condition including corner upright.</li> <li>• 12 no. uprights in poor condition around services boxing (limited access). Allow for wholesale replacement to match.</li> <li>• 10 no. lower uprights with quatre foil design in poor condition. Allow for replacement to match.</li> </ul> <p>Note: corrosion likely to be significant where uprights are below the stone plinth line. Some railings not visible due to plant growth. Allow for provisional sum for further repairs/ replacement.</p>

11.4	Carefully prepare surfaces for new paint finish.	
11.5	Provide new paint system in full accordance with manufacturers recommendation (subject to successful trials – see item 5.8 above)

11.6	Carry out repairs as needed to existing stone plinth whilst gates are off site. See section 8.0.	
11.7	Clear away protections.	
<b>12.0</b>	<b>Lamp posts</b> Note: Only 19 no. lamp posts are listed (16, 17, 18, 20, 23, 24, 25, 26, 28, 29, 30, 31, 32, 38, 40, 41, 42, 43 and 44). Lamp posts 11, 12, 13, 14 and 15 are not listed but are within the parkland boundary and are of a similar insignia design to the listed lamp posts. See the GA site plans for details and locations. The condition varies to each lamp post, however, the principle for repair will be the same to all the lamp posts. A trial repair should be carried out to one existing listed lamppost (TBC on site) and reviewed prior to carrying out works to all the lamp posts. The colour scheme of the paint finish should be informed by the historic paint analysis and trials carried out for agreement. Non listed Lamp posts 1 to 10 added. Recent refurbishment of lanterns noted.

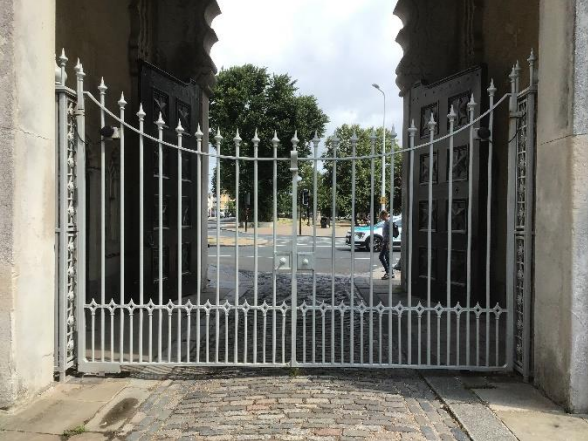
12.10	Refer to Allen Scott Landscape Architects details for works to existing adjacent paths/ external works.	
<b>13.0</b>	North Gate Vehicular Gates Drawing 1012 Site Plan 3 and RHP detail drawing 5040.	
	Automatic Vehicle Gate to North Gate. Existing modern painted galvanised steel automatic vehicle gates and 2 no. piers.

13.1	Suitably prepare to remove all corrosion prime and redecorate with suitable paint finish to provide weather protection. Colour subject to paint sample as item 5.6 above.

13.2	Retain and suitably protect gate automation gear.	
13.3	Gate is listed, ensure all paving and stonework is suitably protected during Gate repair and re-decoration works.	
<b>14.0</b>	South (India) Gates and RHP detail drawing 5030. Drawing 1012 Site Plan 3	
	Existing timber gates set within India gate and adjacent 2 no. pedestrian gates. <b>All to be retained and repaired.</b>

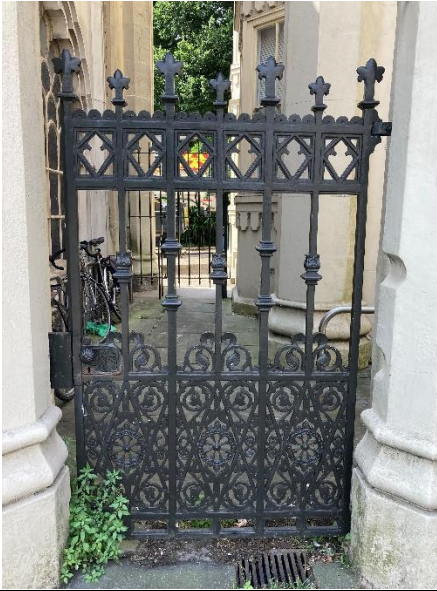
Drawing 1012 Site Plan 3 and RHP detail drawing 5040.	
	Cast iron ornate Gate on the boundary of the garden.

15.1	Suitable preparation to remove all corrosion, prime and redecorate with suitable paint finish to provide weather protection. Colour subject to paint sample as item 5.7 above.

15.2	Repair corroded lock – allow for matching replacement box. Overhaul, ease and adjust lock to make operational. Retain and repair knobs.	
15.3	Upper railings to be suitably preparation to remove all corrosion, prime and redecorate with suitable paint finish to provide weather protection. Provide high level access to assess stone coping. Allow for new leak caulking to all uprights.

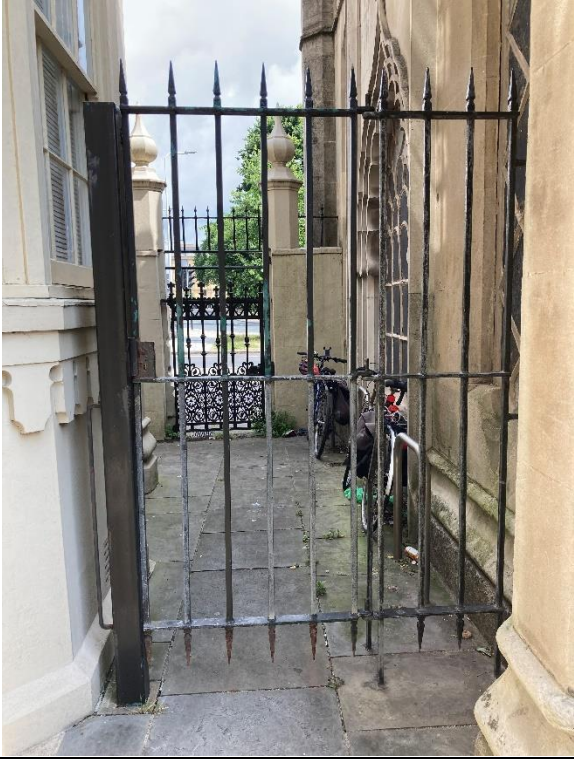
16.0	Modern Gate to North Gate	
	Drawing 1012 Site Plan 3 and RHP detail drawing 5040.	
	Modern galvanized steel gate

16.1	Suitably prepare to remove all corrosion, prime and redecorate with suitable paint finish to provide weather protection.	
16.2	Repair corroded lock – allow for matching replacement box. Overhaul, ease and adjust lock to make operational.	
17.0	South Gate Boundary Wall	
	<p>Drawing 1016 Site Plan 7 and RHP detail drawing 5030.</p>
