Asbestos Refurbishment/Demolition Survey
For Roy Allum
at
Barns & Out Building
Sycamore Lodge
Green Lane
Melton Mowbray
LE14-3QF

Project Number: 005169RS

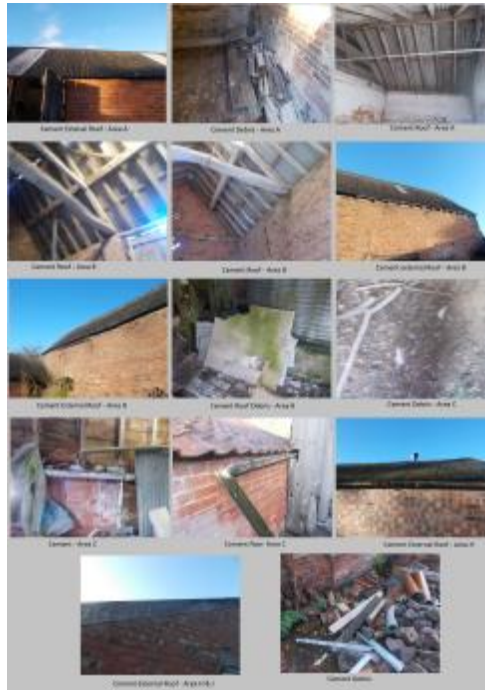
Location ID:	<input type="text" value="37424"/>	Survey Type:	<input type="text" value="RDS"/>
Location Ref:	<input type="text" value="01/s1"/>	Product Type:	<input type="text" value="Asbestos cement"/>
Product:	<input type="text" value="Cement"/>	Damage:	<input type="text" value="High damage: Visible debris"/>
Area:	<input type="text" value="Barns & Out Building"/>	Treatment:	<input type="text" value="Asbestos cement sheets etc"/>
Floor:	<input type="text"/>	Asbestos Type:	<input type="text" value="Chrysotile"/>
Room:	<input type="text" value="Several"/>	Identification:	<input type="text" value="Identified"/>
Surveyor Name:	<input type="text" value="Chris Brailsford"/>	Quantity:	<input type="text"/>

Material Risk Score:	<input type="text" value="6"/>
Material Risk Band:	<input type="text" value="Low Risk"/>
Priority Risk Score:	<input type="text" value="N/A"/>

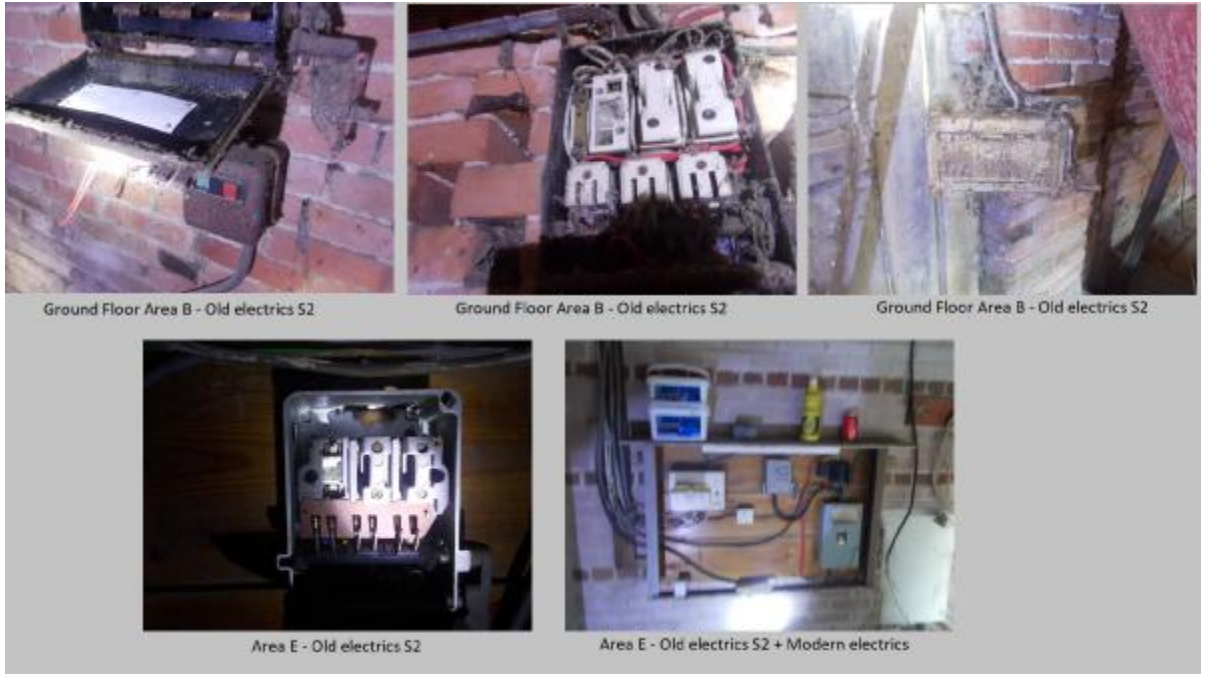
Location ID:	<input type="text" value="37425"/>	Survey Type:	<input type="text" value="RDS"/>
Location Ref:	<input type="text" value="02/s2"/>	Product Type:	<input type="text" value="Ropes and woven textiles"/>
Product:	<input type="text" value="Old electrics"/>	Damage:	<input type="text" value="No visible damage"/>
Area:	<input type="text" value="Barns & Out Building"/>	Treatment:	<input type="text" value="Encapsulated lagging and spray"/>
Floor:	<input type="text"/>	Asbestos Type:	<input type="text" value="Chrysotile/Amosite"/>
Room:	<input type="text" value="Several"/>	Identification:	<input type="text" value="Identified"/>
Surveyor Name:	<input type="text" value="Chris Brailsford"/>	Quantity:	<input type="text"/>

Material Risk Score:	<input type="text" value="6"/>
Material Risk Band:	<input type="text" value="Low Risk"/>
Priority Risk Score:	<input type="text" value="N/A"/>

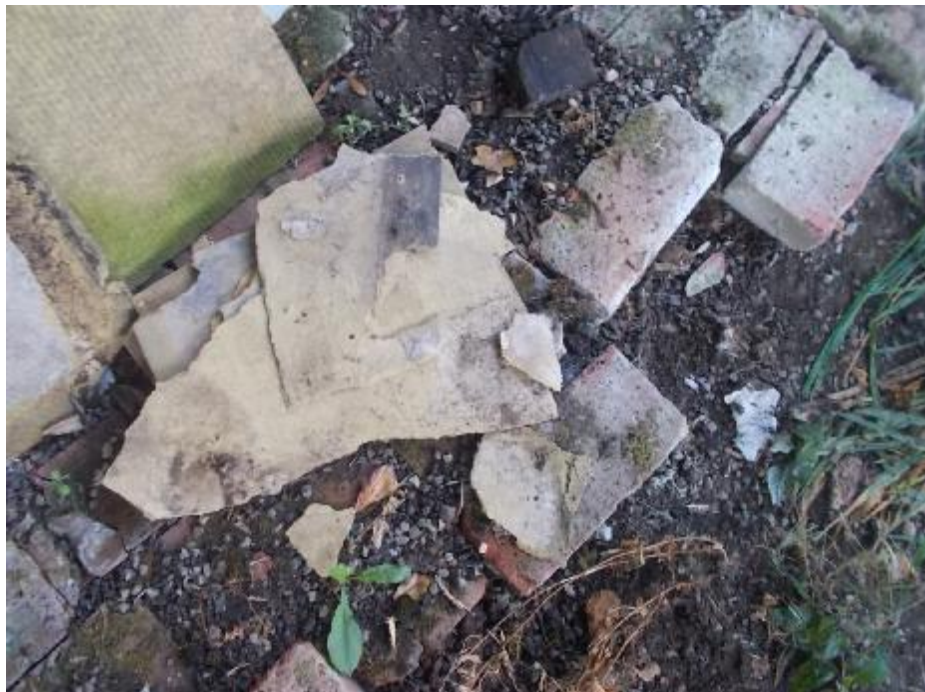
Location ID:	<input type="text" value="37426"/>	Survey Type:	<input type="text" value="RDS"/>
Location Ref:	<input type="text" value="03/s3"/>	Product Type:	<input type="text" value="Asbestos cement"/>
Product:	<input type="text" value="Cement"/>	Damage:	<input type="text" value="High damage: Visible debris"/>
Area:	<input type="text" value="Barns & Out Building"/>	Treatment:	<input type="text" value="Asbestos cement sheets etc"/>
Floor:	<input type="text" value="External"/>	Asbestos Type:	<input type="text" value="Chrysotile"/>
Room:	<input type="text" value="Area B"/>	Identification:	<input type="text" value="Identified"/>
Surveyor Name:	<input type="text" value="Chris Brailsford"/>	Quantity:	<input type="text"/>

Material Risk Score:	<input type="text" value="6"/>
Material Risk Band:	<input type="text" value="Low Risk"/>
Priority Risk Score:	<input type="text" value="N/A"/>

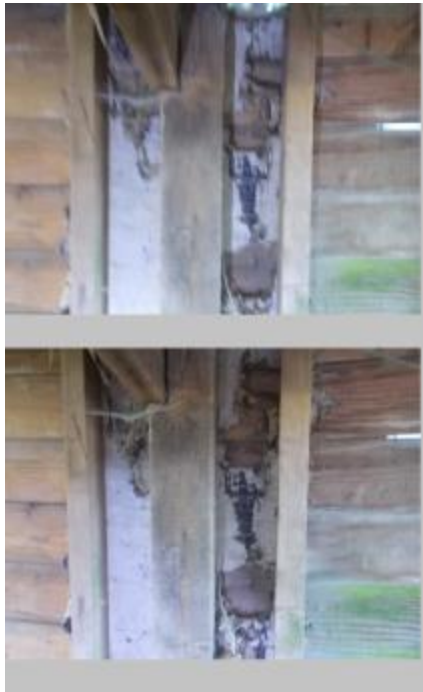
Location ID:	<input type="text" value="37427"/>	Survey Type:	<input type="text" value="RDS"/>
Location Ref:	<input type="text" value="04/s4"/>	Product Type:	<input type="text" value="NADIS"/>
Product:	<input type="text" value="Bitumen"/>	Damage:	<input type="text" value="NADIS"/>
Area:	<input type="text" value="Barns & Out Building"/>	Treatment:	<input type="text" value="NADIS"/>
Floor:	<input type="text" value="Ground floor"/>	Asbestos Type:	<input type="text" value="NADIS"/>
Room:	<input type="text" value="Area C"/>	Identification:	<input type="text" value="Identified"/>
Surveyor Name:	<input type="text" value="Chris Brailsford"/>	Quantity:	<input type="text"/>
Drawing Ref:	<input type="text"/>		
Asbestos ?	<input type="text" value="No"/>		
Date:	<input type="text" value="08 October 2022"/>		
Next Inspection:	<input type="text" value="Not Applicable"/>

Material Risk Score:	<input type="text" value="0"/>
Material Risk Band:	<input type="text" value="NADIS"/>
Priority Risk Score:	<input type="text" value="N/A"/>

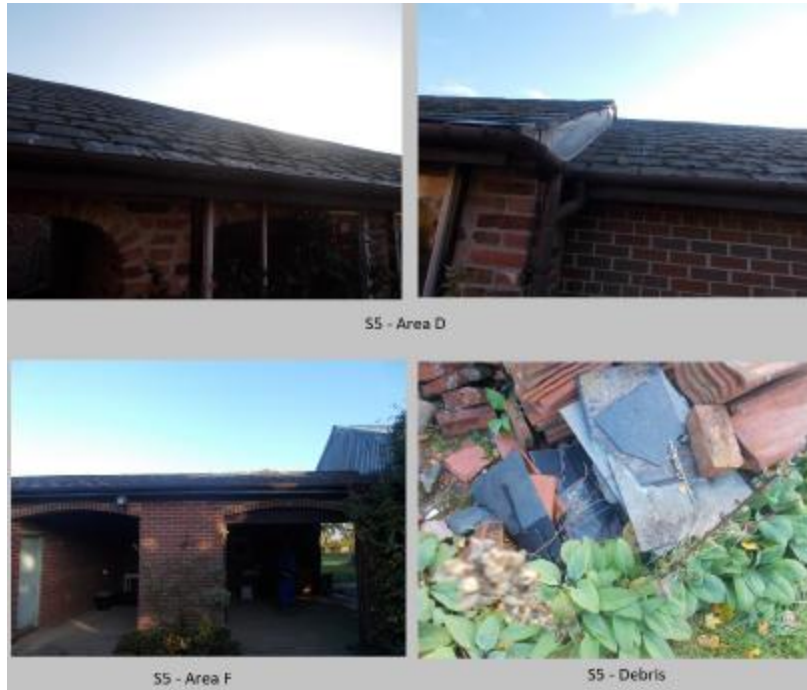
Location ID:	<input type="text" value="37428"/>	Survey Type:	<input type="text" value="RDS"/>
Location Ref:	<input type="text" value="05/s5"/>	Product Type:	<input type="text" value="Asbestos cement"/>
Product:	<input type="text" value="Eternite roof tiles"/>	Damage:	<input type="text" value="High damage: Visible debris"/>
Area:	<input type="text" value="Barns & Out Building"/>	Treatment:	<input type="text" value="Asbestos cement sheets etc"/>
Floor:	<input type="text" value="External"/>	Asbestos Type:	<input type="text" value="Chrysotile"/>
Room:	<input type="text" value="Areas D, E & F"/>	Identification:	<input type="text" value="Identified"/>
Surveyor Name:	<input type="text" value="Chris Brailsford"/>	Quantity:	<input type="text"/>

Material Risk Score:	<input type="text" value="6"/>
Material Risk Band:	<input type="text" value="Low Risk"/>
Priority Risk Score:	<input type="text" value="N/A"/>

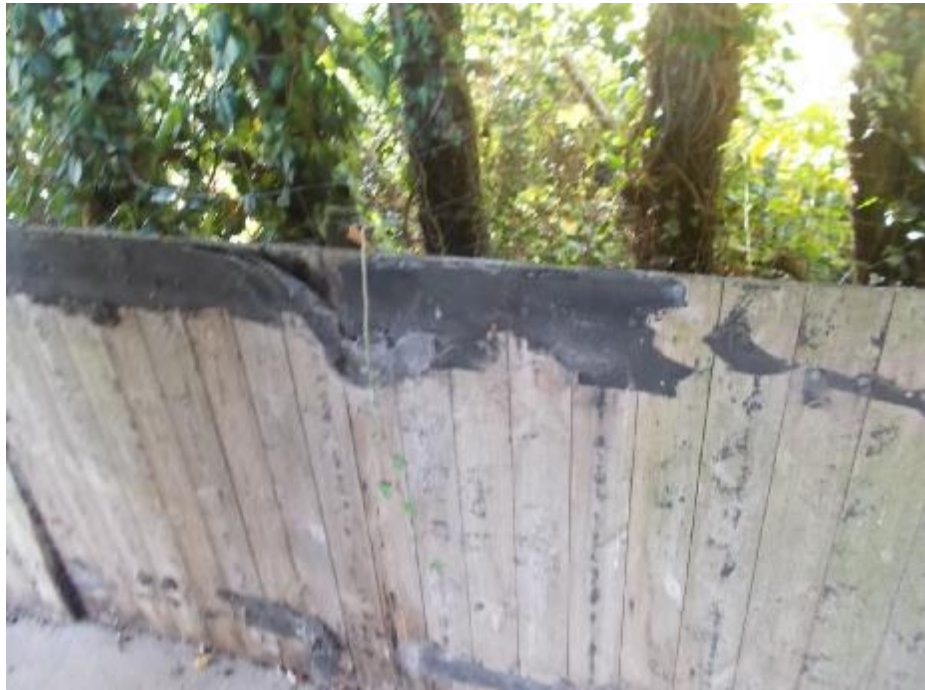
Location ID:	<input type="text" value="37429"/>	Survey Type:	<input type="text" value="RDS"/>
Location Ref:	<input type="text" value="06/s6"/>	Product Type:	<input type="text" value="NADIS"/>
Product:	<input type="text" value="Bitumen"/>	Damage:	<input type="text" value="NADIS"/>
Area:	<input type="text" value="Barns & Out Building"/>	Treatment:	<input type="text" value="NADIS"/>
Floor:	<input type="text"/>	Asbestos Type:	<input type="text" value="NADIS"/>
Room:	<input type="text" value="Area G"/>	Identification:	<input type="text" value="Identified"/>
Surveyor Name:	<input type="text" value="Chris Brailsford"/>	Quantity:	<input type="text"/>
Drawing Ref:	<input type="text"/>		
Asbestos ?	<input type="text" value="No"/>		
Date:	<input type="text" value="08 October 2022"/>		
Next Inspection:	<input type="text" value="Not Applicable"/>

Material Risk Score:	<input type="text" value="0"/>
Material Risk Band:	<input type="text" value="NADIS"/>
Priority Risk Score:	<input type="text" value="N/A"/>

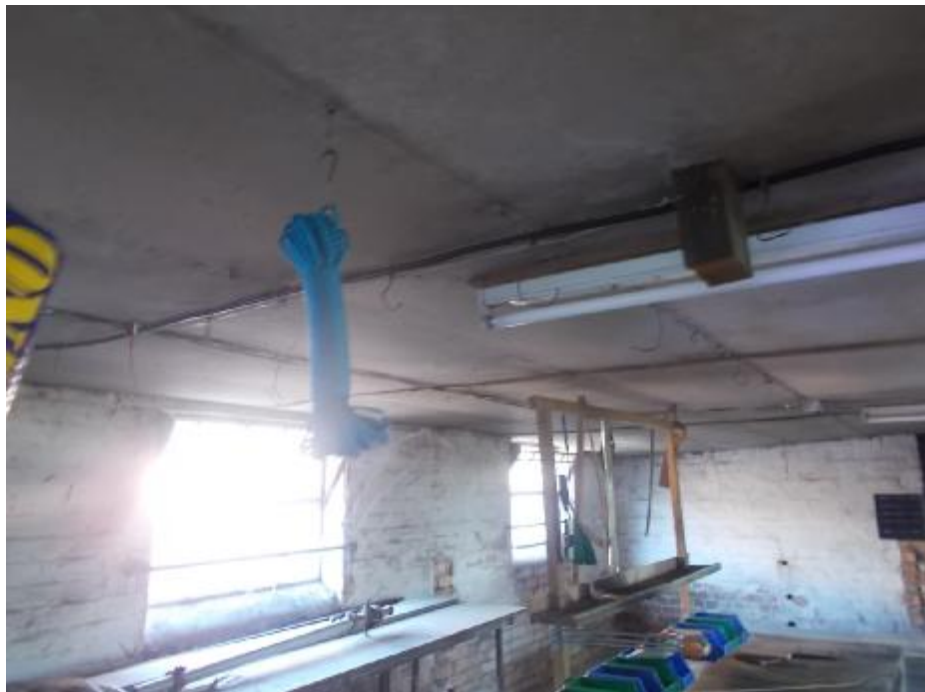
Location ID:	<input type="text" value="37430"/>	Survey Type:	<input type="text" value="RDS"/>
Location Ref:	<input type="text" value="07/s7"/>	Product Type:	<input type="text" value="Asbestos Insulating Board"/>
Product:	<input type="text" value="Ceiling"/>	Damage:	<input type="text" value="Good condition"/>
Area:	<input type="text" value="Barns & Out Building"/>	Treatment:	<input type="text" value="AIB painted or encapsulated"/>
Floor:	<input type="text"/>	Asbestos Type:	<input type="text" value="Chrysotile"/>
Room:	<input type="text" value="Areas H & J"/>	Identification:	<input type="text" value="Identified"/>
Surveyor Name:	<input type="text" value="Chris Brailsford"/>	Quantity:	<input type="text"/>

Material Risk Score:	<input type="text" value="4"/>
Material Risk Band:	<input type="text" value="Very Low Risk"/>
Priority Risk Score:	<input type="text" value="N/A"/>

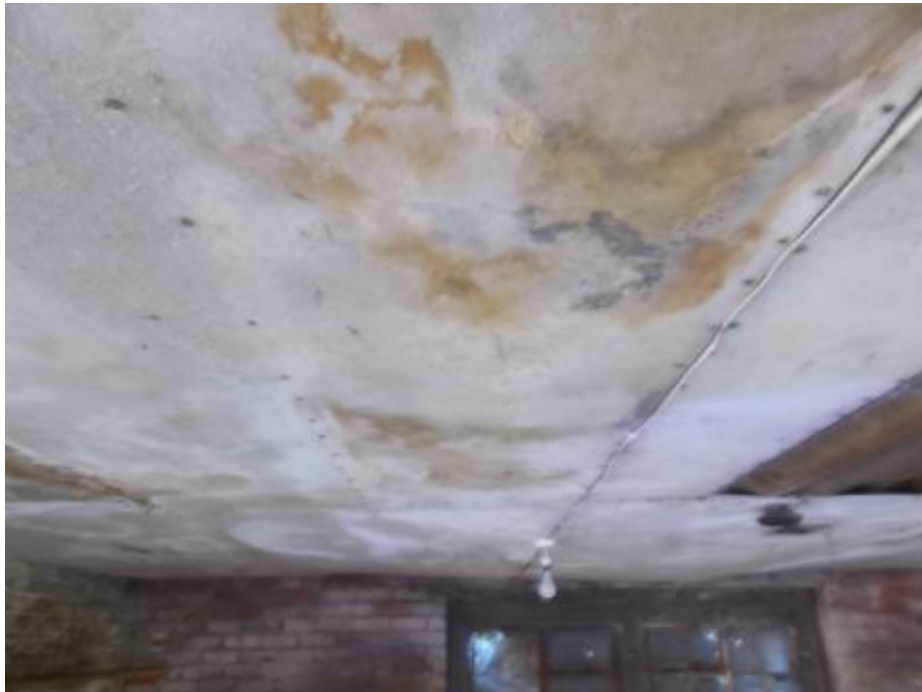
Location ID:	<input type="text" value="37431"/>	Survey Type:	<input type="text" value="RDS"/>
Location Ref:	<input type="text" value="08/s8"/>	Product Type:	<input type="text" value="Asbestos Insulating Board"/>
Product:	<input type="text" value="Ceiling"/>	Damage:	<input type="text" value="Medium damage"/>
Area:	<input type="text" value="Barns & Out Building"/>	Treatment:	<input type="text" value="AIB painted or encapsulated"/>
Floor:	<input type="text"/>	Asbestos Type:	<input type="text" value="Chrysotile"/>
Room:	<input type="text" value="Area J"/>	Identification:	<input type="text" value="Identified"/>
Surveyor Name:	<input type="text" value="Chris Brailsford"/>	Quantity:	<input type="text"/>

Drawing Ref:	<input type="text"/>		
Asbestos ?	<input type="text" value="Yes"/>		
Date:	<input type="text" value="08 October 2022"/>		
Next Inspection:	<input type="text" value="09 April 2023"/>		
		Material Risk Score:	<input type="text" value="6"/>
		Material Risk Band:	<input type="text" value="Low Risk"/>
		Priority Risk Score:	<input type="text" value="N/A"/>

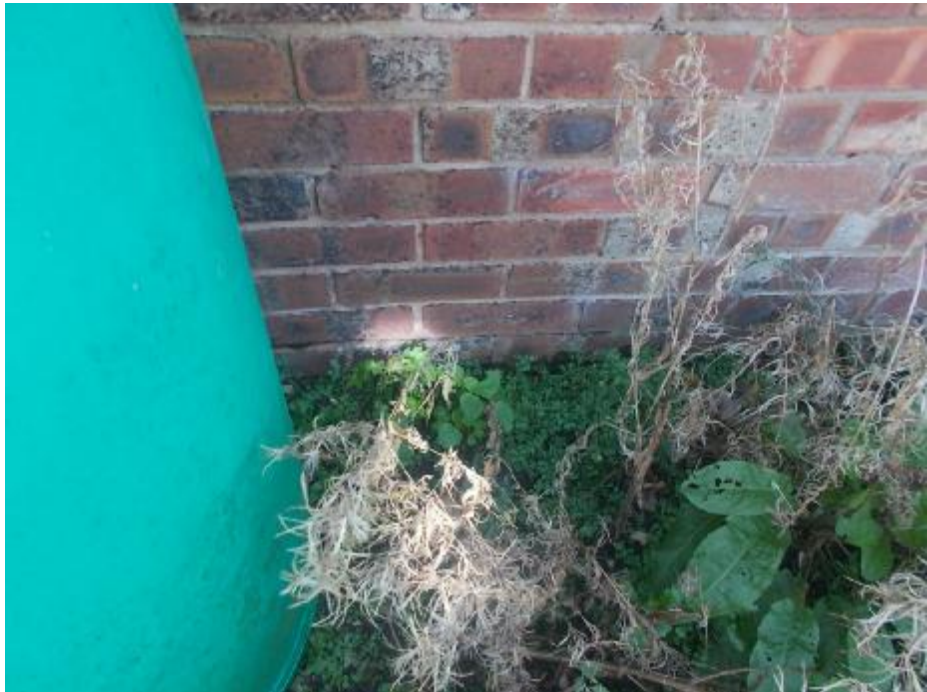
Location ID:	<input type="text" value="37432"/>	Survey Type:	<input type="text" value="RDS"/>
Location Ref:	<input type="text" value="09/s9"/>	Product Type:	<input type="text" value="Roofing felts"/>
Product:	<input type="text" value="Damp corse membrane"/>	Damage:	<input type="text" value="Good condition"/>
Area:	<input type="text" value="Barns & Out Building"/>	Treatment:	<input type="text" value="Sealed paper"/>
Floor:	<input type="text" value="External"/>	Asbestos Type:	<input type="text" value="Chrysotile"/>
Room:	<input type="text" value="Areas H & J"/>	Identification:	<input type="text" value="Identified"/>
Surveyor Name:	<input type="text" value="Chris Brailsford"/>	Quantity:	<input type="text"/>

Material Risk Score:	<input type="text" value="3"/>
Material Risk Band:	<input type="text" value="Very Low Risk"/>
Priority Risk Score:	<input type="text" value="N/A"/>

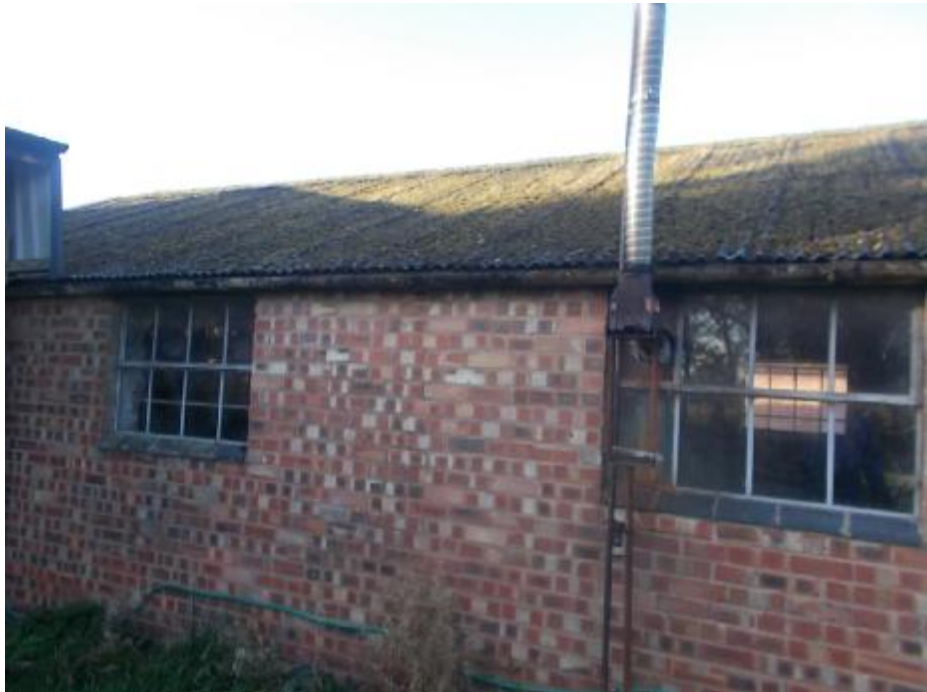
Location ID:	<input type="text" value="37433"/>	Survey Type:	<input type="text" value="RDS"/>
Location Ref:	<input type="text" value="10/s10"/>	Product Type:	<input type="text" value="NADIS"/>
Product:	<input type="text" value="Putty"/>	Damage:	<input type="text" value="NADIS"/>
Area:	<input type="text" value="Barns & Out Building"/>	Treatment:	<input type="text" value="NADIS"/>
Floor:	<input type="text" value="External"/>	Asbestos Type:	<input type="text" value="NADIS"/>
Room:	<input type="text" value="Areas H & J"/>	Identification:	<input type="text" value="Identified"/>
Surveyor Name:	<input type="text" value="Chris Brailsford"/>	Quantity:	<input type="text"/>
Drawing Ref:	<input type="text"/>		
Asbestos ?	<input type="text" value="No"/>		
Date:	<input type="text" value="08 October 2022"/>		
Next Inspection:	<input type="text" value="Not Applicable"/>

Material Risk Score:	<input type="text" value="0"/>
Material Risk Band:	<input type="text" value="NADIS"/>
Priority Risk Score:	<input type="text" value="N/A"/>
