Asbestos Refurbishment/Demolition Survey
For Roy Allum
at
House
Sycamore Lodge
Green Lane
Melton Mowbray
LE14-3QF

Project Number: 005170RS

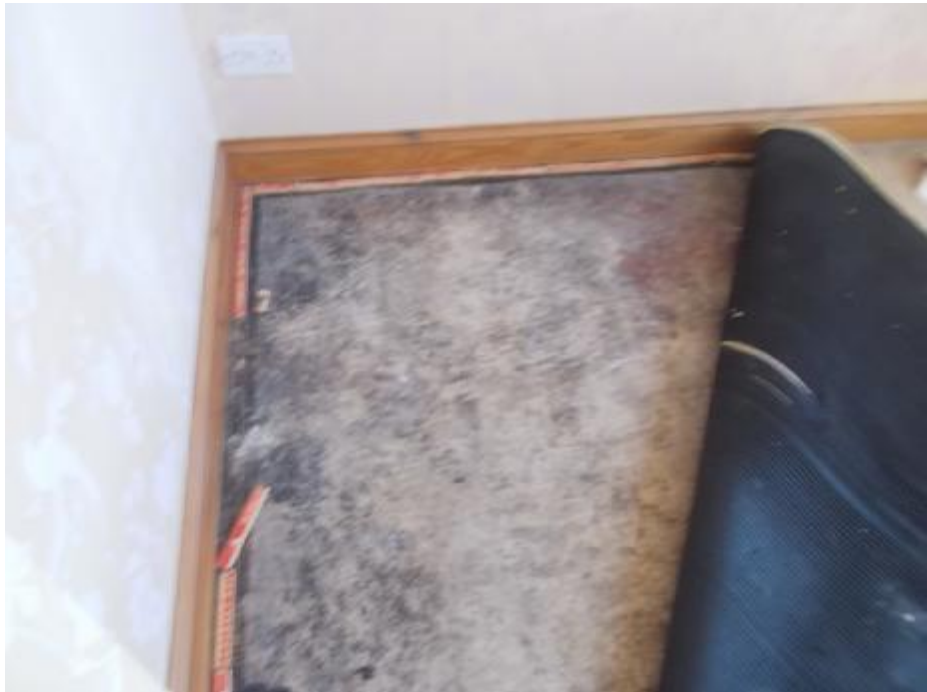
A sample was taken of the bitumen to the floor (S11) this was proven to be asbestos free; there was no visible sign of any asbestos containing materials evident within the above areas.

Location ID:	<input type="text" value="37450"/>	Survey Type:	<input type="text" value="RDS"/>
Location Ref:	<input type="text" value="01/s11"/>	Product Type:	<input type="text" value="NADIS"/>
Product:	<input type="text" value="Bitumen"/>	Damage:	<input type="text" value="NADIS"/>
Area:	<input type="text" value="House"/>	Treatment:	<input type="text" value="NADIS"/>
Floor:	<input type="text" value="1st floor"/>	Asbestos Type:	<input type="text" value="NADIS"/>
Room:	<input type="text" value="Areas 1, 2 & A"/>	Identification:	<input type="text" value="Identified"/>
Surveyor Name:	<input type="text" value="Chris Brailsford"/>	Quantity:	<input type="text"/>
Drawing Ref:	<input type="text"/>		
Asbestos ?	<input type="text" value="No"/>		
Date:	<input type="text" value="08 October 2022"/>		
Next Inspection:	<input type="text" value="Not Applicable"/>

Material Risk Score:	<input type="text" value="0"/>
Material Risk Band:	<input type="text" value="NADIS"/>
Priority Risk Score:	<input type="text" value="N/A"/>

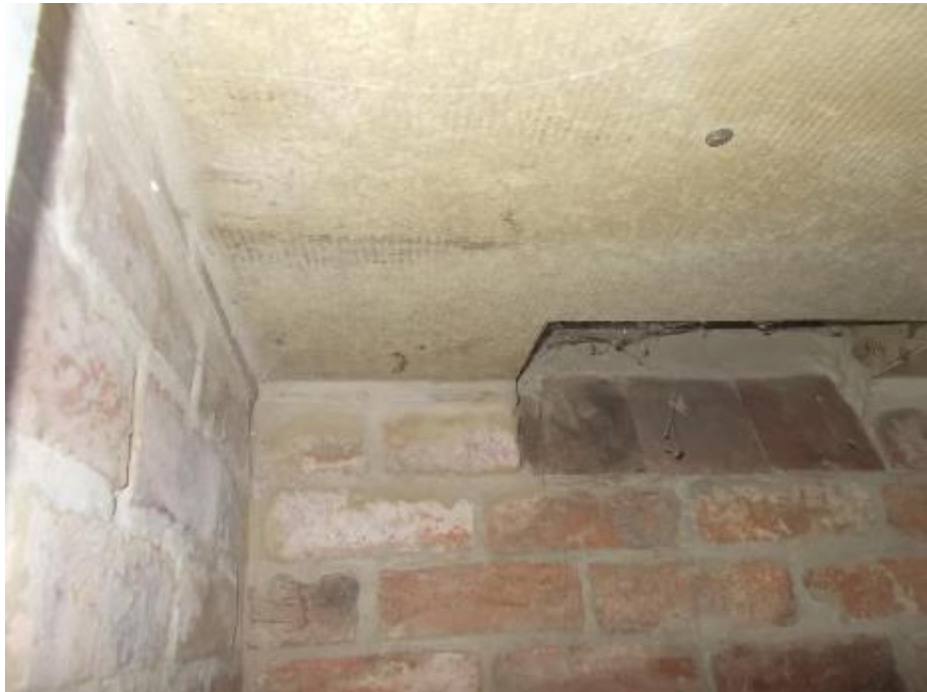
A sample was taken of the millboard to fireplace (S12) this was proven to be asbestos (chrysotile).

LICENSABLE MATERIALS – Millboard S12

Location ID:	<input type="text" value="37451"/>	Survey Type:	<input type="text" value="RDS"/>
Location Ref:	<input type="text" value="02/s12"/>	Product Type:	<input type="text" value="Asbestos Insulating Board"/>
Product:	<input type="text" value="Board"/>	Damage:	<input type="text" value="Good condition"/>
Area:	<input type="text" value="House"/>	Treatment:	<input type="text" value="AIB painted or encapsulated"/>
Floor:	<input type="text" value="Ground floor"/>	Asbestos Type:	<input type="text" value="Chrysotile"/>
Room:	<input type="text" value="Area 3"/>	Identification:	<input type="text" value="Identified"/>
Surveyor Name:	<input type="text" value="Chris Brailsford"/>	Quantity:	<input type="text"/>

Material Risk Score:	<input type="text" value="4"/>
Material Risk Band:	<input type="text" value="Very Low Risk"/>
Priority Risk Score:	<input type="text" value="N/A"/>

The material must be removed under full conditions by a contractor who holds a license issued by the H.S.E. after 14 days' notice has been served.

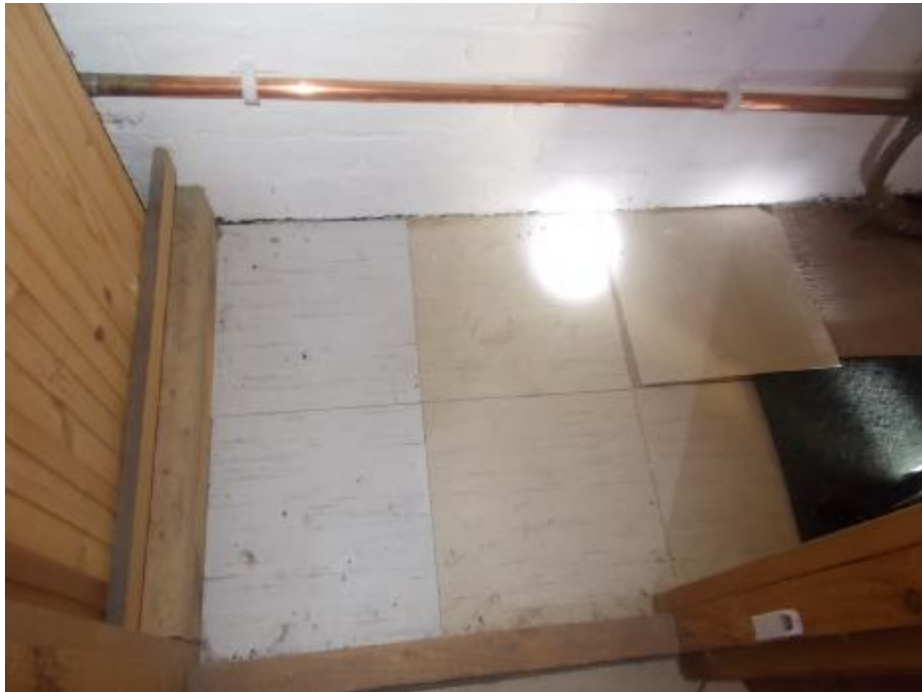
A sample was taken of the floor tile (S13) this was proven to be asbestos free; there was no visible sign of any asbestos containing materials evident within the above area.

Location ID:	<input type="text" value="37452"/>	Survey Type:	<input type="text" value="RDS"/>
Location Ref:	<input type="text" value="03/s13"/>	Product Type:	<input type="text" value="NADIS"/>
Product:	<input type="text" value="Floor tile"/>	Damage:	<input type="text" value="NADIS"/>
Area:	<input type="text" value="House"/>	Treatment:	<input type="text" value="NADIS"/>
Floor:	<input type="text" value="Ground floor"/>	Asbestos Type:	<input type="text" value="NADIS"/>
Room:	<input type="text" value="Areas B & C"/>	Identification:	<input type="text" value="Identified"/>
Surveyor Name:	<input type="text" value="Chris Brailsford"/>	Quantity:	<input type="text"/>
Drawing Ref:	<input type="text"/>		
Asbestos ?	<input type="text" value="No"/>		
Date:	<input type="text" value="08 October 2022"/>		
Next Inspection:	<input type="text" value="Not Applicable"/>

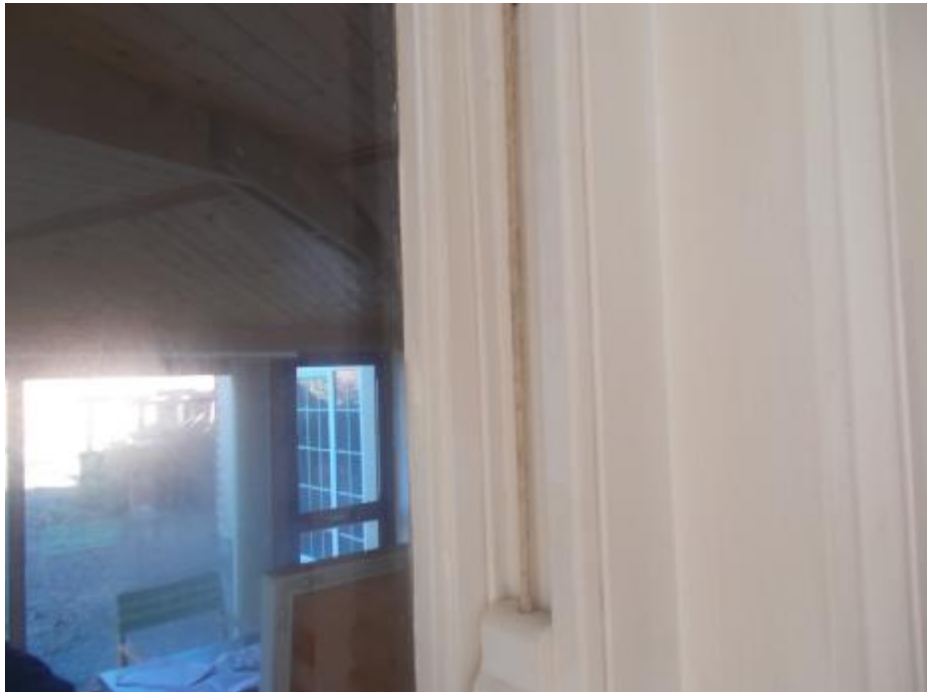
A sample was taken of the rope sash to windows (S14) this was proven to be asbestos free; there was no visible sign of any asbestos containing materials evident within area 7 except cast pipe to fireplace which was presumed to contain asbestos rope in joints, no sample was taken as it is a live service. (Further inspection required).

Location ID:	<input type="text" value="37453"/>	Survey Type:	<input type="text" value="RDS"/>
Location Ref:	<input type="text" value="04/s14"/>	Product Type:	<input type="text" value="NADIS"/>
Product:	<input type="text" value="Rope"/>	Damage:	<input type="text" value="NADIS"/>
Area:	<input type="text" value="House"/>	Treatment:	<input type="text" value="NADIS"/>
Floor:	<input type="text" value="Ground floor"/>	Asbestos Type:	<input type="text" value="NADIS"/>
Room:	<input type="text" value="Area 7"/>	Identification:	<input type="text" value="Identified"/>
Surveyor Name:	<input type="text" value="Chris Brailsford"/>	Quantity:	<input type="text"/>
Drawing Ref:	<input type="text"/>		
Asbestos ?	<input type="text" value="No"/>		
Date:	<input type="text" value="08 October 2022"/>		
Next Inspection:	<input type="text" value="Not Applicable"/>

Material Risk Score:	<input type="text" value="0"/>
Material Risk Band:	<input type="text" value="NADIS"/>
Priority Risk Score:	<input type="text" value="N/A"/>

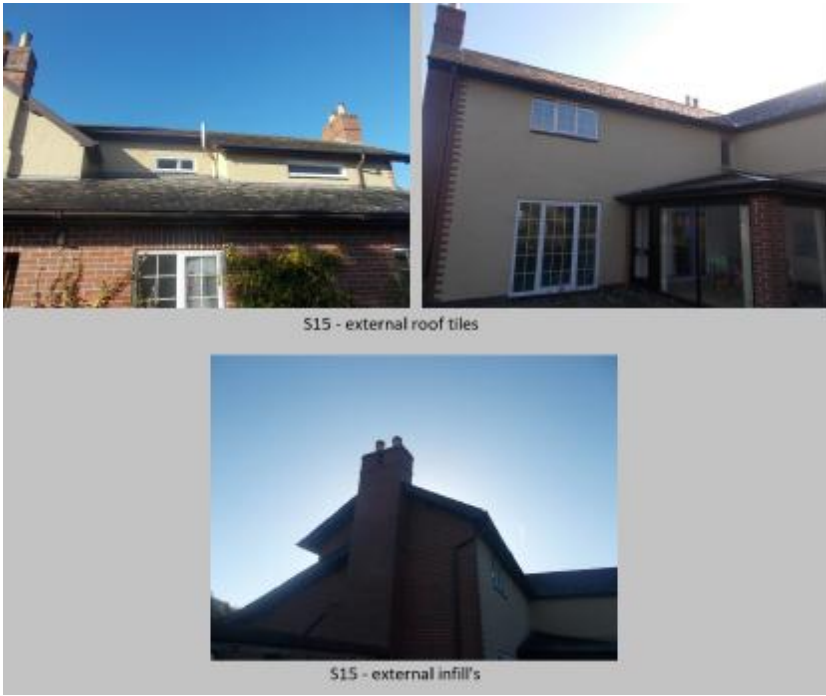
A sample was taken of the eternite cement to roof tiles and infills (S15) this was proven to be asbestos (chrysotile).

NON-LICENSABLE MATERIALS – Asbestos cement S15

Location ID:	<input type="text" value="37454"/>	Survey Type:	<input type="text" value="RDS"/>
Location Ref:	<input type="text" value="05/s15"/>	Product Type:	<input type="text" value="Asbestos cement"/>
Product:	<input type="text" value="Eternite roof tiles"/>	Damage:	<input type="text" value="Good condition"/>
Area:	<input type="text" value="House"/>	Treatment:	<input type="text" value="Asbestos cement sheets etc"/>
Floor:	<input type="text" value="External"/>	Asbestos Type:	<input type="text" value="Chrysotile"/>
Room:	<input type="text" value="External"/>	Identification:	<input type="text" value="Identified"/>
Surveyor Name:	<input type="text" value="Chris Brailsford"/>	Quantity:	<input type="text"/>

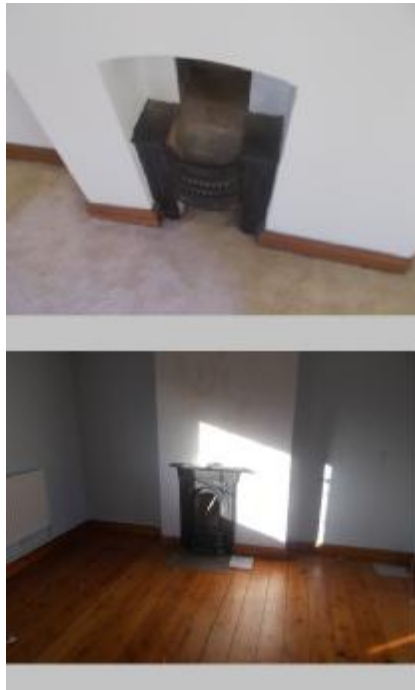
cast pipe to the fireplace which was presumed to contain asbestos rope in joints, no sample was taken as it is a live service. (Further inspection required).

Location ID:	<input type="text" value="37455"/>	Survey Type:	<input type="text" value="RDS"/>
Location Ref:	<input type="text" value="06/p"/>	Product Type:	<input type="text" value="Ropes and woven textiles"/>
Product:	<input type="text" value="Cast pipes"/>	Damage:	<input type="text" value="Good condition"/>
Area:	<input type="text" value="House"/>	Treatment:	<input type="text" value="Encapsulated lagging and spray"/>
Floor:	<input type="text" value="Ground floor"/>	Asbestos Type:	<input type="text"/>
Room:	<input type="text" value="Areas 3 & 7"/>	Identification:	<input type="text" value="Presumed"/>
Surveyor Name:	<input type="text" value="Chris Brailsford"/>	Quantity:	<input type="text"/>
Drawing Ref:	<input type="text"/>		
Asbestos ?	<input type="text" value="Yes"/>		
Date:	<input type="text" value="08 October 2022"/>		
Next Inspection:	<input type="text" value="08 October 2023"/>
