Sycamore Lodge - Workshops & Garage Hickling Pastures

Structural Inspection Report

Prepared by: Anita Hession MSc BEng
Reviewed by: Becky Rabjohns MEng
Job Number: 30123
Document Reference: Report 2

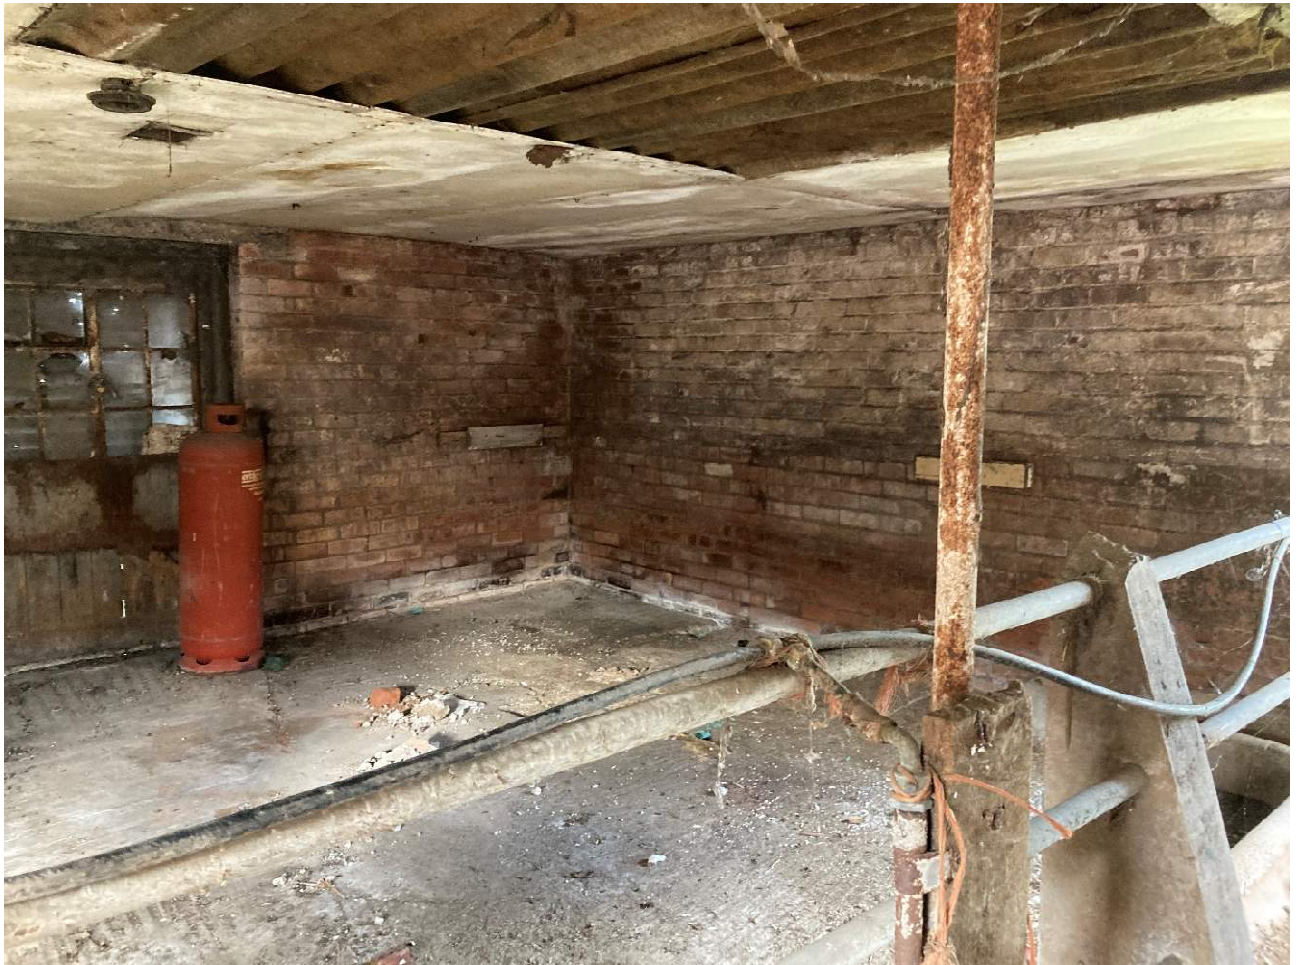
Workshop 1 was previously used as a pig sty; the internal brickwork has been limewashed in the past. The lintels over all the openings were precast concrete, the depths of the internal lintels to the external walls could not be measured as they were crossed by the ceiling and could not be accessed due to asbestos risk. The external lintel to the top double door could be measured at 215mm deep. The door between the workshops had a 140mm deep concrete lintel.

There was efflorescence noted in the top right corner on the inside face of the exterior wall, the extent of the efflorescence internally is hard to gauge due to the previous lime wash.

The efflorescence within the workshops may have been caused by repeated washing of the pigsty floor to Workshop 1 and by leaking external gutters or previous leaking internal sinks to Workshop 2. Once the new external skin of the wall is installed this can be cleaned off the walls with a wire brush and ensure DPM to ground slab wraps up the side adjacent the wall.

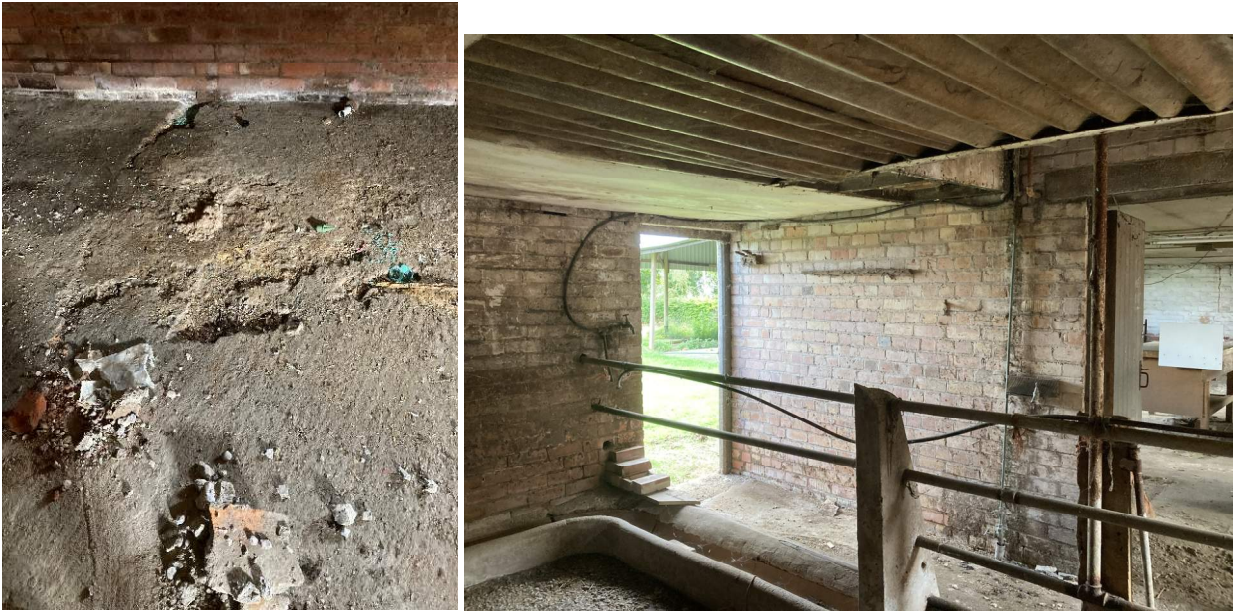
The concrete slab was 100mm thick on white polythene on 125mm crushed brick fill. The slab was in poor condition due to its previous use and there was a concrete feeding trough cast into the slab.

None of the ground slabs have any reinforcement or insulation. The slabs to the courtyard and workshops are not suitable for reuse due to the cracking and haphazard steps in Workshop 2. The ground slabs to the store and garage are more suited for reuse subject to architect's specification for insulation and levels. The hairline cracking of the garage slabs has occurred at expected locations due to drying shrinkage of the concrete after construction and no reinforcement to control the cracking.

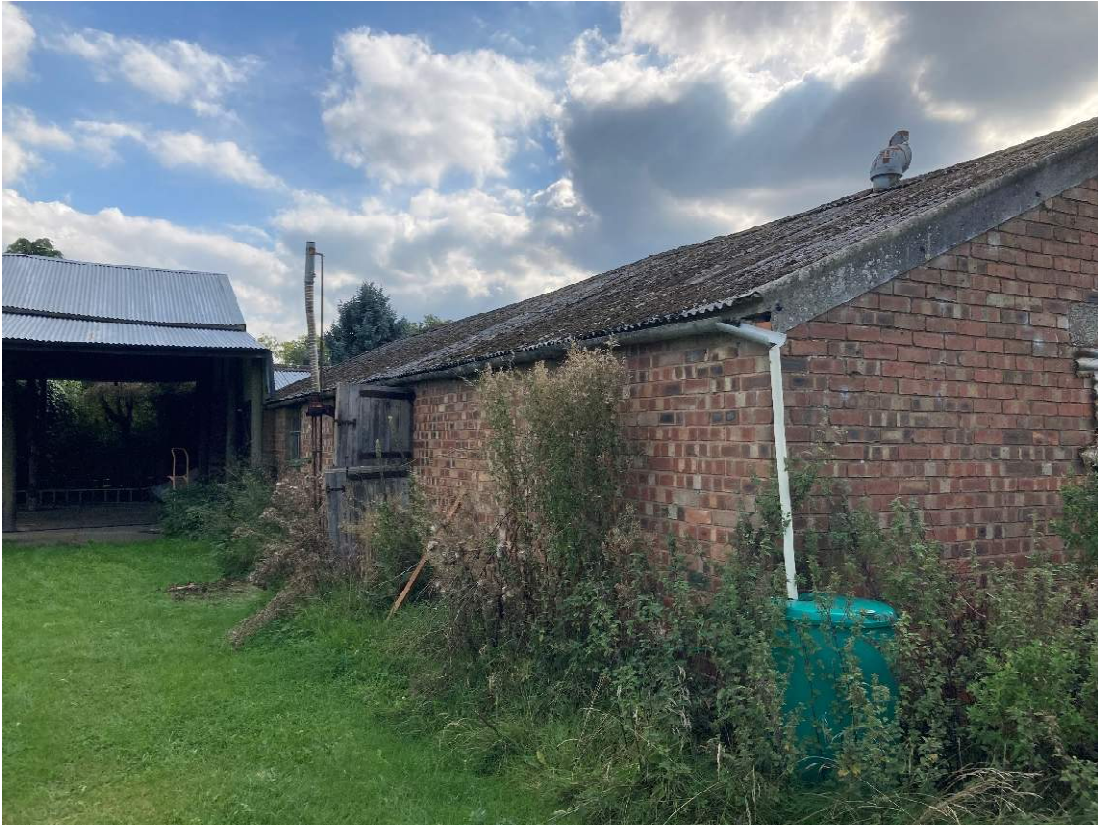
Externally there were no defects apparent in the brickwork that was visible.

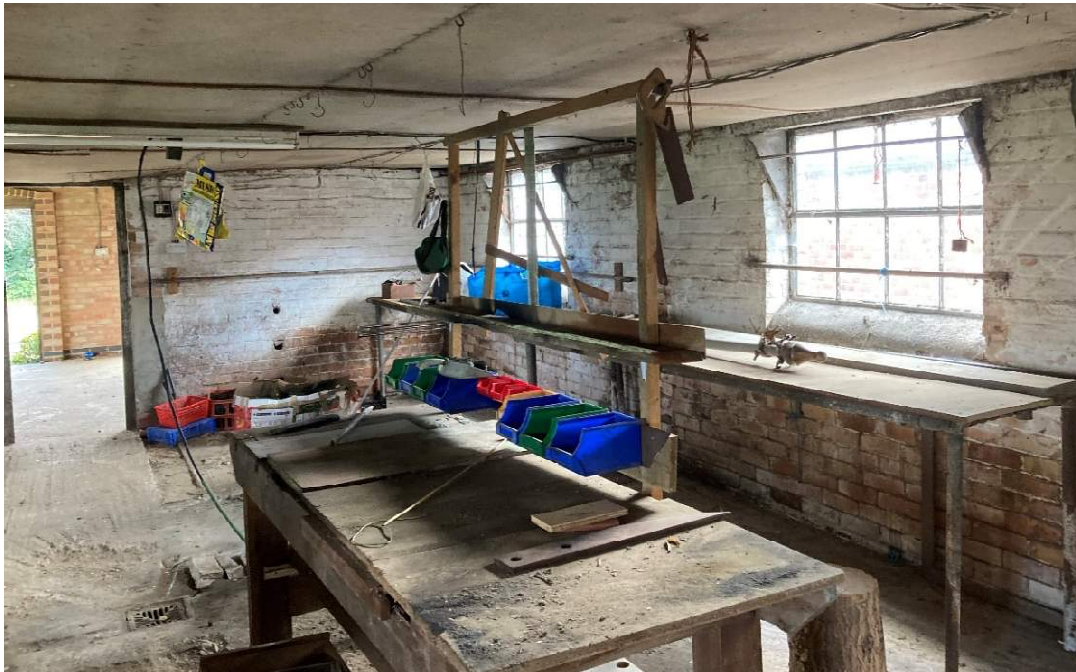
Workshop 2 still seems to be in use as a workshop, the internal brickwork has been limewashed and or painted in the past. The lintels over all the openings were precast concrete, the depths of the internal lintels to the external walls could not be measured as they were crossed by the ceiling. However, the external lintel to the door to the garage was 140mm deep.

There was efflorescence noted in the top right corner of the interior wall, the extent of the efflorescence internally is hard to gauge due to the previous lime wash, also some holes had been cut in this wall.

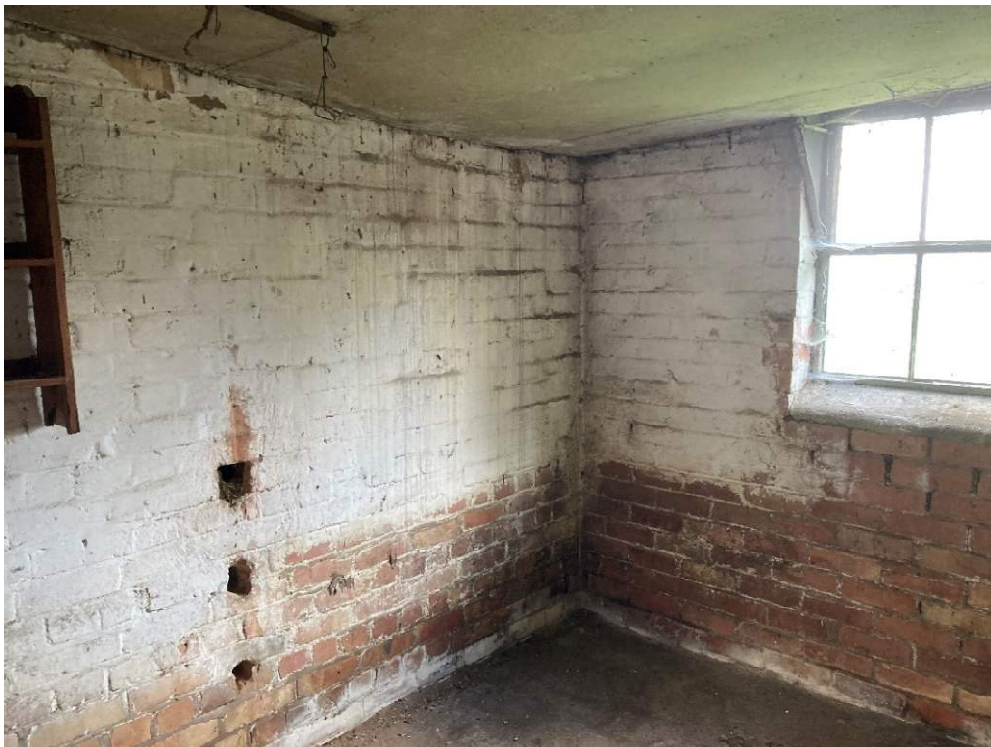
The concrete slab was 100mm thick on white polythene on 125mm crushed brick fill. The slab was in poor condition due to its previous use with level changes, steps and chases where it appears that brick piers have been removed in the past.

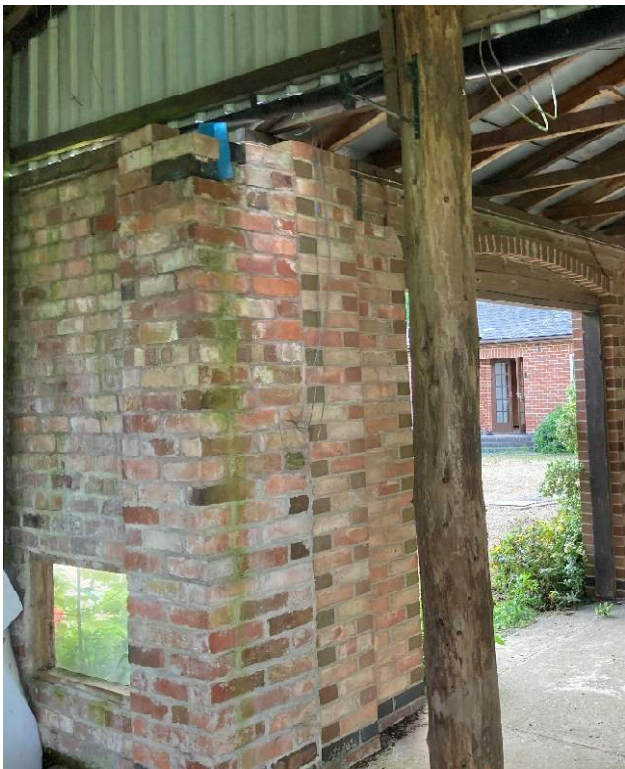
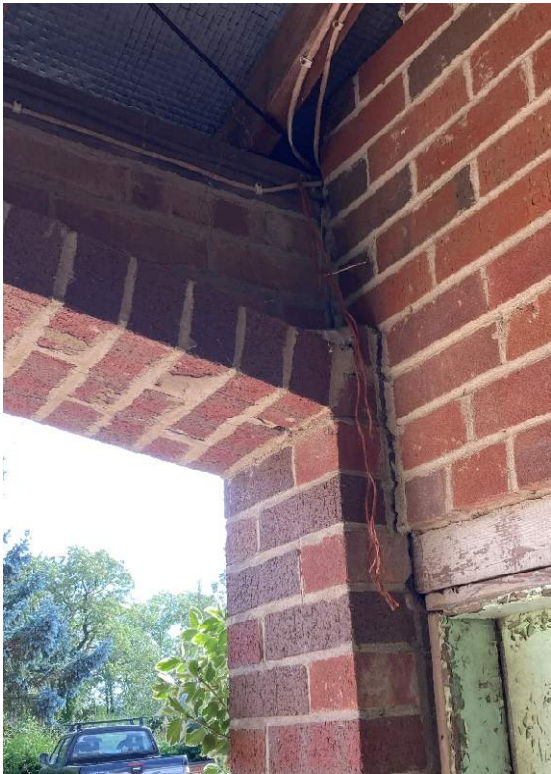
There is a 440mm thick brickwork pier abutting the return wall to the barn has no evident tothing. The junction at the other end of the wall where it abuts Garage 2 shows vertical cracking and signs of previous repairs.

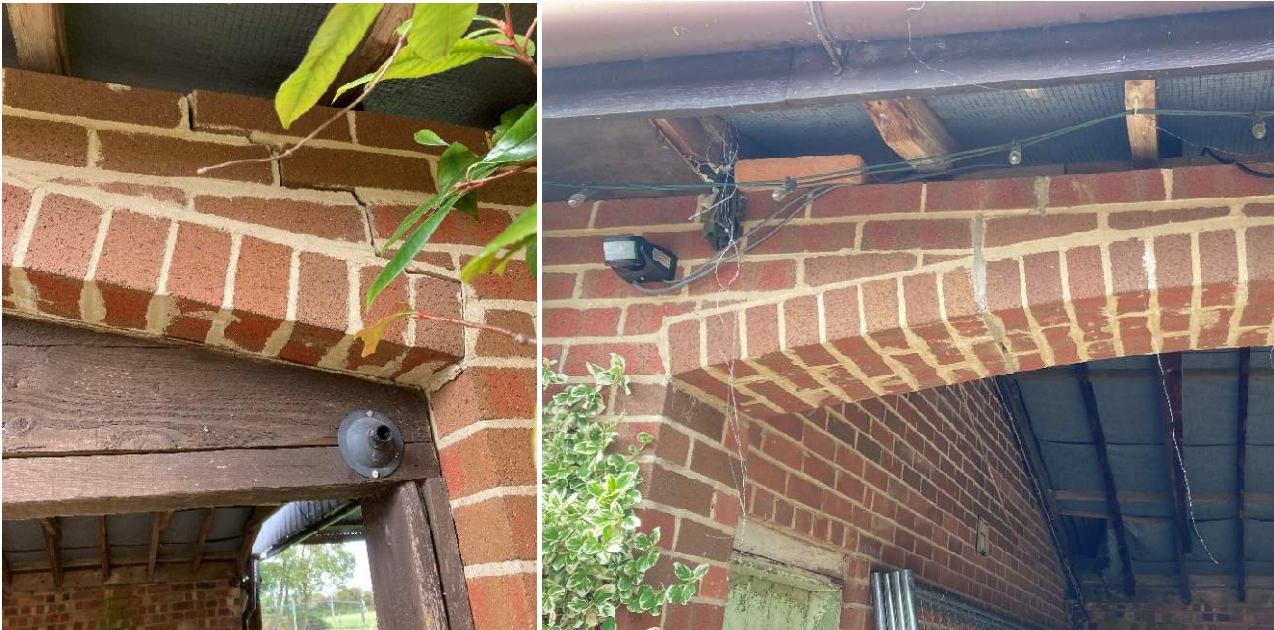
The lintels over the garage door openings show signs of movement with vertical and diagonal cracking with previous mortar repairs. There was no evidence of lintels over these openings other than the brickwork bonding.

The cracking to the flat arch lintels over the garage doors may have been caused by insufficient bearing of the arch masonry on the piers to the supports and the geometry of the flat arch. However, if there is a hidden steelwork lintel then there may be insufficient bearing for this or it has been incorrectly installed. Therefore, if the openings are to remain and use the same geometry a new steelwork lintel should be installed fully to manufacturers' guidelines.

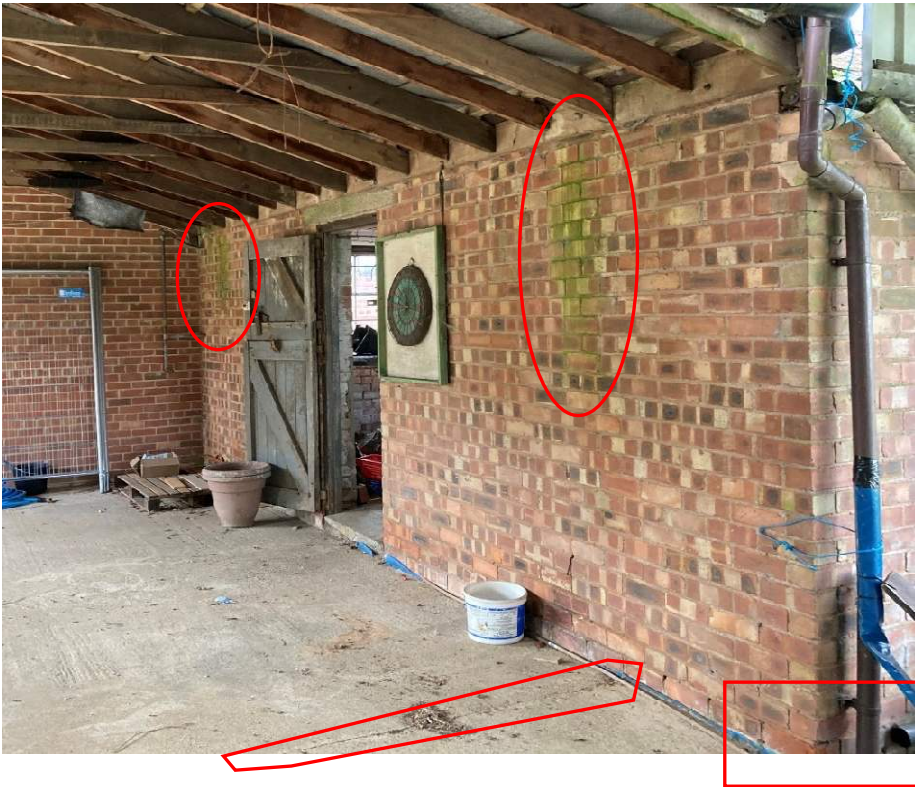
To the external wall of Workshop 2, that forms an internal wall to the garage, there are a couple of areas of moss-stained masonry and there is a single cracked brick to the lower corner adjacent the downpipe and gully.

The ground floor slab is 120mm thick unreinforced concrete on blue polythene on 180mm fill on clay. There is a fine crack to the full length, see above.

The mossy staining to the wall in Garage 1 has been caused by the roof leaking down the wall, this can be cleaned off. It does not appear that the leak has caused any further damage to the brickwork.

The cracked and crumbling brick to Garage 1 adjacent to the gully to be replaced.

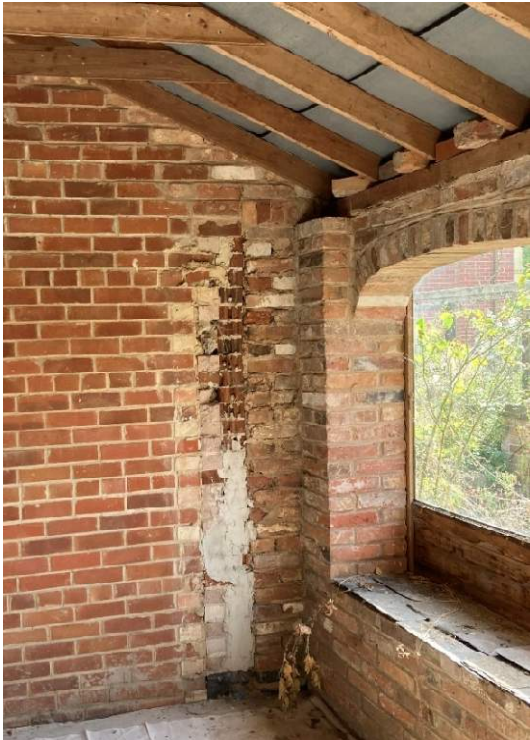
The walls had been poorly bonded into the store building, see below.

It is unclear whether the walls to the store that show no sign of a brick bond have brick ties installed. Brick ties would be consistent with the age of the building; however, the contractor is to investigate and if the walls are not tied then this should be remedied. Potential remedial works could include installing a brick bond or use of a post installed brick tie either resin or mechanically fixed through both leaves of the wall.

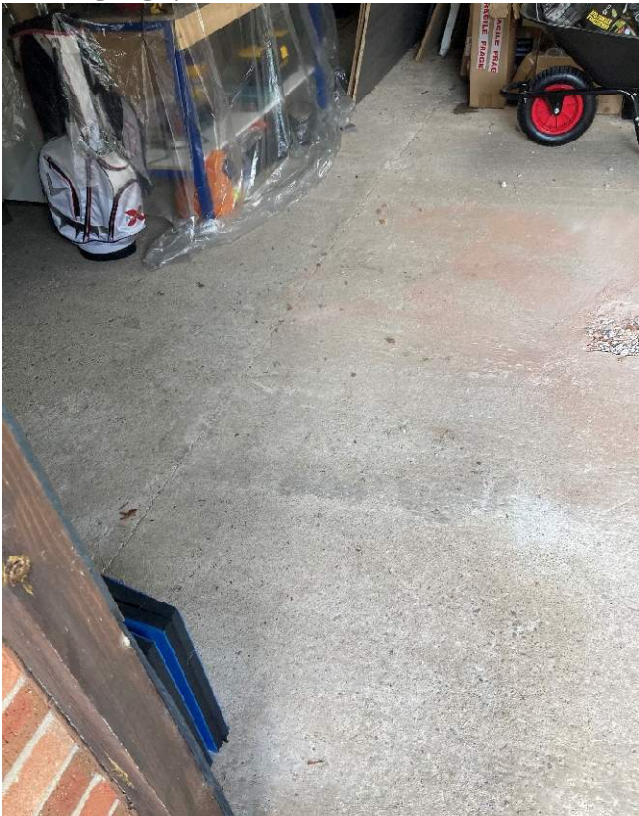
The ground floor slab is 120mm thick unreinforced concrete on blue polythene on 180mm fill on clay. There is a covered garage pit in the floor and a fine crack from the rear corner to between the garage doors, see below.

The lack of reinforcement to the slabs could allow future cracking. If brittle finishes are to be used, it is recommended to replace the slabs with a reinforced concrete slab. If non-brittle finishes are to be used, the slabs could be considered acceptable however replacement would still be recommended.

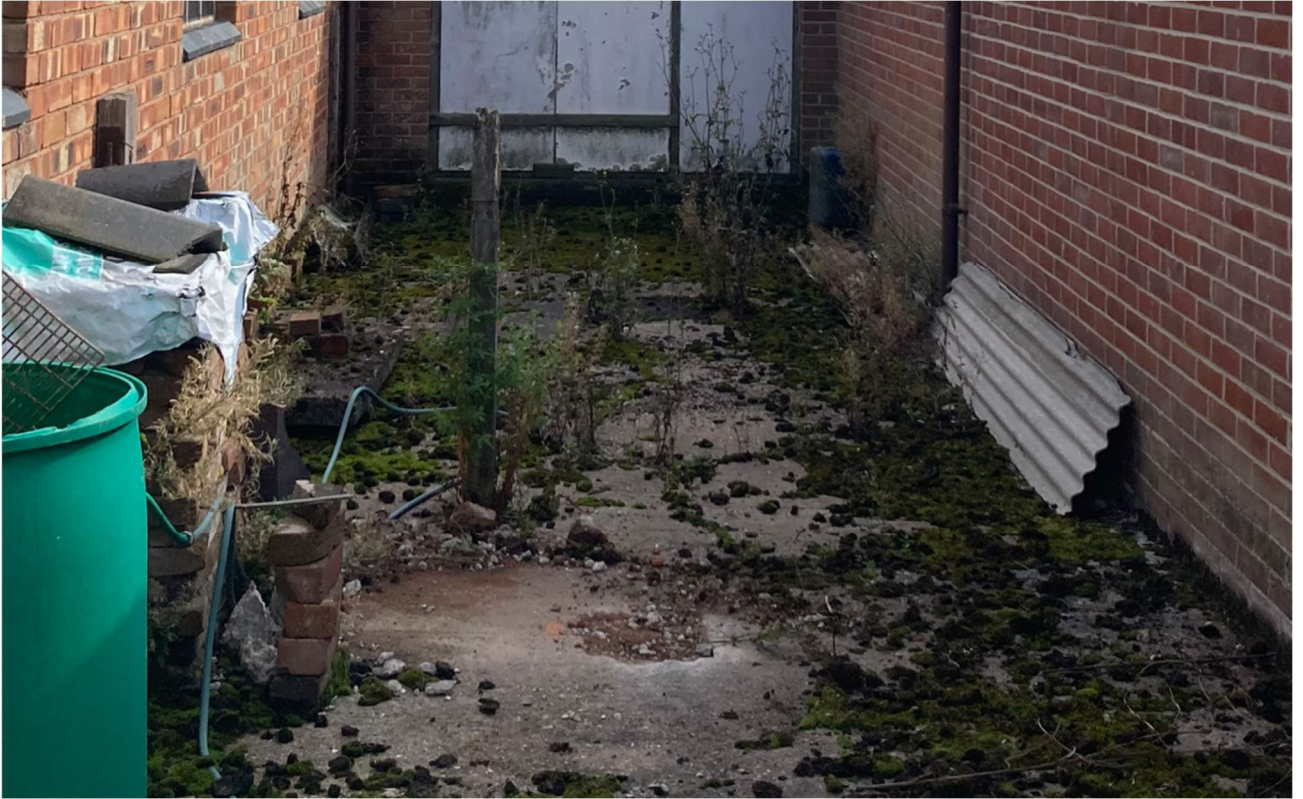
The courtyard external concrete slab is 100mm thick unreinforced concrete on 100mm fill, much of the slab is not visible as it is covered with moss, but it is in poor condition and cracked, with plants growing through the cracks.
