Sycamore Lodge Outbuildings Hickling Pastures

Structural Inspection Report

Job Number: 30123
Document Reference: Report

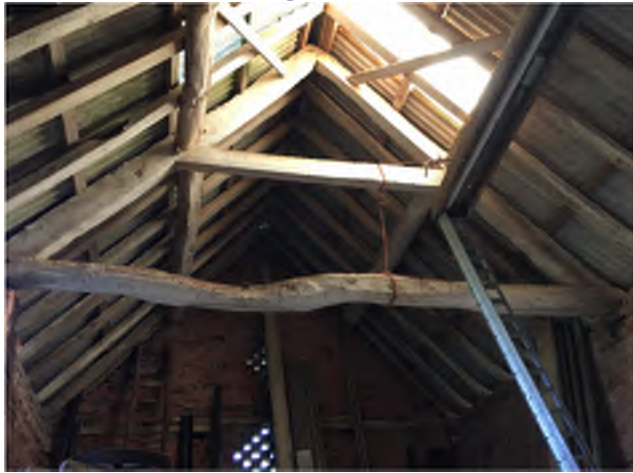
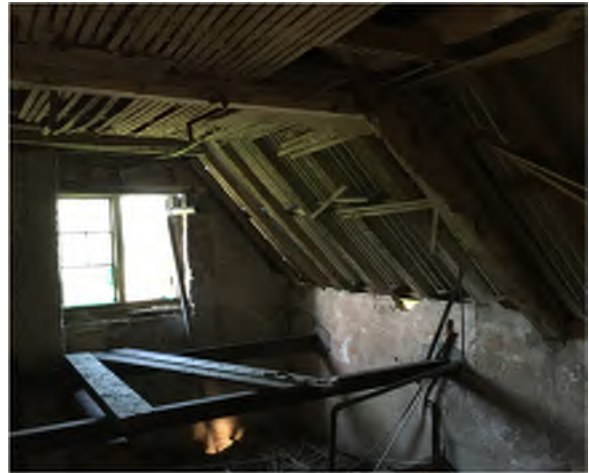
The truss members are rotten in places, and hugely non-straight. The bottom chord of one truss is almost completely decayed-through;

The roof as a whole could not be justified structurally because of its multiple defects.

- Wholesale replacement, repairs and strengthening to the roof. There are areas of substantial decay, the rafters and purlins are inadequate.
- Replacement of the first floor and mezzanine
- Removal of the brick-paved ground floor to allow a new insulated slab to be installed. This would probably undercut the existing shallow foundations, necessitating underpinning to carry it out
- Repairs to external walls including crack repair and corner bonding.
- Excavation of trial holes to check existing foundation details. It is likely that the walls sit on shallow spread foundations, and the observed movements indicate that settlement has occurred, so underpinning would probably be required.
- All other non-structural works to bring the shell up to modern insulation requirements.

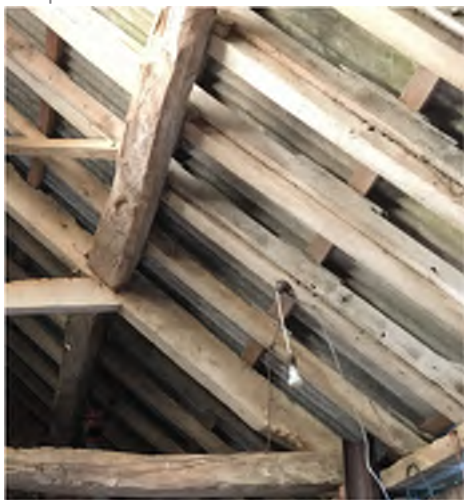
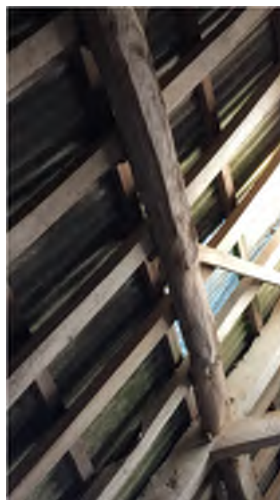
The rafters are haphazard sizes at variable centres, the purlins are misshapen timbers, some having been added to in the past

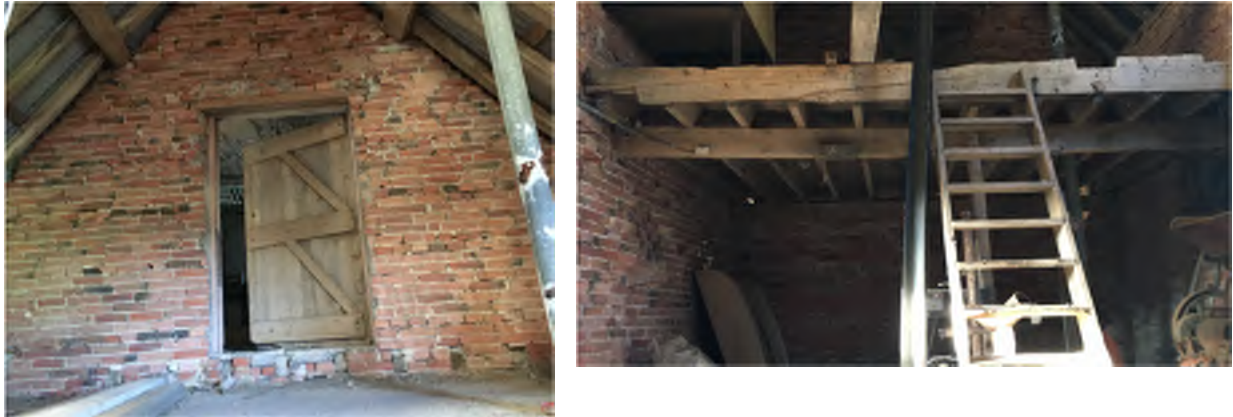
Floor primary members have been heavily notched, one of the primary beams has been propped off the ground floor

The mezzanines as a whole could not be justified structurally because of their multiple defects.

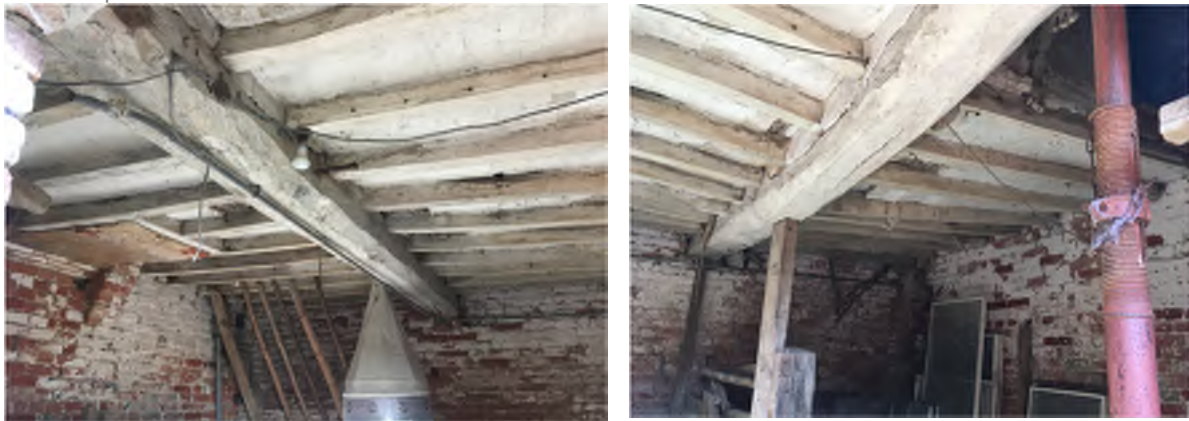
The primary beams show signs of significant decay and infestations, the end of one beam having propped with an Acrow because of the decay at its end. Other end are similarly decayed.

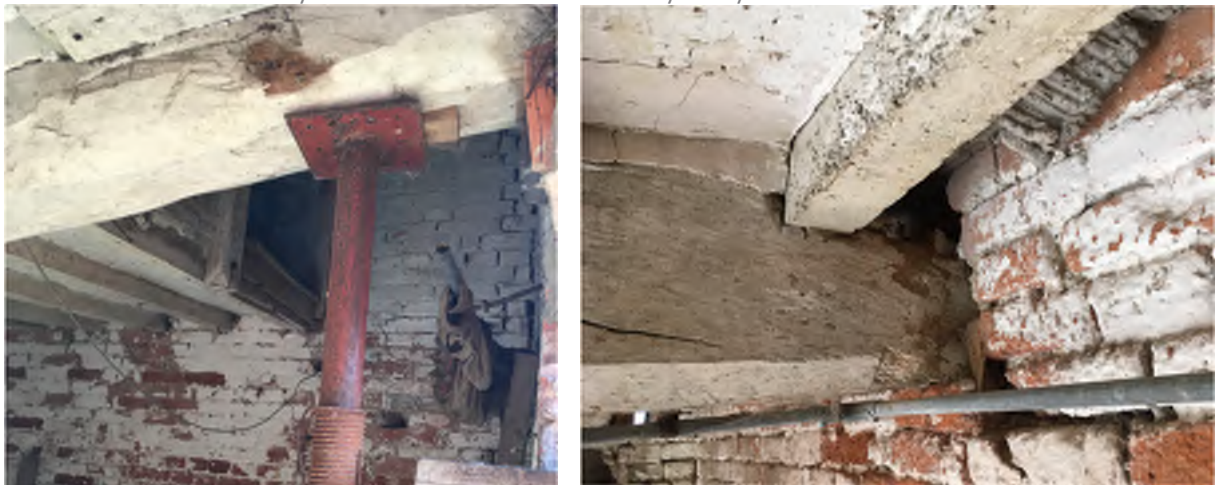
There is a significant fall on the floor towards the propped beam.

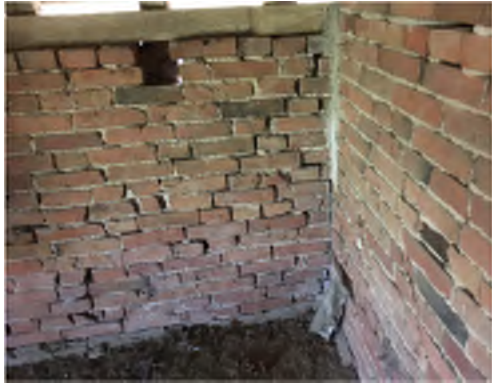
The external front and rear walls of the Barn lean out, measured as 20mm in a 1200mm spirit level. There are several cracks at wall junctions and visible externally.

Wall crack at corner of part mezzanine

No trial holes were excavated but it is likely that the whole barn is on shallow corbelled brick foundations, susceptible to seasonal movements.

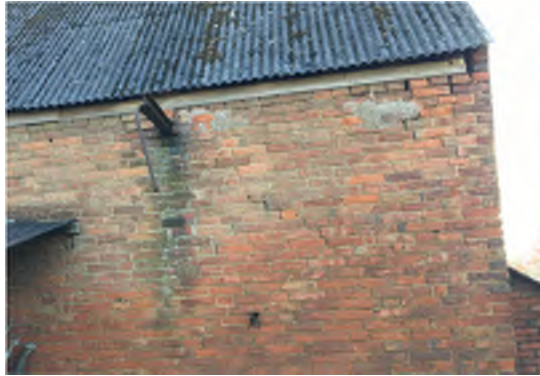
Crack at rear external corner

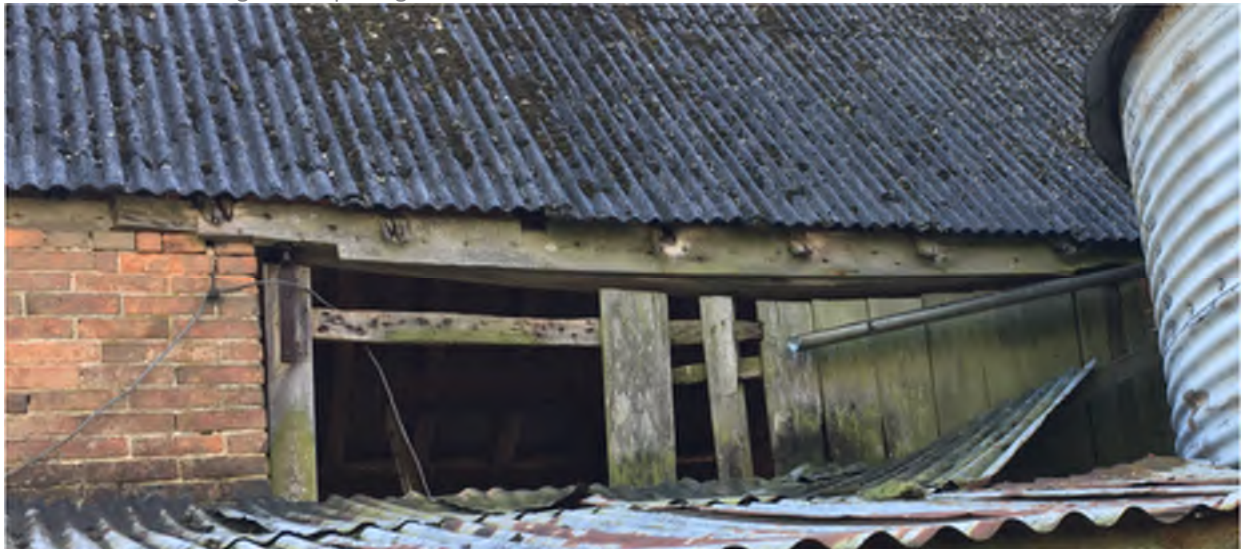
The lintel over the large rear opening has failed.

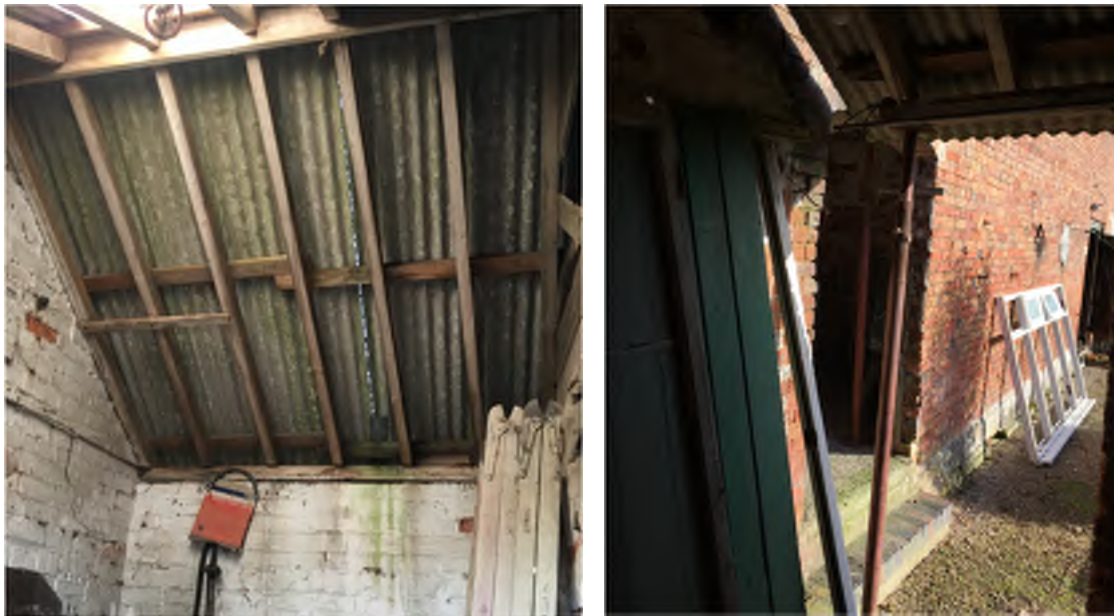
The roof is cementitious corrugated sheets supported by timber rafters and a timber ridge beam. One of the wallplates has been Acrow-propped where the Stable meets the Barn

The roof members are adequate for a cementitious roof but are unlikely to be justifiable for any heavier replacement roof covering.

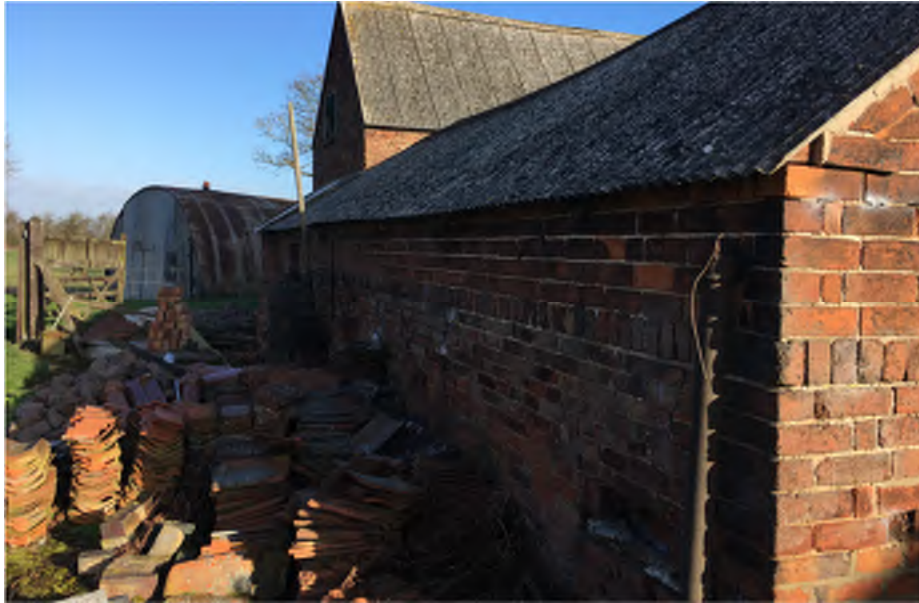
The front wall of the stable leans out, the rear wall leans in being most pronounced at 50mm in a 1200mm spirit level. The rear wall appears to have been partially rebuilt, and its height increased.

The rear wall needs to be rebuilt.

- Demolition of the rear wall, and therefore the roof, to allow the walls to be rebuilt on new foundations.
- Removal of the brick-paved ground floor to allow a new insulated slab to be installed. This would probably undercut the existing shallow foundations, necessitating underpinning to carry it out
- All other non-structural works to bring the shell up to modern insulation requirements.

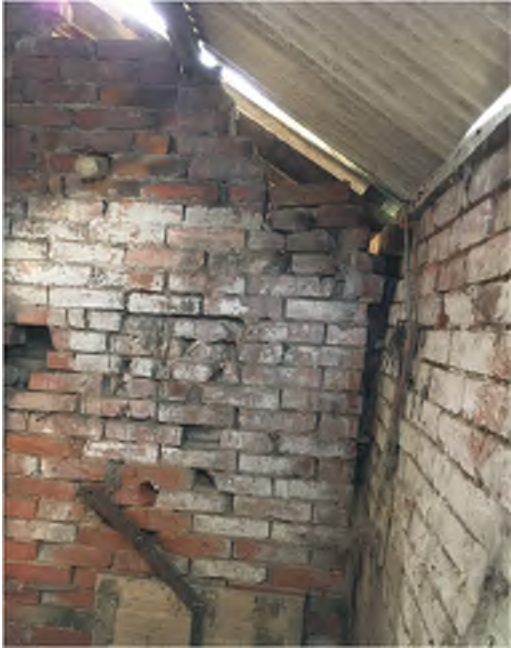
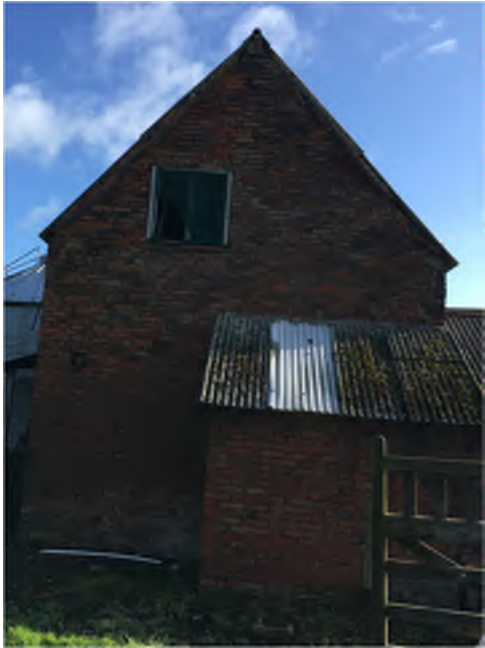
Left Gable of Threshing Barn

There is a small lean-to at the outside corner where the Bran meets the Stables. This has a part-polycarbonate part-cementitious roof supported by timber rafters. The walls lean out and there are significant cracks at the wall junctions. This needs to be demolished.

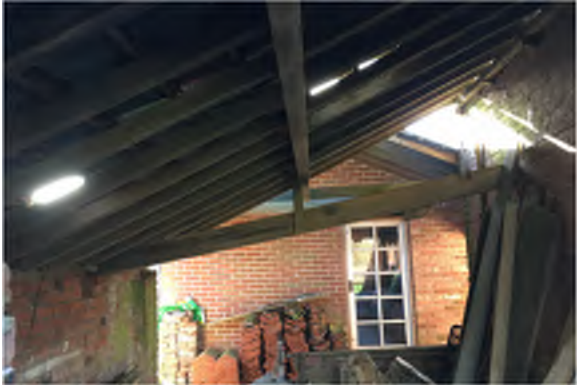
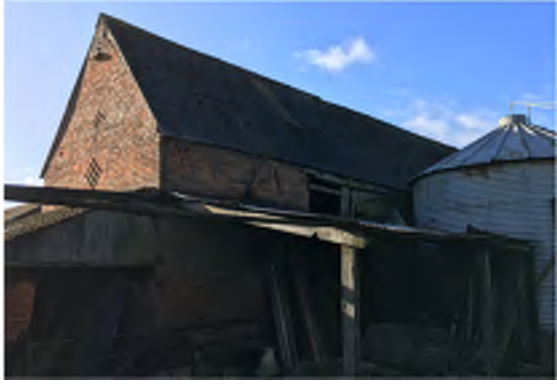
Right Gable of Threshing Barn

These lean-to's that wrap around the opposite gable are in a poor condition and should be demolished.
