**Tree condition survey of
59 trees**

**1 Snode Hill, Beech, Hampshire, GU34 4AX
///lawful.library.chaos**

Report date
22nd December 2022

Report reference
J1461

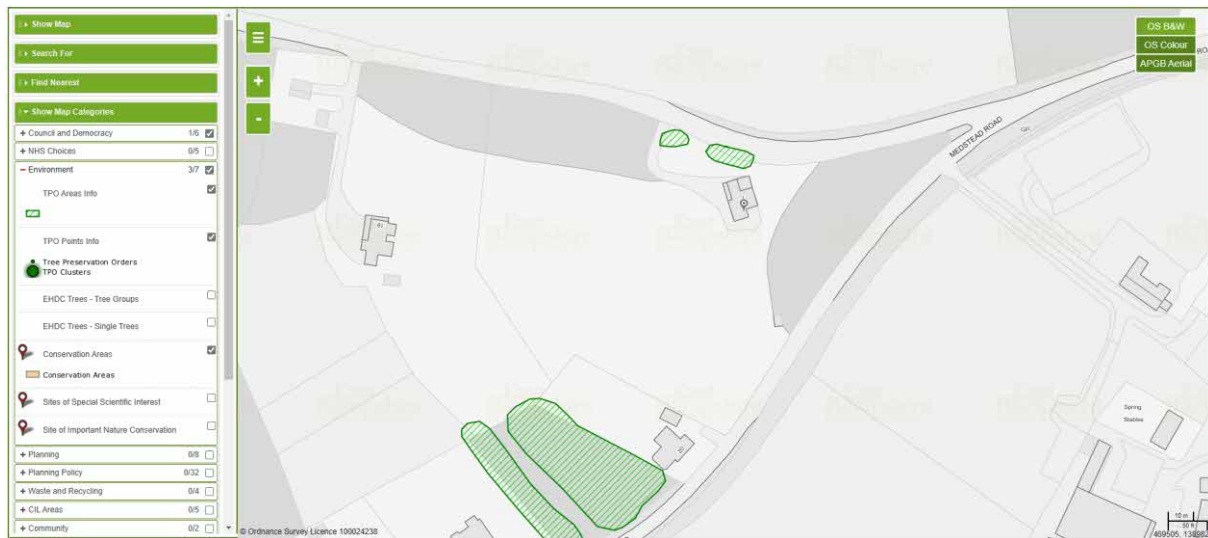
SAL1 Data provided by planning authority website¹.

- 3.2 Due to the position of the two defined areas of green hatch, I believe that T1801, T1802, T1803, and T1804 are subject to Tree Preservation Order EH1192 of 2022. The PDF copy of the TPO document and plan were not available from the council website on the day of accessing the data.
