HISTORIC BUILDING ASSESSMENT With Phasing Plans

ROSEMARY COTTAGE, SIDLESHAM, WEST SUSSEX

PHASING OF HISTORIC DEVELOPMENT

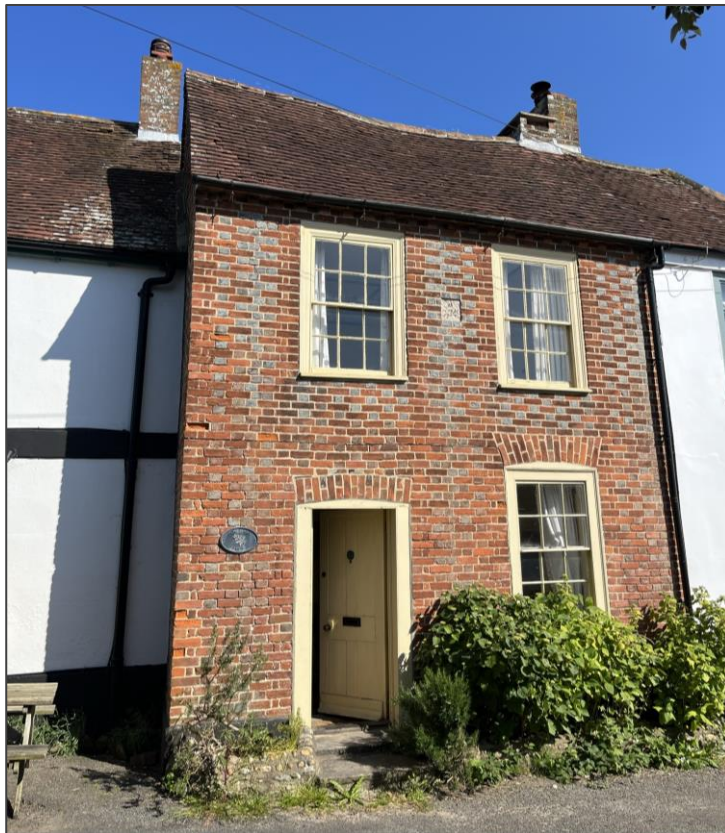
The principal Elevation of Rosemary Cottage comprises Flemish bond brickwork and both gauged segmental and flat arches. Six panel door and sliding sashes with pointed panes and simple mouldings. The façade is believed to be largely original and is typical of modest late Georgian construction.

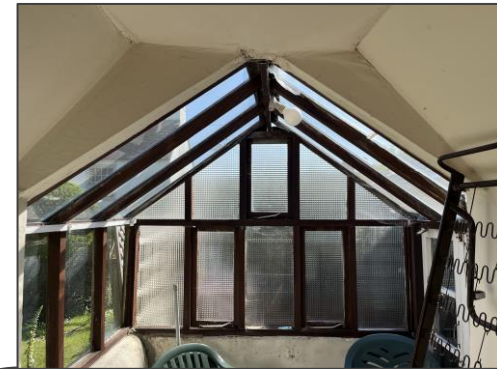
Poorly constructed modern conservatory

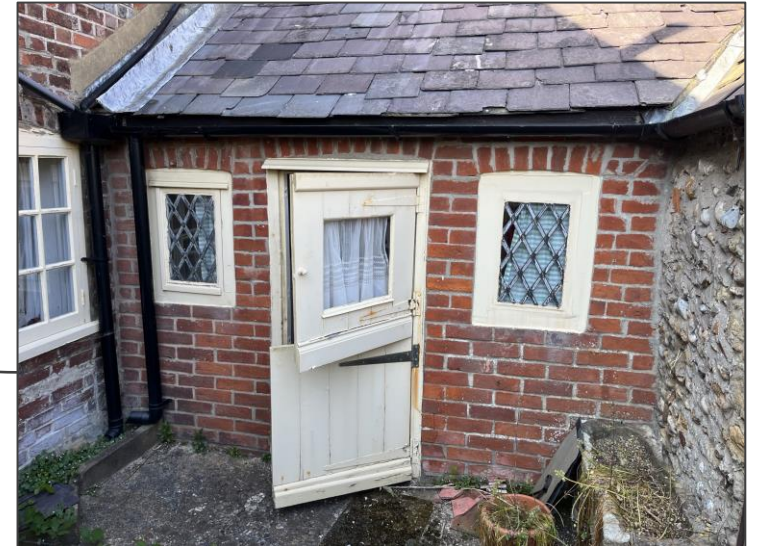
Modern brickwork and flintwork with cement mortar and external joinery. Modern concrete courtyard.

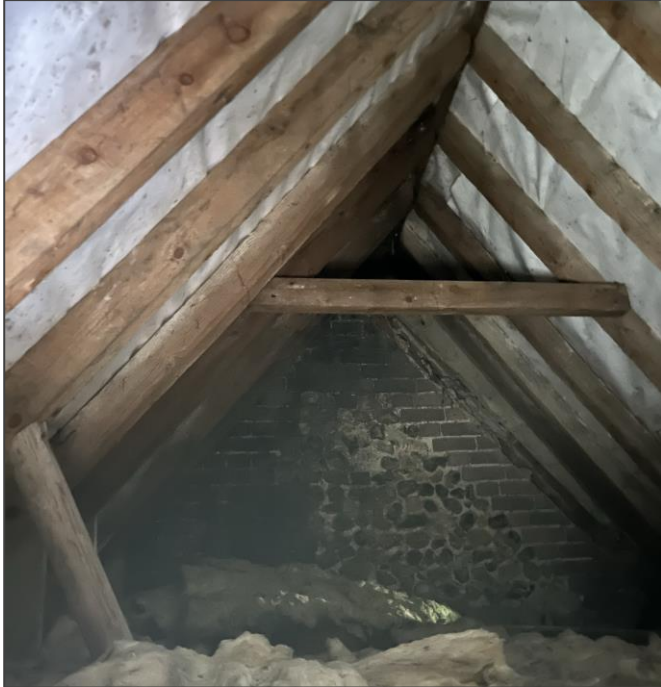
Attic space with coursed flintwork to gable and primarily modern rafters.

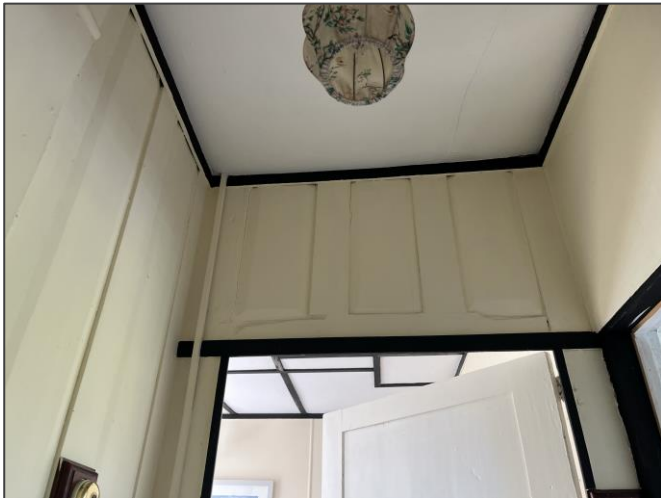
Vertical raised and fielded panelling at the head of the stairs is typical of late C18 or early C19 work.

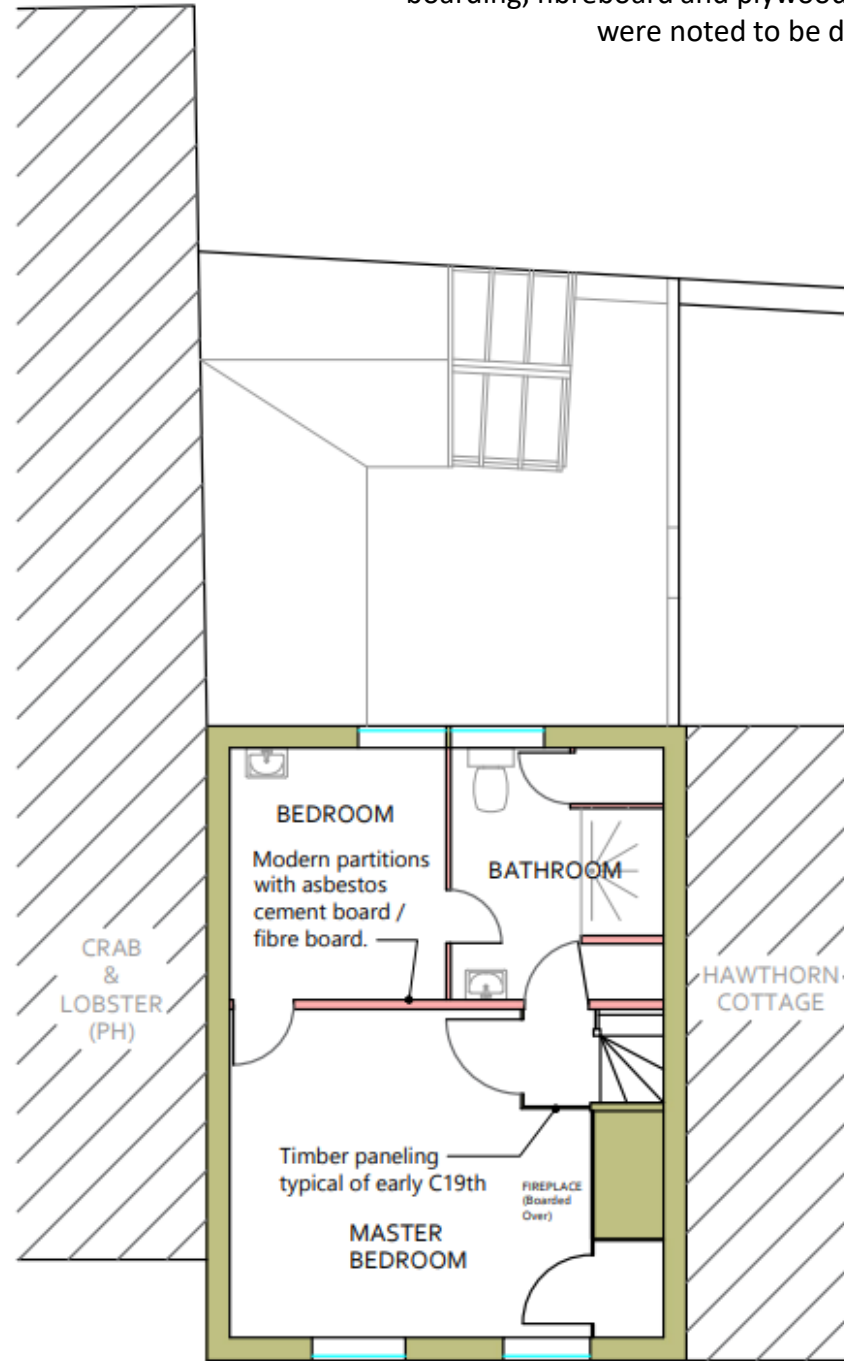
EXISTING FIRST FLOOR

Ceilings and partition walls at First Floor level are of modern construction including asbestos cement boarding, fibreboard and plywood. The external walls were noted to be damp in many areas.
