**Supplemental Phase I Site & limited Phase 2 Investigation: J.M.  
Strang's Filling Station, North Deeside Rd, Kincardine O'Neil,  
Aberdeenshire**

**Project no:** ESL1834  
**Version no:** 1  
**Status:** Draft  
**Date of Release:** 06/06/18  
**Prepared on behalf of:** Mr Alan Riach, Deeside Log Cabins  
**Prepared by:** Dr Fiona Moore [REDACTED]

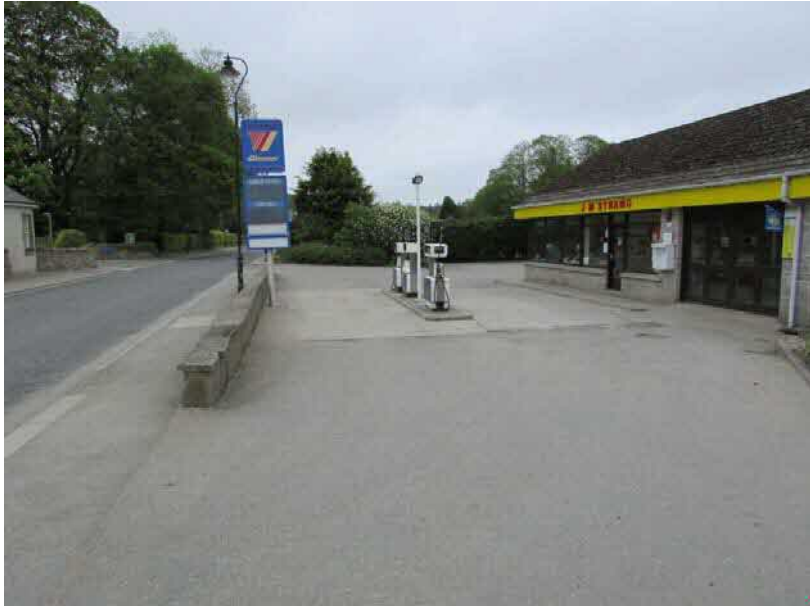
Filling Station site by the roadside and is very well maintained.

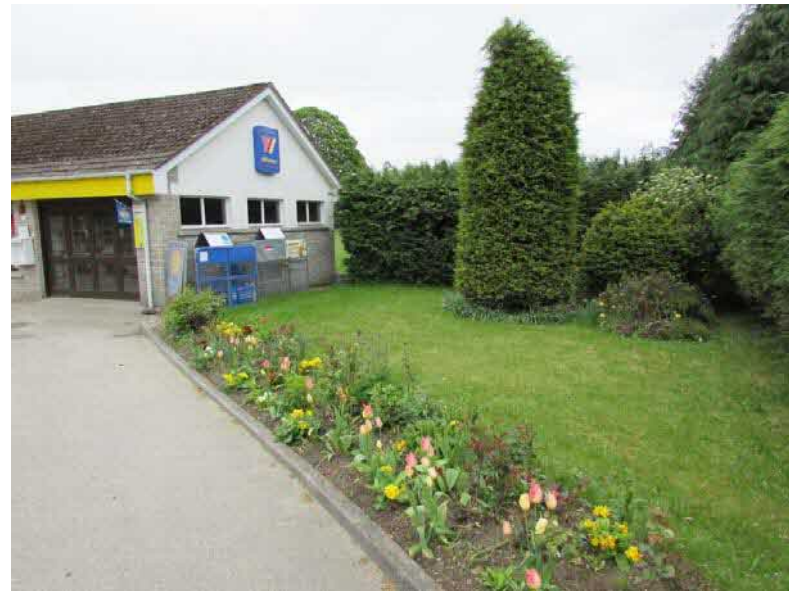
View from E boundary looking towards W, tanks out of sight to L

The grounds are all landscaped with no signs of plants being stunted

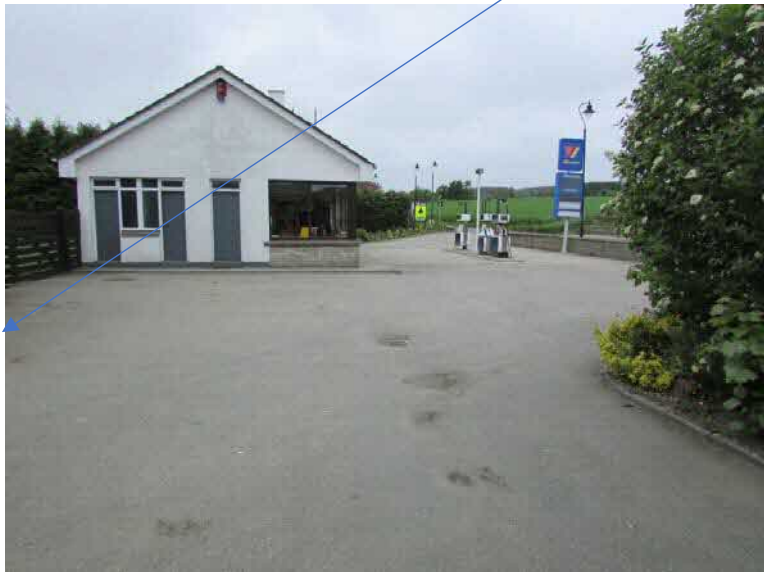
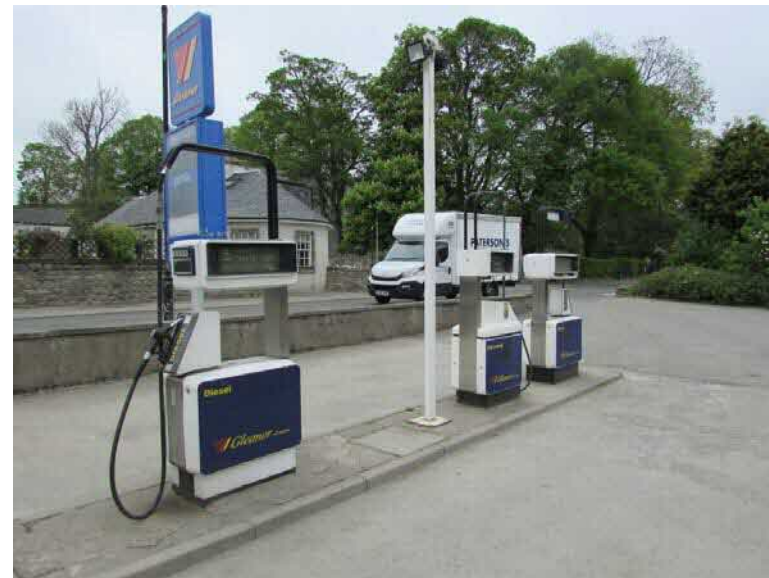
Three fuel dispensing pumps on the forecourt with no sign of staining

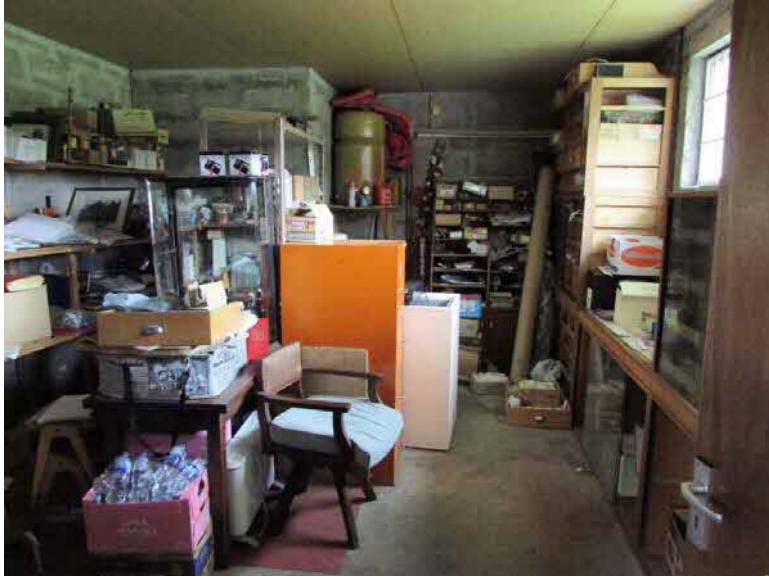
In the only building there is a shop with a storeroom to the rear

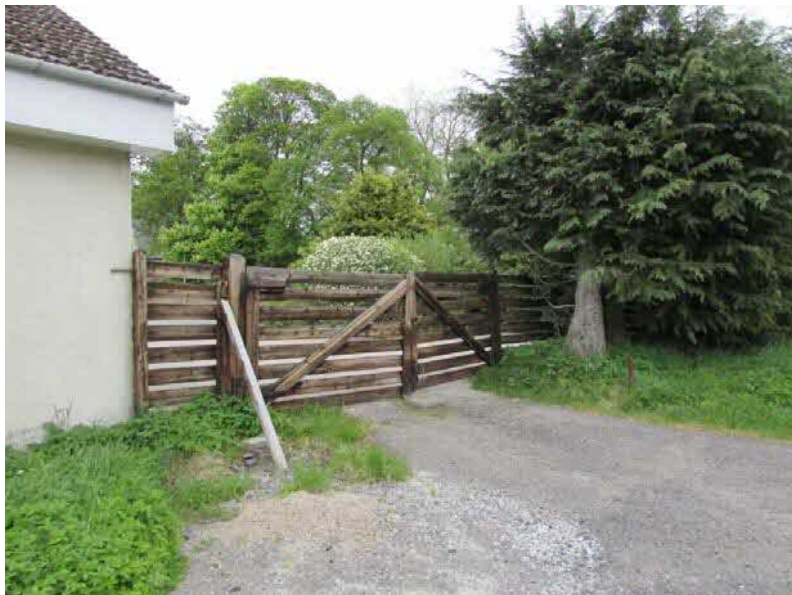
Wooden gates attach to side of shop, rear of shop seen here

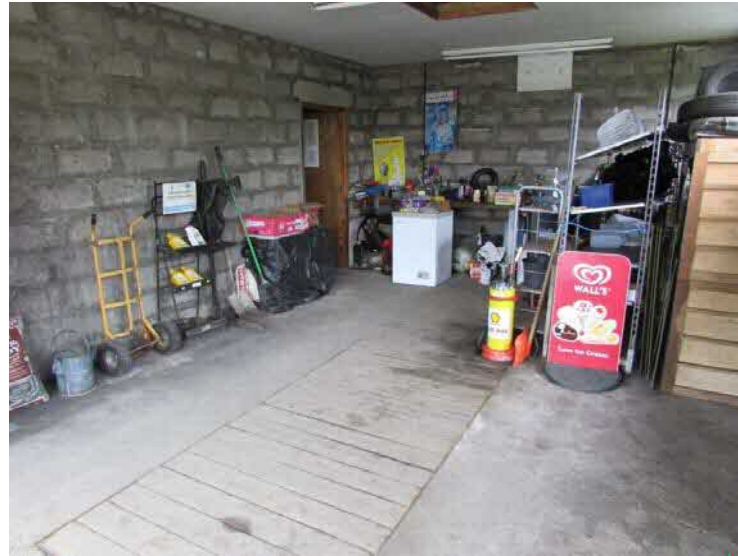
As well as the tank inspection the remainder of the site was inspected for potential contamination risks. There is a single storey rectangular building on site. This is made from concrete block and render, with a concrete tile roof. This is mainly used for the shop area but there is a very small single car workshop at the west end, with an inspection pit. A doorway here leads through to a storage room. In the workshop area there was no sign of staining on the concrete floor and no noted storage of new or waste oil. The inspection pit was boarded over so the base could not be seen.

There is a small single car workshop by the shop with an inspection pit in the floor

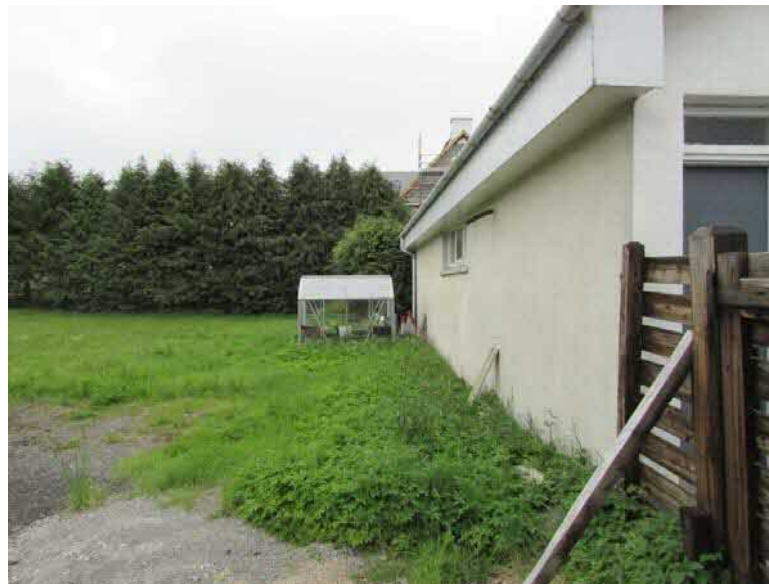
Behind the shop/workshop is a greenhouse but otherwise open space

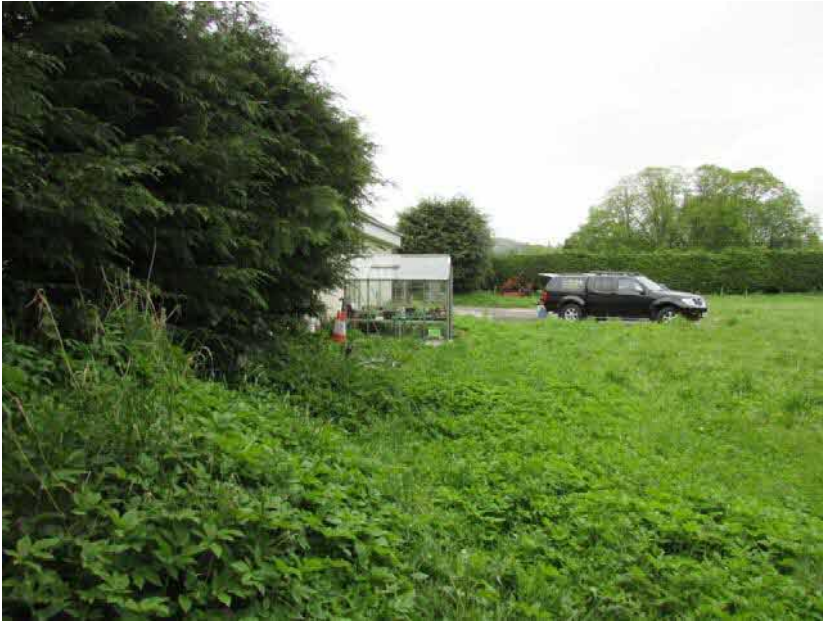
View from NW corner of green space behind the forecourt, looking W

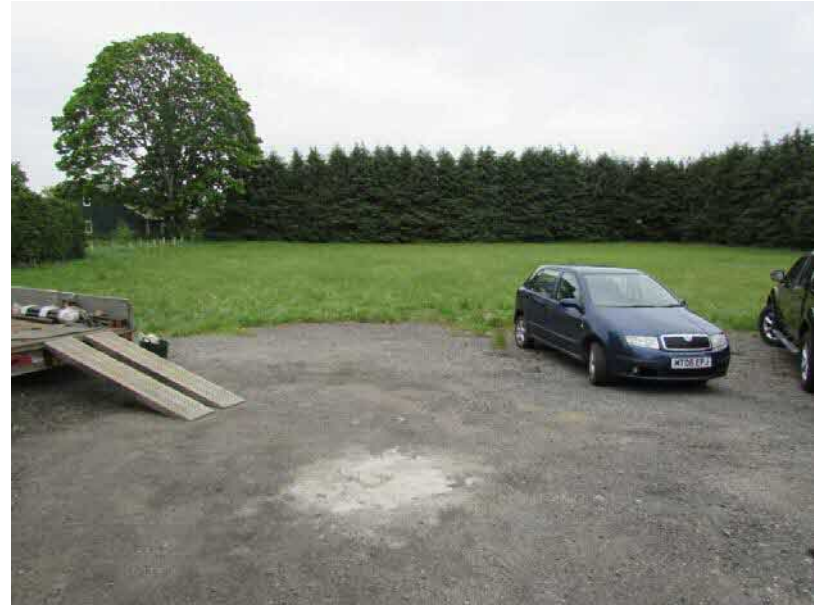
Small parking area just inside the wooden gates where owners leaves their cars

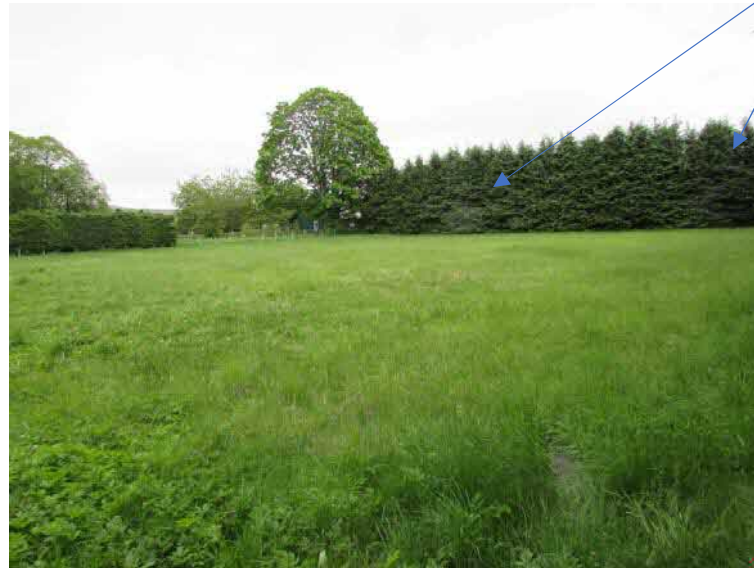
The bulk of the site is a large green space. The boreholes installed in 2015 are just beyond this hedge.

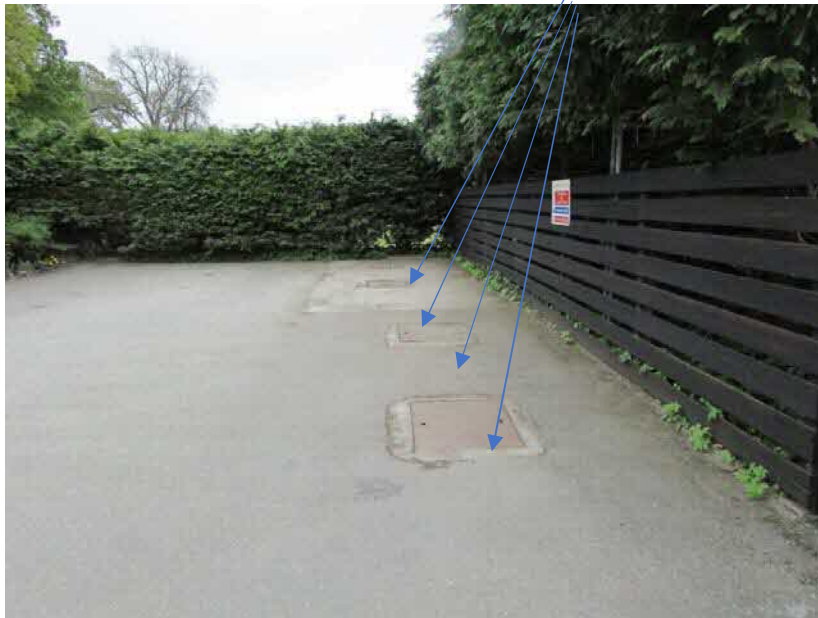
The filling station has four underground fuel tanks. These comprise two pairs of twin-tanks. One pair was installed in 1972 and a second pair was installed in 1989. As the life-span of an underground tank is usually assumed to safely be 25 years these tanks are both beyond that, although those installed in 1989 are close to this precautionary age limit. This does not mean that they are however definitely leaking.

UG tanks are located on E side of Forecourt – 4 covers

- Arrange for a reputable company (such as Taylors Industrial Services or Adler & Allan) to decommission each of the tanks by removing any fuel in them, blowing all fuel supply lines clear, cleaning the tanks and providing a gas certificate to confirm they are safe to remove. This should be arranged in tandem with an excavator to extract the tanks from the ground, a disposal method for the tanks, and an environmental consultant on site to photograph the tanks, inspect them and inspect the void in the ground. Soil sampling from the void may be required if there is an indication of fuel leakage and this should be immediate rather than from holes left open for a period of time. This will provide independent verification of the tank condition. This can then be reported to add to the existing body of information.

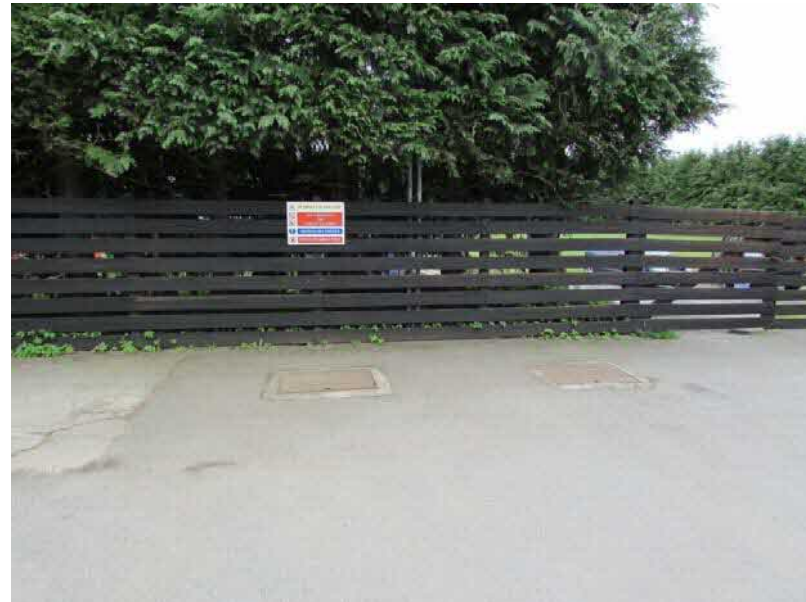
Breather pipe attached to rear of fence

Tanks in relation to wooden gate to rear of the site

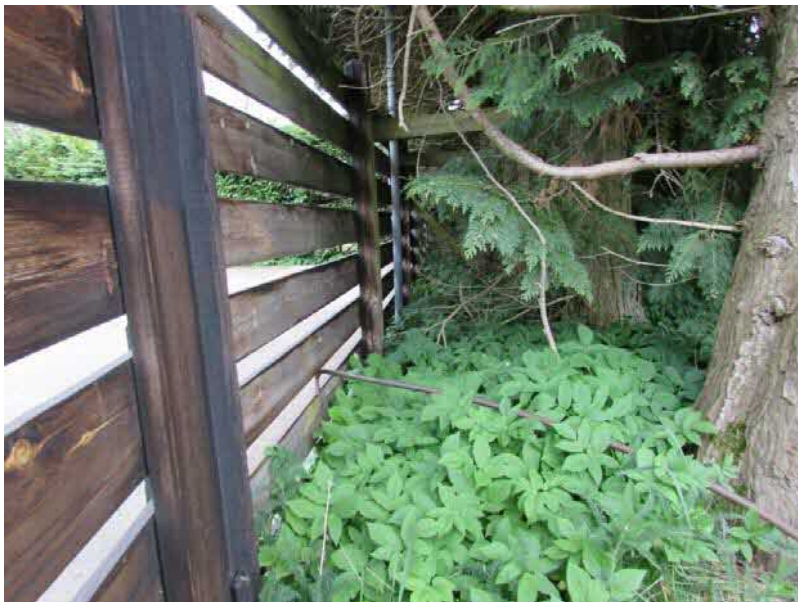
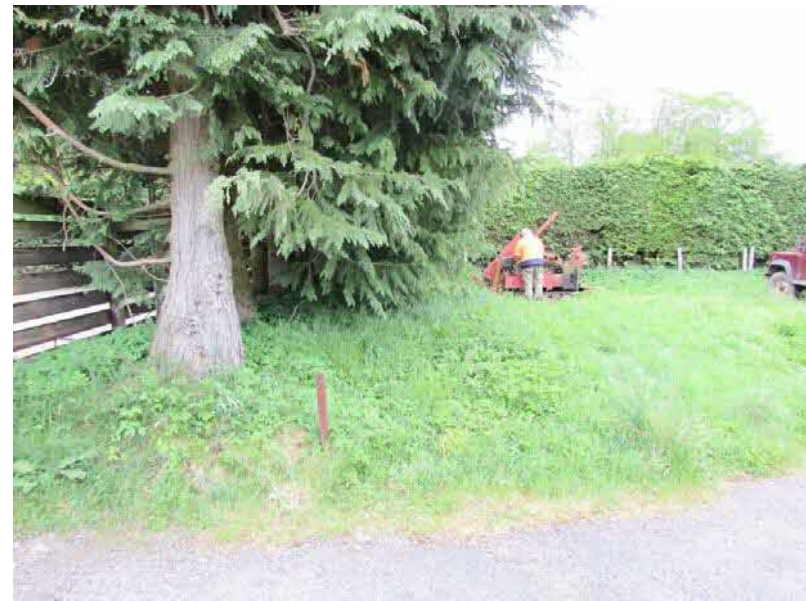
Drilling rig on first location

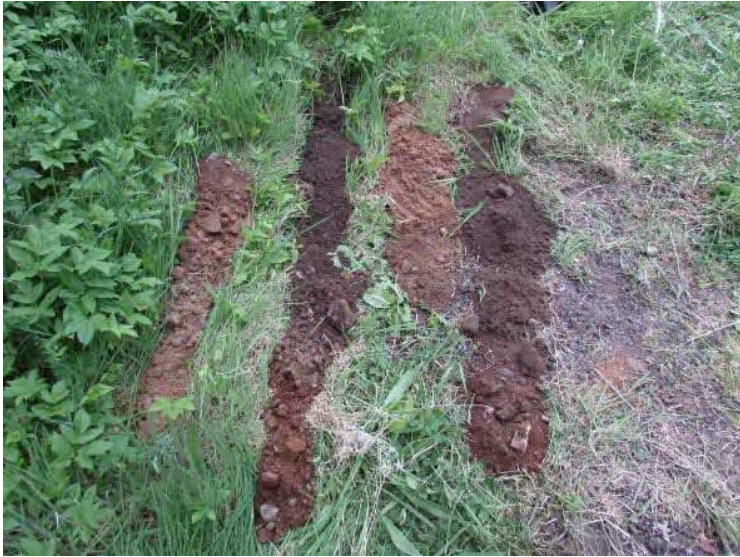
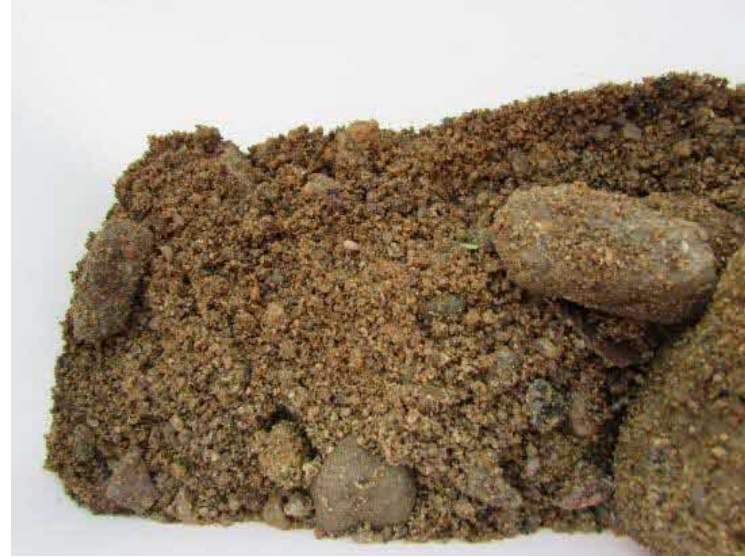
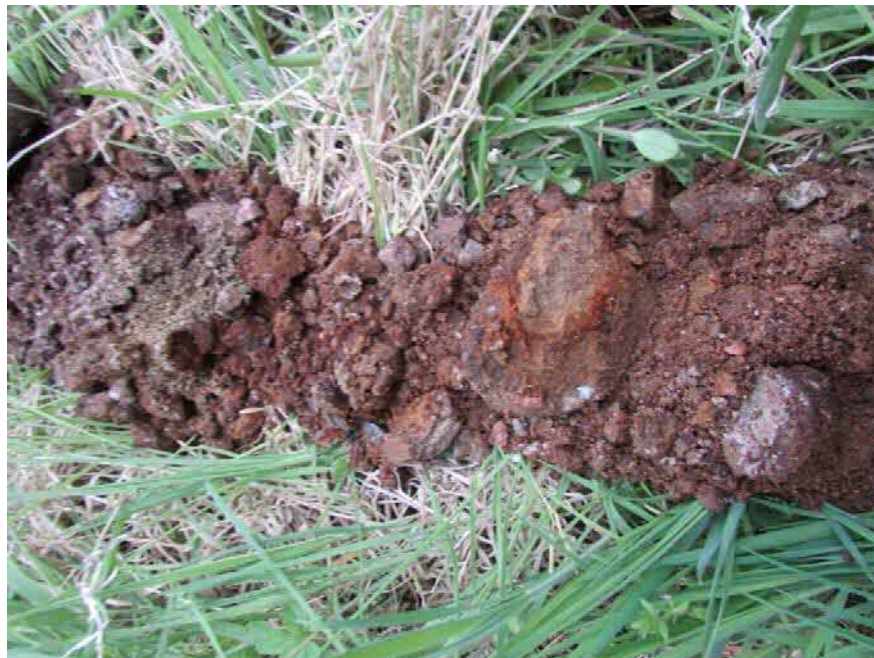
Drill cutting shoes cracked on pink granite – seen in drill casing and after extraction.

Drill arisings – 2 attempts for Borehole one laid out on ground – from L to R : 1 to 1.4m, 0-1.0m, repeat for second attempt. Plus close up of coarse sand with rock fragments frequent

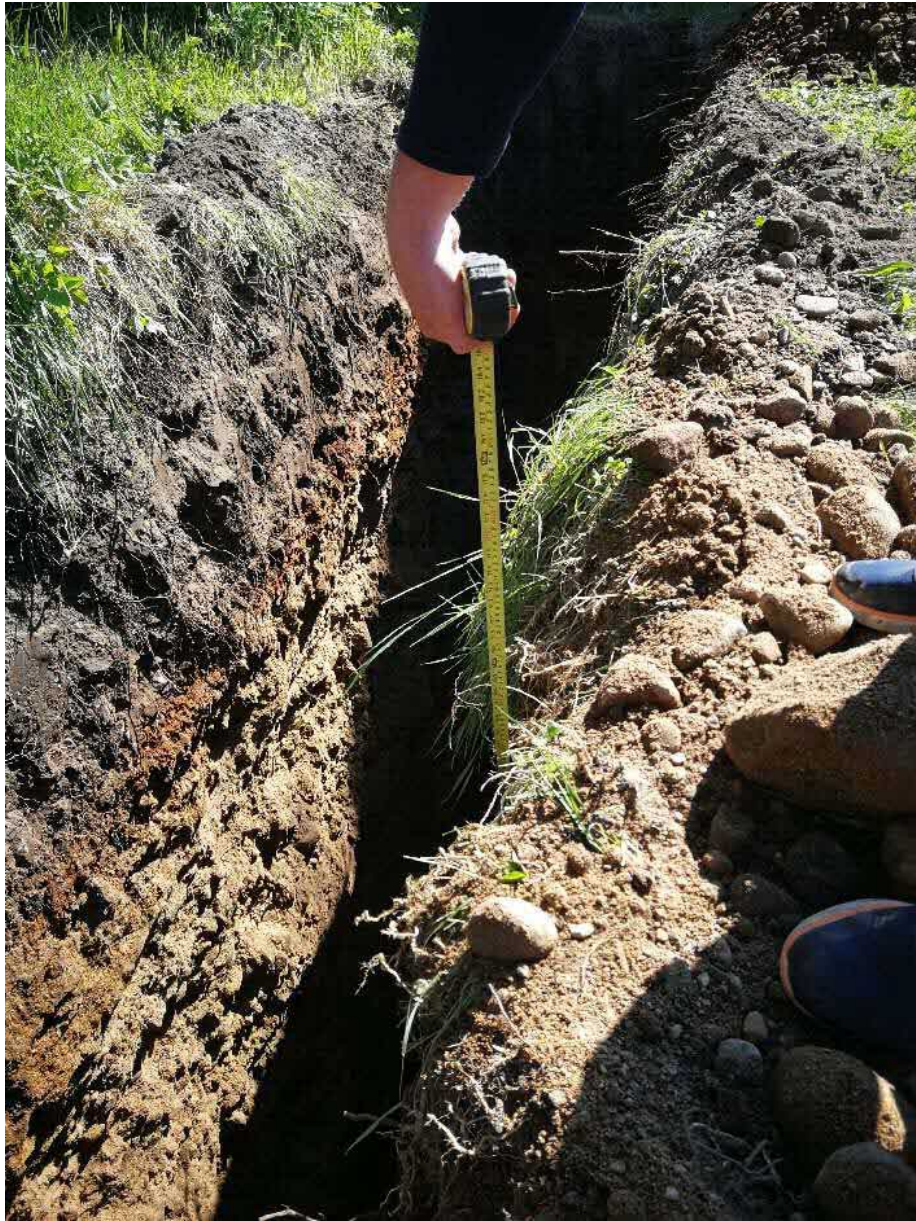
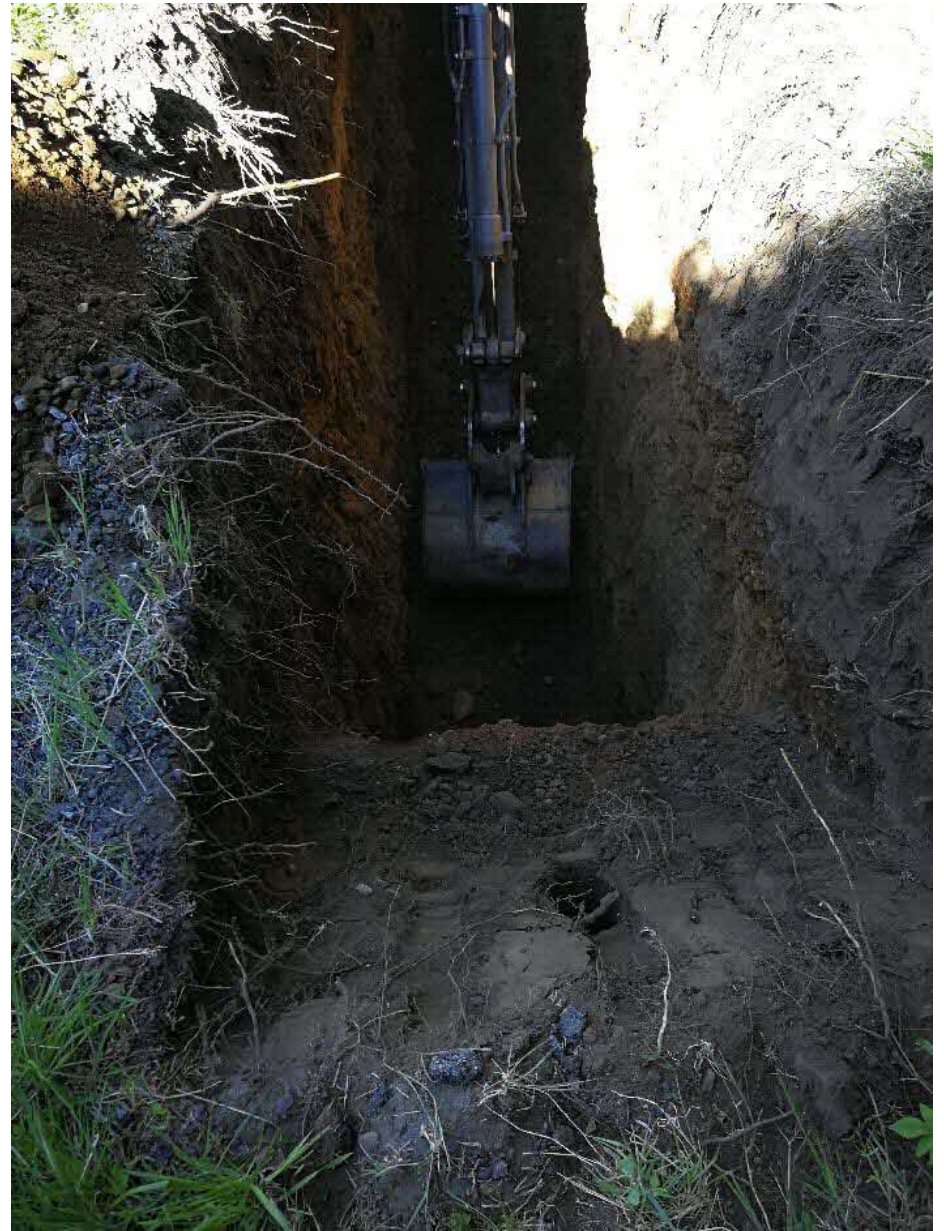
This trench gives a good indication that the likelihood of fuel migration from the tanks is low. There are no guarantees in such a situation, and the client is aware that only at the stage of tank

removal will this be clear, but for Due Diligence purposes this strongly indicates that the surrounding soils may not be impacted.

Trench dug along same line as boreholes. Dug to 4.5mbgl- which should be 1.3m below tank base. All arisings clean

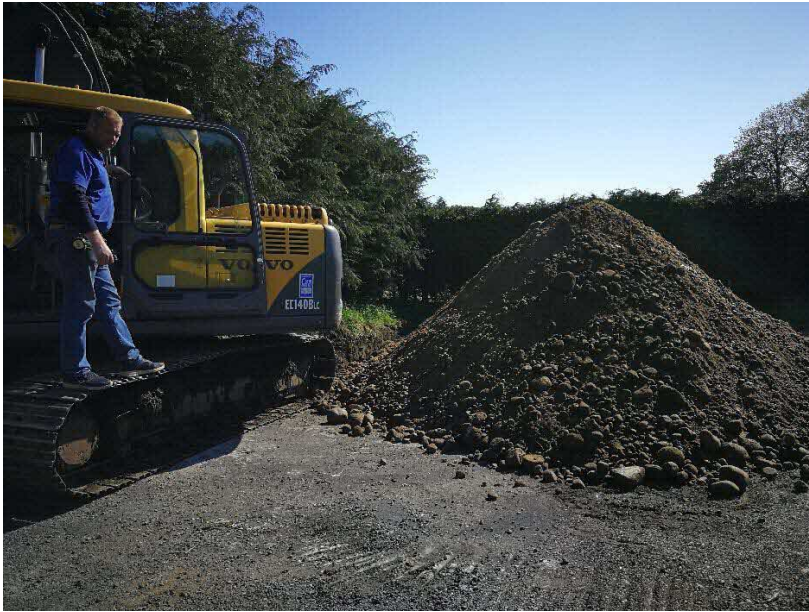
Confirmation of location and sandy gravelly nature of arisings, several cobbles seen. In 2015 the borehole records also indicate large rocks present.

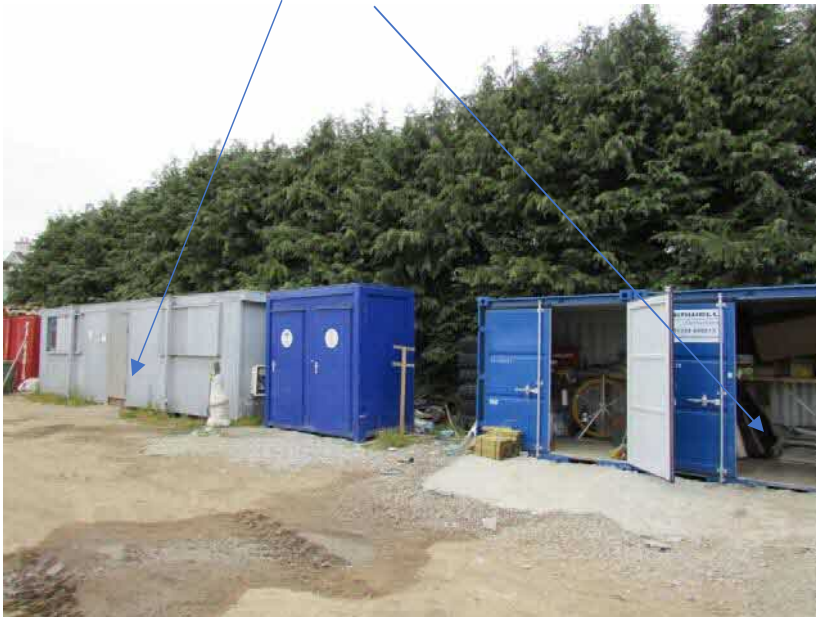
During the drilling works we also attempted to examine the 2 deep boreholes placed on the boundary line of the JM Strang's site in 2015. The intention was to bring up a groundwater sample from the base of each borehole for examination for odour and sheen, and potentially lab testing if there was any suspicion of fuel. However, on visiting the site it was found that this boundary is now covered by the portacabins, storage unit and welfare facilities for the construction staff working on this housing. This includes temporary installation of services for the welfare units. The boreholes could not be located and are assumed to either be under a cabin or potentially damaged.

Location of 2015 boreholes on the other side of the hedge

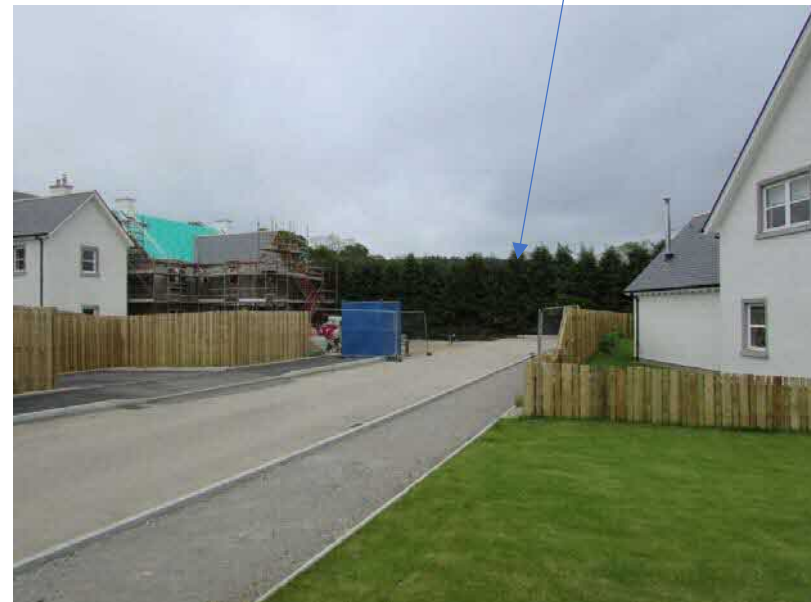
Western boundary of site seen from other side of the hedge in new housing area
