Tree Report

Mortgage and Insurance Purposes

88 Millers Lane
Carisbrooke
Isle of Wight
PO30 1PE

Reference: WIT-23-19-008-rep

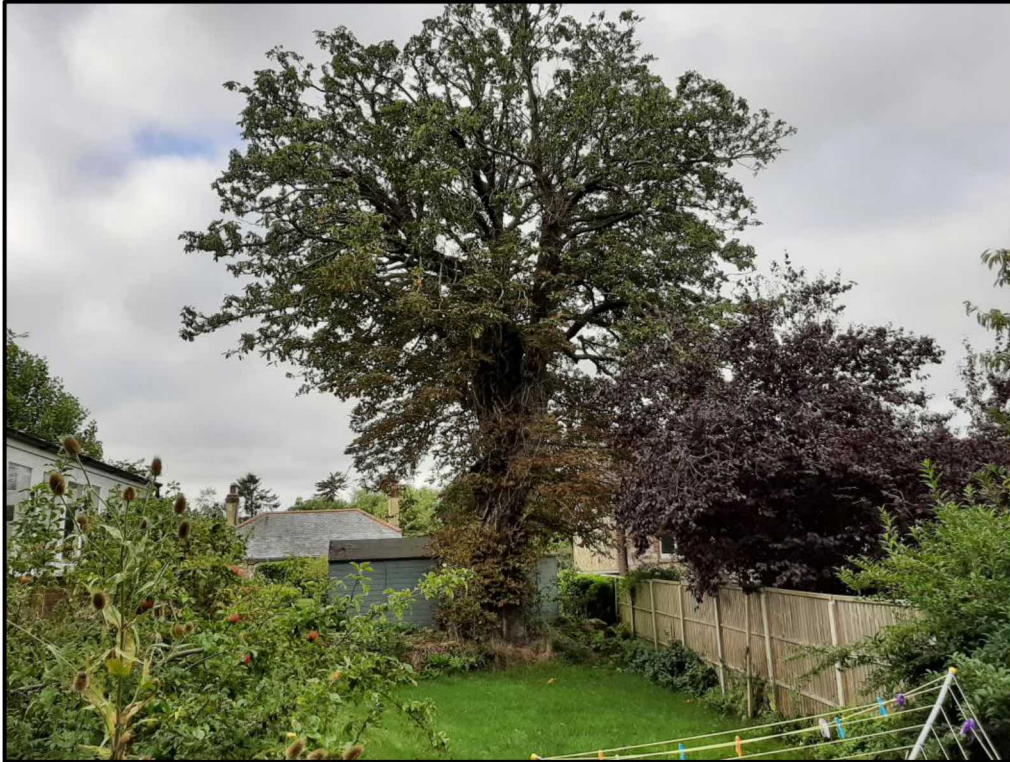
Picture 3: T1 Horse chestnut, looking south.

(P)	(S)	Occupancy rate	Likelihood of Failure	Likelihood of Impact	Consequence	Risk Category			
T1	Horse chestnut (<i>Aesculus hippocastanum</i>)	7m from Conservatory 10m from Main Property	Within the property.	14m	1200 est	4.5m	Mature	Fair	Fair	Constant	Improbable			Low	Canopy looking poor due to horse chestnut leaf miner infestation, and minor deadwood through crown. Bark. scar on lower stem north side with loose bark extending upwards, but no signs of any significant decay.		
T2	Cherry (<i>Prunus sp.</i>)	12m from Conservatory	Within the property.	5m	225 est	4m	Semi-mature	Fair	Good	Occasional	Improbable			Low	Leaves chlorotic - probably due to underlying chalk soil.		
T3	Medlar (<i>Mespilus germanica</i>)	12m from Conservatory	Within the property.	3m	70 est	2.5m	Semi-mature	Fair	Fair	Occasional	Improbable			Low	No significant faults or defects visible.		
T4	Apple (<i>Malus sp.</i>)	5m from Conservatory	Within the property.	5m	80 est	2.5m	Semi-mature	Good	Good	Occasional	Improbable			Low	No significant faults or defects visible.

- 5.1 Reinspect the trees within three years or following high winds or storms.

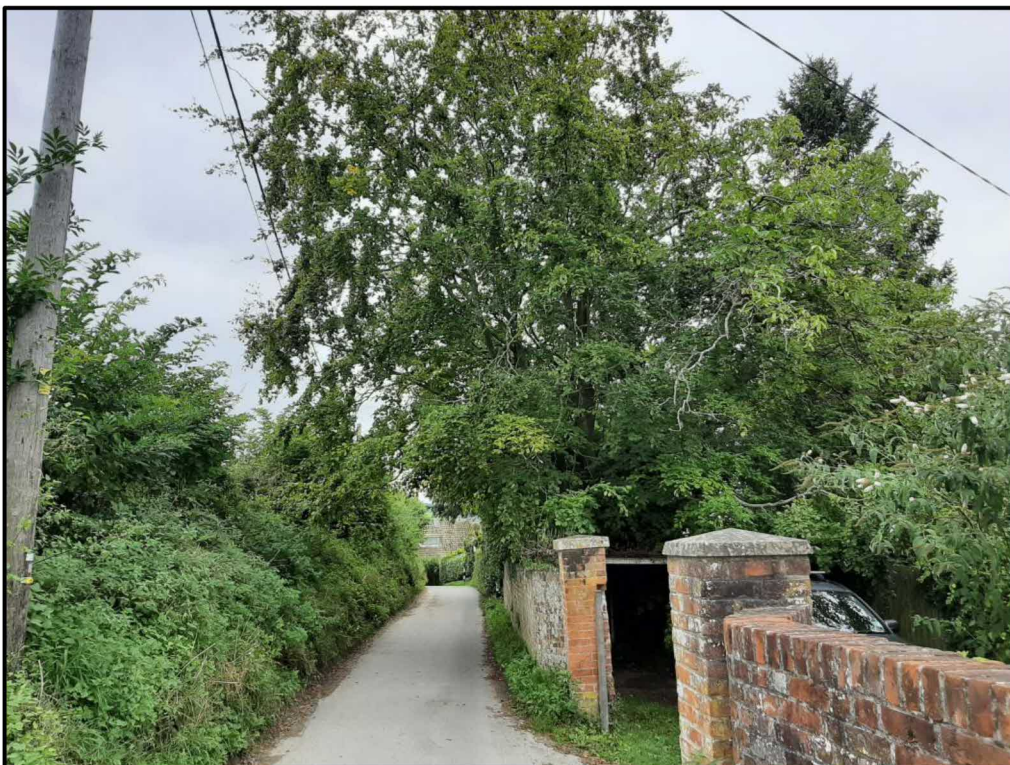
- 3.1 **Harm to persons or damage to property by tree failure:** I have assessed the trees within the scope of work for condition, and likelihood of failure. My findings are included at Appendix 4. These do not show any trees with an unreasonable risk. The walnut tree T11 has a decay pocket at the base which cannot be fully quantified by visual survey alone. This could be done with specialist equipment such as a micro-drill.

- 3.2 To allocate a risk rating to this tree (T11) I have used a worst-case-scenario for the likelihood of failure which has resulted in a risk rating of *Low*. This is due to the low likelihood of impact influenced by the *occasional* use of the site and adjacent road. If the occupancy of the site increases then this should be re-assessed, as the likelihood of failure would be more significant in the risk rating calculation.

- 3.3 So, overall the trees on the site currently have a *low* risk rating for harm or damage due to tree failure.
- 3.4 **Direct damage to structures, by physical contact pressure, by the tree and roots:** There are no trees in close enough proximity to the main house to cause direct damage from contact pressure. However, trees T11 and T12 could damage the boundary wall in the future.

Picture 4: T11 and T12 beech and walnut, looking south.

T10	Lawson cypress cultivar (<i>Chamaecyparis lawsoniana cv.</i>)	17.5m from Main Property	Within the property.	7m	80 est	1m	Semi-mature	Fair	Fair	Occasional	Improbable			Low	Poor form leaning into adjacent tree; no current safety concern.		
T11	Common walnut (<i>Juglans regia</i>)	20m from Main Property 2.7m from Garden wall	Within the property.	12m	650	8m	Mature	Fair	Fair	Occasional	Probable	Low	Severe	Low	Occasional deadwood in crown to 70mm dia; decay at base accessible from two sides, probably extensive although not possible to quantify from visual assessment only. 'Possible to Probable' likelihood of failure based on information available from visual inspection and more detailed investigation could update this.		
T12	Common beech (<i>Fagus sylvatica</i>)	22m from Main Property 1.5m from Garden wall	Within the property.	12m	450 est	7.5m	Semi-mature	Good	Good	Occasional	Improbable			Low	No significant faults or defects visible.
