LOWER WOODHOUSE FARM  
FERNHILL  
ALMONDSBURY  
BRISTOL  
BS32 4LU

KYTEX LTD.  
2023067  
[info@kytex.co.uk](mailto:info@kytex.co.uk)

# 1. Introduction

### 3. Structural Description and Observations – Barn A

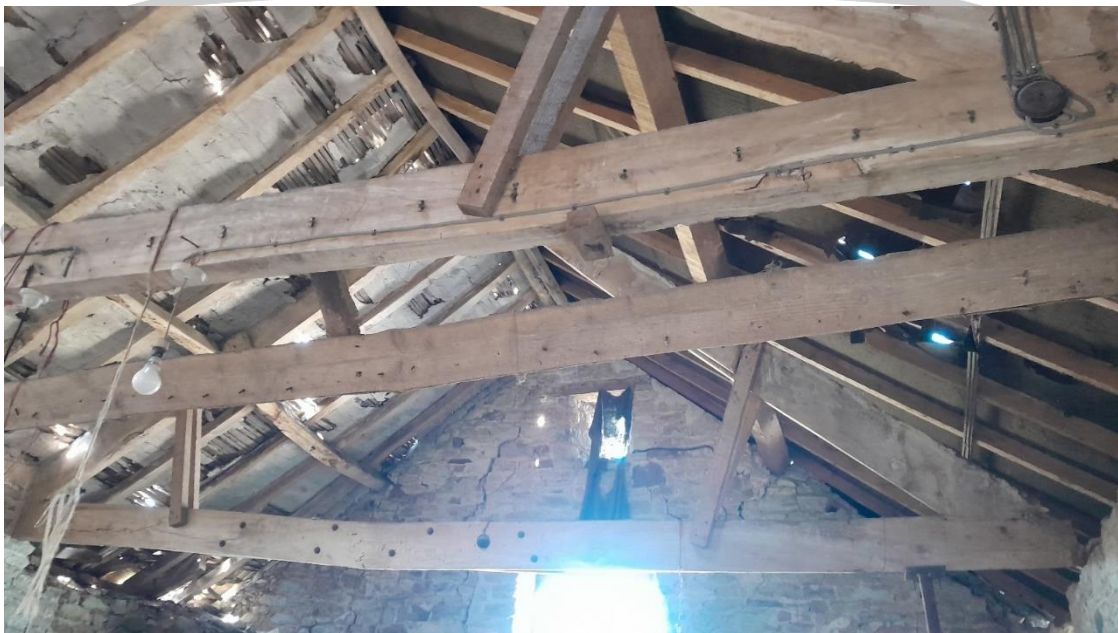
3.2.6 Significant sagging was noted to the ridge line internally and externally of the main duo pitch roof.

*Photo 1: Central area roof internal view*

6.2.1 New build-ups including finishes and insulation will add additional weight to the current structure. It is highly likely that the existing timbers will require strengthening or replacing particularly where they have suffered from water ingress and decay.

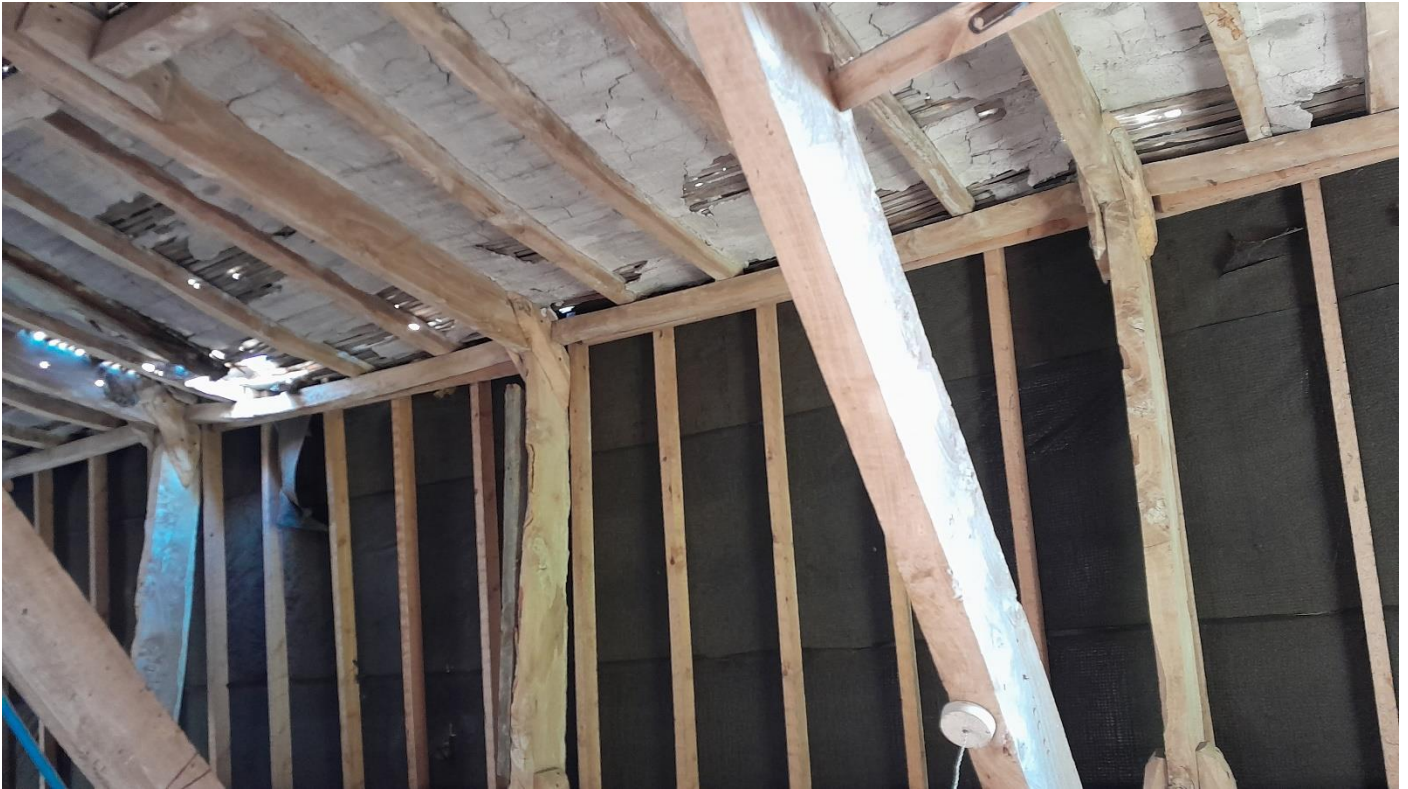
3.2.2 The underside of the roof slope in the southwest, has remnants of a lath and plaster finish. The underside of the northeast roof slope is just felt.

3.2.3 The rafters on the southwest half of the building consists of circa 75mm x 50mm timbers at 300-400mm centres and are assumed to be original. On the northeast slope, newer circa. 50mm x 50mm rafters span at 300-400mm centres.

*Photo 2: Older and newer ceiling halves of the central area*

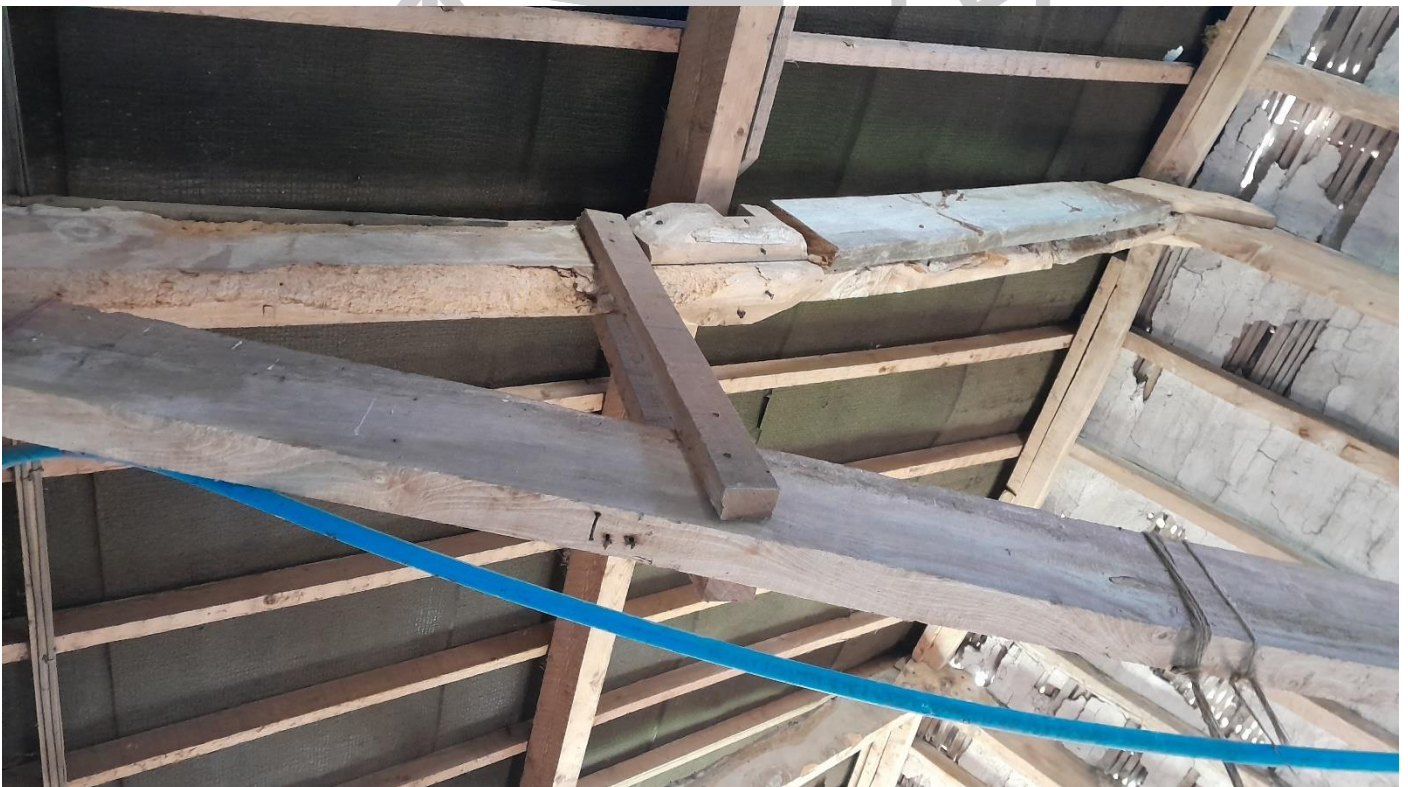
*Photo 3: Timber decay on truss rafters and previous repairs*

6.2.2 Existing timbers will require inspections to identify areas of decay or significant section loss.

6.2.3 Existing timbers should be appropriately treated against decay and insect attack.

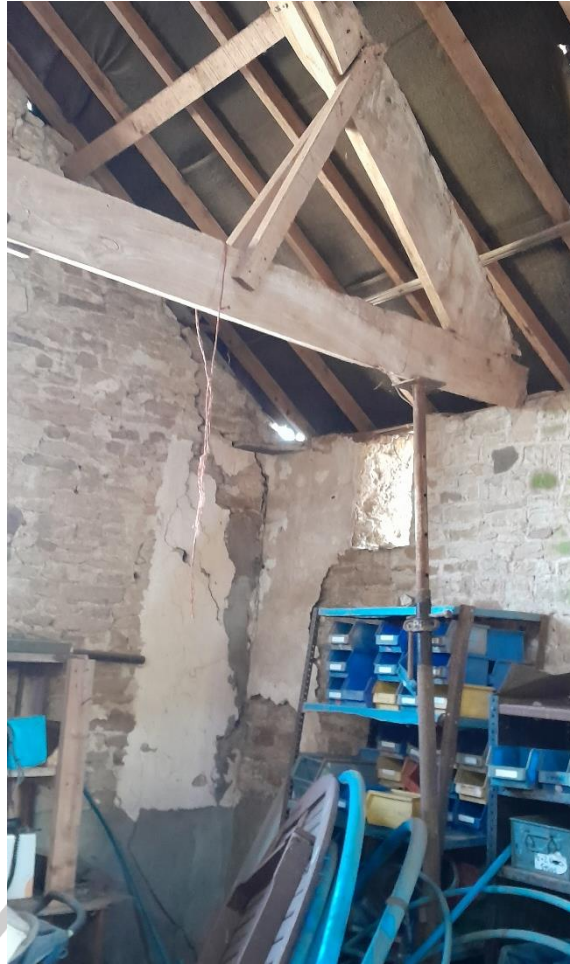
3.2.5 The purlins and ridge are supported off 4 internal hardwood timber trusses. They are constructed from 250mm x 75mm truss rafters, 225mm x 75mm timber ties, and 75mm x 50mm internal timber struts. The northwest truss has lost its bearing at the east eaves and is currently supported with an acrow prop.

*Photo 4: Propping of northwest truss*

6.2.4 The repairs to the roof timbers along with adequate strapping and securing the walls (in accordance with building regulations) is expected to stabilise the walls.

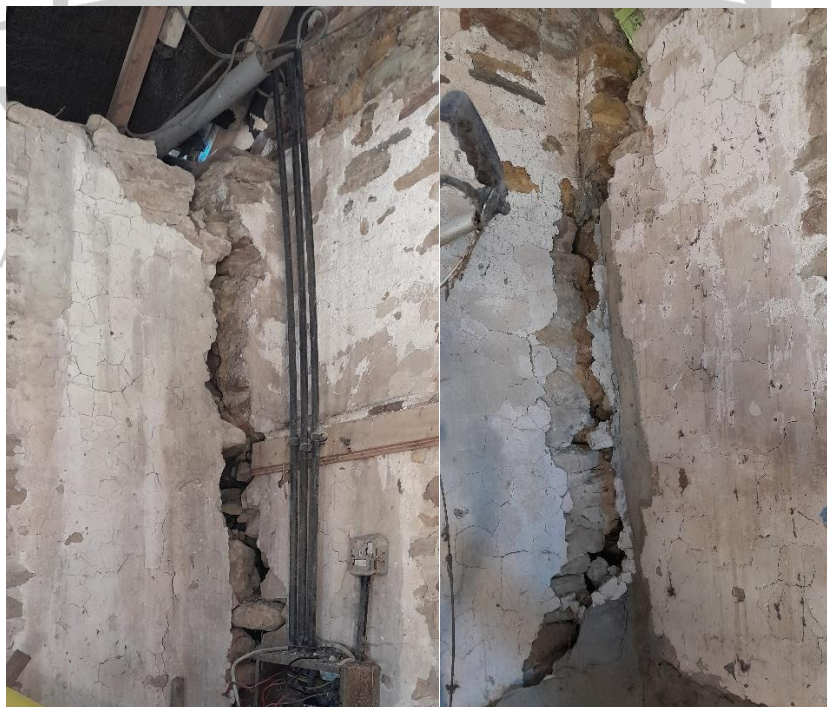
3.3.2 The southeast gable wall is noted to have pulled away from the return walls with significant cracking present on the south and east corners. The purlins have likely lost their bearings through decay and water ingress which has destabilised the wall.

3.3.3 The northwest gable also has multiple cracks present. A large vertical crack runs to the left-hand side of the window opening.

*Photo 7: Cracking at the eastern corner      Photo 8: Cracking at the southern corner*

6.5.2 Large cracks will require a combination of specialist stitch bars and partial rebuilding to ensure the walls are sufficiently bonded into the return buttressing walls.

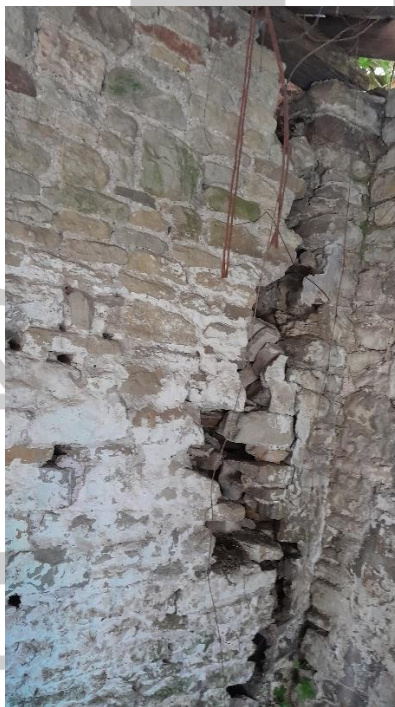
*Photo 9: Cracking at the east corner of the timber lean-to*

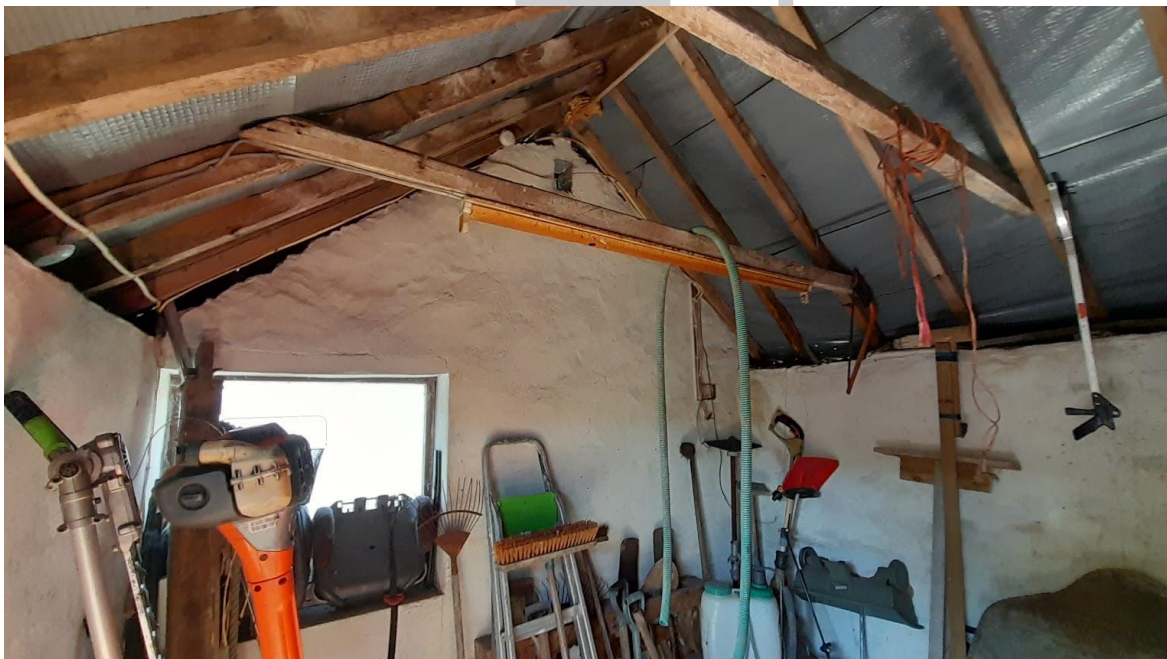
5.2.4 The southern end of the roof has tiles missing and a visible sag on the rafter line.

Photo 22: Internal view of barn

8.2.1 The existing roof rafters are currently tied with collars for every other rafters. A collar to every rafter is expected to provide a sufficient roof design.

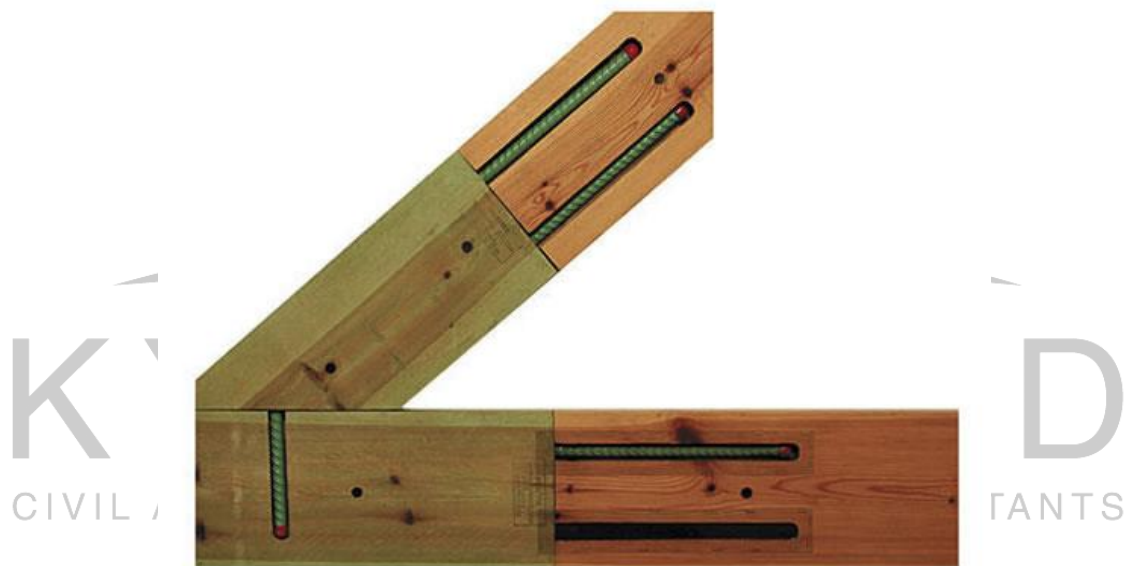
*Photo 27: Typical truss bearing repair*
