Arboricultural Consultancy for Lloyds Bank

Insured	Mr Trevor Williams	Address	8 Taylors Cottages , Potters Bar, EN6 3LL		
Client	Subsidence Management Services	Contact	Ian Domigan	Claim No.	IFS-LBG-SUB-22-0104199
ES Ref	SA-253088	Consultant	Keith Burgess	Contact No.	0330 380 1036
Report Date	09/06/2023

Ridge 8 Taylers Cottages, Potters Bar, EN6 3LL

Risk Address: Ridge 8 Taylors Cottage, Potters Bar EN6 3LL

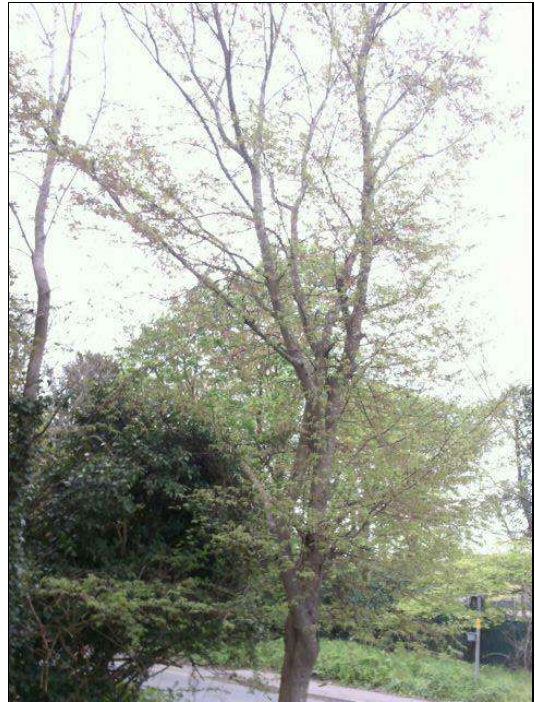
T3 - Hornbeam

With due regards to species profile, size and proximity, T2 (Ash), T3 (Hornbeam) and TG1 (Apple) are considered the dominant features proximate to the advised area(s) of movement and accordingly, where vegetation is confirmed as being causal, we have identified them as the primary cause of the current subsidence damage.

Tree No.	Species	Age Cat	Approx. Height (m)	Distance to Building (m) *	Ownership	Action	Requirement
T2	Ash	1	10	3.3	F - Commercial Third Party	Remove	Remove close to ground level and treat stump to inhibit regrowth.
T3	Hornbeam	1	10	6.9	C - Insured	Remove	Remove close to ground level and treat stump to inhibit regrowth.
TG1	Apple	1	10	3.3	F - Commercial Third Party	Remove	Remove x2 Apples close to ground level; do not treat stumps due to translocation risk. Where such a risk exists, we advise that any emergent regrowth is removed annually.

Consequently, we have advocated the complete removal of T2, T3 and TG1 as it will offer the most certain arboricultural solution likely to restore long-term stability.

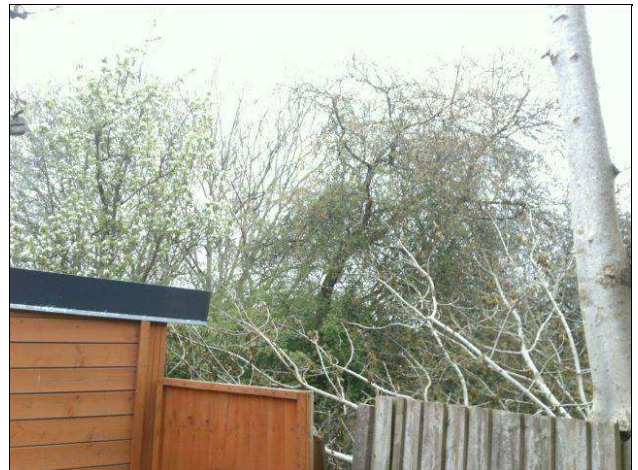
TG2 - Mixed species group

Tree No.	Species	Age Cat	Approx. Height (m)	Distance to Building (m) *	Ownership	Action	Requirement
T1	Oak	2	12	11.4	C - Insured	Action to avoid future risk	Maintain at, or below current dimensions by way of regular pruning.
TG2	Mixed species group: including Ash, Cherry & Willow.	1	10	6.0	F - Commercial Third Party	Action to avoid future risk	Maintain those trees within recognised influencing distance of the property (based on species, size and proximity) at, or below current dimensions by way of regular pruning. Any pruning undertaken should be in accordance with BRE IP7/06 and repeated on a 3-year (max) basis to be deemed as effective.
TG3	Cypress	1	2	4.0	A - Third Party	Action to avoid future risk	Maintain at broadly current dimensions by way of regular pruning.

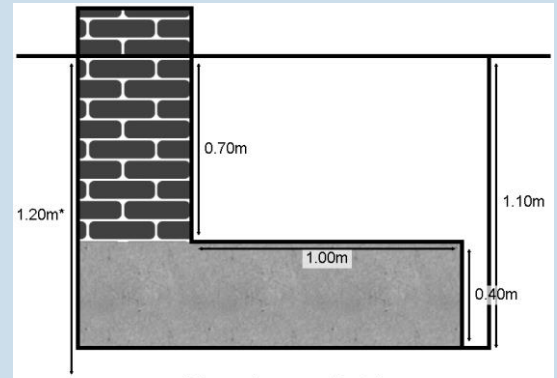
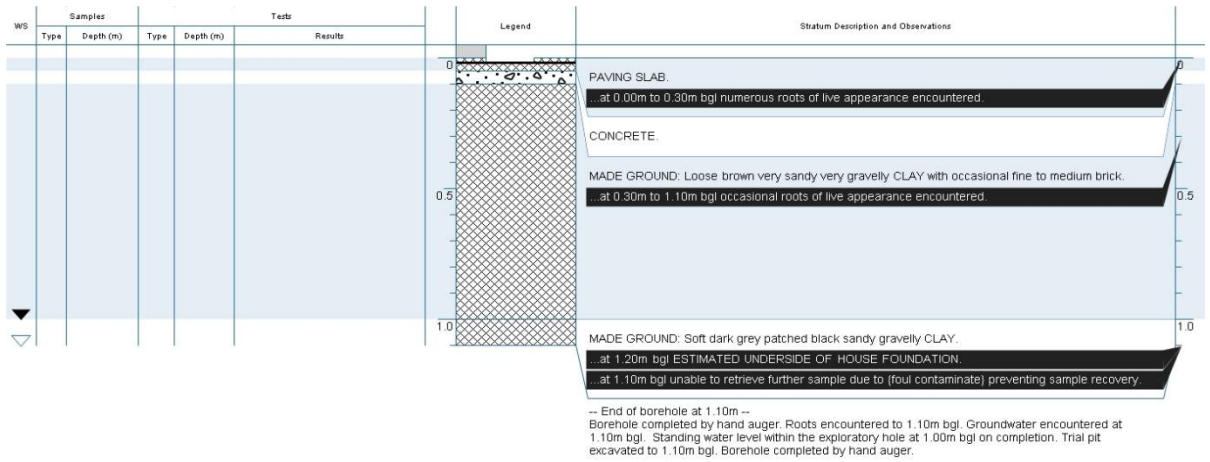
TP/BH2 Foundation Detail and Borehole Log

House foundation was partially exposed and comprised of brick wall to 700mm bgl, bearing on concrete to a depth of at least 1200mm bgl, with a total projection of 1000mm from the elevation.

At 1.20m bgl ESTIMATED UNDERSIDE OF HOUSE FOUNDATION in TP/BH2.

At 0.00m to 0.30m bgl numerous roots of live appearance encountered in TP/BH2.

At 0.30m to 1.10m bgl occasional roots of live appearance encountered in TP/BH2.

A water strike (WS) was encountered in the made ground at 1.10m bgl (TP/BH 2), with a standing water level (SWL) recorded at 1.00m bgl after 10 minutes (TP/BH 2). Standing water level within the exploratory hole at 1.00m bgl (TP/BH 2) on completion.

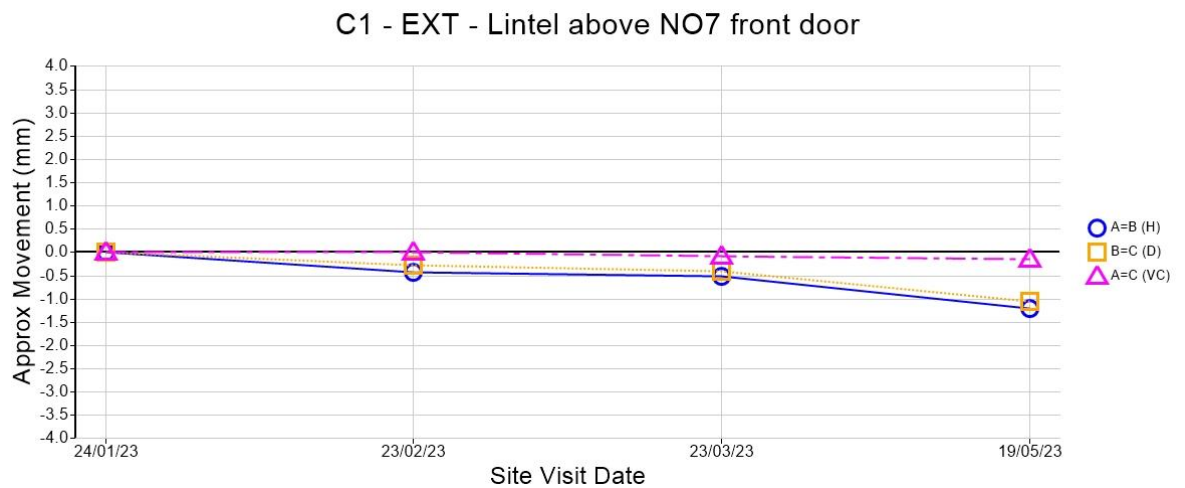
Crack Monitoring Difference Graphs

Date	A=B (H)	B=C (D)	A=C (V)(C)	Crack Width
C1 - EXT - Lintel above NO7 front door				
24 January 2023	110.40	115.90	50.67	8.90 - 7.30
23 February 2023	109.97	115.64	50.67	7.00 - 21.40
23 March 2023	109.90	115.51	50.59	
19 May 2023	109.19	114.86	50.54	6.80 - 20.70

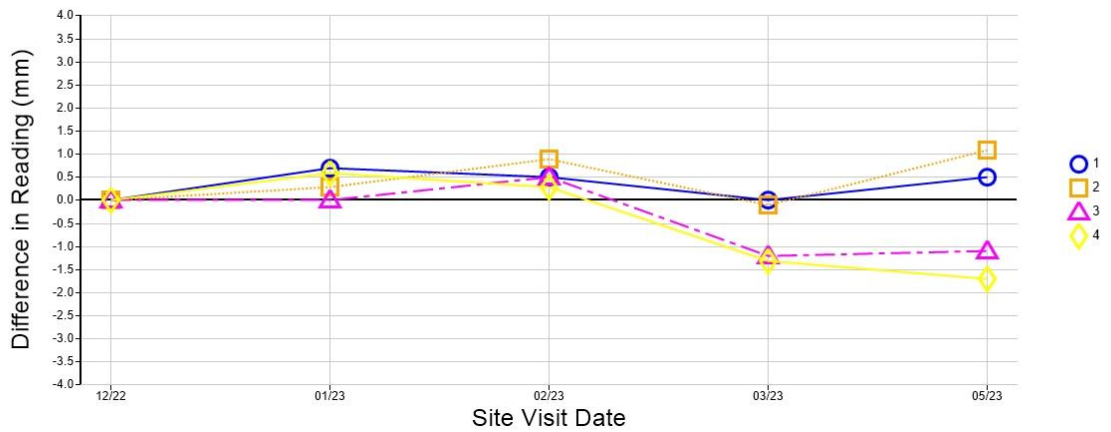
Level Monitoring Difference Graphs

Date	1	2	3	4
28/12/2022	11.2507	11.1322	11.1983	11.5491
24/01/2023	11.2514	11.1325	11.1983	11.5497
23/02/2023	11.2512	11.1331	11.1988	11.5494
23/03/2023	11.2507	11.1321	11.1971	11.5478
19/05/2023	11.2512	11.1333	11.1972	11.5474
