Ballantruan Farmhouse

Ballindalloch, Moray

Analytical assessment

January 2023

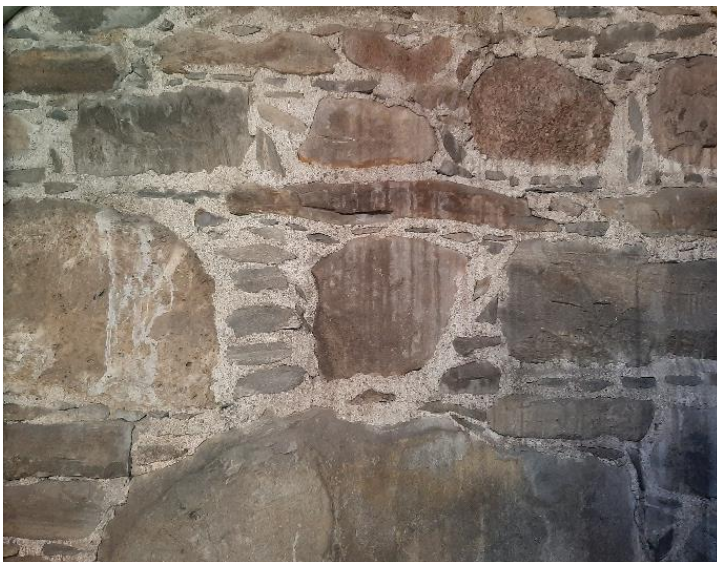
Detail of masonry of the main house, seen within the loft room of the kitchen extension

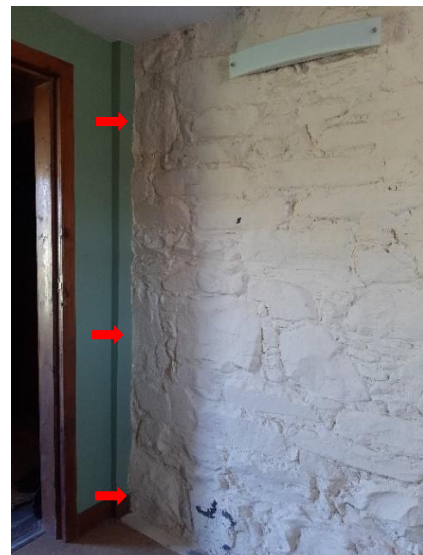
Detail of masonry of north gable – exterior as seen within the kitchen range; arrows indicate hewn jamb stones of opening further to the left

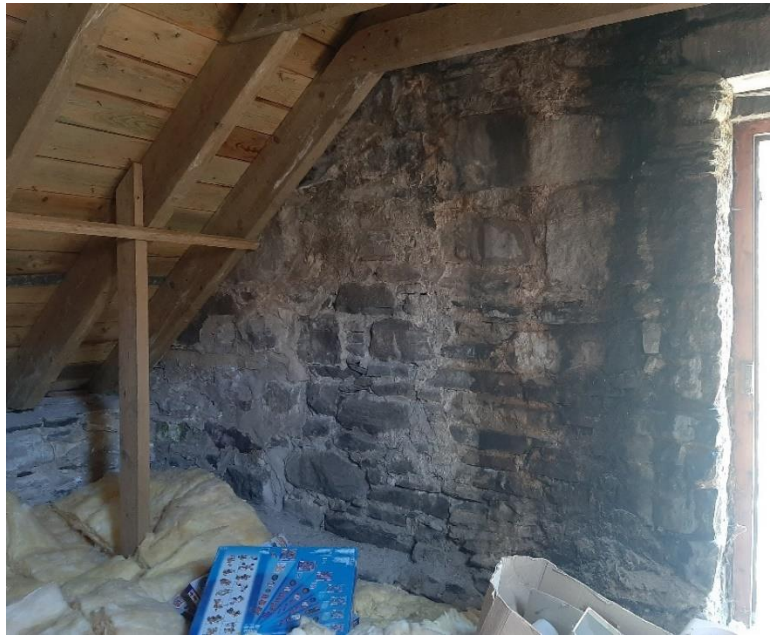
Though rubble-built the masonry of the kitchen extension appears to be of less refined construction although visual access is limited to the interior wall face within the north gable at the upper level.

Interior of the north gable of the kitchen extension – detail of masonry construction

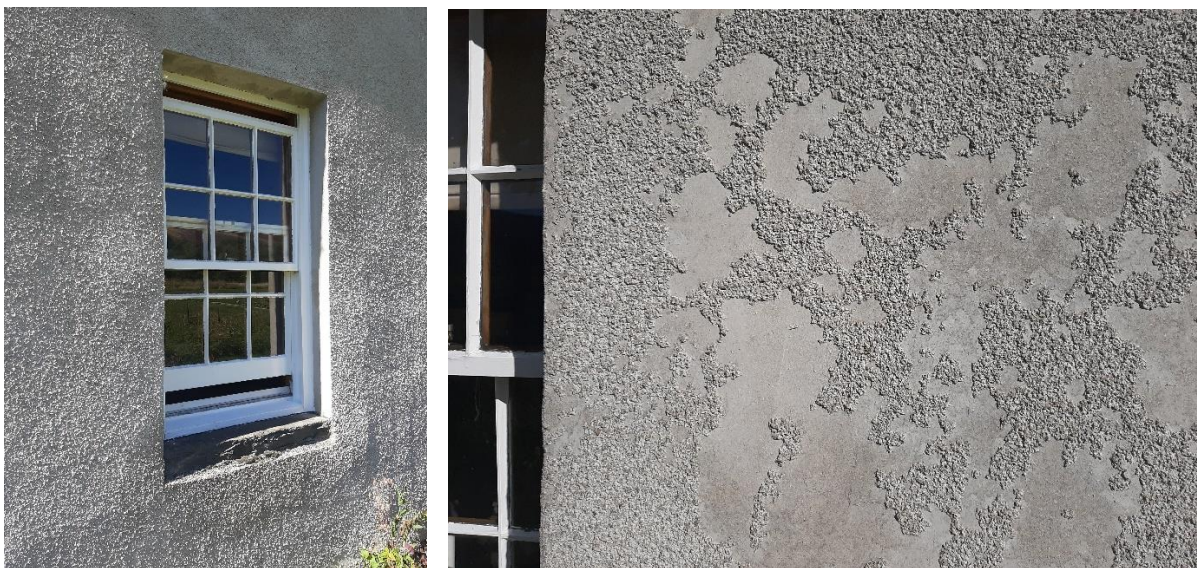
The existing harled finish extends to all exterior walls. This was applied during the c.1985 works evidently according to a specification supplied by the Historic Buildings Council for Scotland's architect. This stipulated,

East elevation – detail of harl application at ground floor window

West elevation – detail of existing harl finish applied c.1985, no showing harder cement substrate and higher lime-cement finish coat

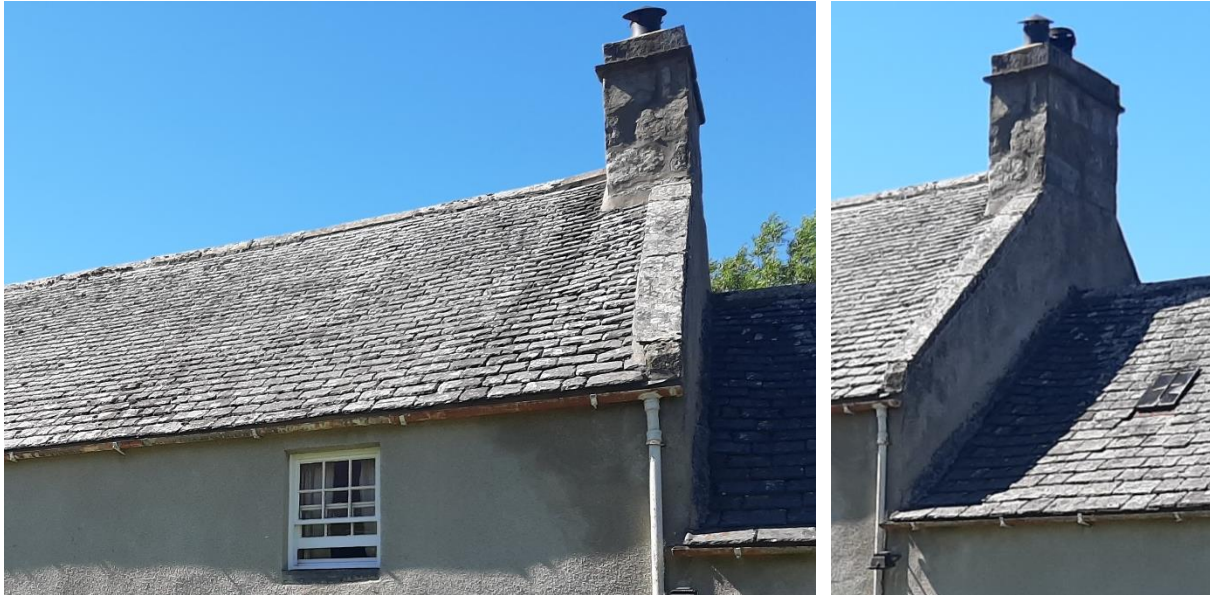
Roofing is of local schist-like *Tomintoul* slate (from the Cnocfergan quarry, NGR: NJ12SW0058), this laid in diminishing courses rising to sandstone ridge stones at the apex. The raised gable heads are coped with slabs, held by plain skew-putts; the chimneys are formed with roughly squared rubble quoins and detailed with a drip course.

Main house – roof details, slating, gable head and chimney

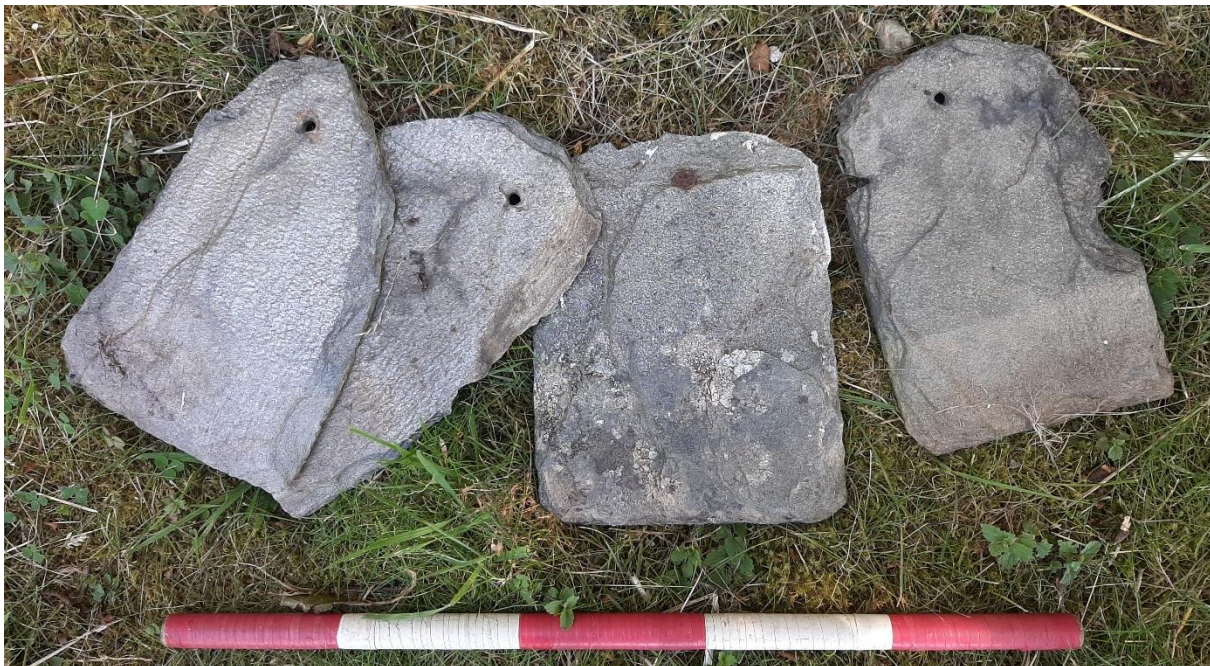
Ex situ 'Tomintoul' slates at site, some retaining wrought iron nails, some with mortar residues

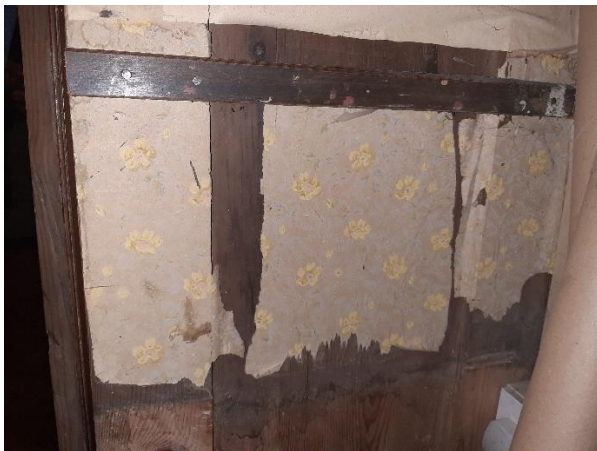
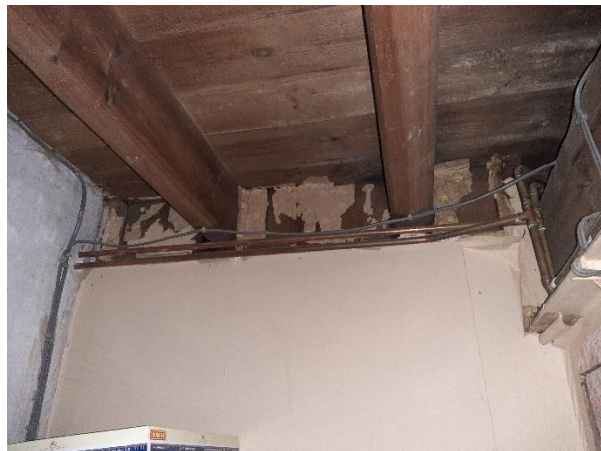
Left - wall-papered interior of western box bed, paper onto timber lining boards terminating at top of bed-frame below, now missing; right – paper lining visible within eastern box bed

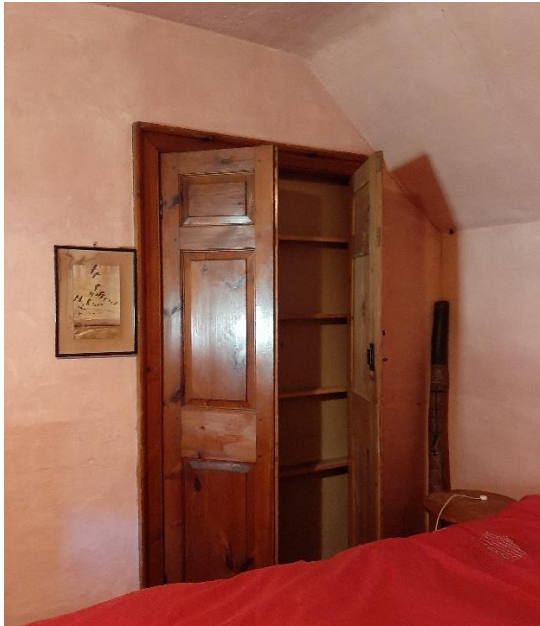
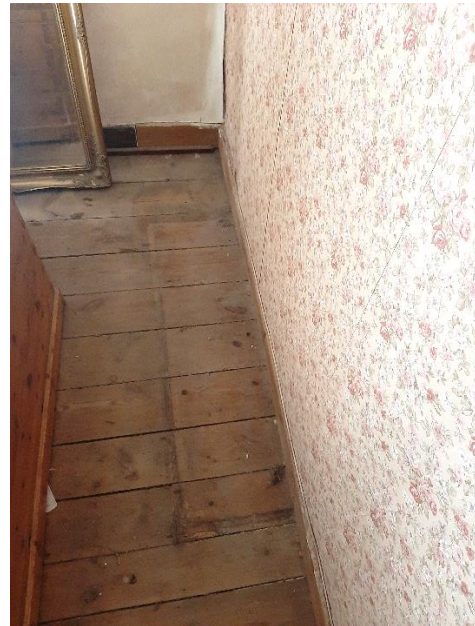
Left - press to west end of south wall; right – evidence within central room that rear of press formerly extended

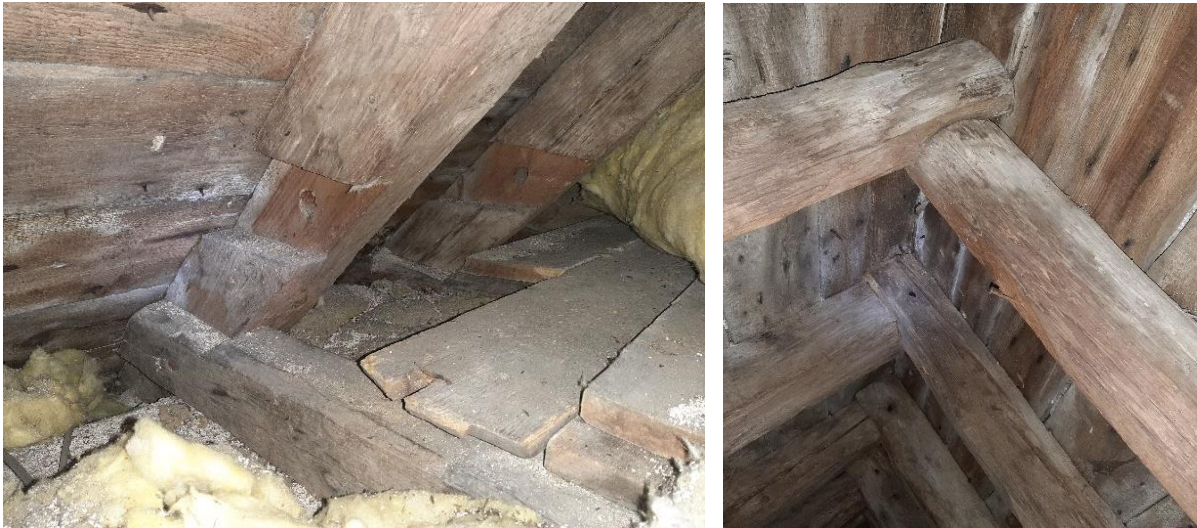
Left : roof - detail showing relict collar-beam lap-joints with peg-holes, and the existing collar below, similarly jointed but affixed with an iron spike.

Right - roof apex joint

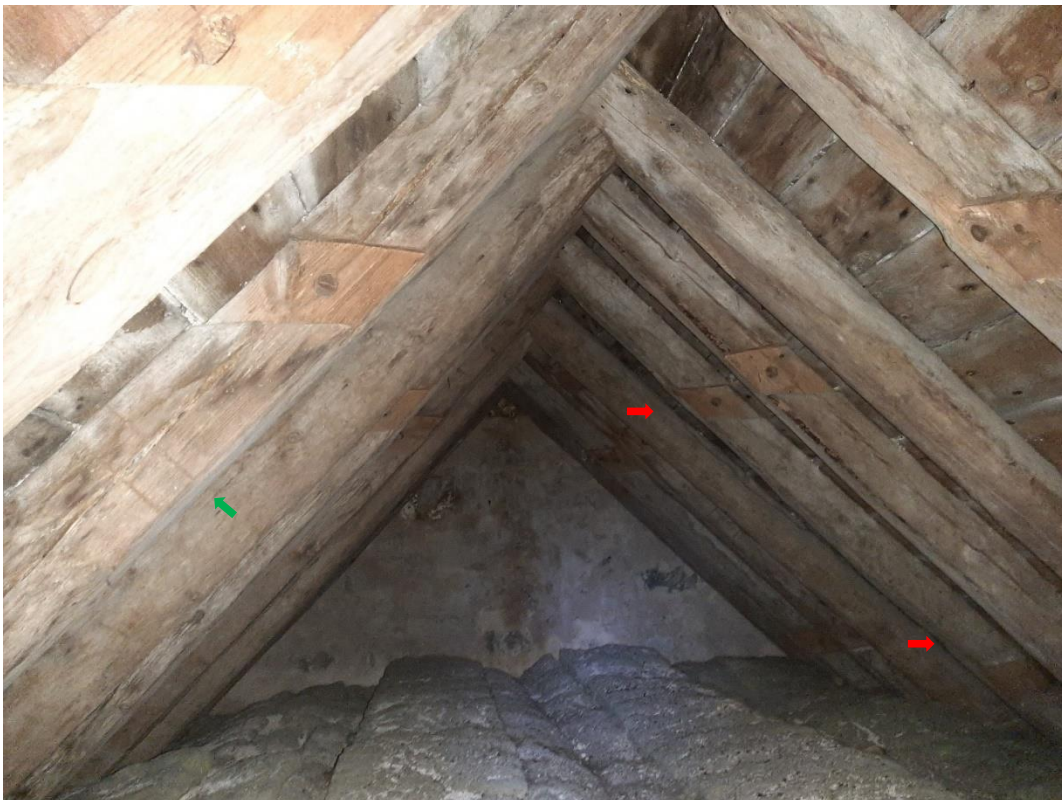
The structure displays evidence for a complex history. The upper (north) faces of many (but not all) rafters display relict joints of both upper and lower collars, the latter at higher level than the existing, and, in some instances multiple collar joints. Some carpenters' assembly marks are also in evidence, but displaying no sequence. That many relict joints appear to correspond between rafter pairs and also between respective couples – i.e. jointing at the same level suggests that most if not all timbers that display relict joints come from the same roof of origin – possibly an original roof structure for the existing building. While the existing joints are spiked with iron all pre-existing joints had been pegged into drilled holes; some pegs still remain *in situ*. Some rafters displayed evidence for more than one phase of relict joint.

Roof interior looking south; upper faces of many rafters display relict upper and lower collar lap-joints (red arrows); some timbers display assembly marks (green arrow)

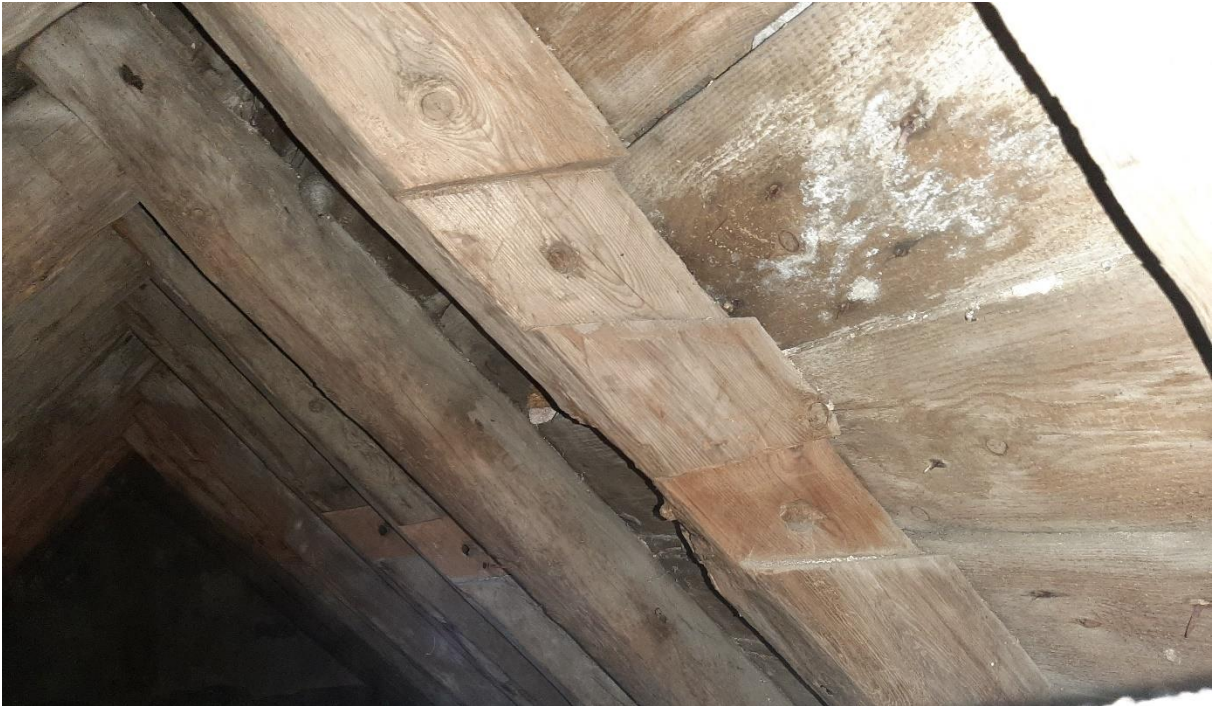
Detail showing relict collar joints – the upper with some weathering, the lower more recently exposed, both pegged

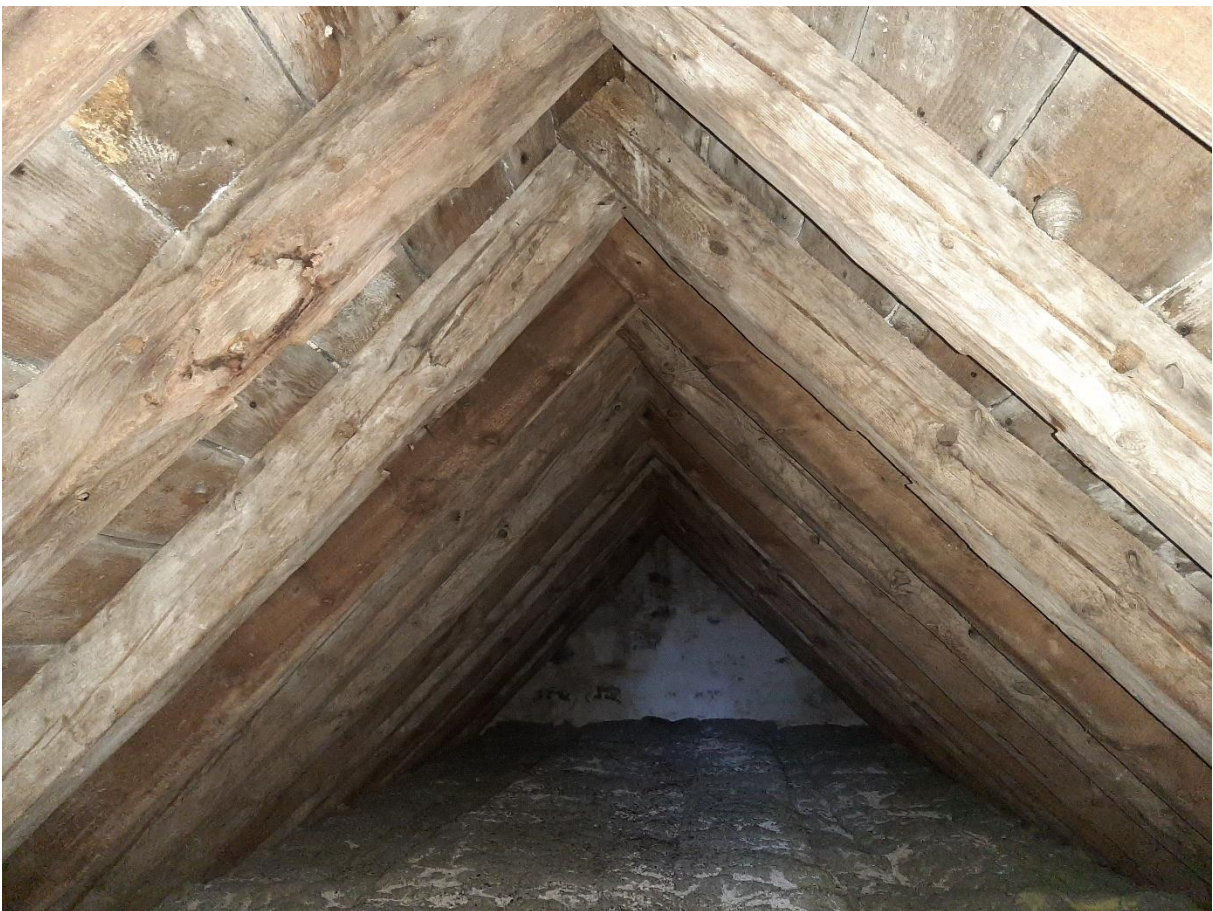
Interior of roof structure, looking north; note to right in situ pegs within relict collar joints

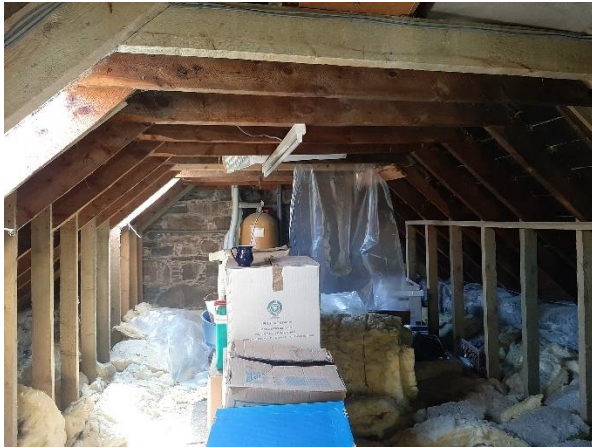
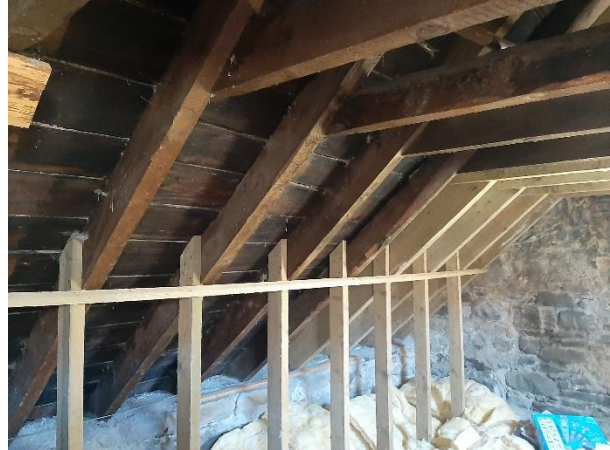
The upper level of the kitchen range is reached by an external stone stair at the north gable, a straight flight that rises to the west, the subject of considerable repair c.1985. The loft-space thus accessed contains few individual features. The roof structure is constructed of machine-sawn conifer boards. The kitchen range roof is of a simple A-frame configuration with rafter couples rising from a plate, half-lapped and nailed at the apex, with a single collar, again half-lapped and nailed, the collar ends chamfered. The northern four couples were renewed c.1985 at which time structural bracing was also inserted rising from the floor to support the rafter soffits to either side; the flooring at the north end was also repaired at this stage, with renewal of existing joists.

General view of the kitchen range roof structure looking south

Detail of the west side of the roof structure, showing extent of roof repair at north end, and general strengthening
