**Heritage Assessment of Ashlett Mill, Ashlett Creek,  
Fawley, Hampshire, SO45 1DT**

March 2023

## NON-TECHNICAL SUMMARY

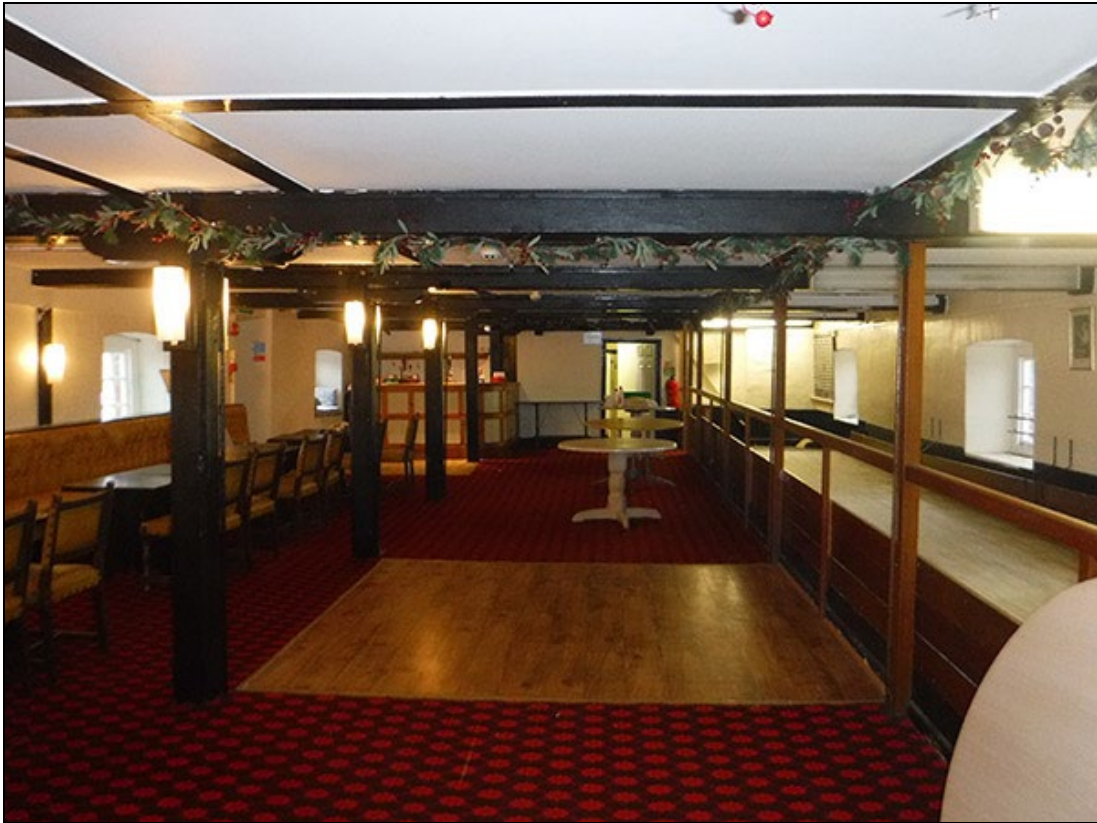
**Figure 10** View of the second floor looking north-east, showing the transverse beams supported on their posts, although the right hand posts are all replacements linked to the skittle alley (and probably shooting range before)

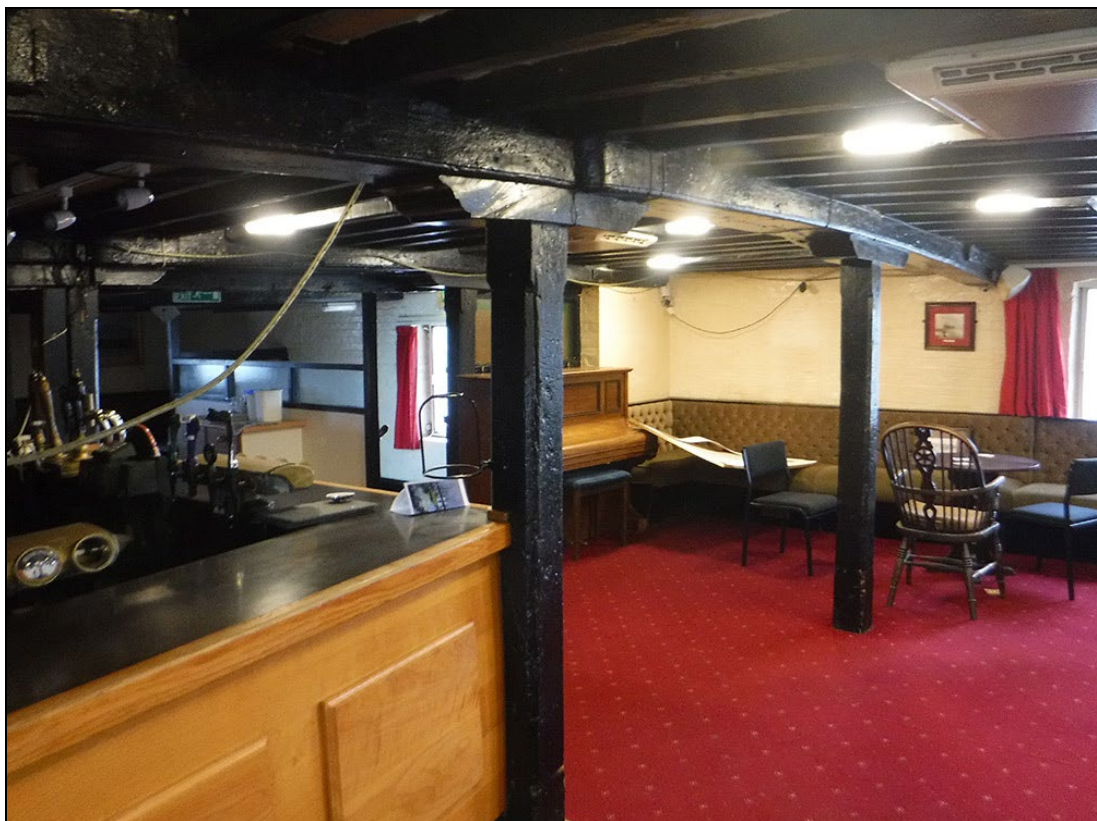
**Figure 11** View of the first floor showing the two cambered and moulded transverse beams at its north-eastern end, probably re-used ships timbers

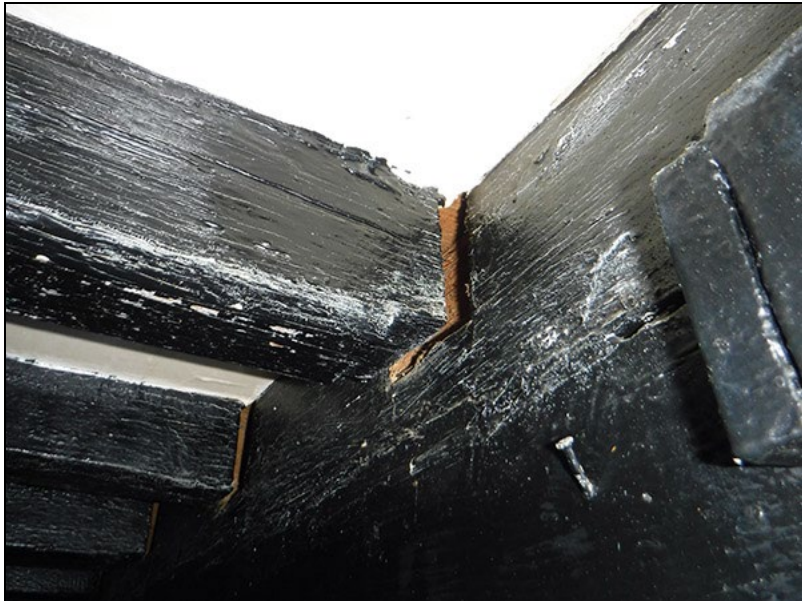
7. The floor joists running between the beams are softwood, many having partially slipped from their housings, but still remaining in place since the projection of the joist above the transverse beams is of sufficient length. At the north-eastern end of the building there is a three-bay brick extension of smaller dimensions, with both front and rear elevations being set back from those of the main building (the rear, seaward, being more so), and of only two storeys, with a simple double pitched roof. Internally the ceilings are supported on three more transverse beams. At the south-western end of the main building a single storey range of buildings was attached, now demolished and replaced, possibly originally including the cottage and outbuilding belonging to the previous mill.

**Figure 12** A floor joist on the first floor projecting out of its housing in a transvers beam

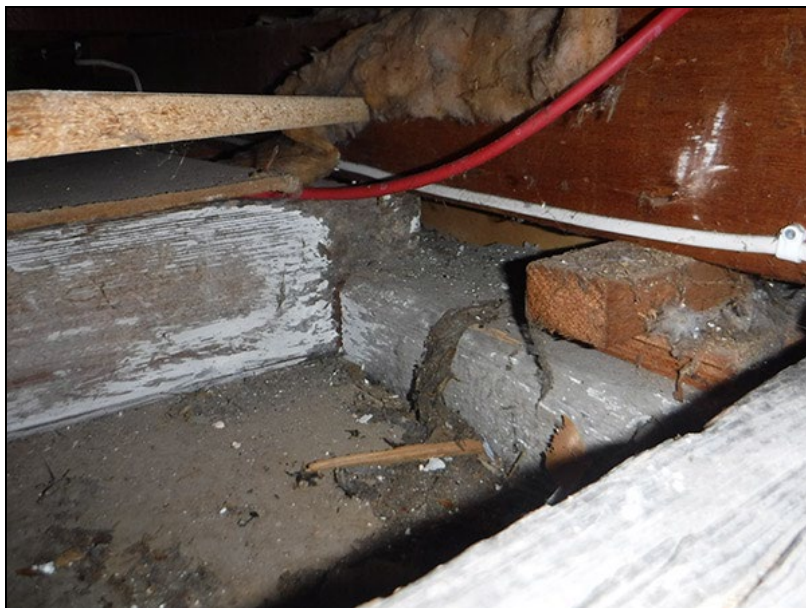
**Figure 13** The top of a floor joist in the top floor showing its upper projection resting on a transverse beam

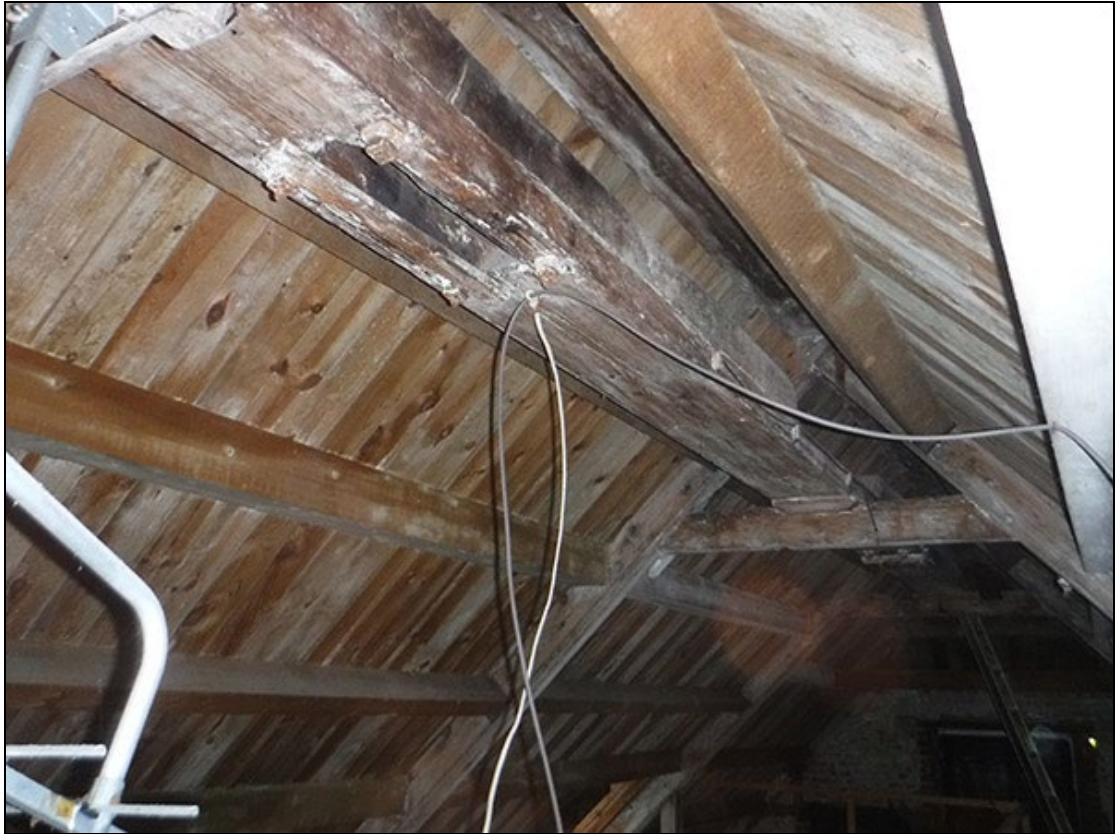
**Figure 21** The remains of the hoist timber in the roof-space of the upper floor, looking north

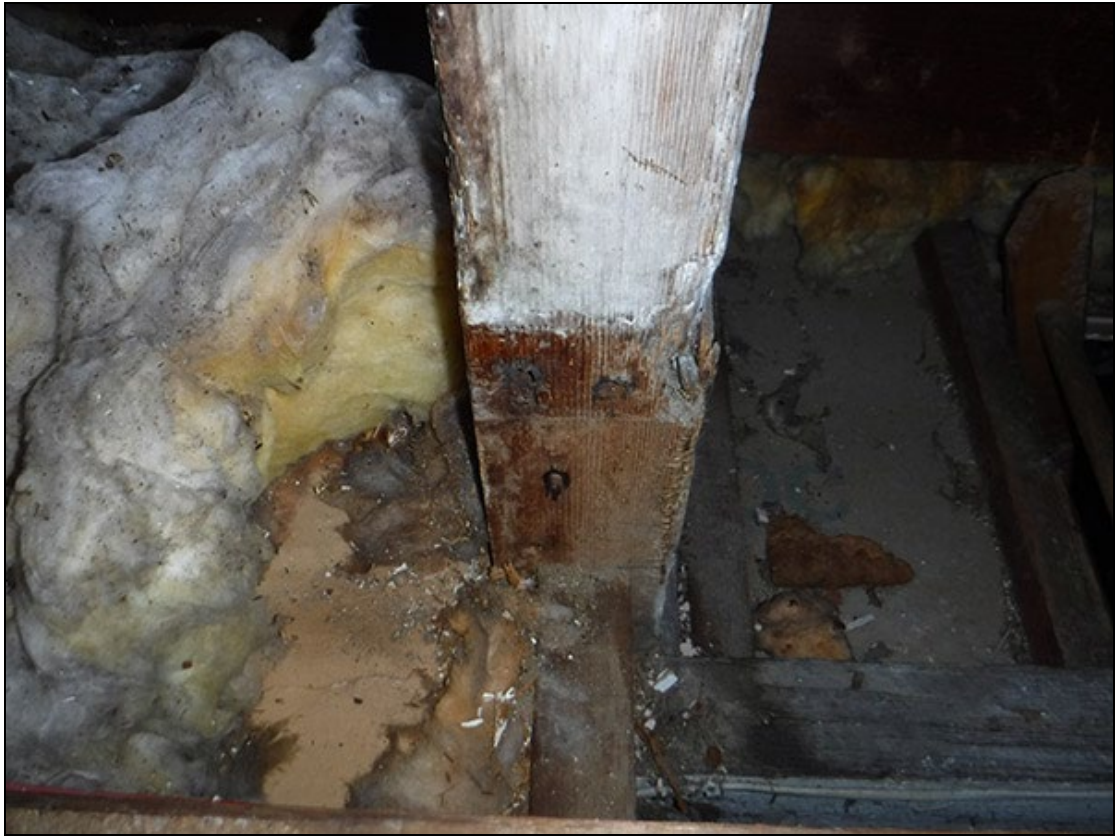
**Figure 23** The evidence for a low-level retaining board in the fourth floor on one of the posts, with a coat of whitewash respecting their position

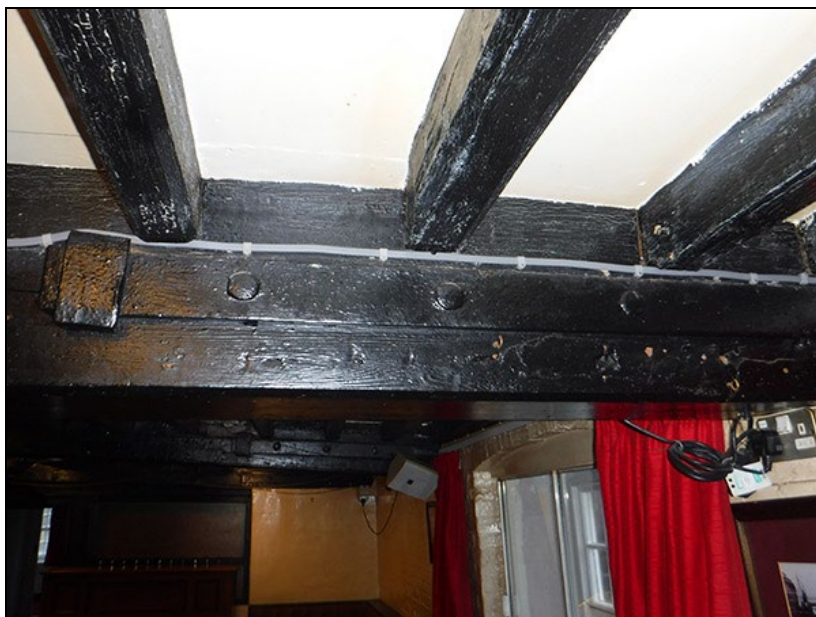
17. In addition to the changes outlined above seen on the historic photographs, and probably during the working life of the mill, the internal timbers were painted, first in blue and then using a white limewash or distemper. Also during this phase metal straps were attached to the ends of the transverse beams of the ground and first floor ceilings in order to restrain the external brickwork with large cruciform washers, an operation that might have been linked to settlement evidenced by the dislocation of the stone string courses.

**Figure 29** One of the metal straps attached to the transverse beams

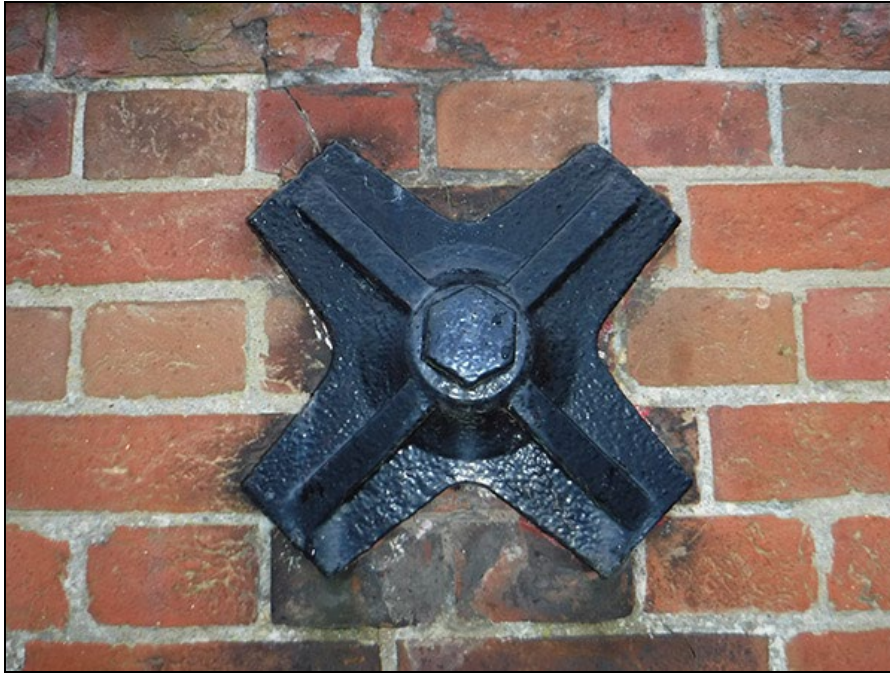
**Figure 30** Details of one of the large cruciform washers on the exterior brickwork
