Structural Survey Report

Head of the River
St Aldgate's
40 Pembroke Square
Oxford
OX1 4LB

Fuller Smith & Turner Plc

DATE OF SURVEY: 20th June 2023 & 15th August 2023

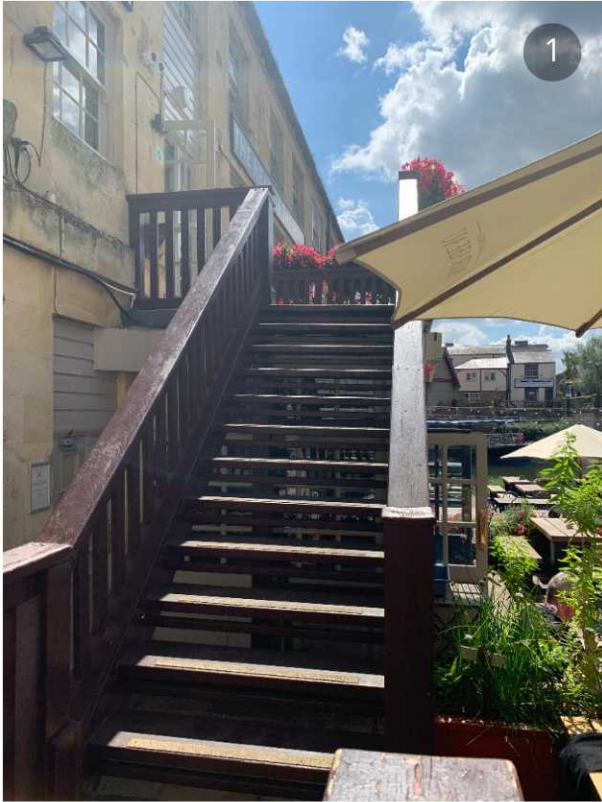
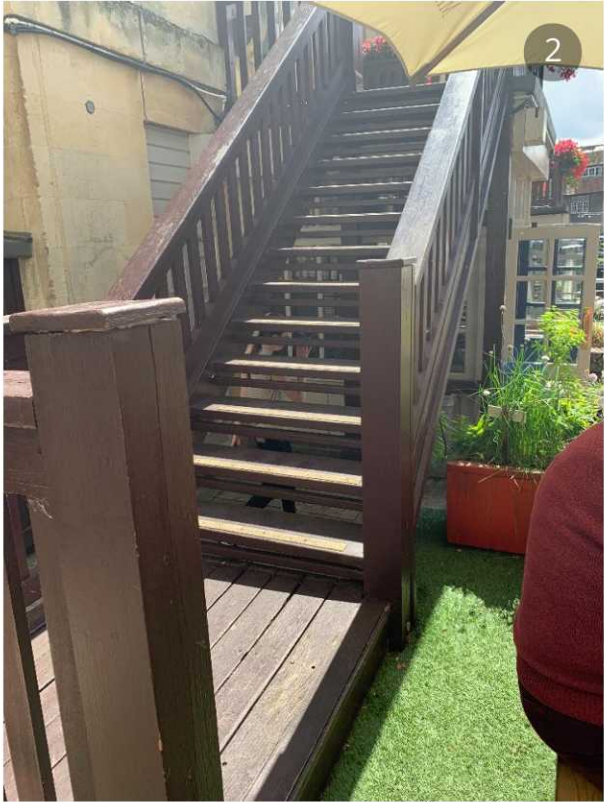
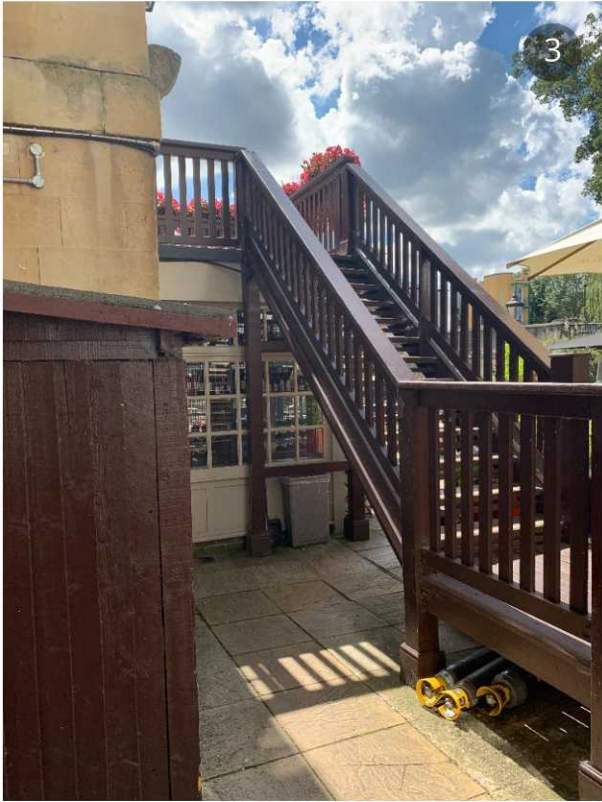
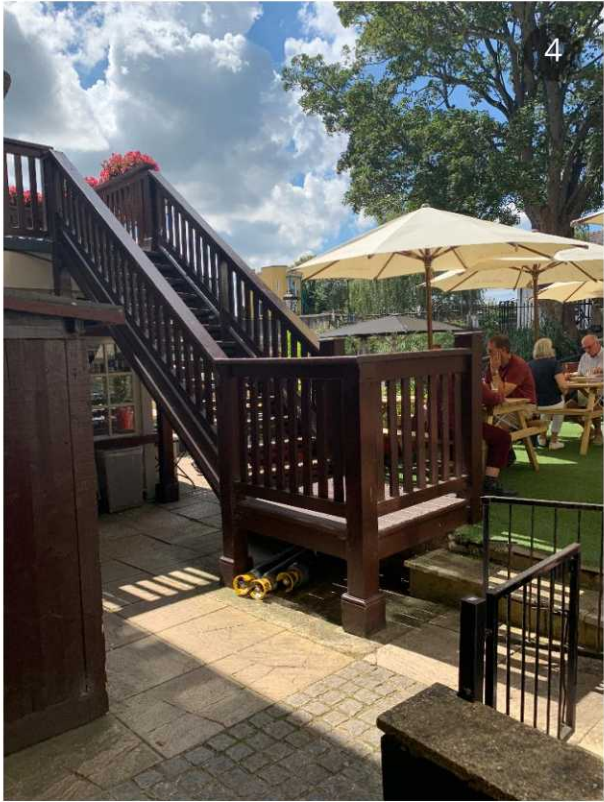
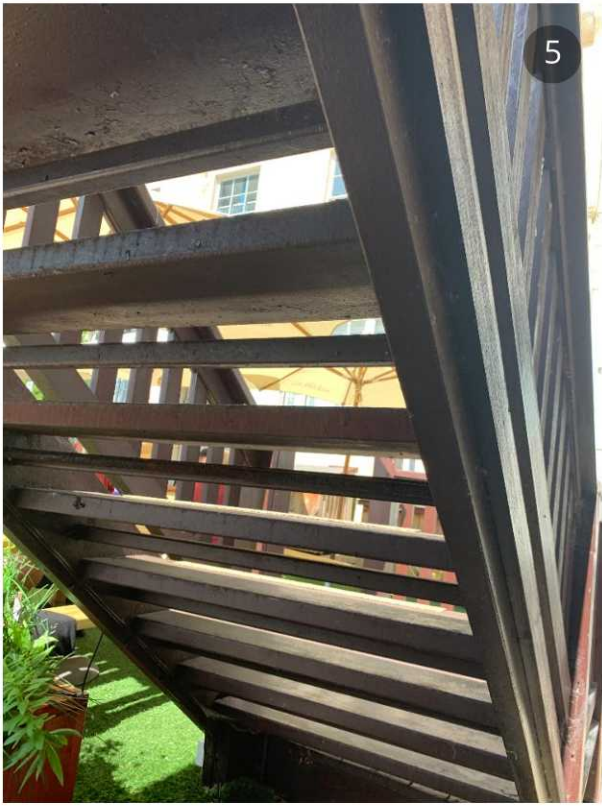
WEST TIMBER FIRE ESCAPE

The west side external timber staircase, from the ground to first floor, has had numerous repairs undertaken over its lifetime. The bottom of the posts have become rotten and we have been informed proprietary steel shoes had been installed, though this wasn't visible during our inspection as they have been cladded over. Some sections of the timber stairs and balustrade have been spliced and patched repaired in the past.

We recommend removing the existing fire escape staircases and replace them in hardwood timber sections to match existing sections and connections details, like for like.

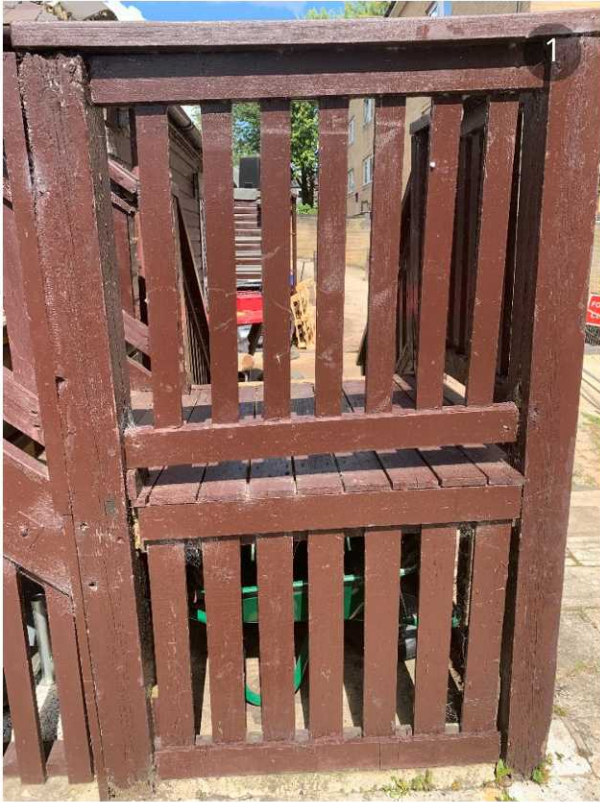
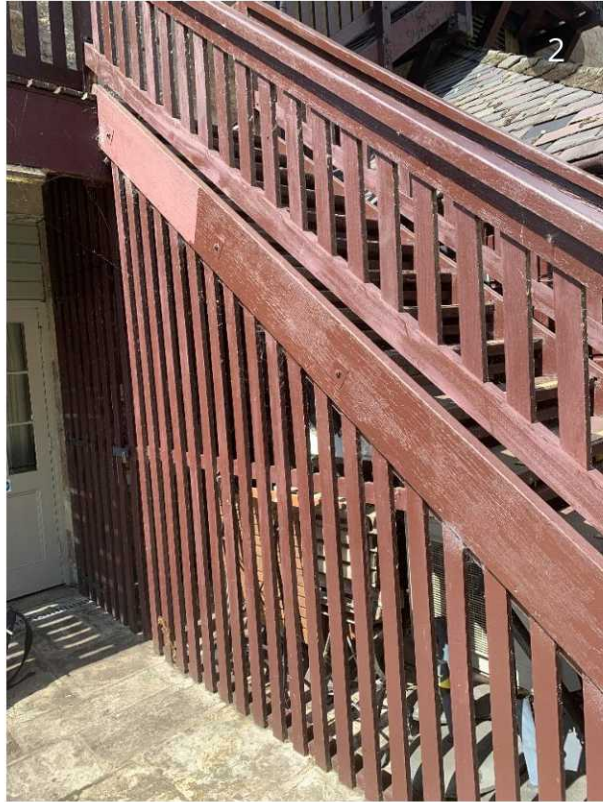
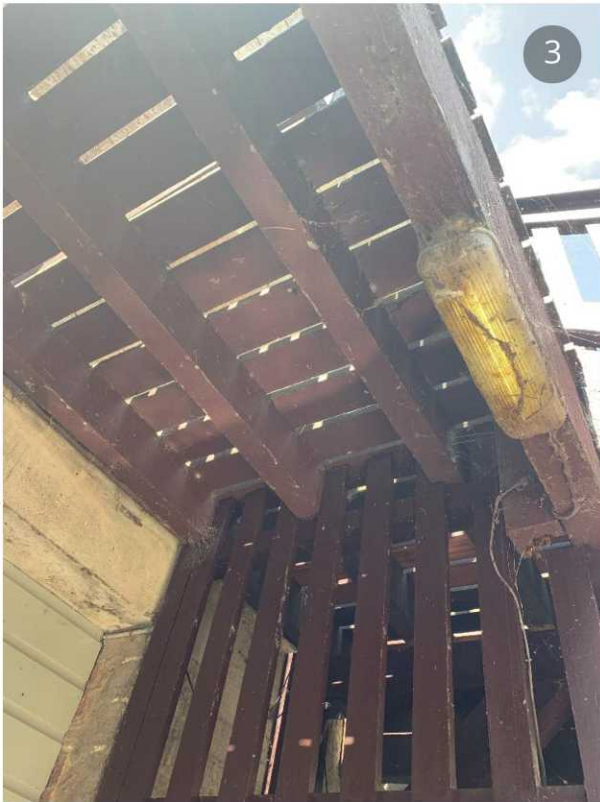
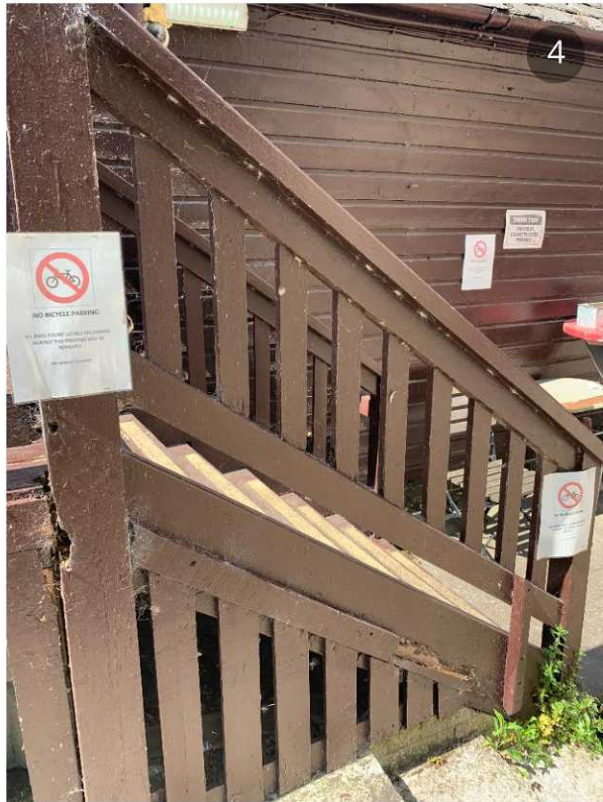
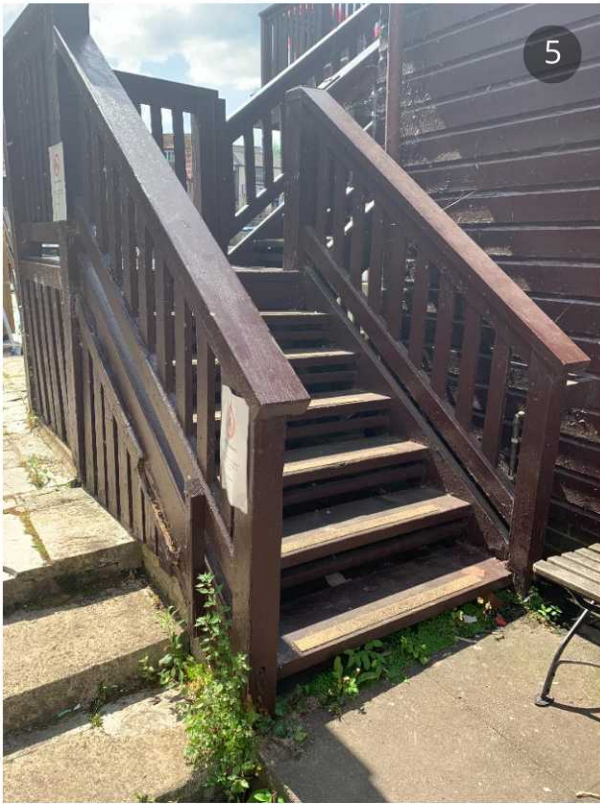
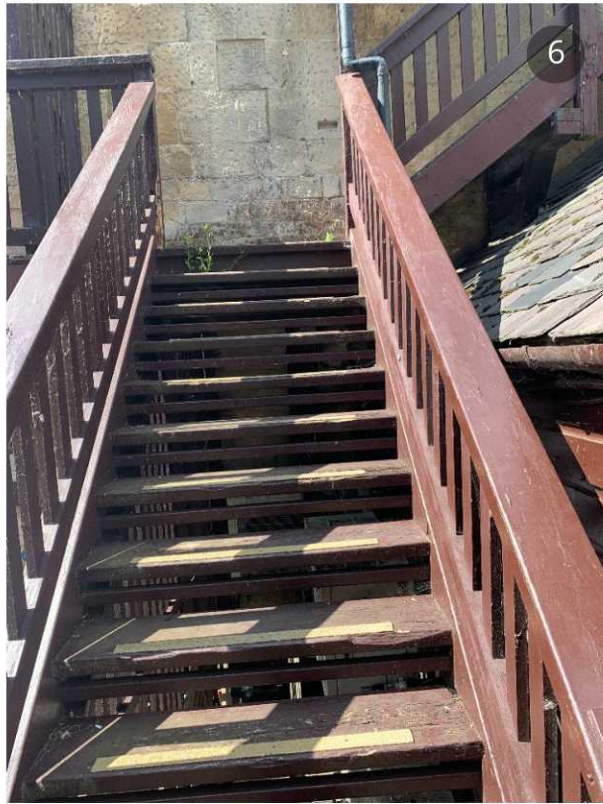
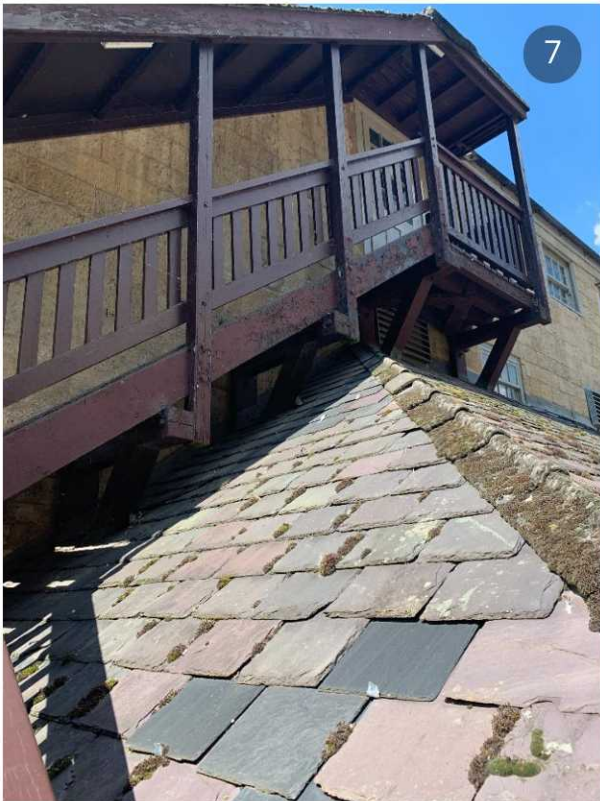
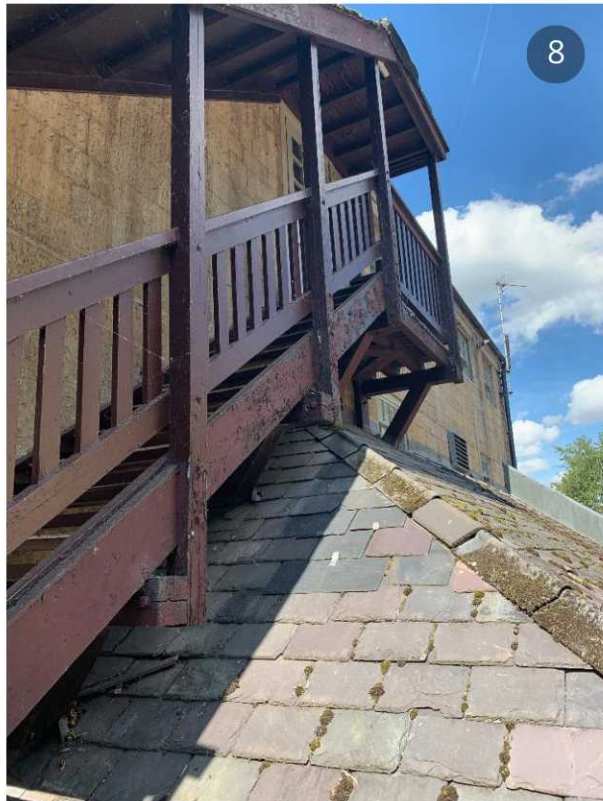
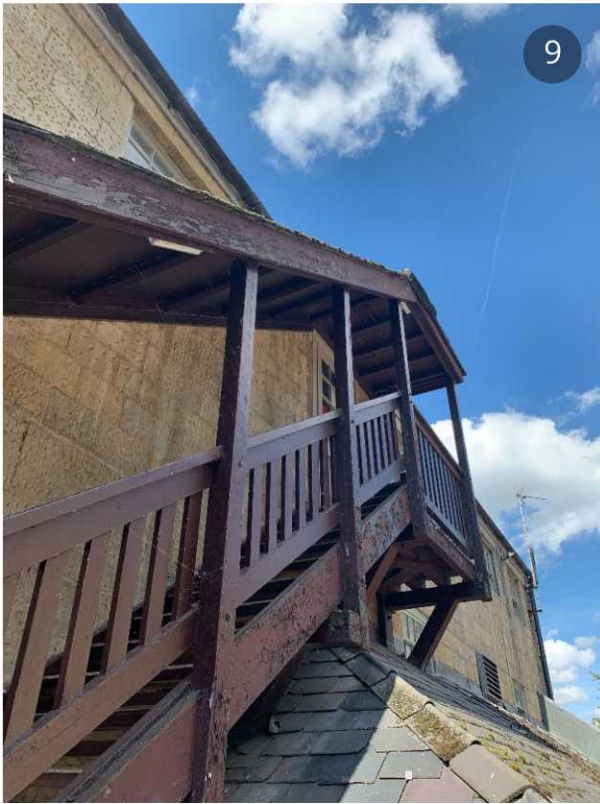
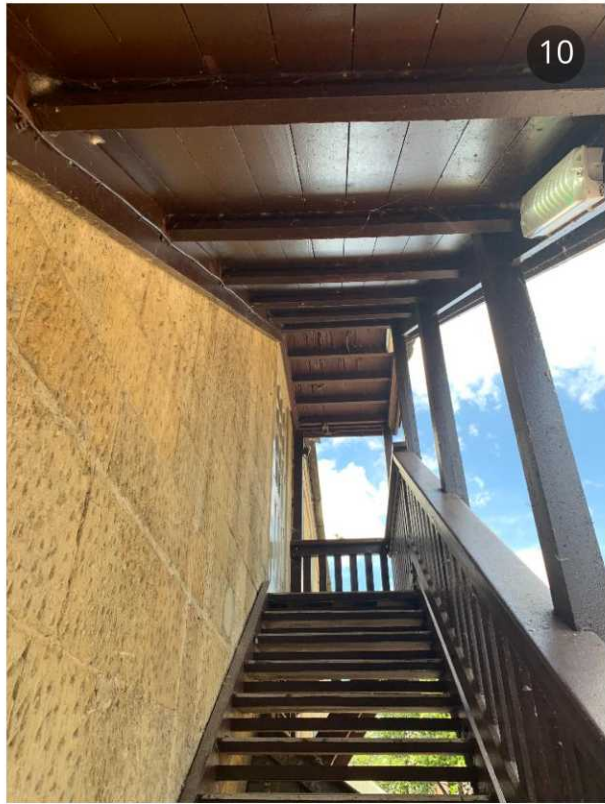
EAST TIMBER FIRE ESCAPE

The east side external timber staircase, from ground floor to first floor, also appears to have been repaired numerous times in the past. The posts show signs of rotting to both balustrade and treads, Moreover the treads appear loose and unstable. The handrail is also loose and it easy to move. In addition, there are several spindles loose and rotten.

On the eastern side of the building there is an existing external timber staircase from 1st to 2nd floor with its own timber roof. The timber stairs are supported by existing timber gallows bracket supports. The bottom half of these brackets are within the 1st floor roof structure. The existing timber roof is supported off the stone wall and the timber posts that form the timber stairs. The roofing felt appears in poor condition and some timbers showing signs of rot.

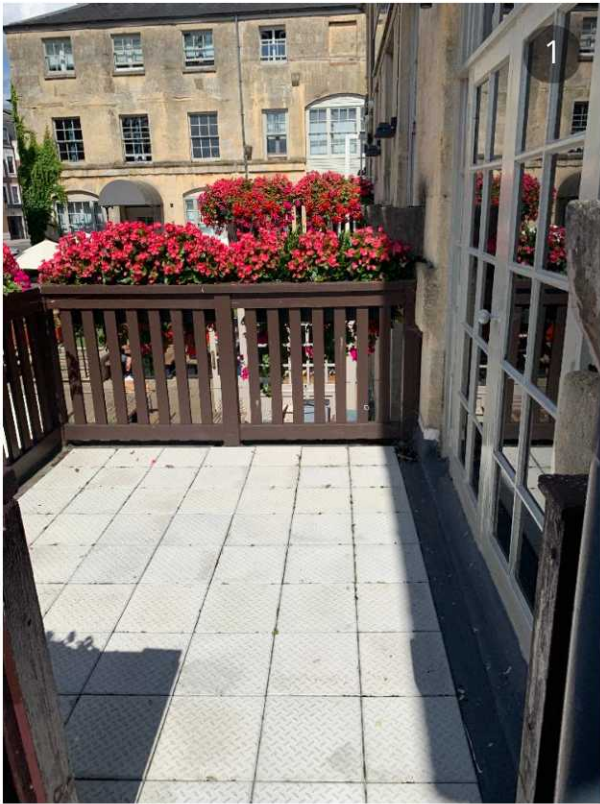
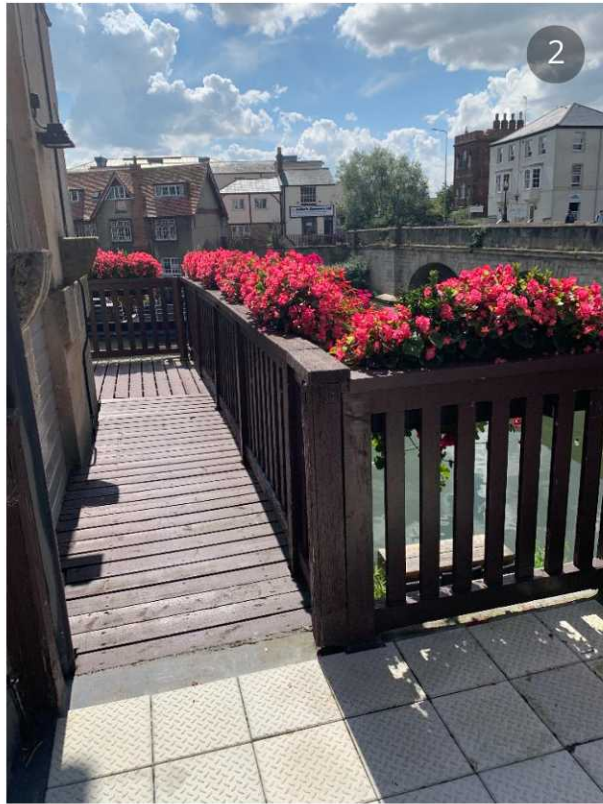
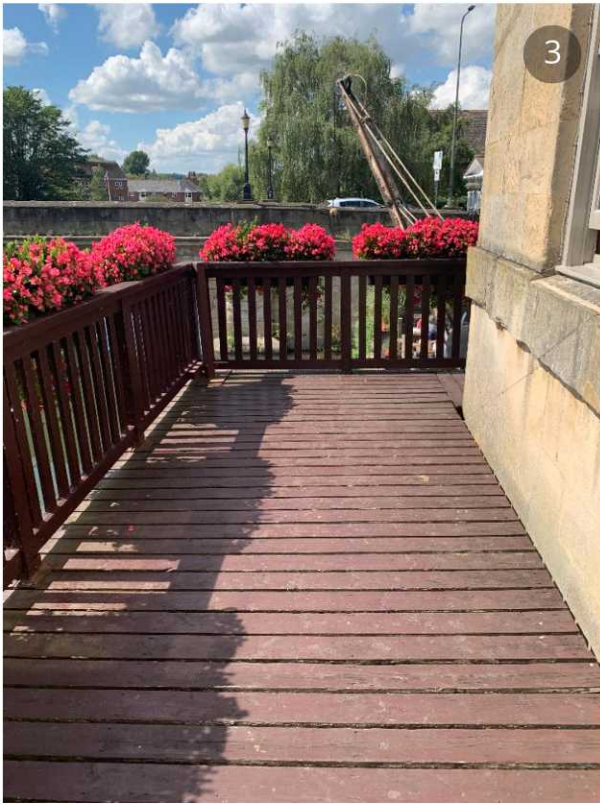
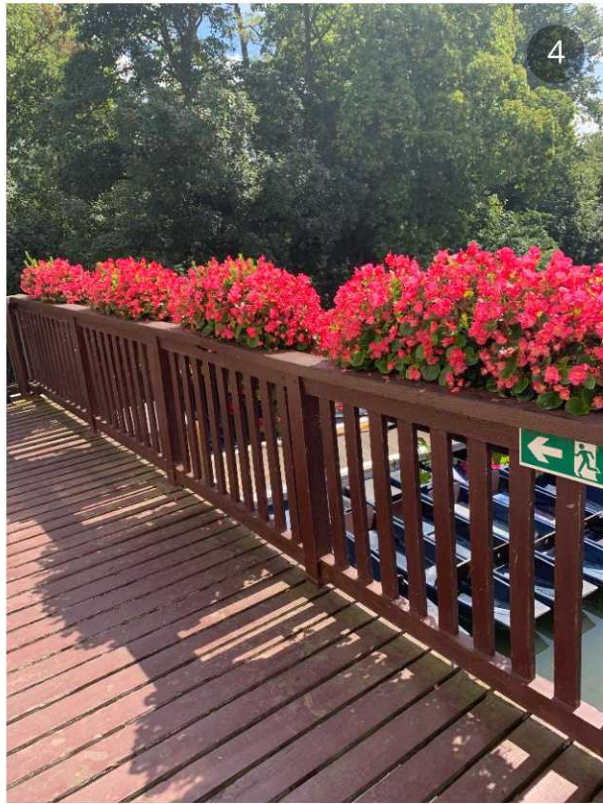
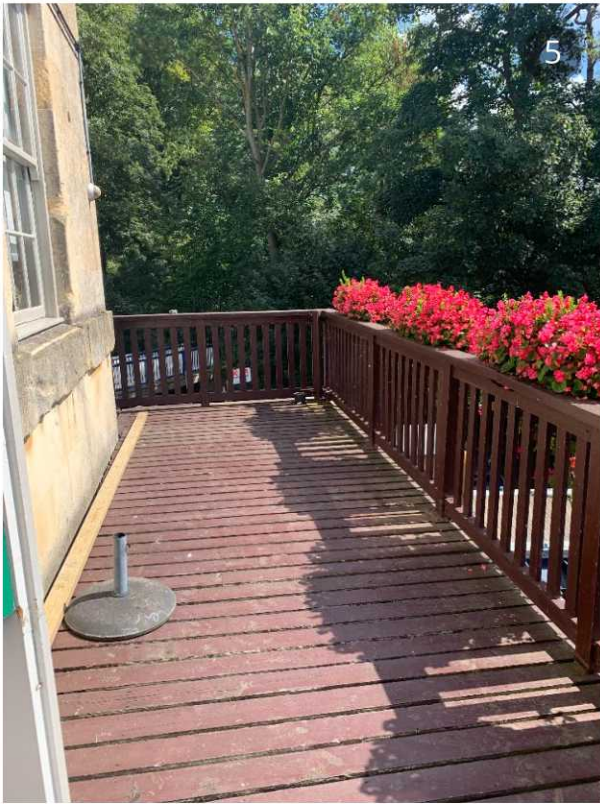
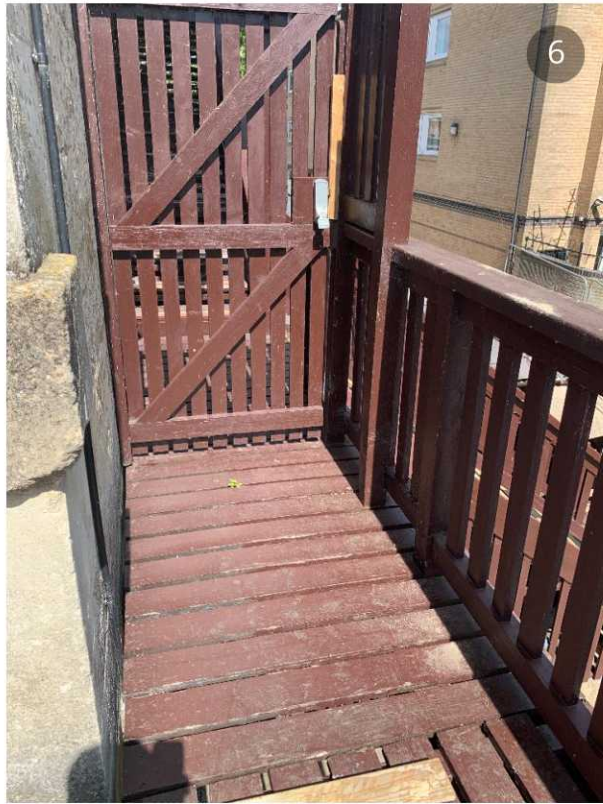
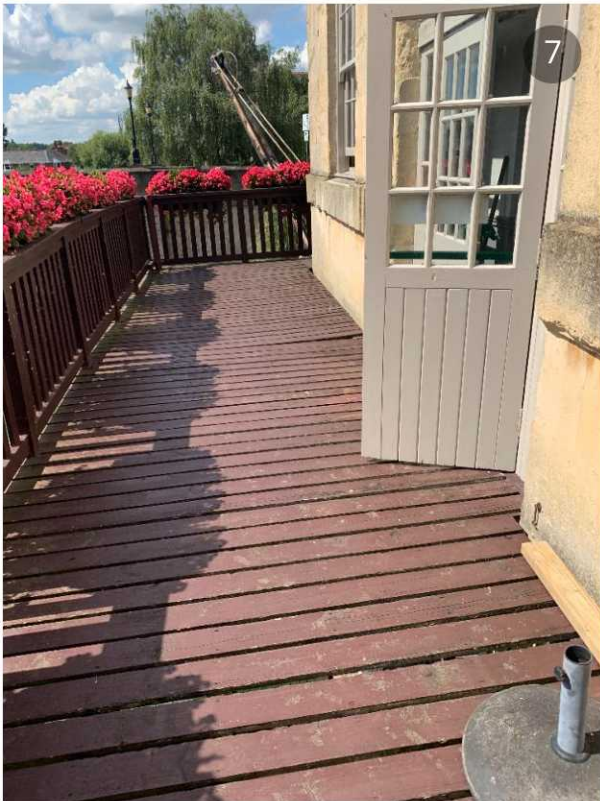
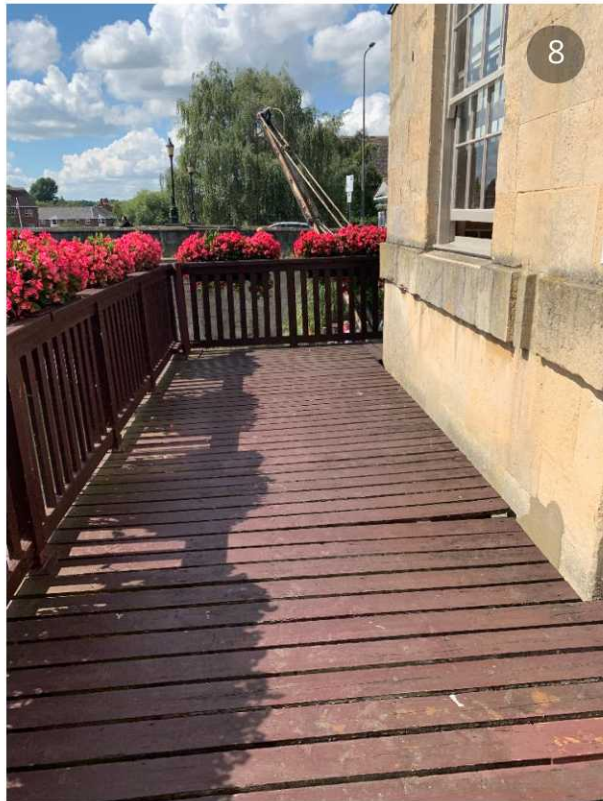
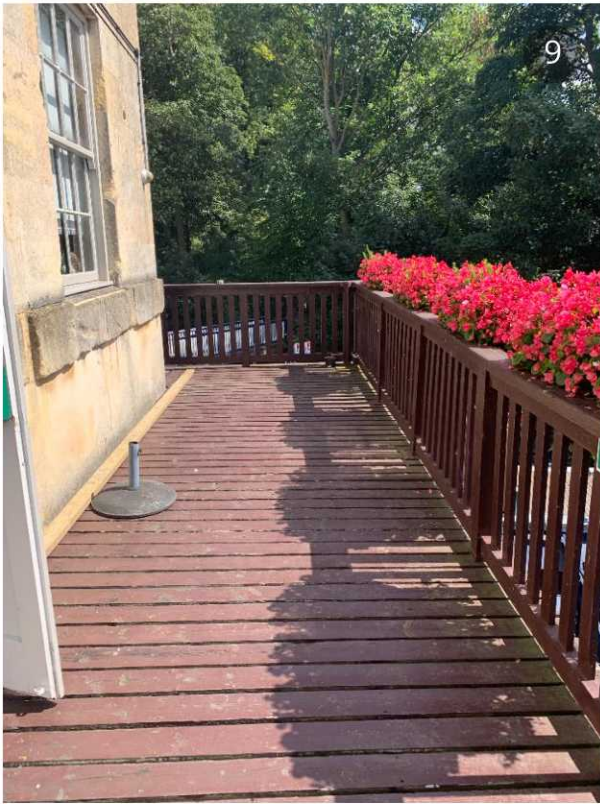
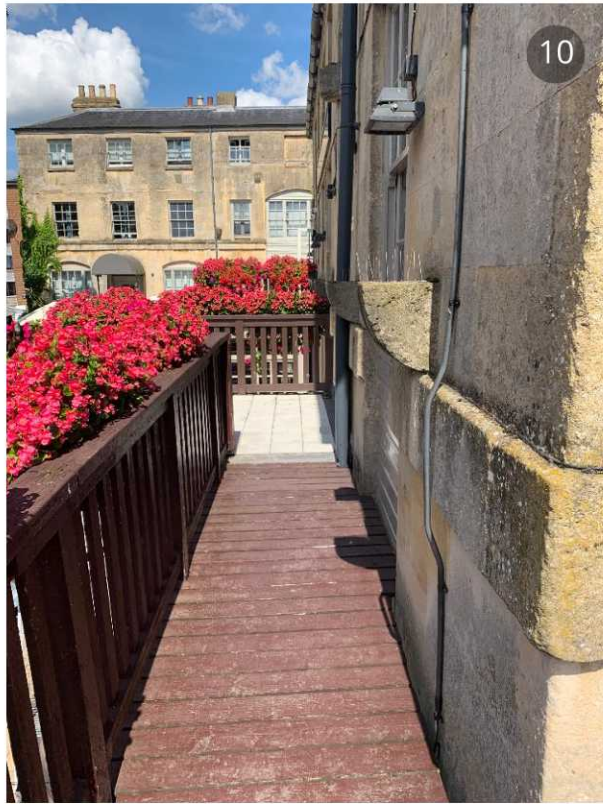
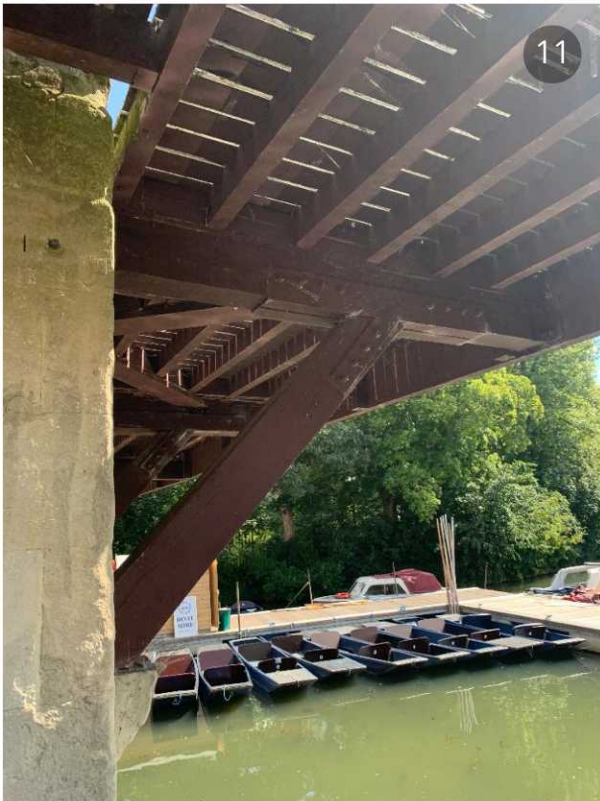
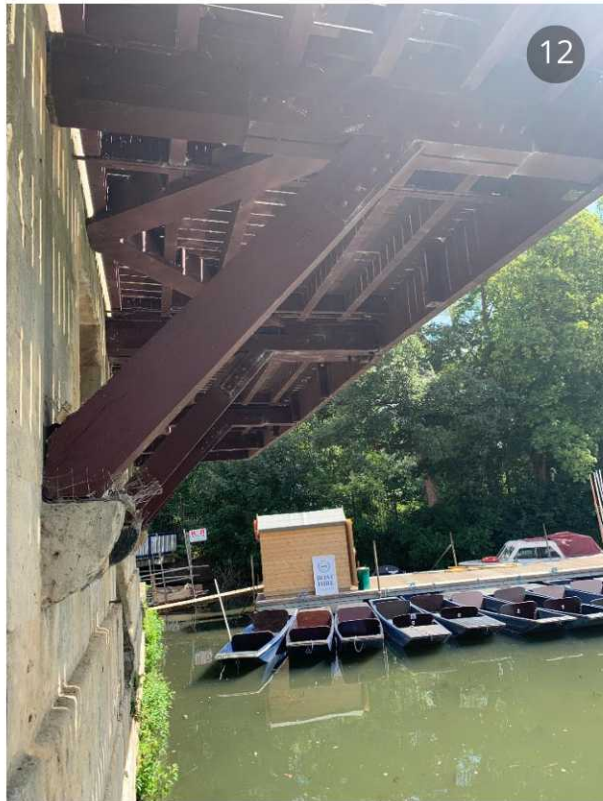
SOUTH REAR TIMBER FIRE ESCAPE BALCONY

The south rear timber fire escape balcony also has been repaired numerous times in the past. The balcony structure is noticeably deflecting downwards towards its outside edge. The existing timber primary support beams appear rotten and are pulling from the existing building face. Timber posts for the balustrade are rotten at their base which has compromised the structures strength of the balustrade.

We undertook an intrusive inspection of the ground floor ceiling and identified that the existing timber primary beams supporting the south fire escape balcony has a continuous span through to the internal wall support. One of the central timber beams appears to have been cut and removed internally and a 203 UC section steel beam installed adjacent to the original timber as a method of strengthening the existing structure. It appears the two edge primary beams for the fire escape balcony are built into the existing external walls.

For the south fire escape balcony, we recommend replacing the primary timber beams and diagonal struts with new galvanised steel sections. We feel this will provide a structure will far less maintenance issues considering the difficulty in undertaking the repairs over the river. The steel beams would be painted to match the colour finish of the timber elements. The remaining structure including, joist, plan bracing, side gallows brackets and balustrade will be replaced in hardwood timber section to match the existing and connection details like for like.
