Chartered
Building
Surveyor

INSPECTION REPORT

**“WOODSIDE”
ASHBROOKE RANGE
ASHBROOKE
SUNDERLAND
SR2 9BP**

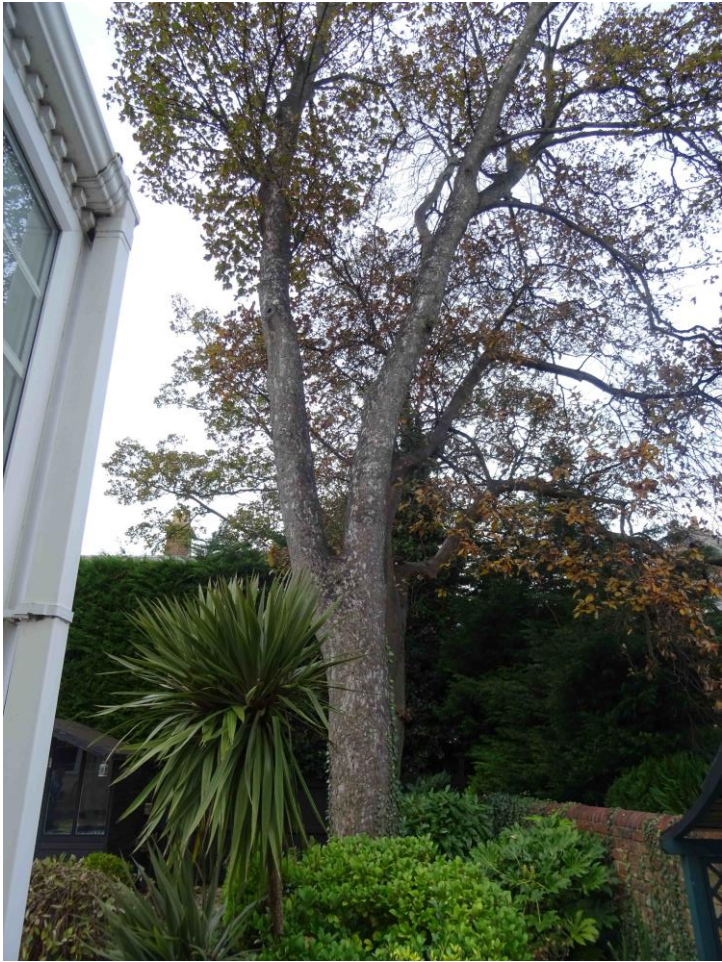
A mature deciduous Sycamore tree is present to the rear garden, located around 5.300m from the rear of the house, and which is estimated as being around 25.000m in height.

The "Zone of Influence" for a Sycamore, within which the tree rots can damage the building structure, is typically considered as being around 50% of the mature tree height, which in this instance would be around 12.000m

The subject tree is located within such a zone and whilst no associated structural defects were noted, there remains significant potential for such occurrences in the future, and with root growth noted immediately adjacent to the external walls supporting such conclusions.

1. Sycamore tree

I would therefore recommend that the subject Sycamore tree be felled/removed by an appropriately experienced specialist contractor.

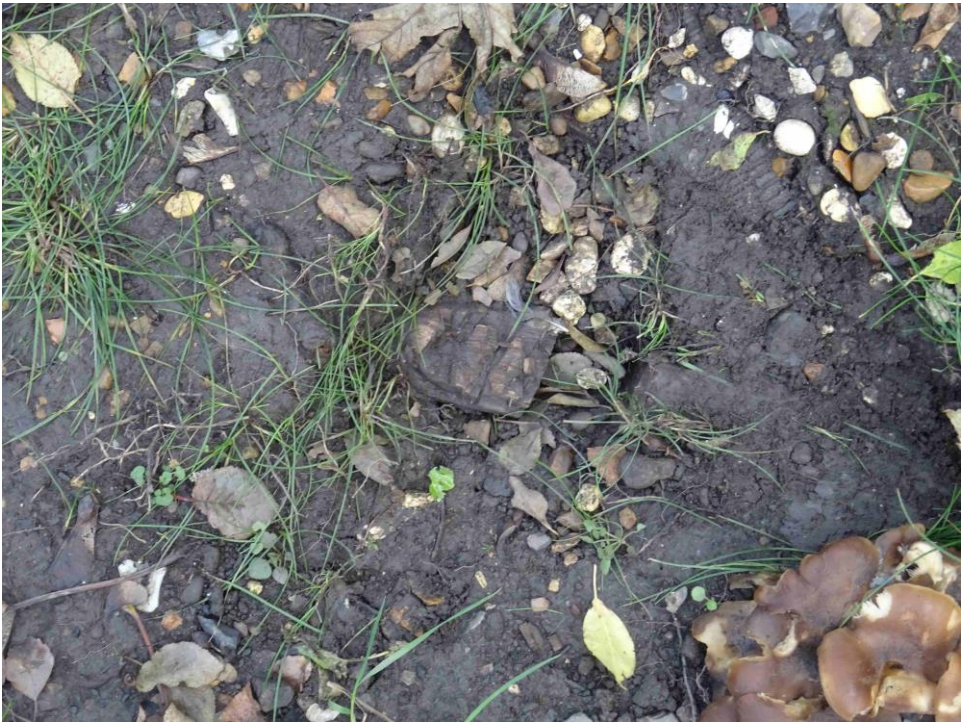
Lateral tree roots were noted at ground level in close proximity to the external walls of the house.

2. Lateral root growth

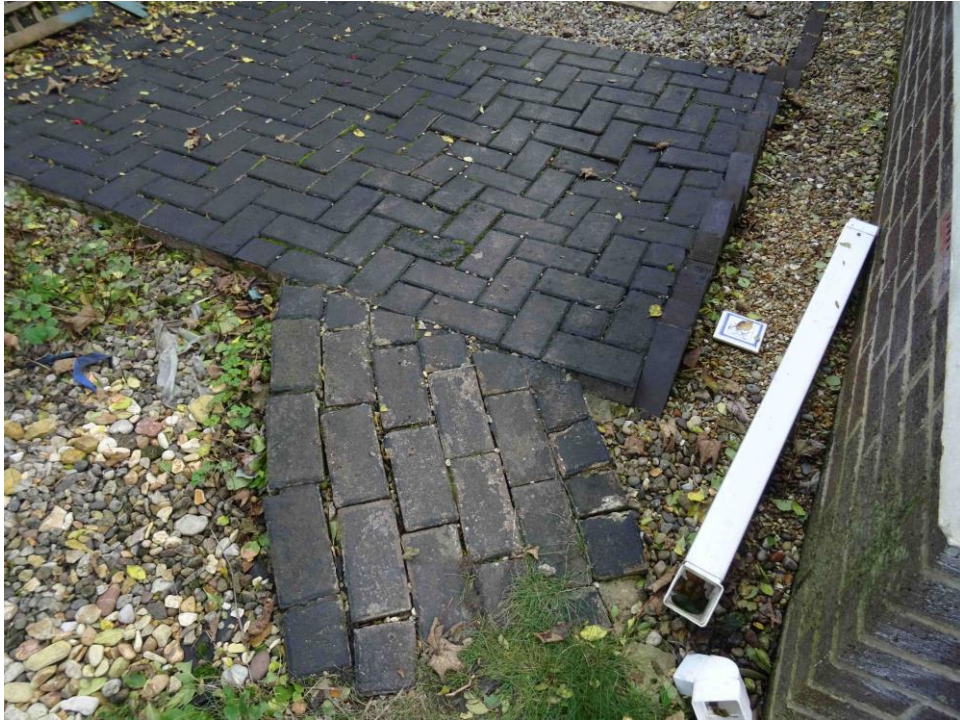
Displacement to nearby block paving is reasonably assumed as related to the actions of roots.

3. Displaced block paving
