Asterleigh Farm
Kiddington Estate, Oxon

Report on the Condition of
The Plot 2

May 2023

Project Number: 03271

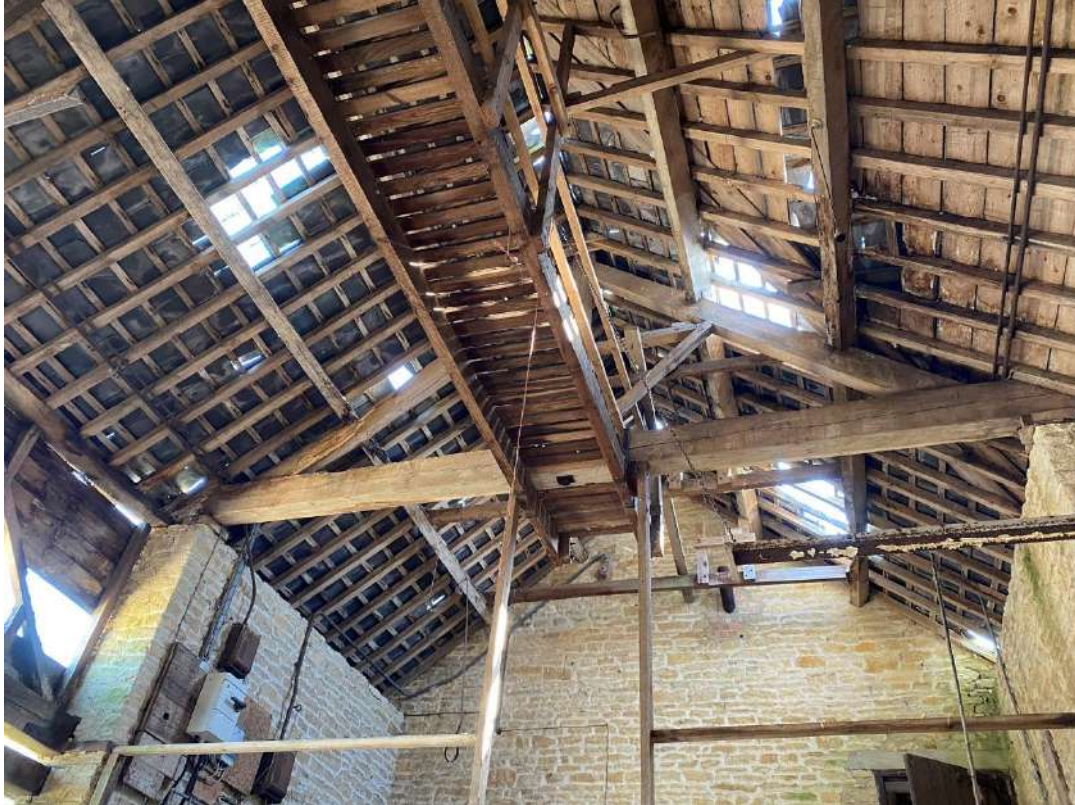
The trusses span between the front and rear walls. Part of the rear barn has timber sarking boards beneath the slate finishes but the sarking boards are absent at the front of the barn and on either side of the lay boards forming the valley with the southern portion of the barn. (Please see Figure 1).

There are significant openings in the roof coverings of the northern portion of the barn. (Please see Figure 1). The resulting increase in moisture content of the timber has encouraged fungal growth and decay of the purlins at the junction of the purlin and roof trusses. (Please see Figure 6).

Figure 1 - Existing Roof Structure to Northern Half of Barn

The roof coverings, and associated rainwater goods, should be renovated to prevent any moisture ingress into the barns. Whilst the roof coverings are being renewed. Any broken or decayed rafters should be replaced with a timber member of a similar species and cross-section.

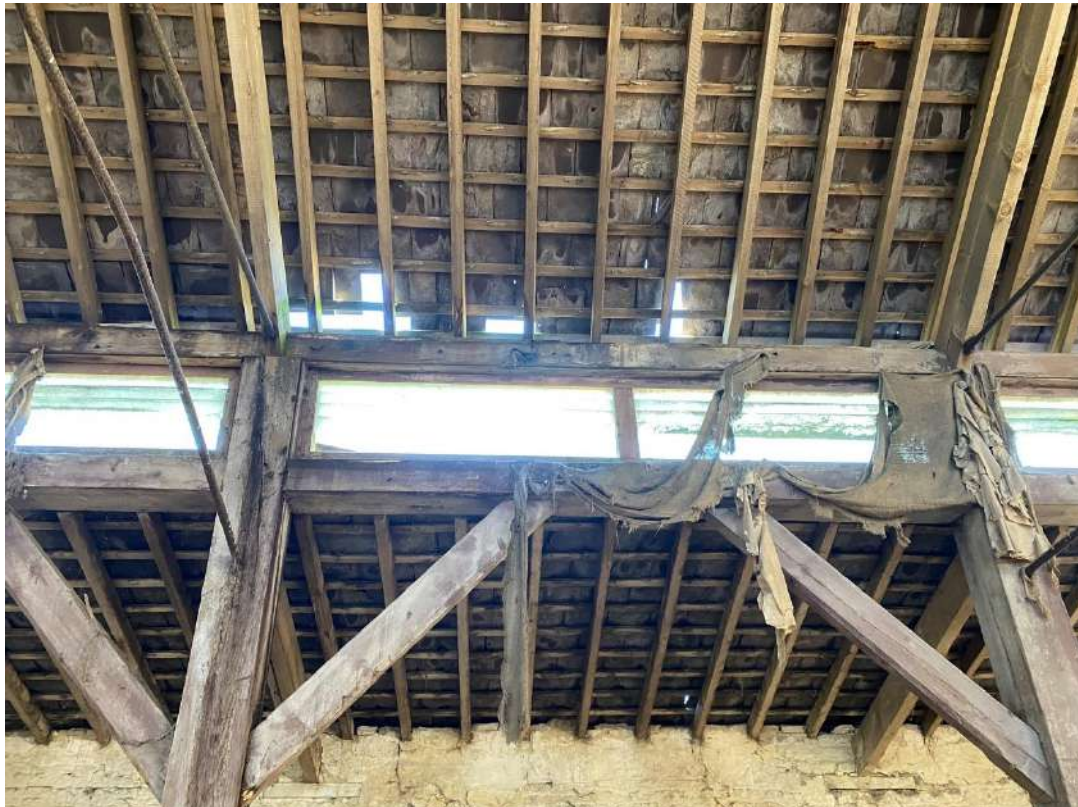
The main roof rafters rest on purlins which are supported by timber trusses that are restrained to the supporting timber columns by steel tie bars. (Please see Figure 2).

Figure 2 - Existing Roof Structure of Southern Half of Barn

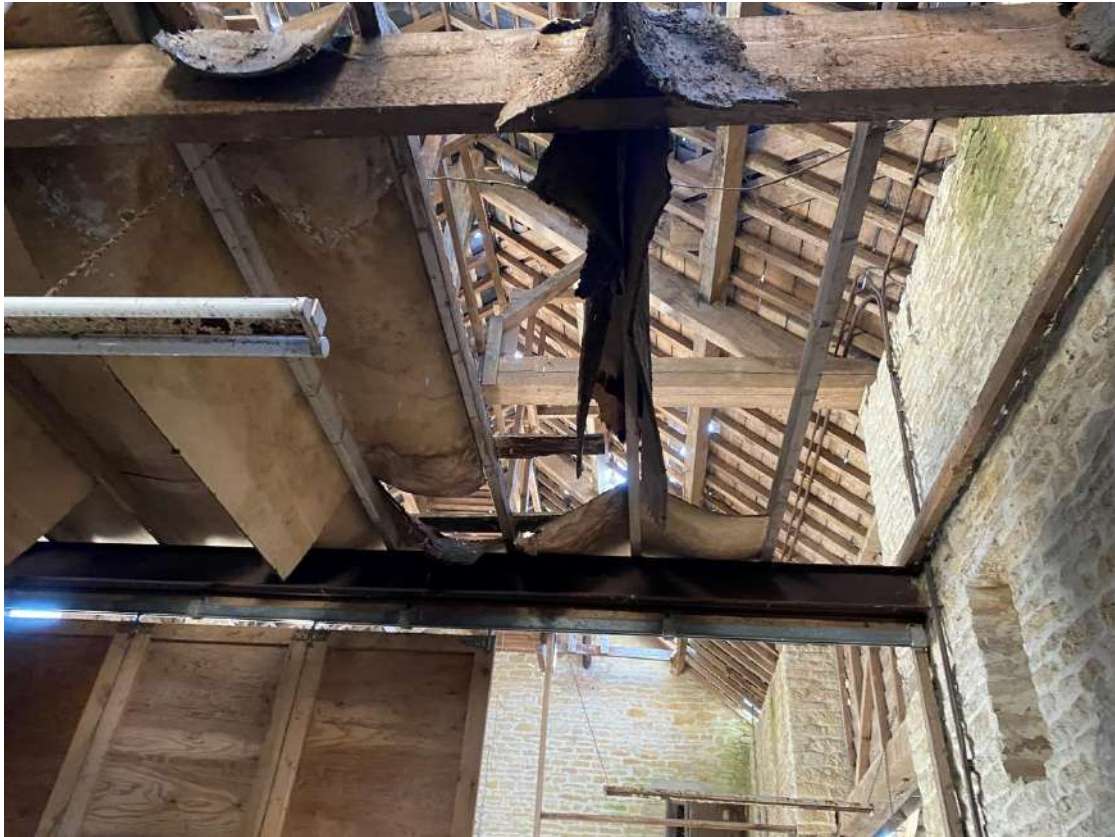
There are the remains of a mezzanine floor to the northern half of the boundary. The floor joists span from left to right and are supported by a combination of steel and timber floor beams. (Please see Figure 3)

Figure 3 - Remains of Mezzanine Floors

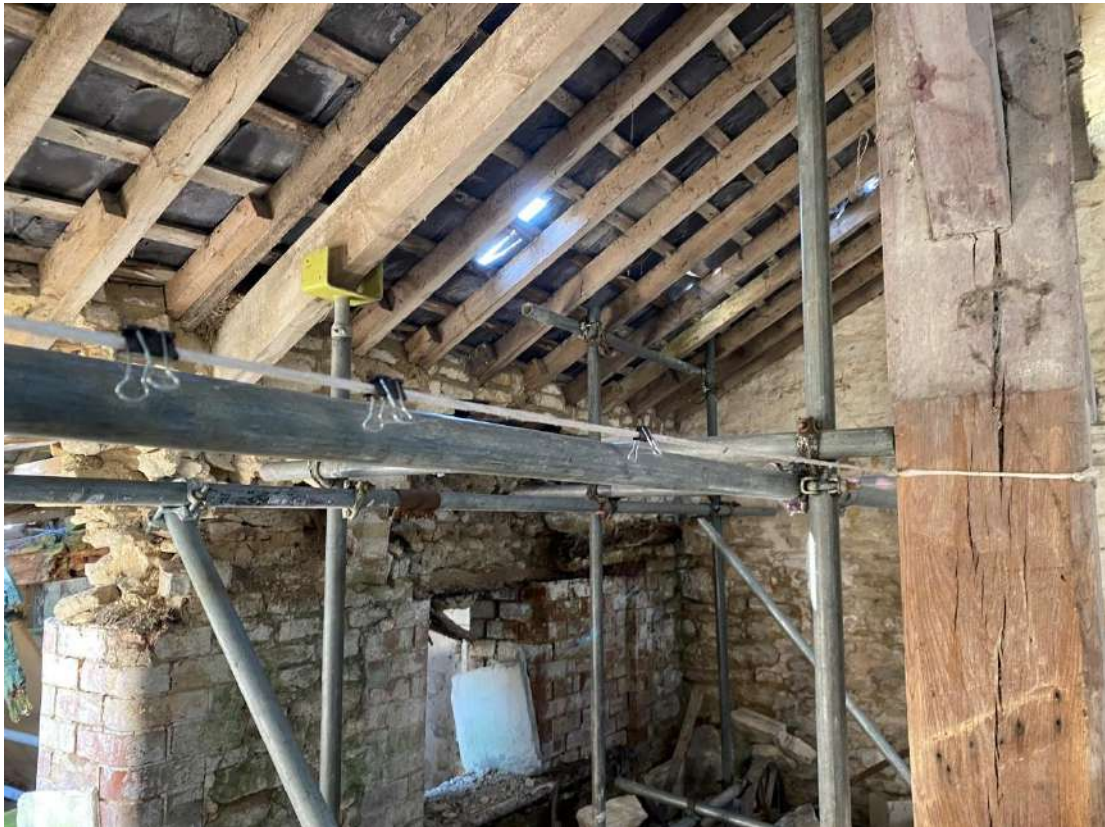
1. The left-hand wall of the southern portion of the barn has been rebuilt in brickwork. (Please see Figure 4)
2. The extension to the left of the northern barn has been built in the brickwork above the timber beam at the first-floor level. (Please see Figure 5)

Figure 4 - Rebuilt Wall at Left Hand Side of covered yard

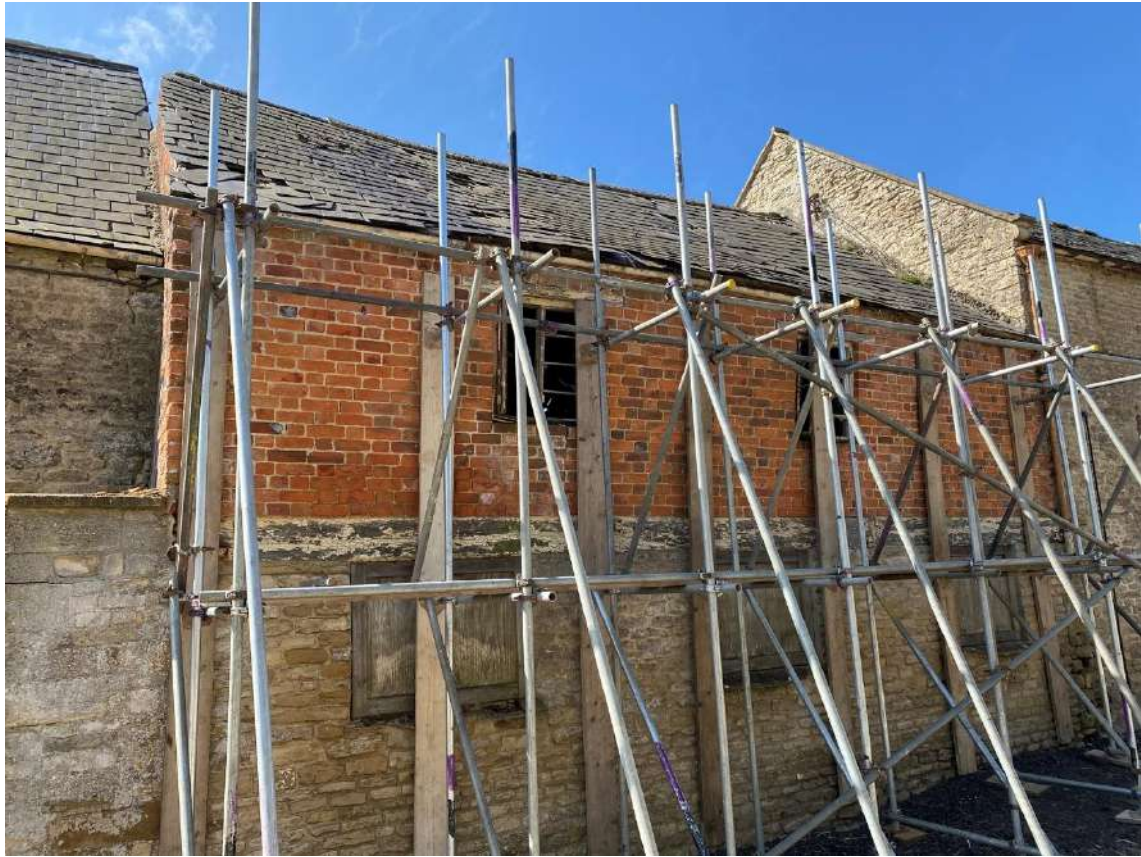
Figure 5 - Vertical Extension of Covered Yard

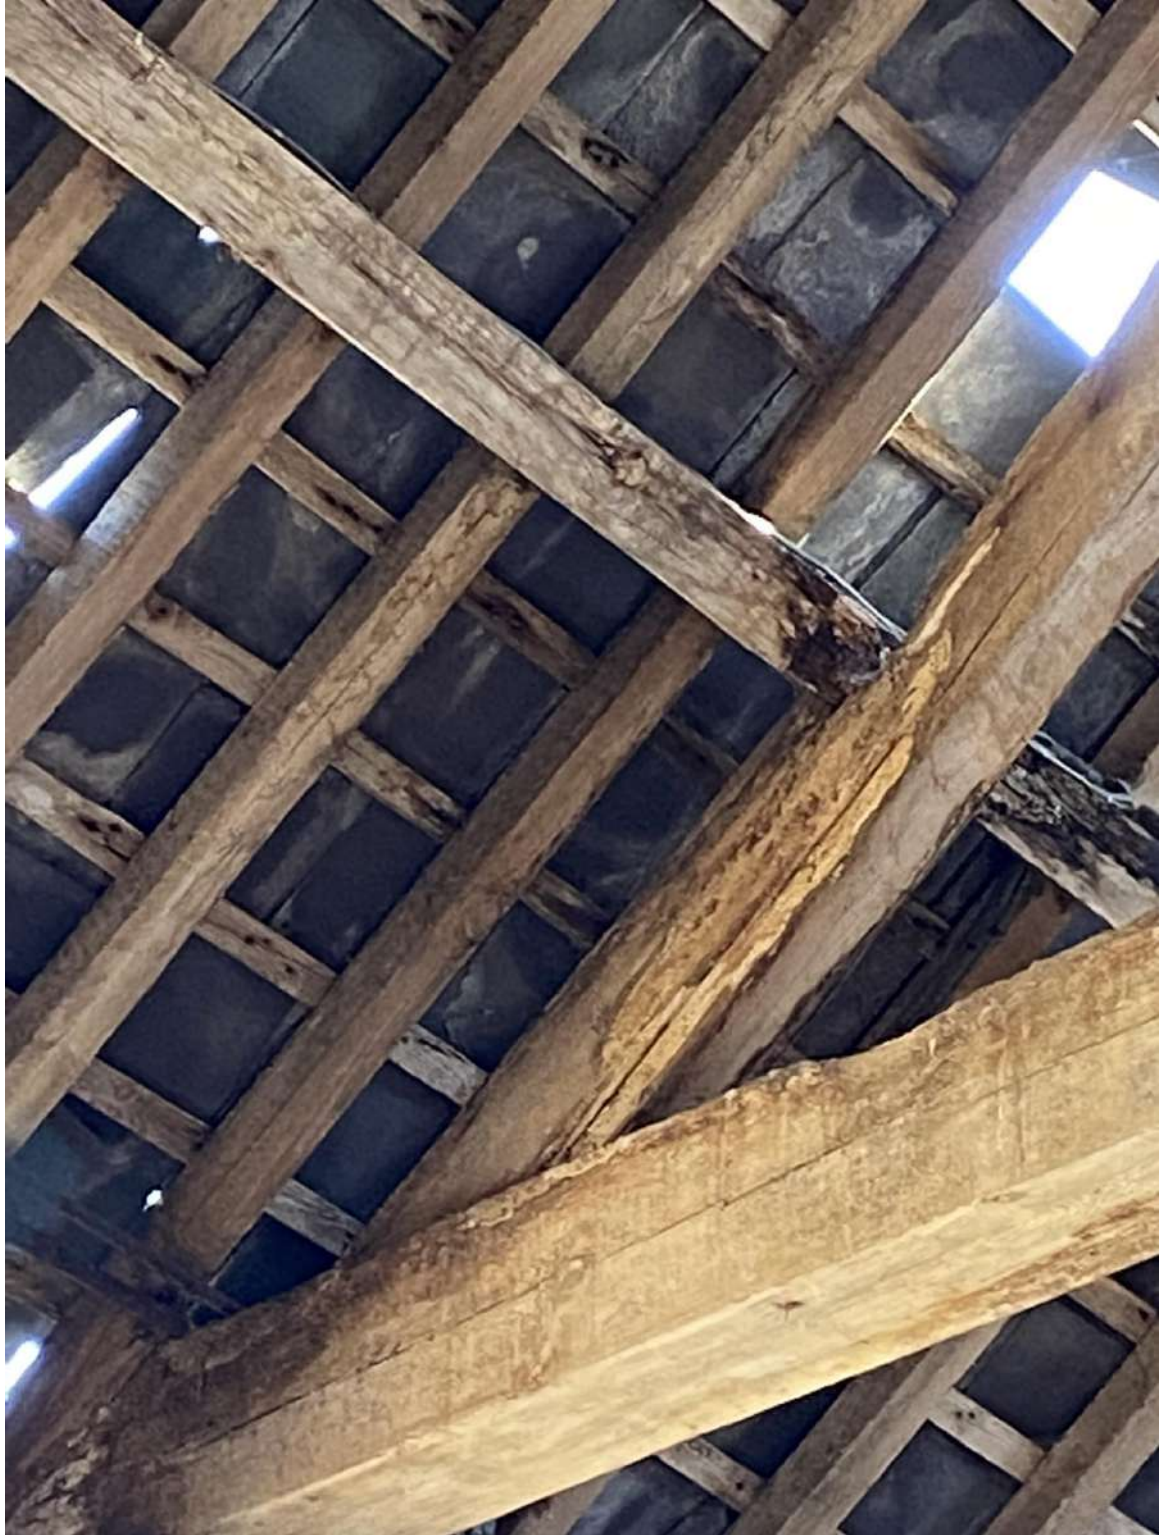
Figure 6 - Fungal Attack and Decay of the Supporting Timber

Once the remaining timbers have had the opportunity to dry out, e.g. after three to six months, a suitable specialist, e.g. Timberwise, should be appointed to survey the existing timbers to:

1. Prepare a specification for the treatment of the timber to prevent fungal decay of the timber
2. Prepare specifications for the treatment of the timber to prevent insect attack
3. To prepare a schedule of timber repairs, in conjunction with the engineer, to allow any damaged sections of the trusses and supporting timber frames to be replaced.

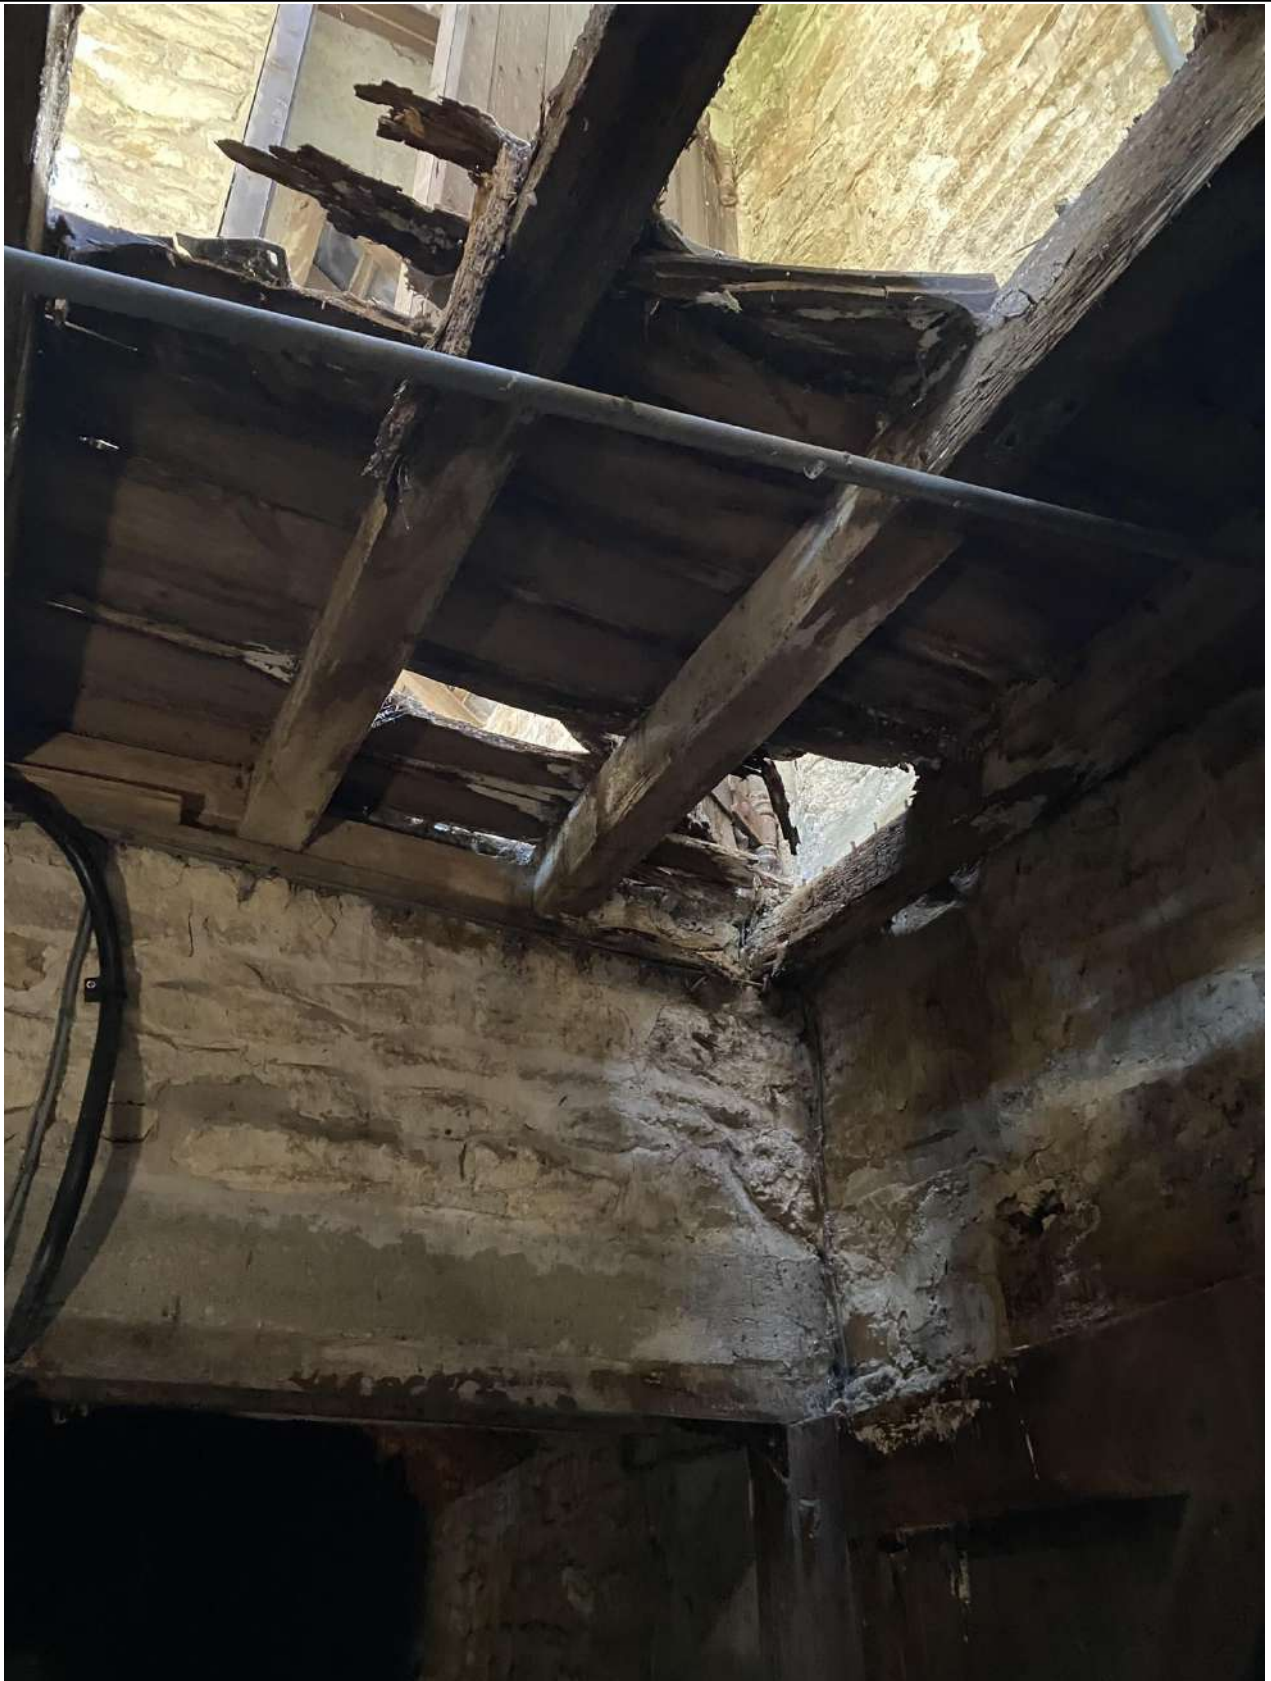
The timber mezzanine floors within the northern portion of the barn also show signs of significant decay owing to moisture penetration into the building. (Please see Figure 7)

Figure 7 - Decay of the Timber Mezzanine Floor

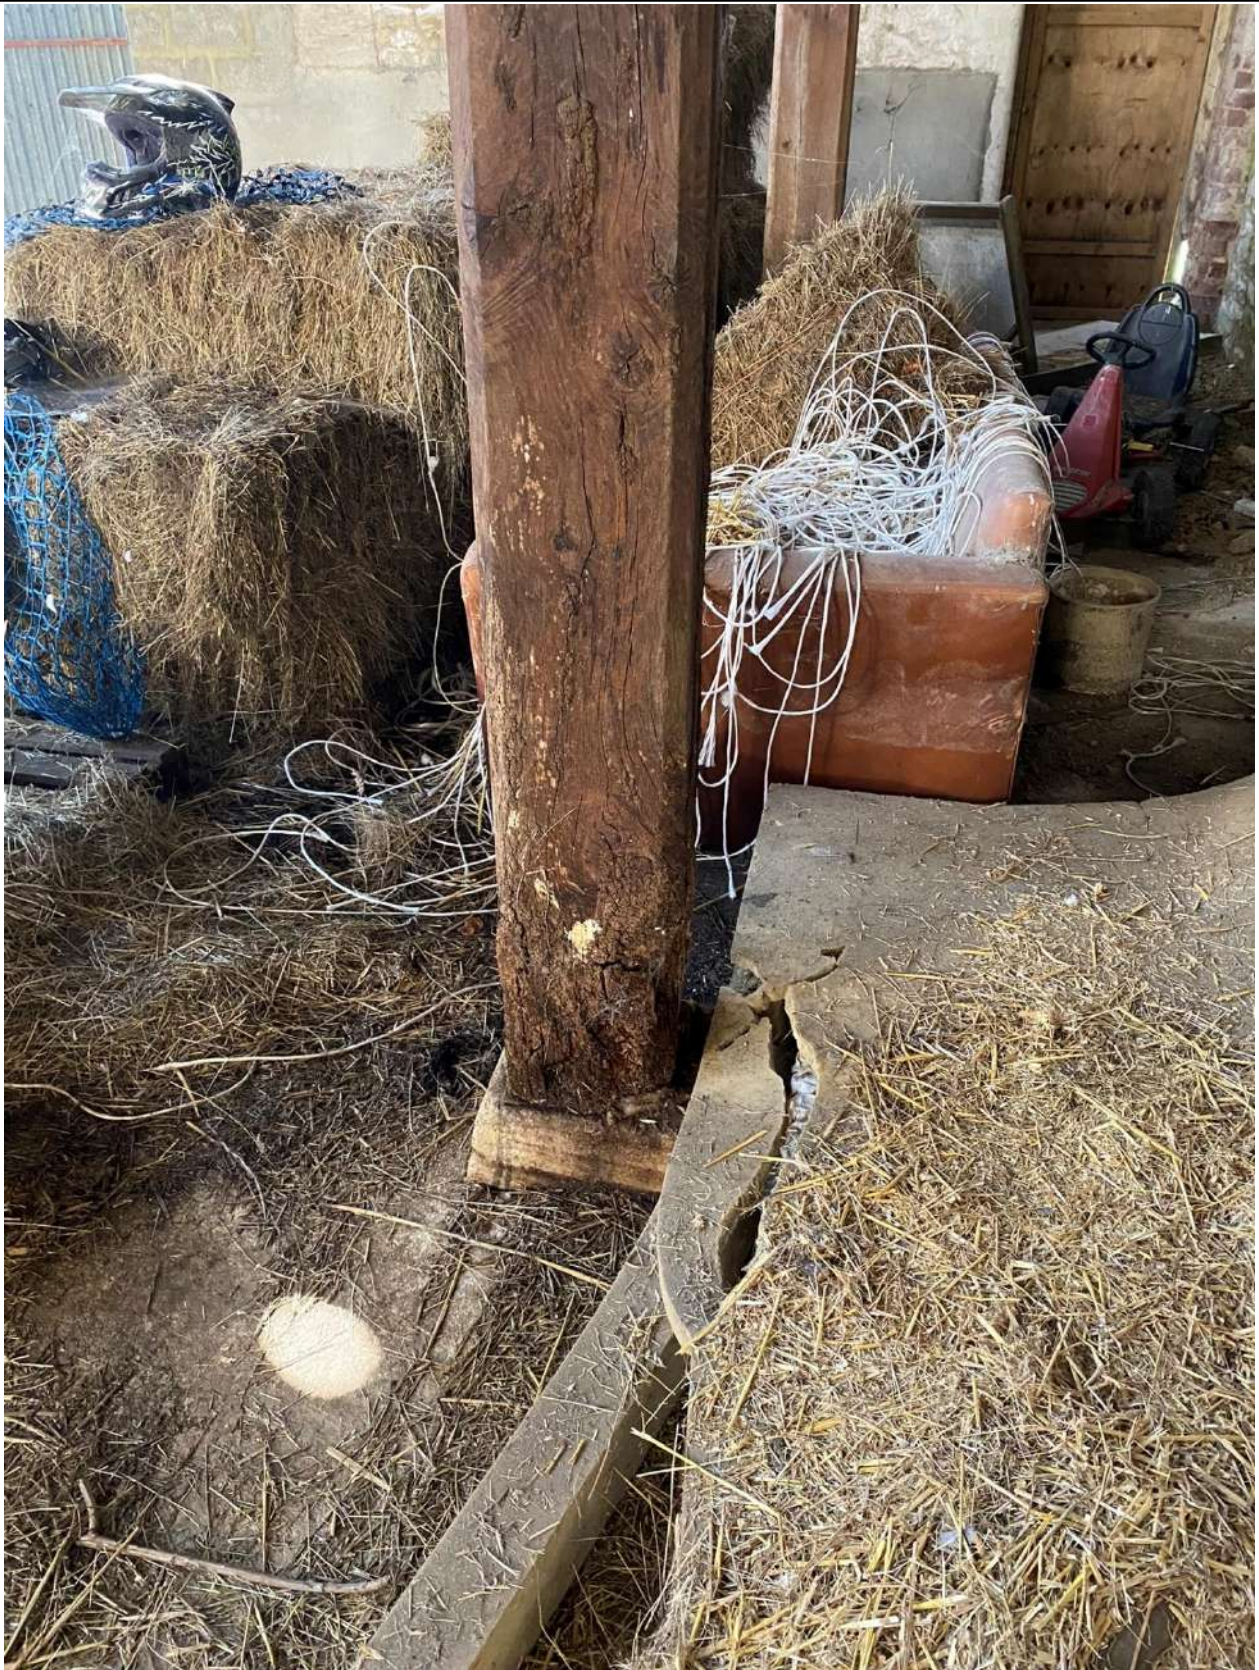
Whilst stone plinths have been provided at the base of the columns, the timber columns on the right-hand side of the barn are showing significant signs of decay at the base of the columns.

The most likely explanation is that the sloping of the floor slab internally to provide a consistent fall across the barn has raised the floor level above the base of the columns.

There is evidence of attempts at repairs in the past with timber sections that do not match the size of the existing columns. (Please see Figures 8 and 9)

Figure 8 - Decay of Column at Base

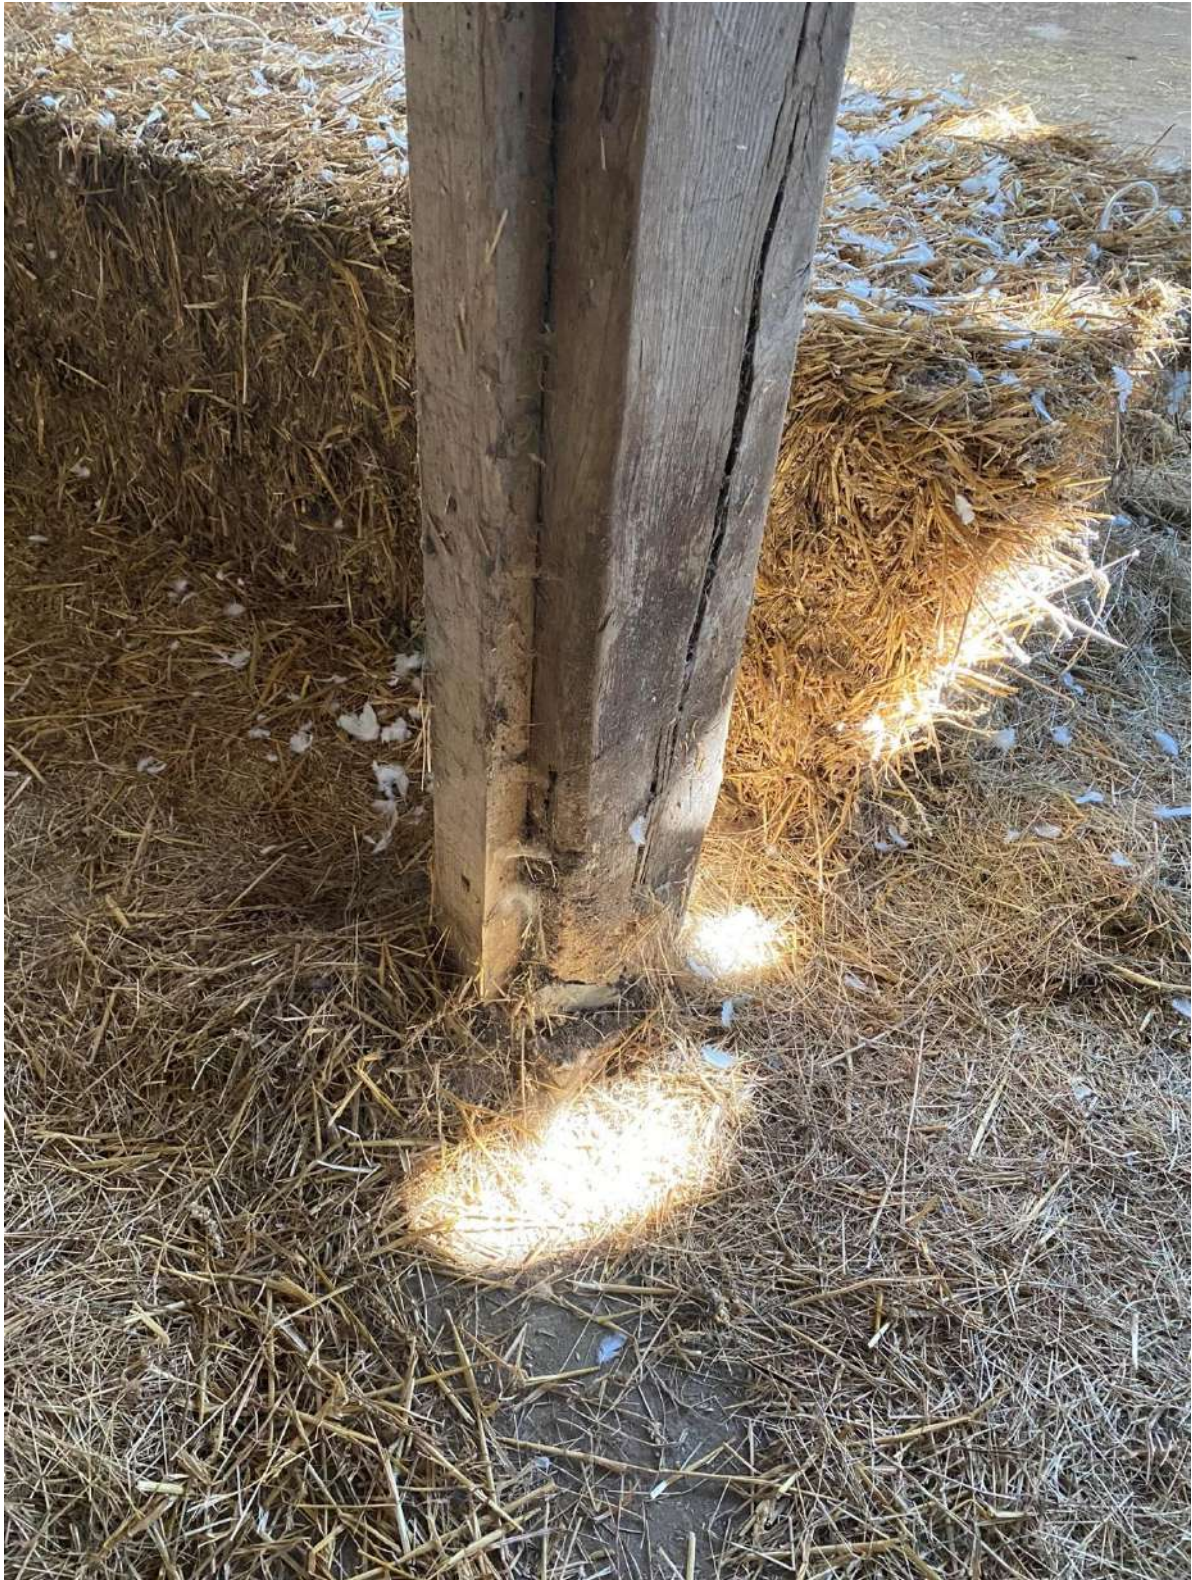
Figure 9 - Previous Repair of Column

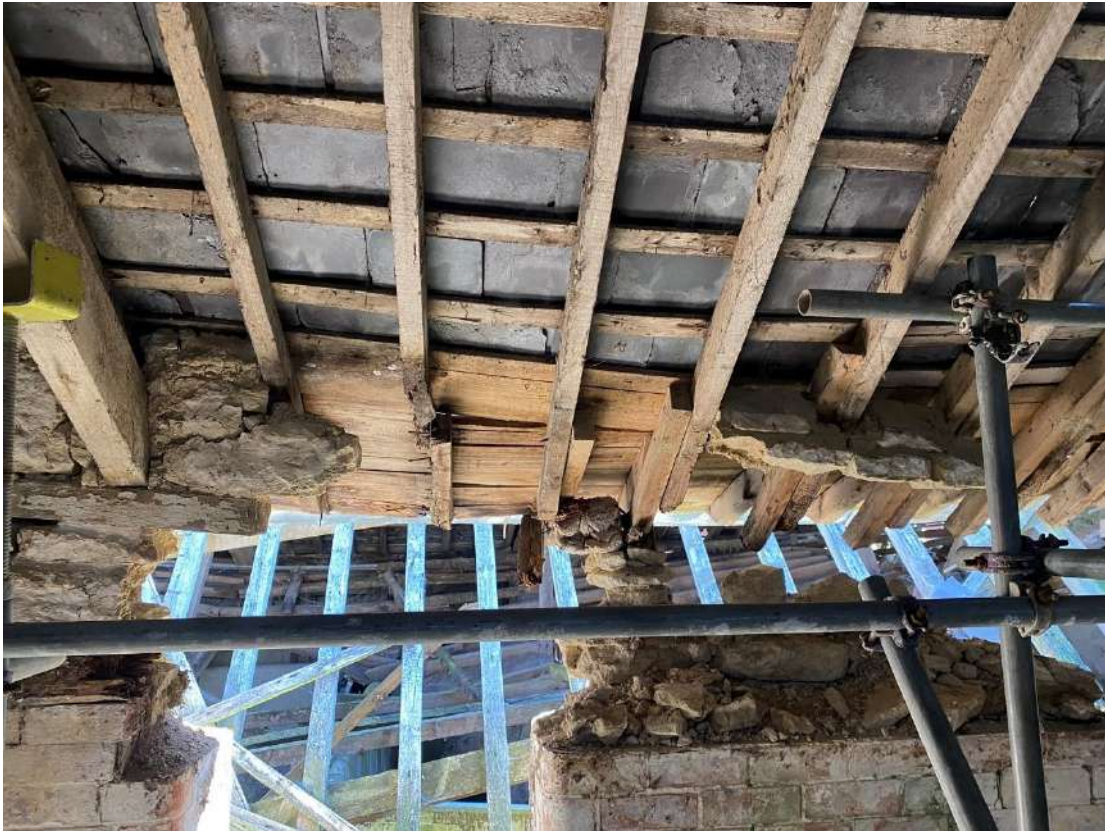
The left-hand wall of the southern portion of the barn supports a valley which is formed by the lower roof of the covered yard and the roof of the western block of The Stonemasons Courtyard which will become part of Plot 3.

There appears to have been water ingressing through the barn for some considerable time which has led to the partial collapse of the wall resulting in a consequential loss of support of the roof to the Stonemasons Courtyard and the roof of the covered yard. A scaffold frame has been erected to support the lower roof of the covered yard. (Please see Figures 10 and 11)

Figure 10 - Loss of Masonry At Valley Between Stonemasons Courtyard and the Covered Yard

Once the Masons Courtyard roof has been removed and the rubble removed from around the southeastern wall, a suitably qualified stone mason should be appointed to rebuild the southeastern wall to act as a support for the restored roof.

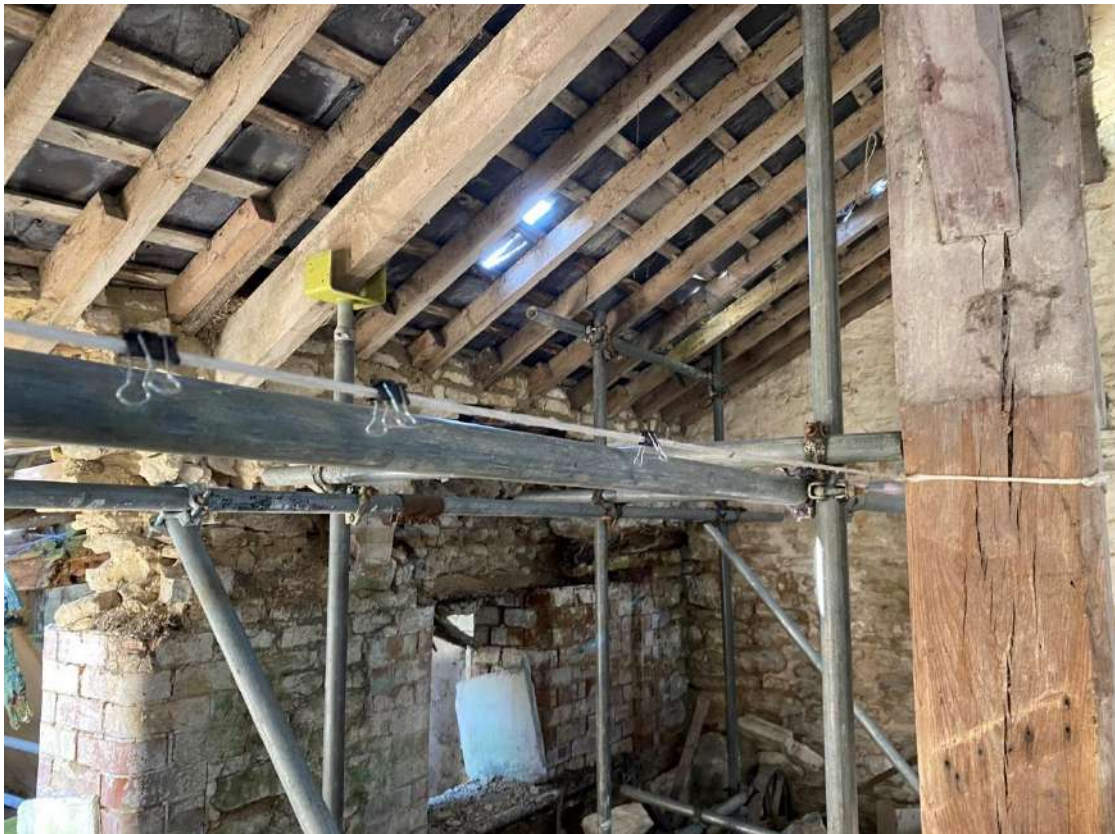
Figure 11 - Scaffold Support to Covered Yard Roof

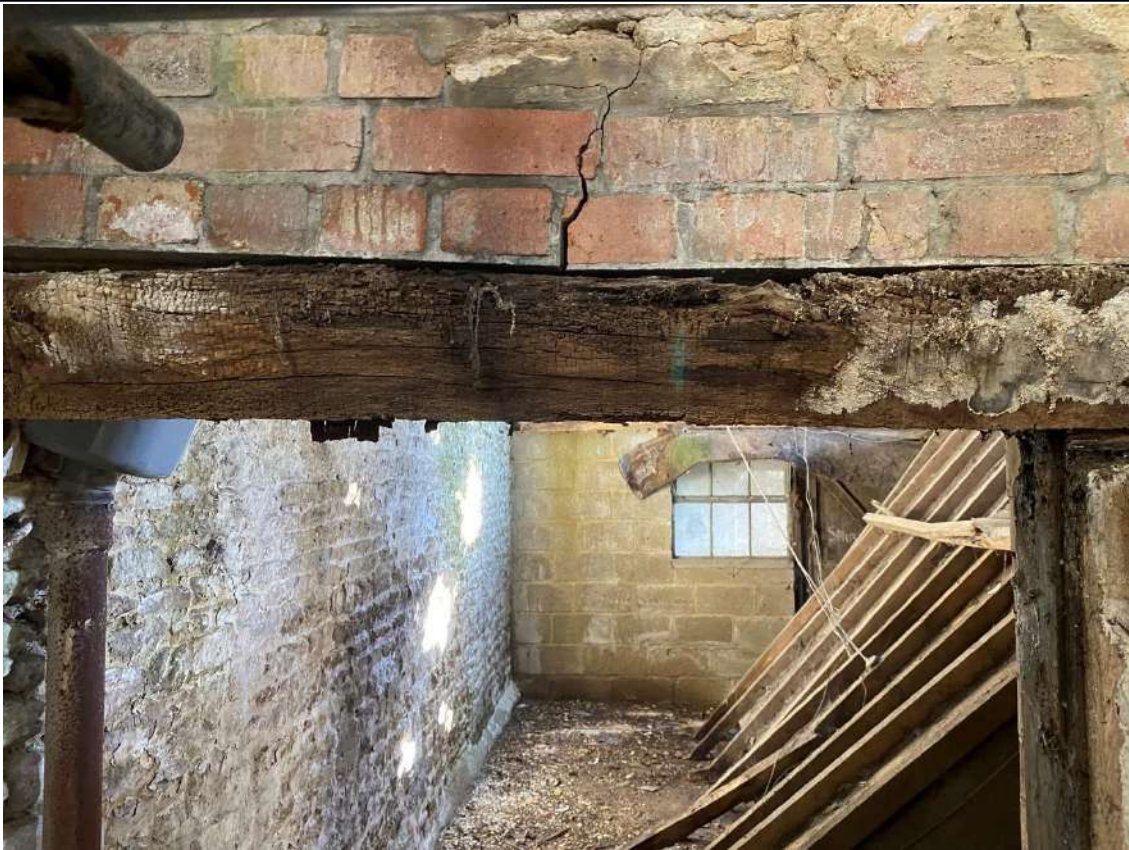
In addition to the collapsed masonry, the remaining timber lintels supporting the walls above the lintels are showing signs of fungal decay and distress in the form of excessive deflection leading to cracking of the masonry above. (Please see Figure 12).

Figure 12 - Lintel Failure in Left Hand Wall

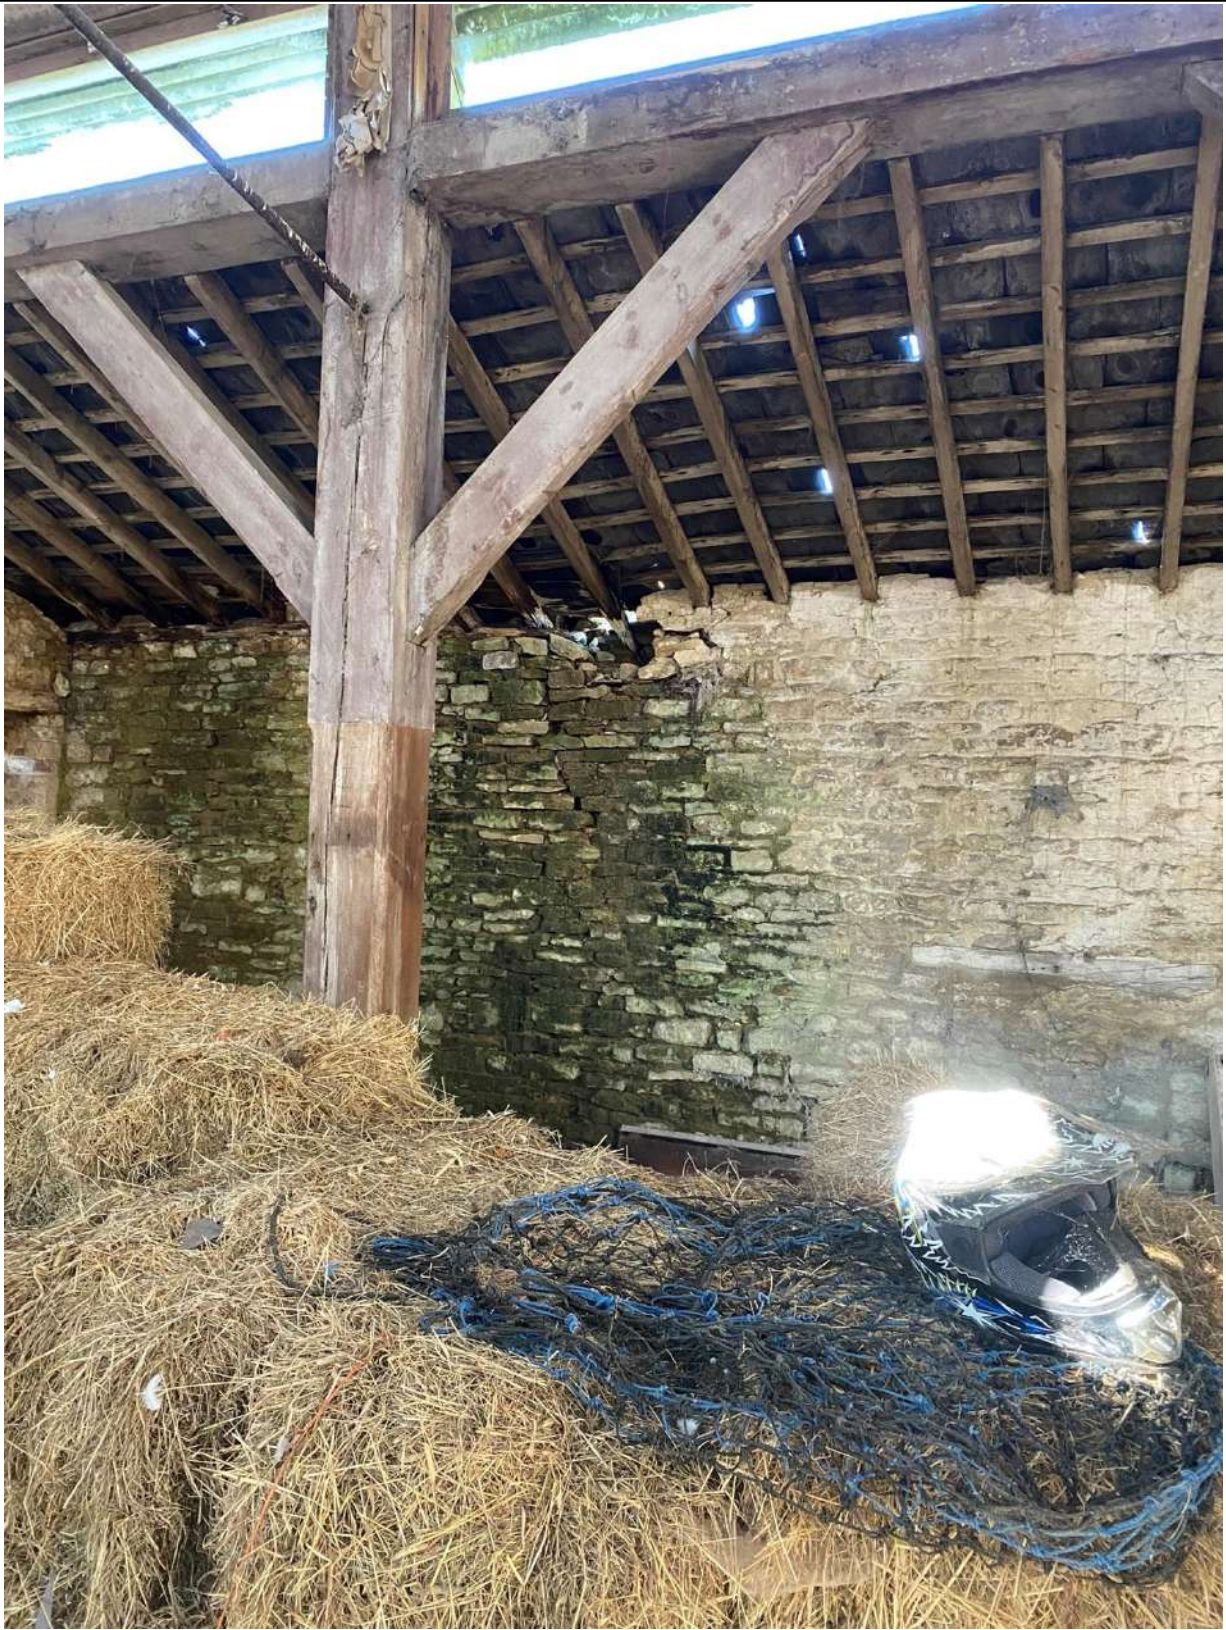
At the southwestern corner of the barn, the masonry wall has been damaged by significant water penetration through the roof which has washed away the mortar and may well have washed out the hearting between the stone leaves.

The continued moisture penetration has also caused the bearings of the rafters and the timber sole plate to decay at this location as well. (Please see Figure 13).

Figure 13 - Damage to Southwestern Corner of the Covered Yard

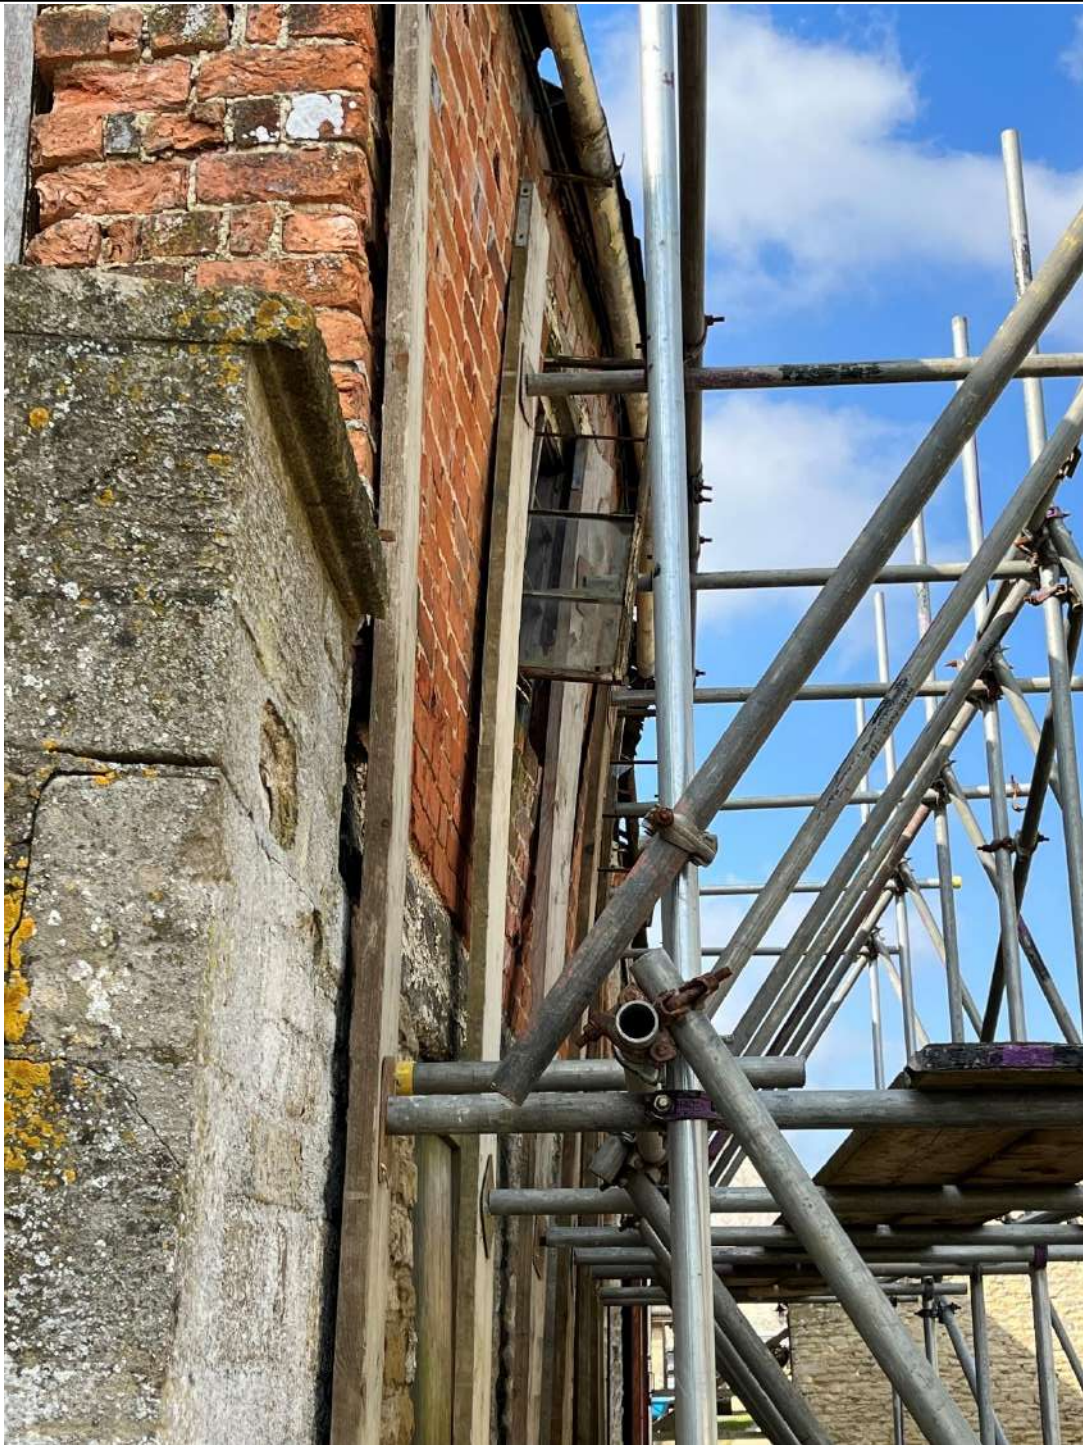
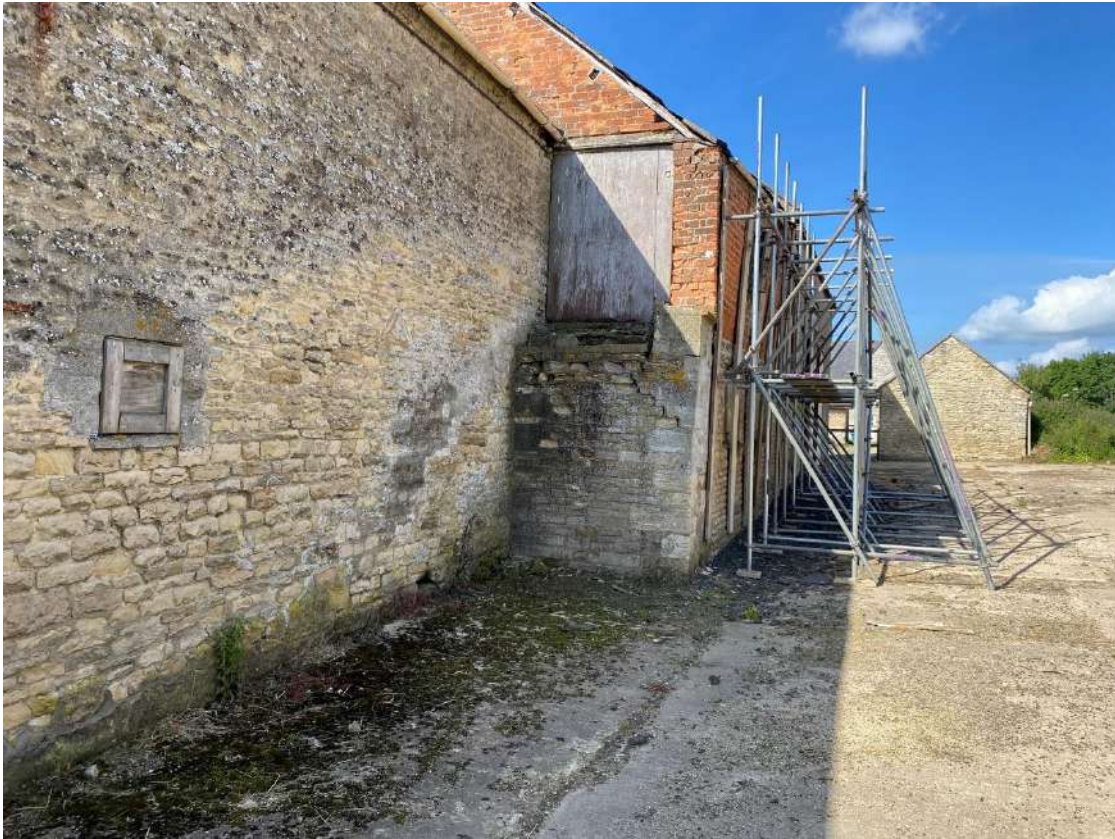
The first floor walls of the eastern extension to the main barn have failed and are currently being propped by a scaffold frame. Whilst we could not gain access to the first floor of the barn to assess the roof structure, it is felt that the most likely cause is the failure of the roof structure and consequential application of horizontal load to the head of the wall. (Please see Figure 14 and 15 in Appendix A).

We believe that the roof to the extension has failed leading to excessive lateral movement of the rafters at wall plate level and the consequent damage to the masonry wall.

Figure 14 - Outward Movement of North Wall

Figure 15 - Outward Movement of First Floor Wall and Installation of Scaffold Shoring

We recommend that the existing roof is removed as soon as possible to allow safe access to the first floor of the barn to allow the walls and floor to be surveyed and a suitable maintenance plan for the floors and wall to be put in place.

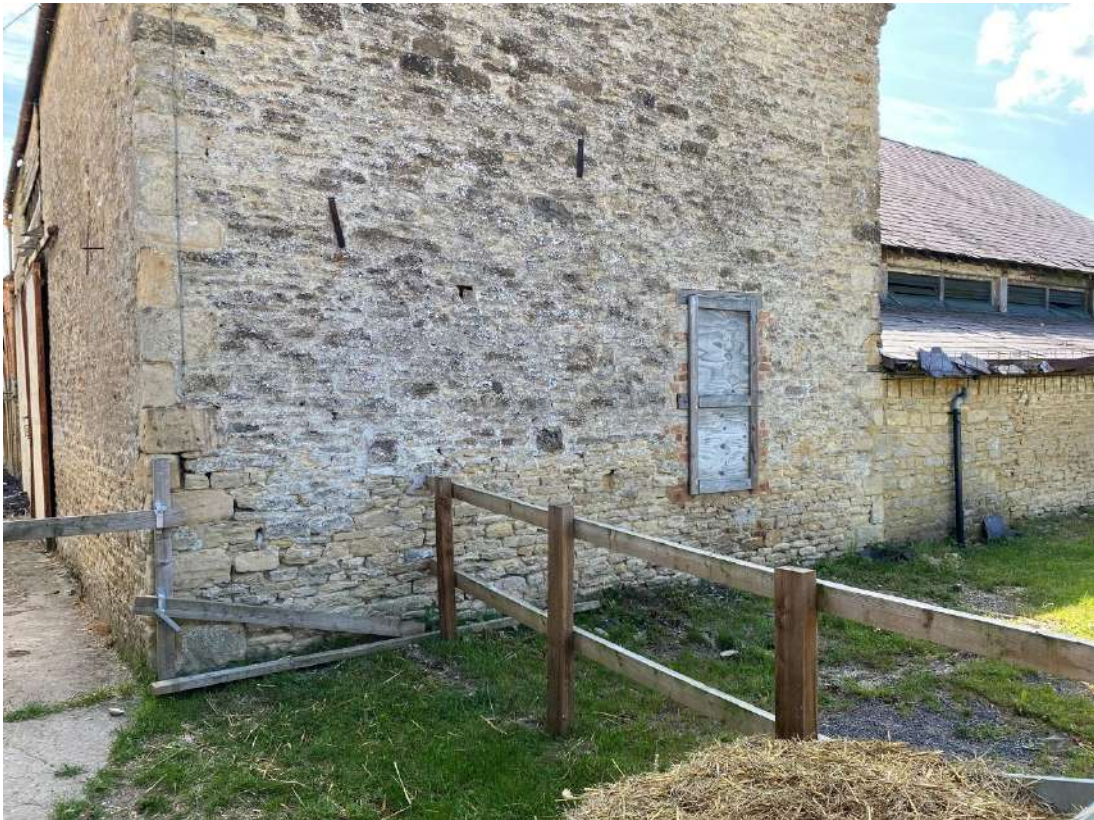
There are various places around the perimeter of the building where the mortar at or just above ground level is absent. (Please see Figure 16).

Figure 16 - Loss of Pointing Along Western Gable

Where the masonry has been damaged by water ingress or where frost action has eroded the mortar at or just above ground level, the walls should be repointed with a suitable lime mortar
