Juxon Ltd

Asterleigh Farm
Kiddington Estate, Oxon

Report on the Condition of
The Plot 3

June 2022

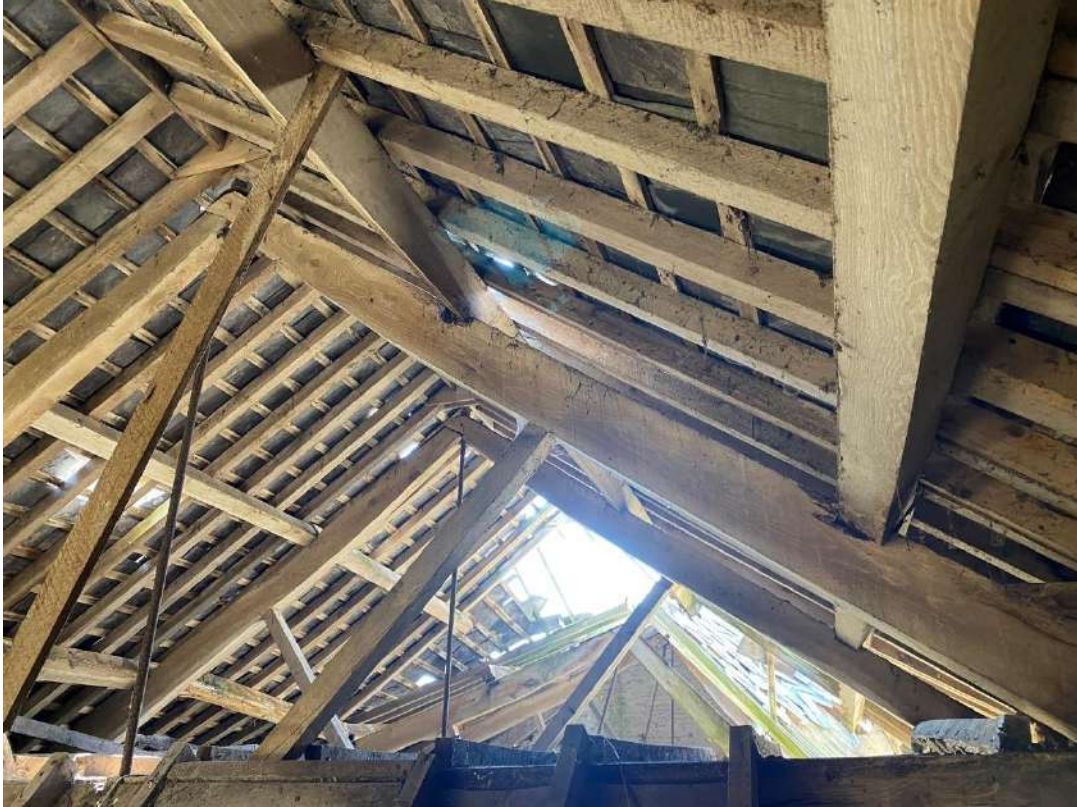
There appears to have been water ingressing through the barn for some considerable time which has led to the partial collapse of the wall resulting in a consequential loss of support of the lower roof of the covered yard (Plot 2) and the Stable Block of the Plot 3. (Plot 3)

The loss of masonry support and degradation of the timber owing to the decay of the timber has led to the failure of the first two trusses and the partial collapse of the roof. (Please see Figures 1 and 2).

Figure 1 - Hole in Roof With Collapsed Roof Beneath

The collapsed roof of the Western Stable Block is dangerous and should be demolished to remove the risk of danger to the occupants of the site and to prevent any further collapse of the roof structure from damaging the remainder of the buildings and adjoining covered yard

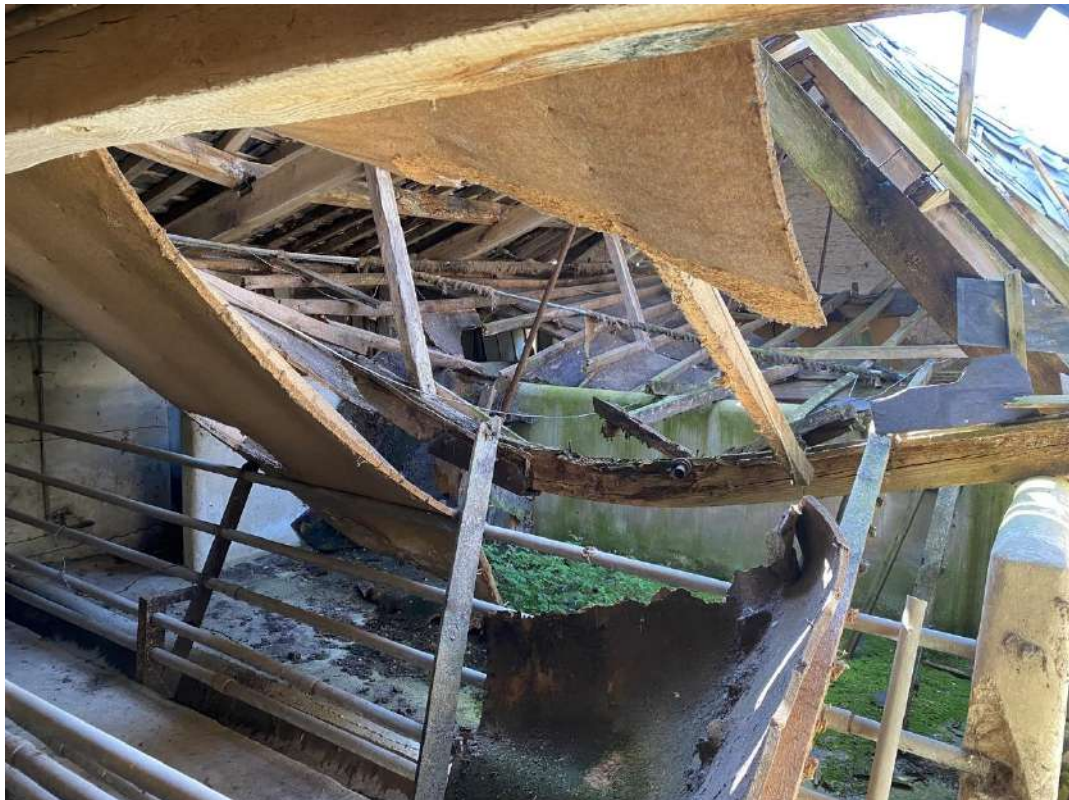
Figure 2 - Failed Truss

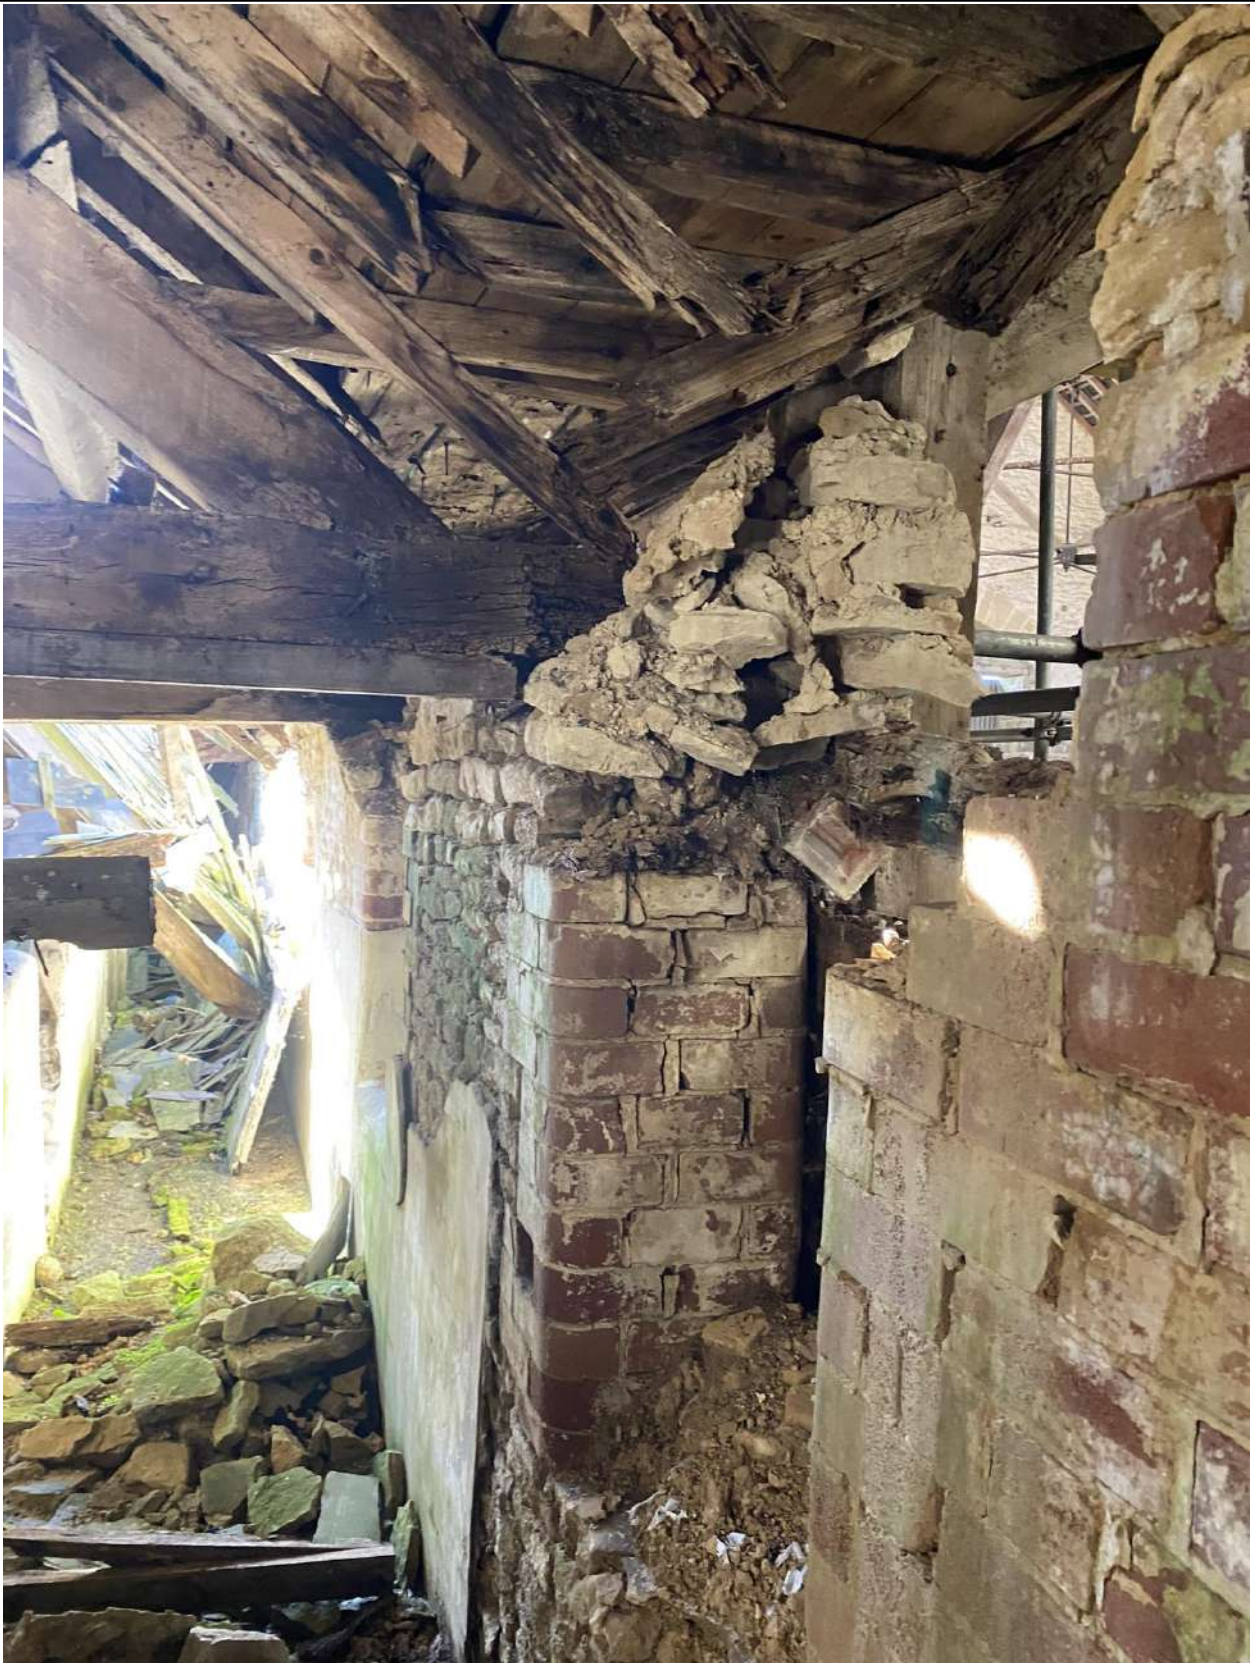
The third and fourth trusses show significant signs of decay at the bearing onto the rear wall and are showing other signs of distress, such as failure of the internal joints and decay of the principal structural members. (Please see Figures 3 to 5).

Figure 3 - Failure of Timber Lintel Supporting Masonry, Decay of Truss at Bearing and Broken, Unsupported Rafters

Once the Western Stable Block roof has been removed and the rubble removed from around the southeastern wall, a suitably qualified stone mason should be appointed to rebuild the southeastern wall to support the restored roof.

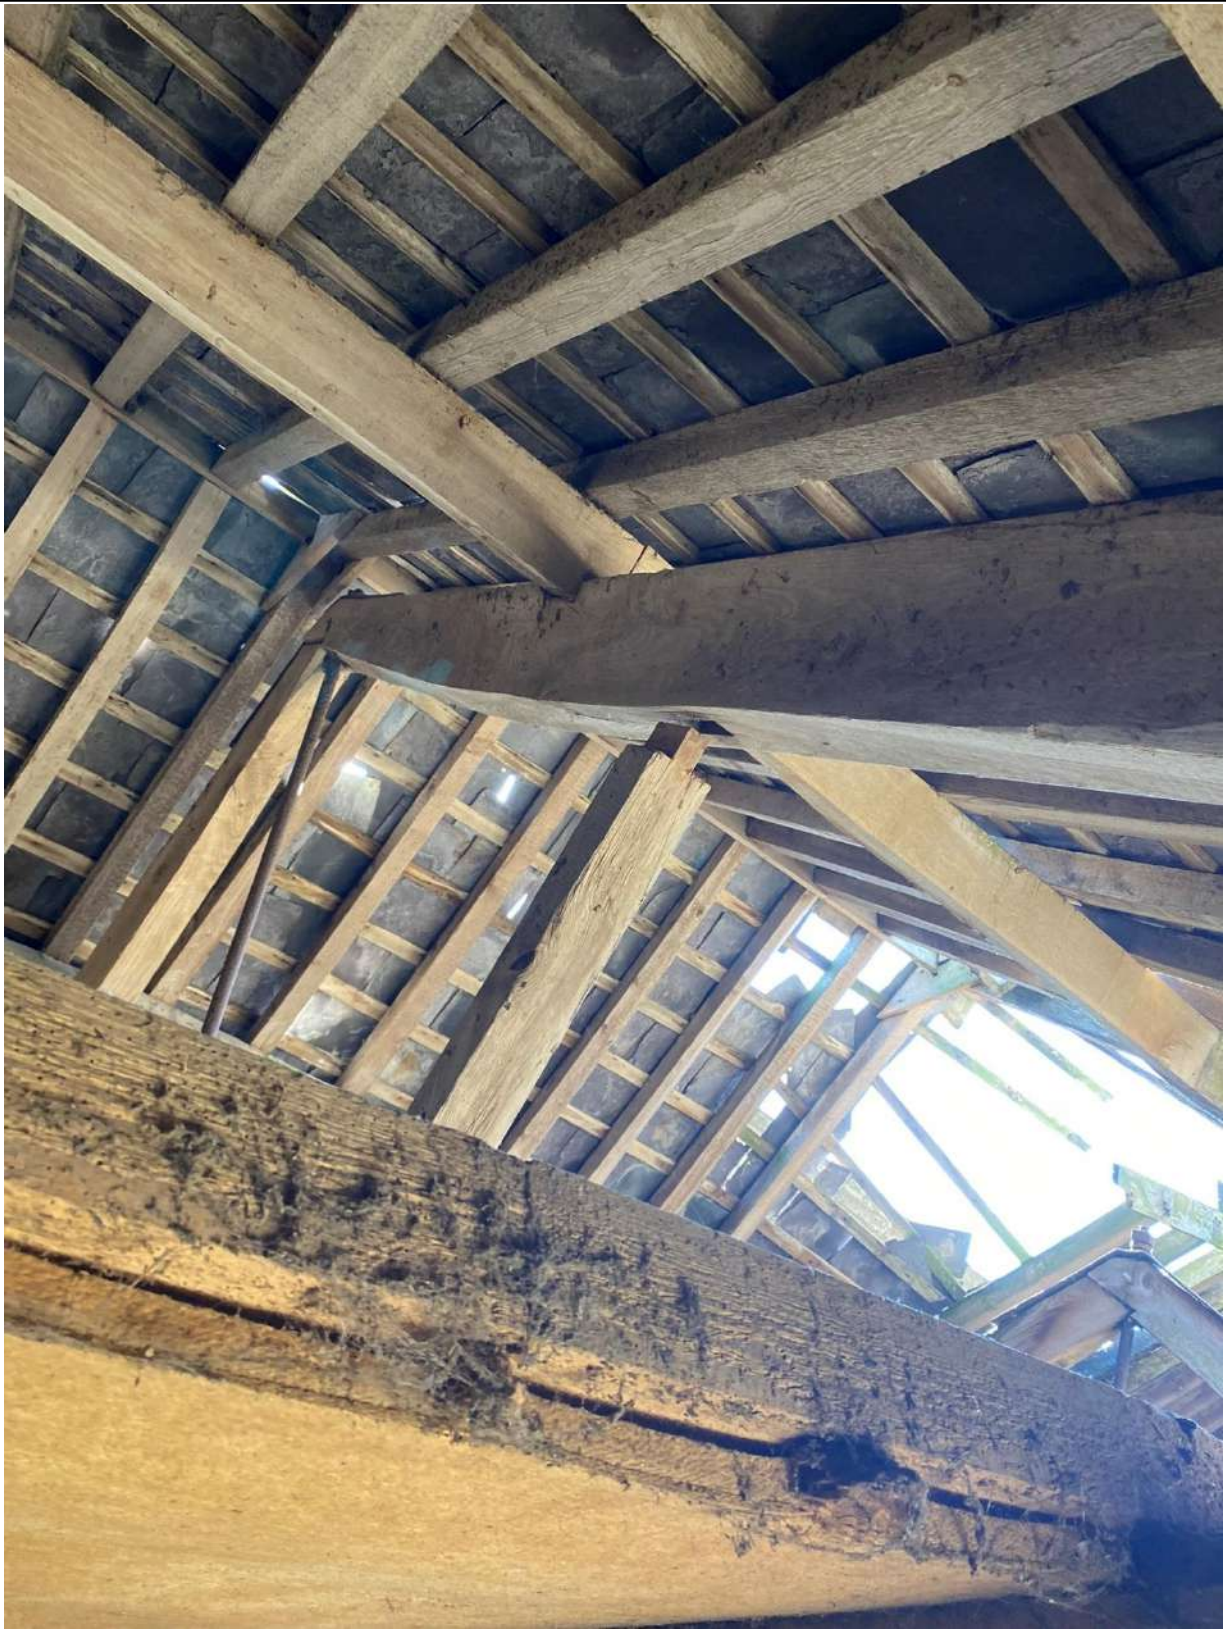
Figure 4 - Local Failure of Joint Between Rafter and Strut

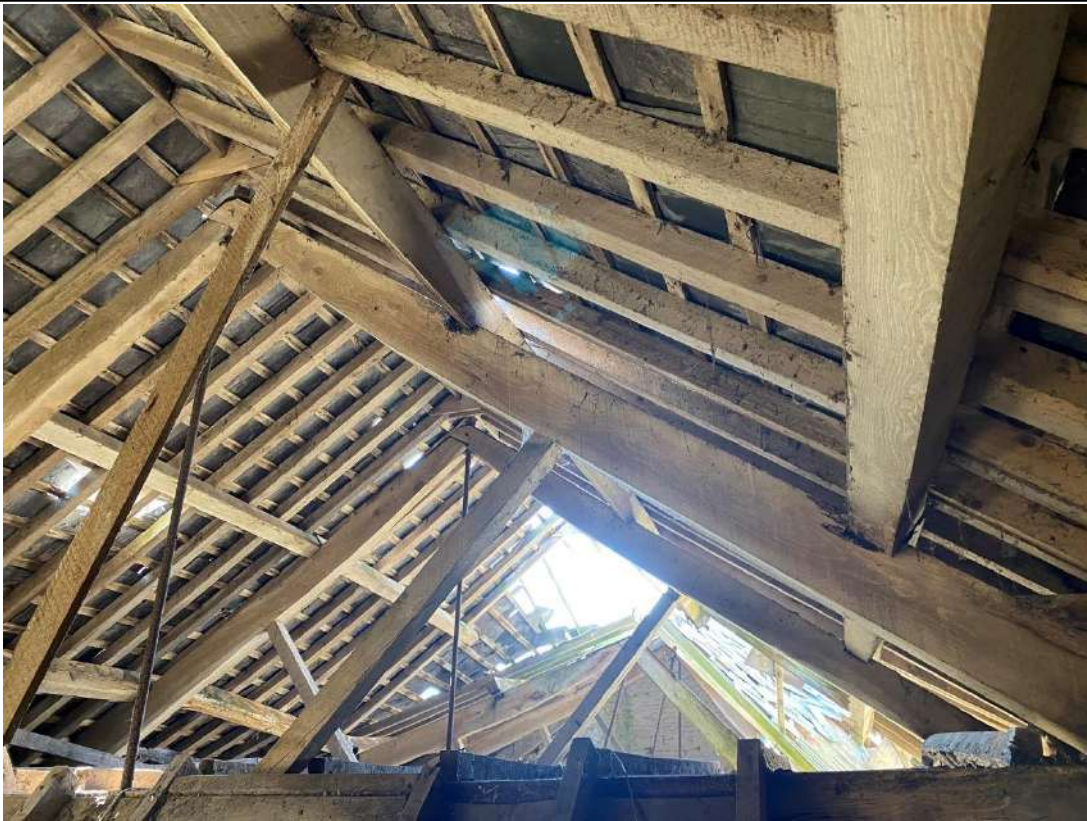
Figure 5 - Decay of Truss Rafter and Purlins at Bearing of Purlin onto Truss

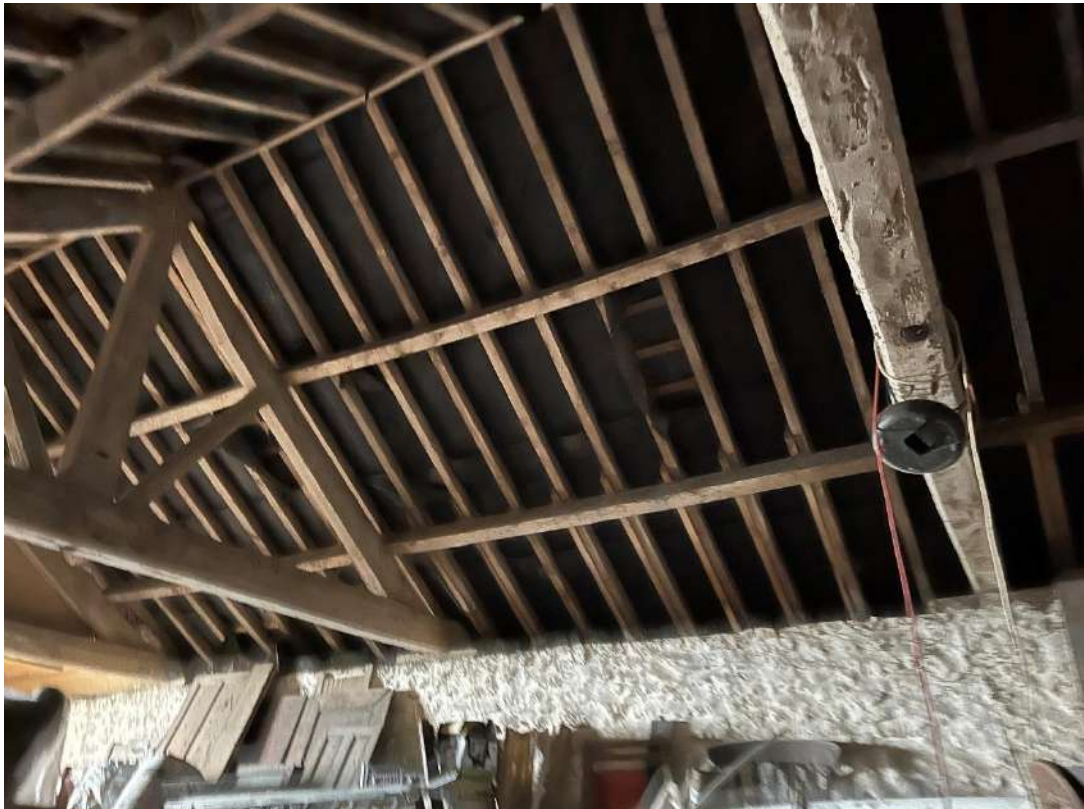
The roof of the workshop is in good condition with no signs of moisture penetration through the roof. There is some minor damage to the roofing felt visible but there are no signs of daylight or moisture penetration through the roof. (Please see Figure 6 in Appendix A).

Figure 6 - Minor Damage to Roofing Felt of the Workshop Roof

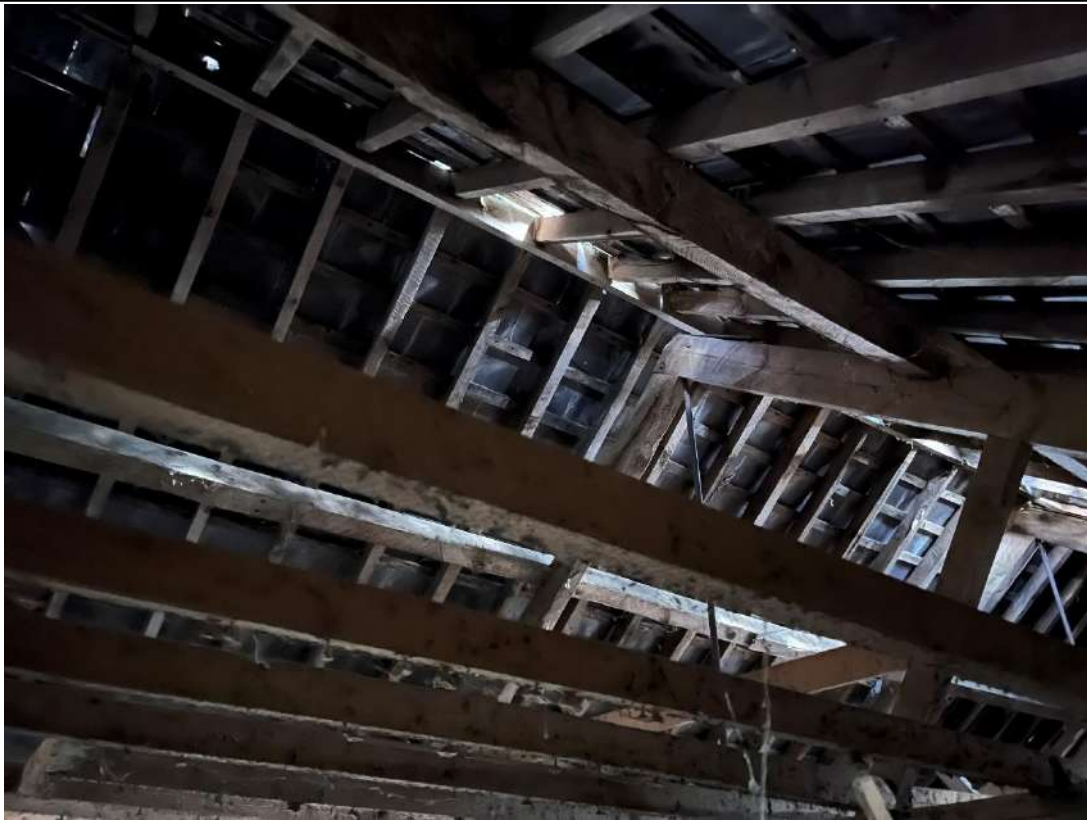
The roof of the southern stable block is generally in good condition with limited signs of moisture penetration but damage to the roof coverings does mean that there is daylight visible when viewing the roof internally. (Please see Figure 7 in Appendix A).

Figure 7 - Daylight Visible Through Roof of Southern Stable Block

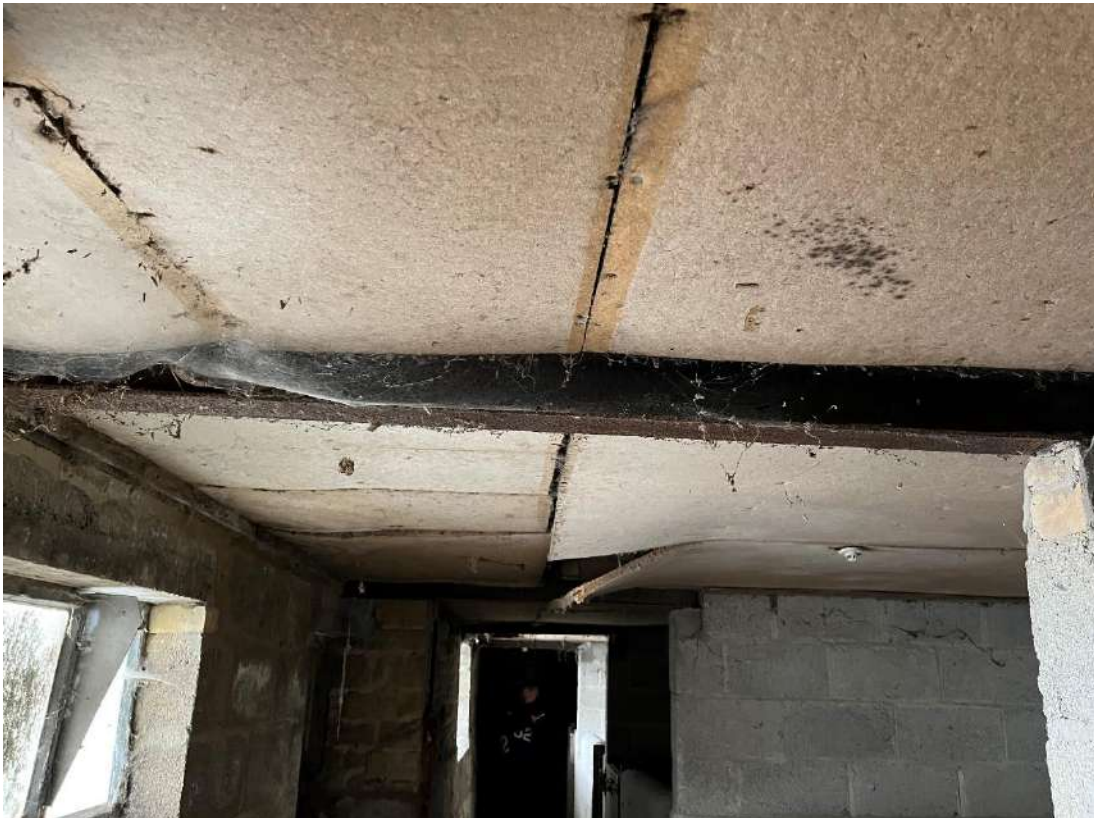
The floor within the northern block could only be viewed from the underside and the joists were obscured by boarding which meant that their condition could not be checked. Generally, the floor was free from signs of excessive deflection but some of the boards applied to the underside of the joists were showing signs of moisture damage and it was not possible to determine if this was due to damp moisture penetration generally. (Please see Figure 8 in Appendix A).

Figure 8 - Moisture Damage To Ceiling of Northern Block

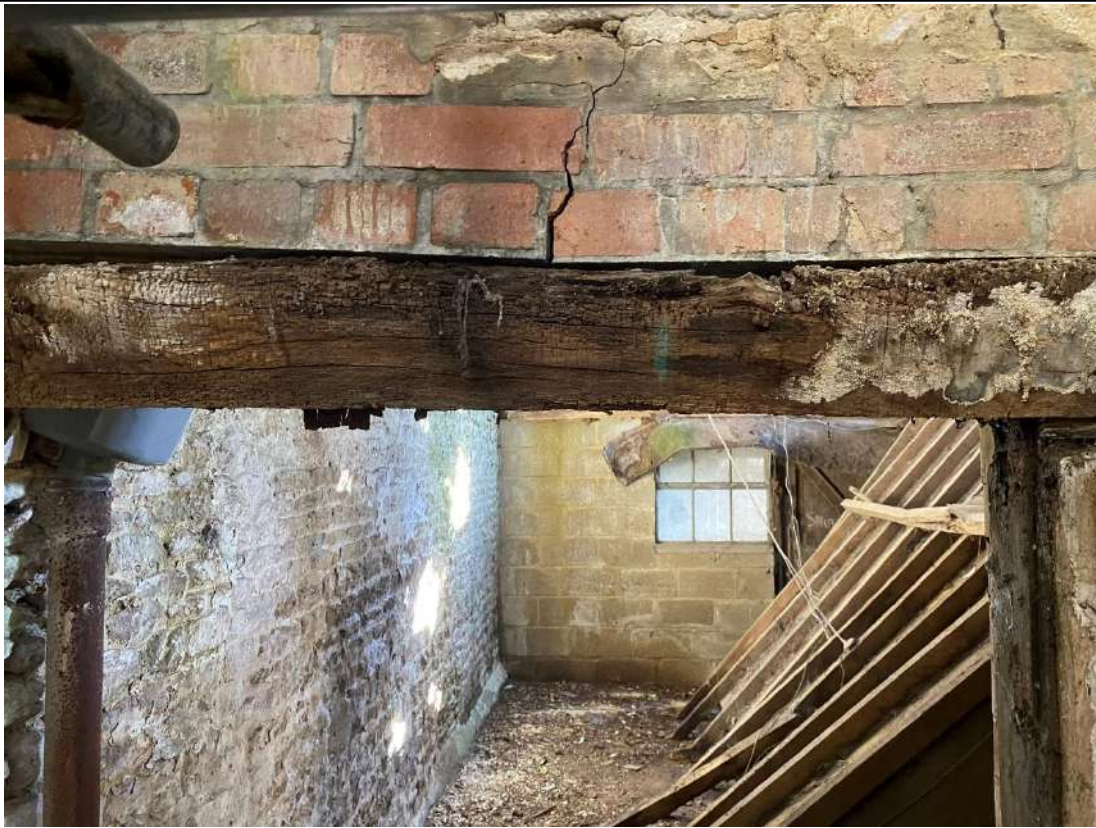
The mezzanine floor in the northern section of the barn has failed. The floor in the southern section of the barn is still in place but is showing decay due to an insect attack. (Please see Figures 6 and 7 in Appendix A)

Figure 9 - Failure of Joist Bearings Onto Wall

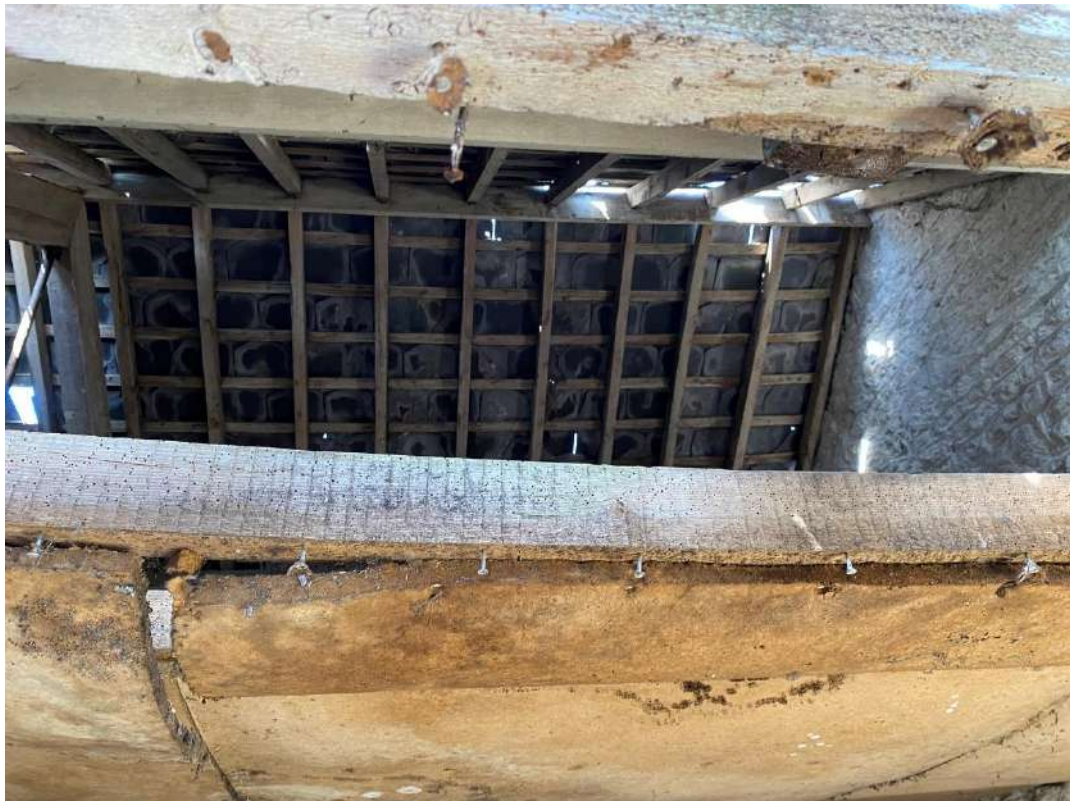
Figure 10 - Insect Attack of Floor Joists

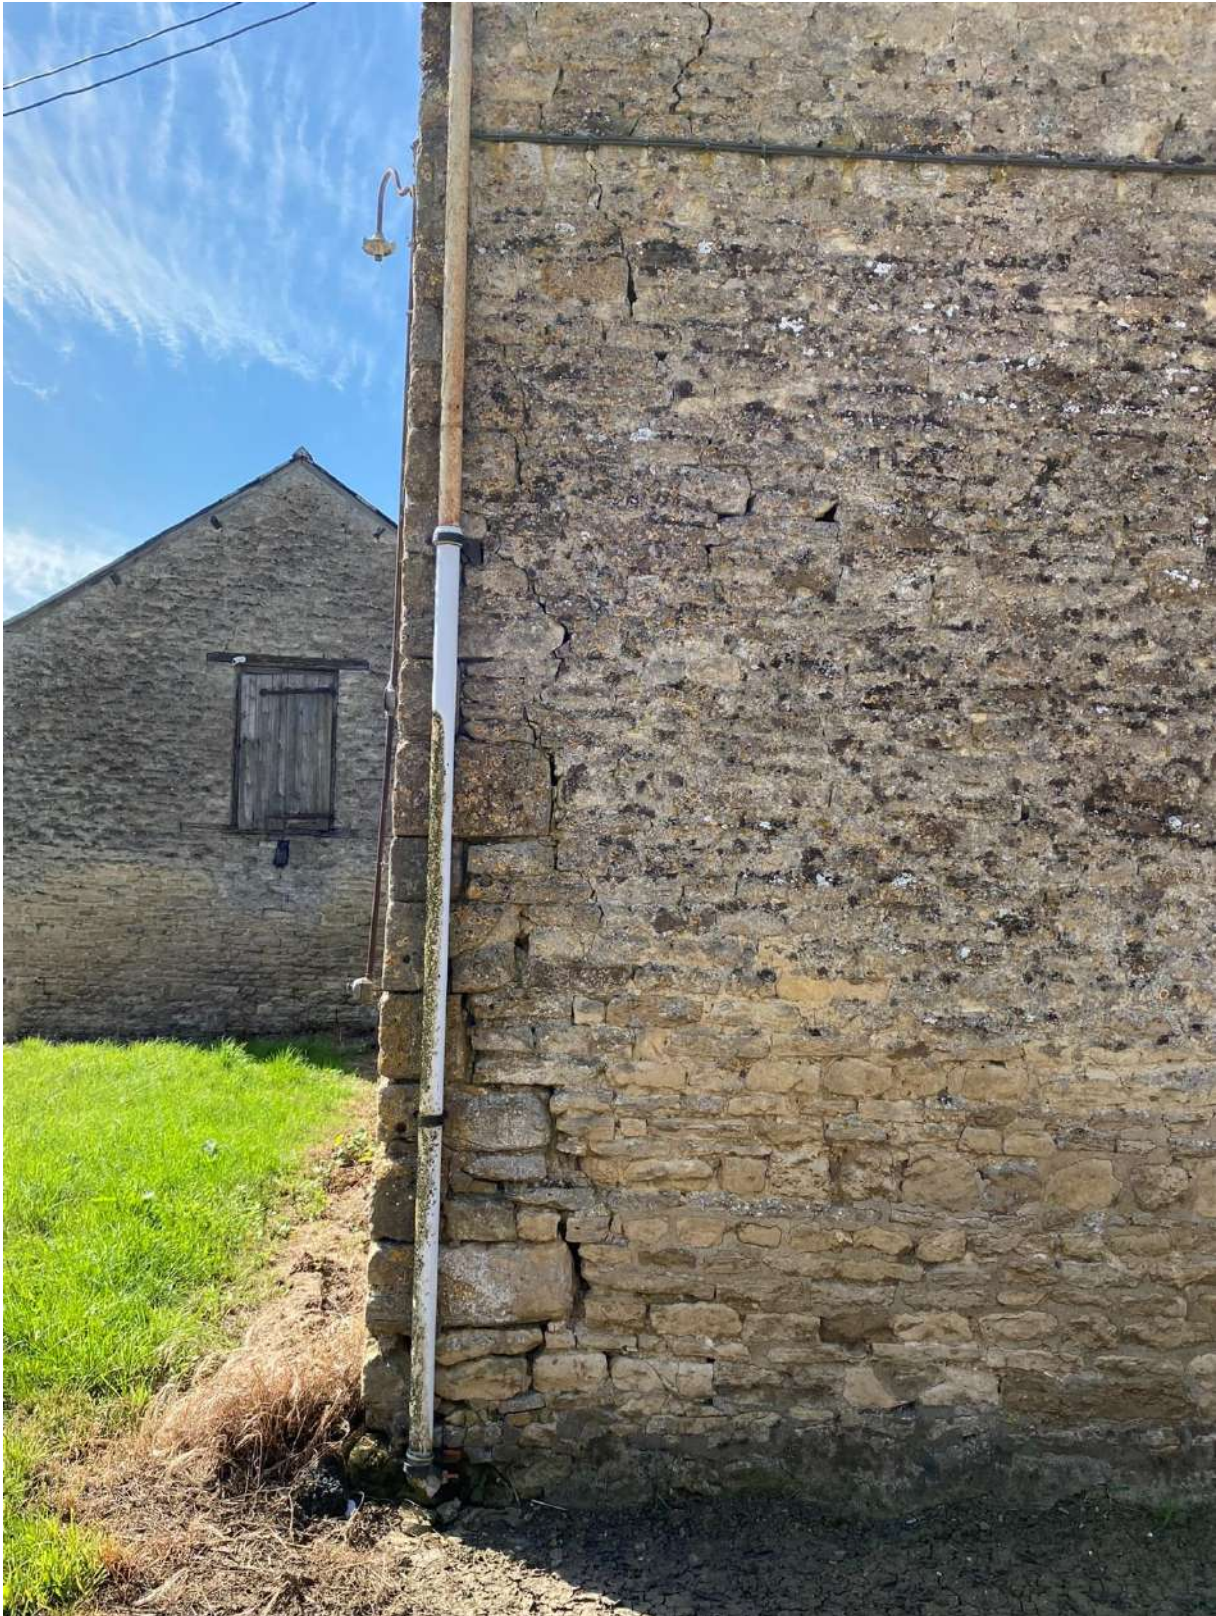
It was noted that a number of the rainwater pipes were discharging the surface water directly to the ground adjacent to the corners of the buildings.

This leads to softening of the founding soils, separation of the quoins from the remaining masonry, and damage to the masonry at or just above ground level. (Please see Figures 11 and 12)

Figure 11 - Cracking at Interface of Stone and Quoins

The rainwater goods should be connected to an underground drainage system which should convey the surface water away from the buildings and discharge to a soakaway located at least 5m from the existing buildings.

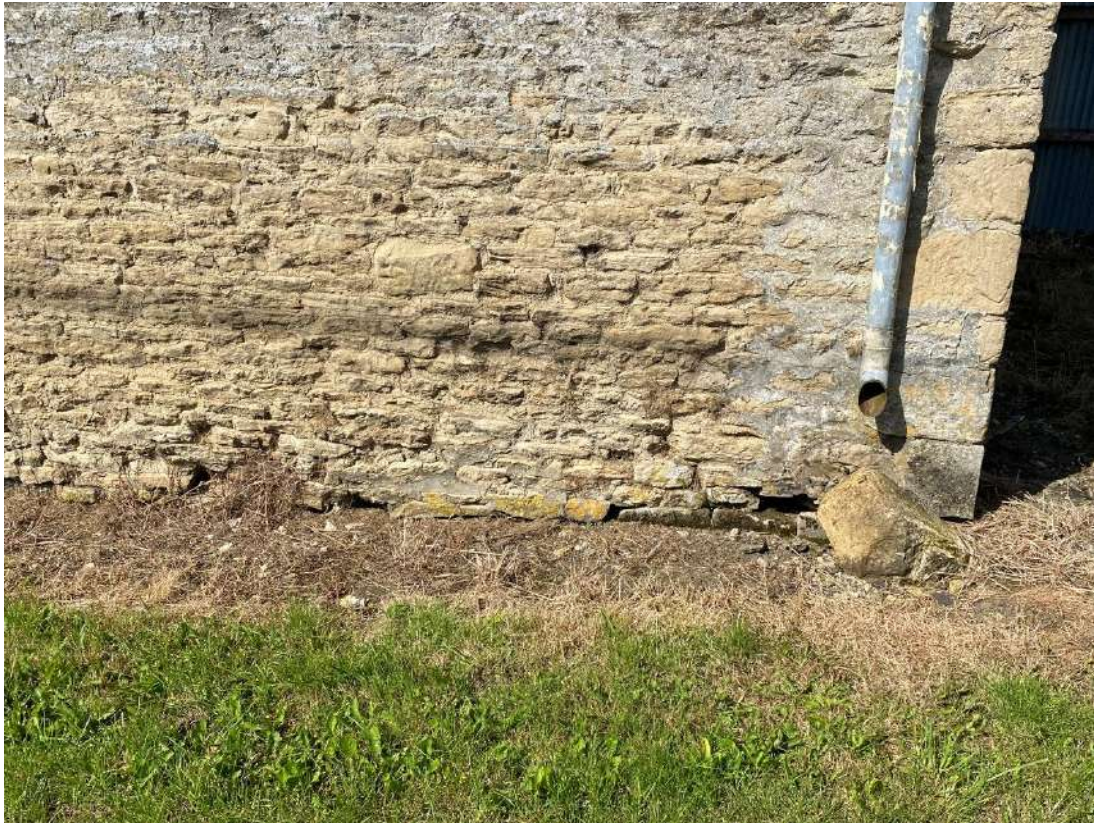
Figure 12 - Damage to Masonry Owing to Discharge of Surface Water to Ground

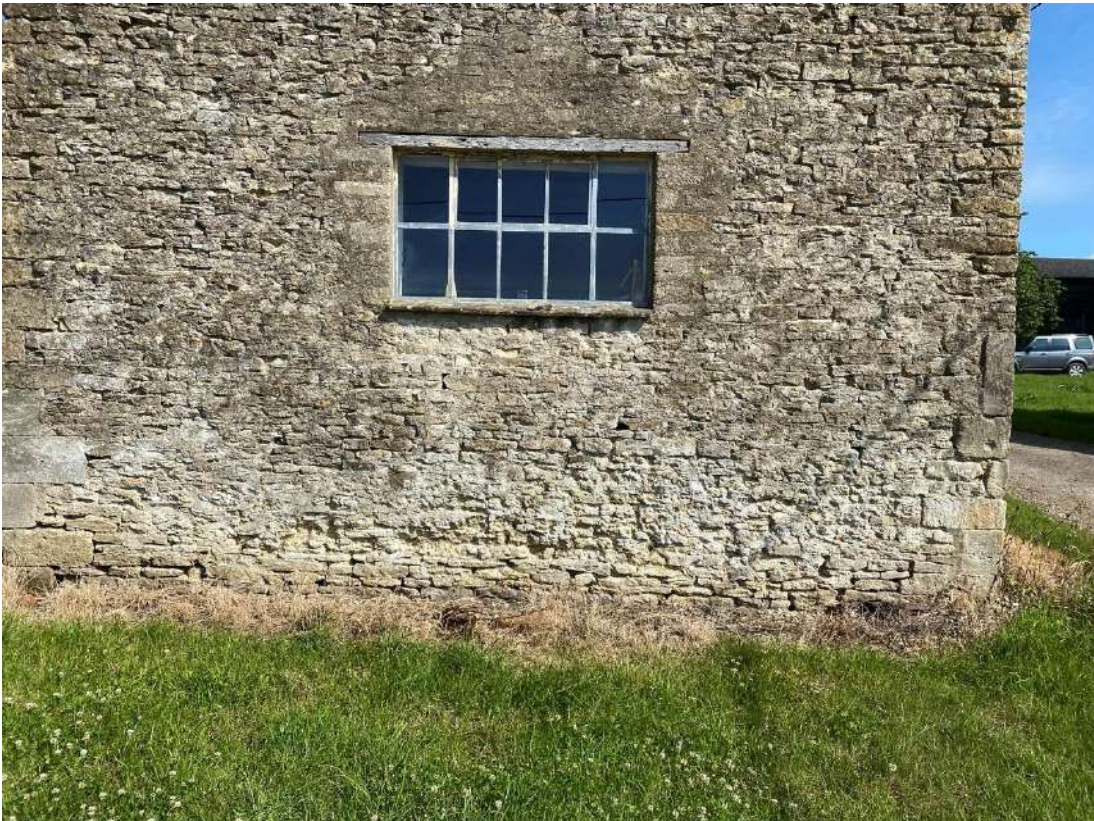
Some of the external stone walls show signs of damage due to frost action in the form of missing or crumbling pointing within the perpendicular and bedding planes of the walls (Please see Figure 13).

Figure 13 - Loss of Pointing at Ground Level

Where the masonry has been damaged by water ingress or where frost action has eroded the mortar at or just above ground level, the walls should be repointed with a suitable lime mortar

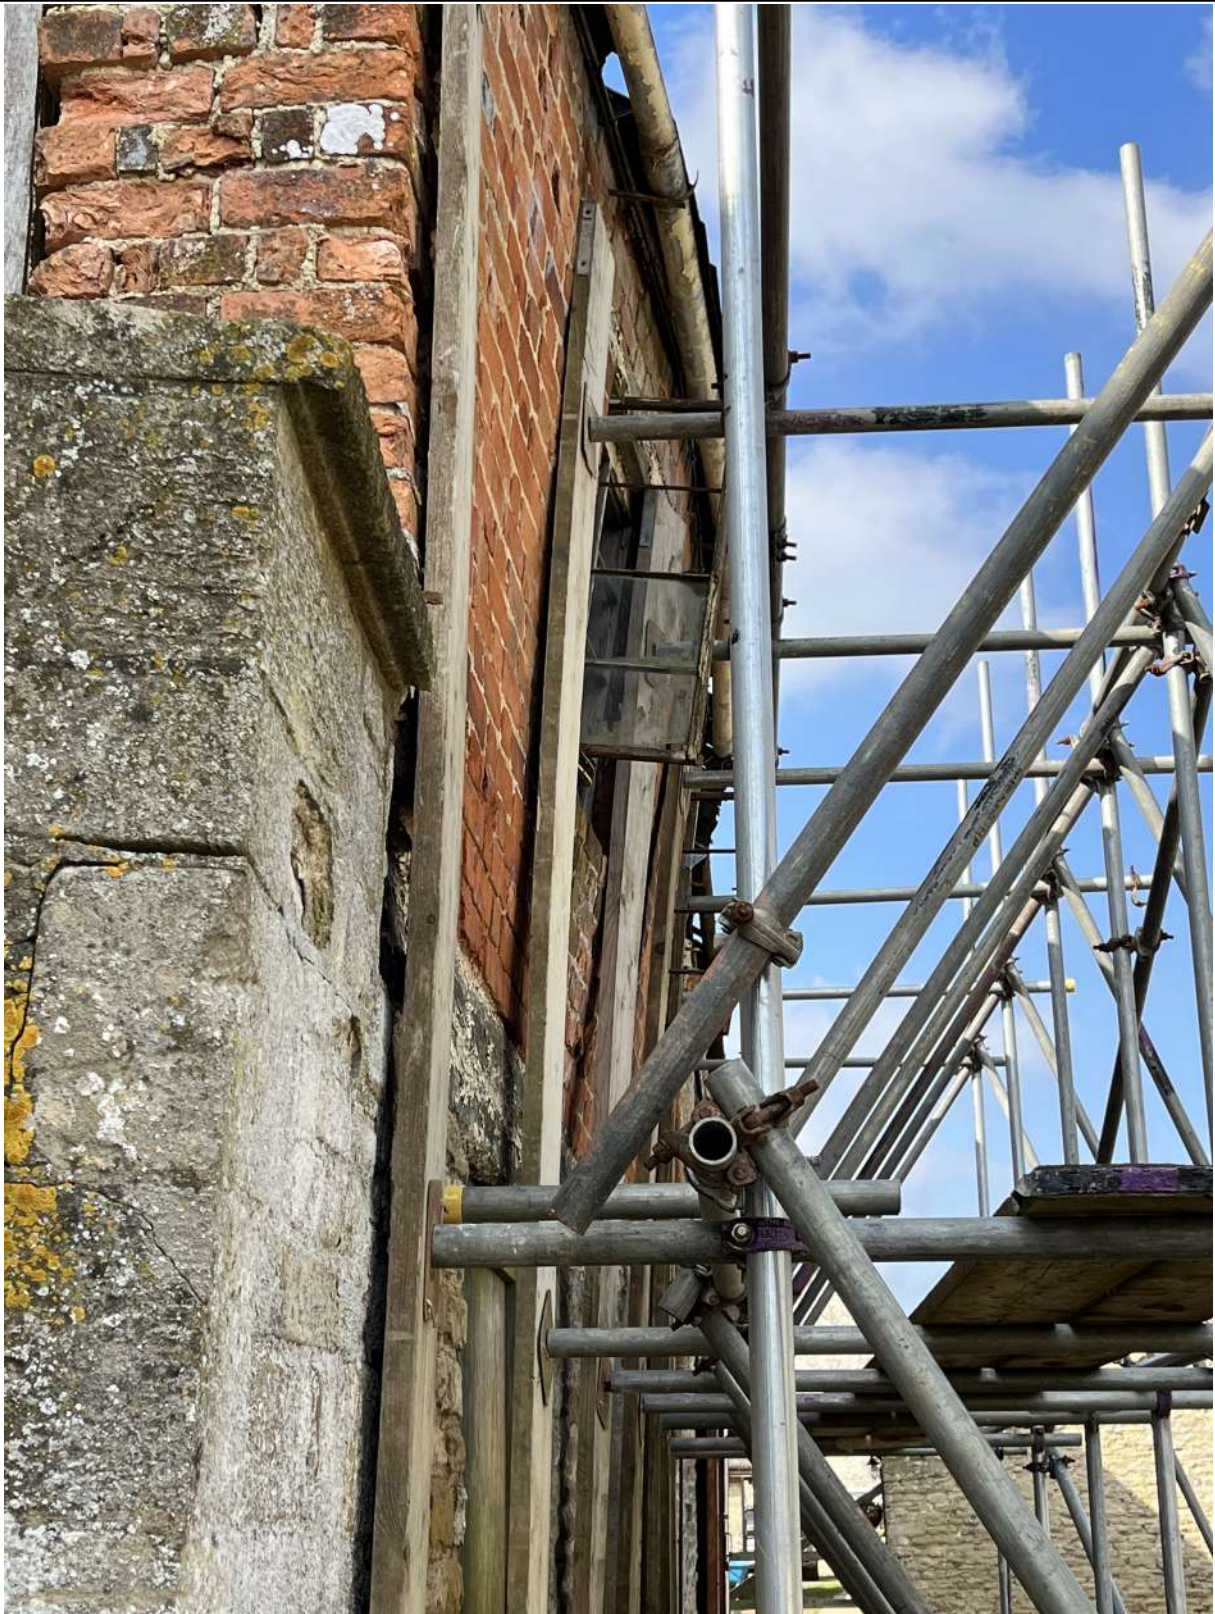
Whilst it was not possible to inspect the roof internally, the roof coverings of the northern block are damaged and there are signs of deflection of the roof leading to outward movement of the masonry at high level. (Please see Figure 14 in Appendix A)

Figure 14 - Outward Movement of Roof and Northern Wall

Safe access to the first floor of the northern block should be provided to allow us to undertake a complete assessment of the condition of the roof.
