Juxon Ltd

Asterleigh Farm
Kiddington Estate, Oxon

Report on the Condition
of Plot 1

May 2023

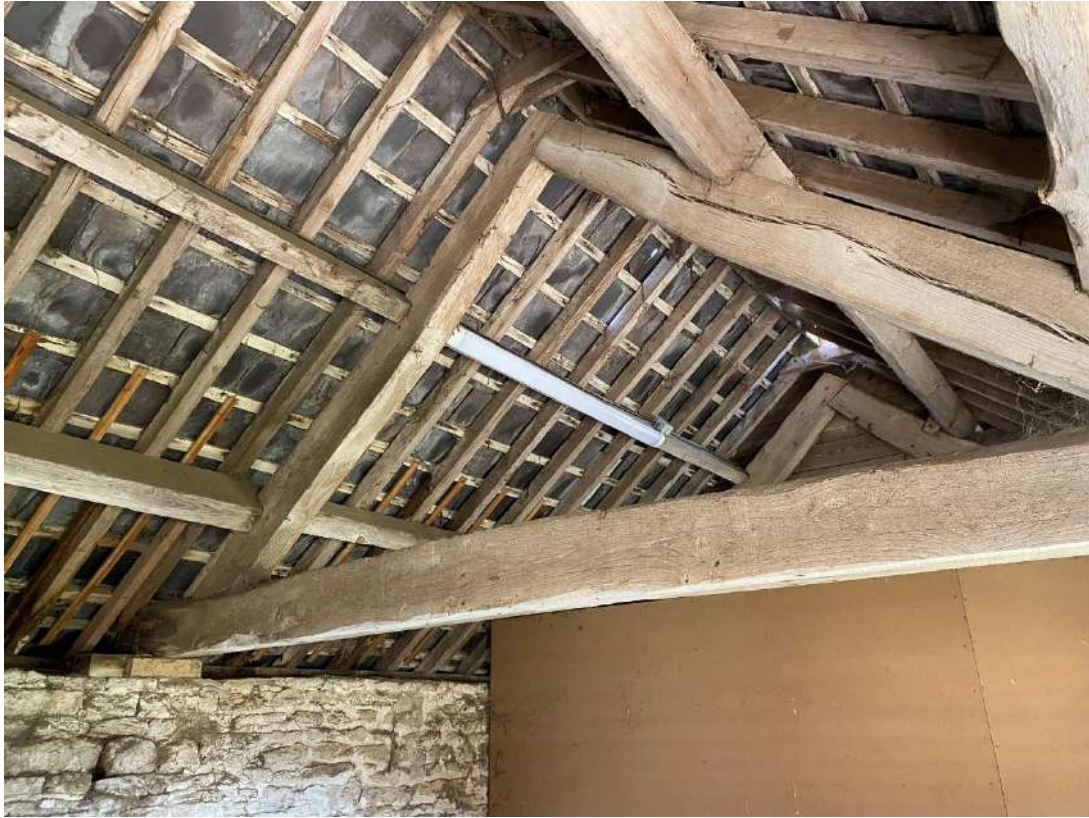
The slate-clad roof of the stables is a traditional cut roof with loose rafters which are supported by hardwood purlins which are, in turn, supported by timber trusses spanning from front to back. (Please see Figure 1)

Figure 1 - View of Stable Roof

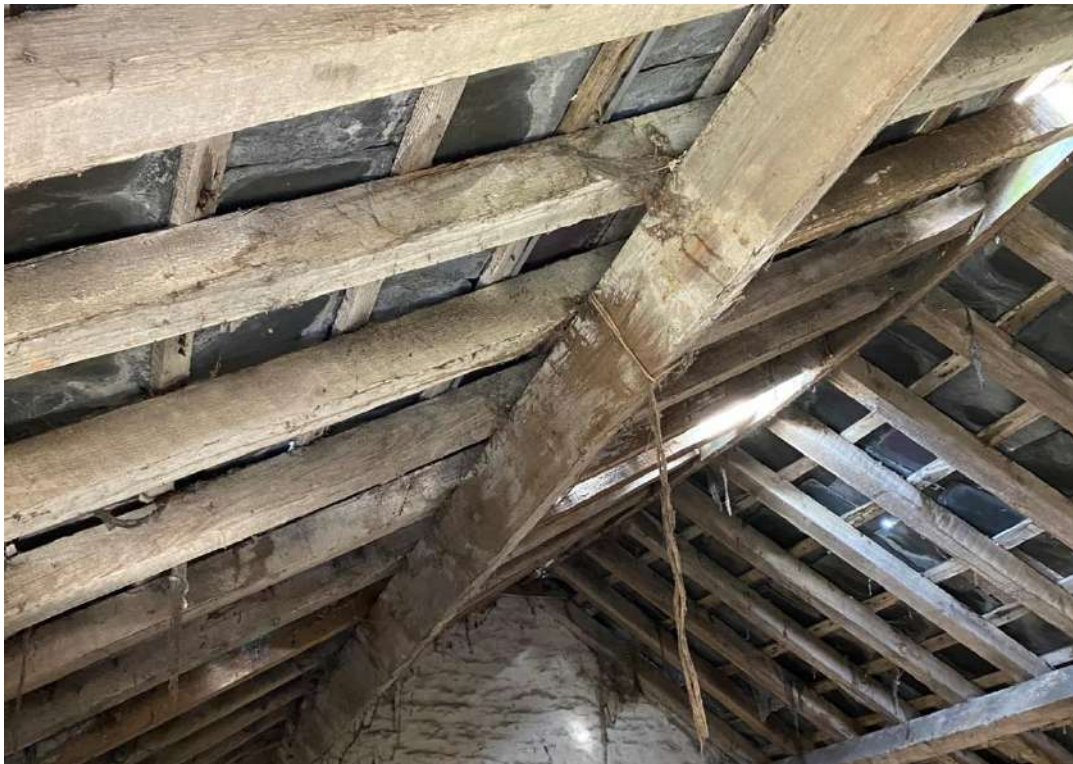
The storeroom roof is of traditional construction but the purlins span the whole length from gable to gable. (Please see Figure 2)

Figure 2 - View of Storeroom Roof

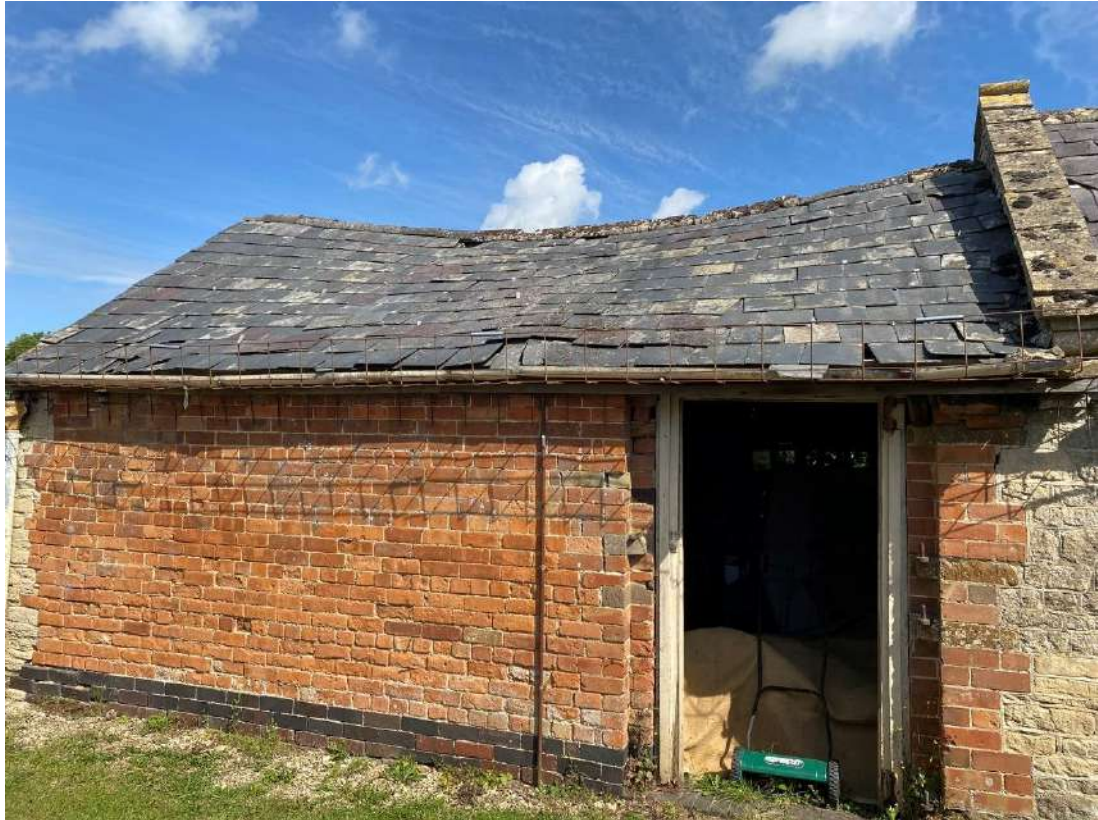
The storeroom roof shows signs of significant deflection, which is visible from the front of the barn (Please see Figure 3).

Figure 3 - Excessive Deflection of Storeroom Roof

The roof covering of the storeroom should be removed and set aside for reuse.

The rafters should be assessed for suitability for re-use with any decayed or damaged rafters replaced with similar size and cross-section timbers.

The timber purlins should be replaced with timber or steel beams that are adequately stiff to resist the roof's applied loadings and prevent the walls' outward spread.

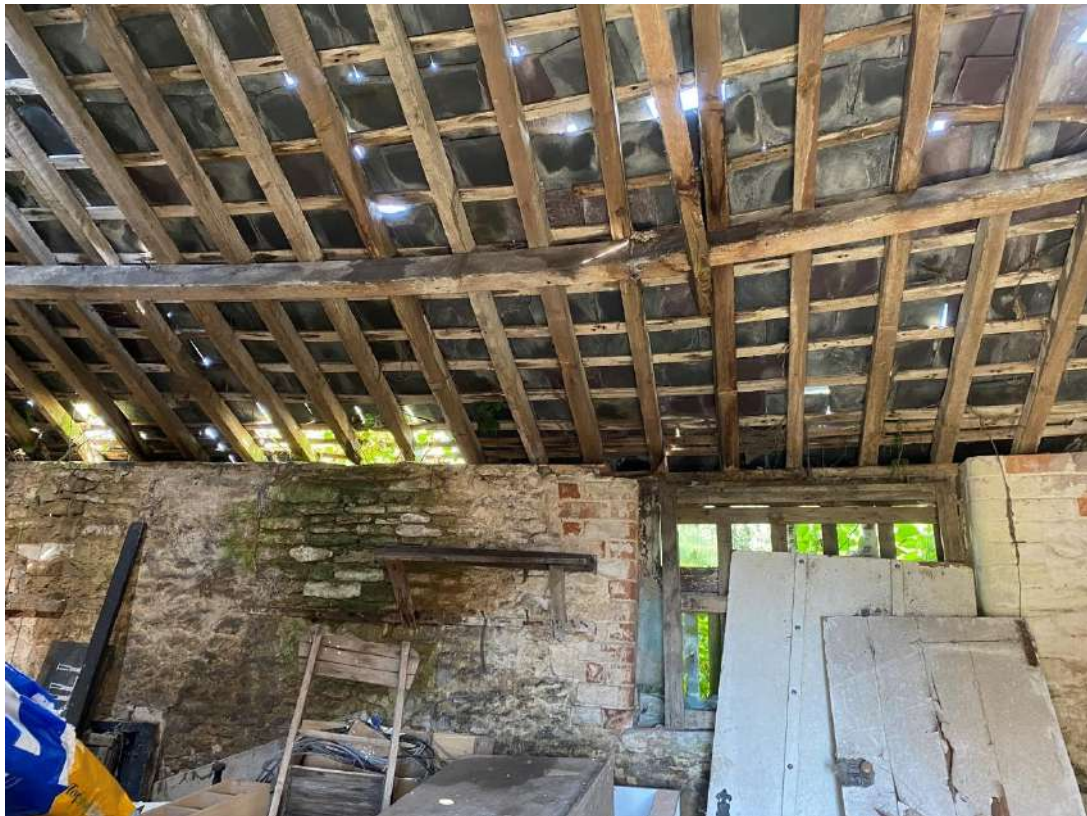
The cause of the movement is moisture penetration through the missing roof coverings which have led to the decay of the rafters at their bearing onto the rear wall and failure of the timber purlin to the rear of the stable block. (Please see Figure 4).

Figure 4 - Evidence of Moisture Penetration, Decay of Timber Rafters and Failure of Supporting Purlin

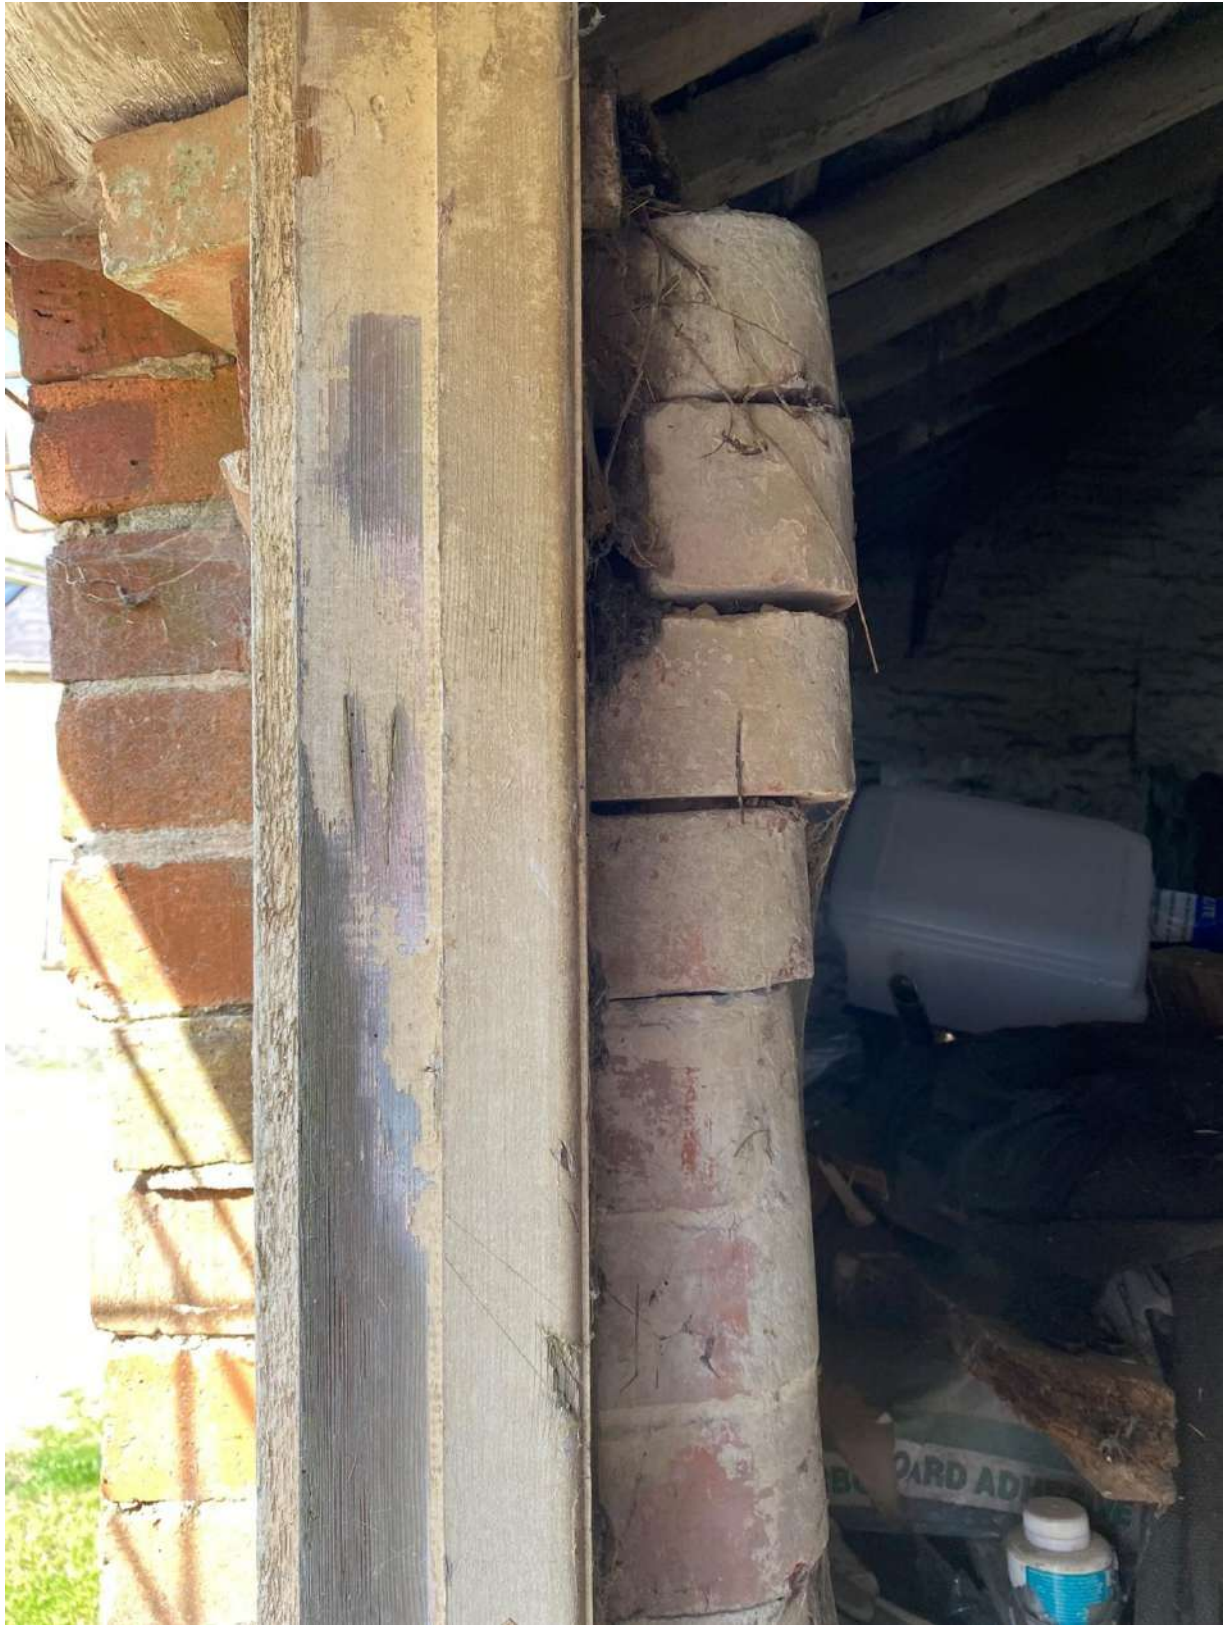
More worryingly, the bond between the inner and outer skin of the brick wall has failed leaving a substantial vertical crack adjacent to the existing door which is visible. (Please see Figures 5 and 6).

Figure 5 Damage to Masonry At Bearing of Lintel Above Entrance Door

The front wall of the storeroom should be taken down and rebuilt.

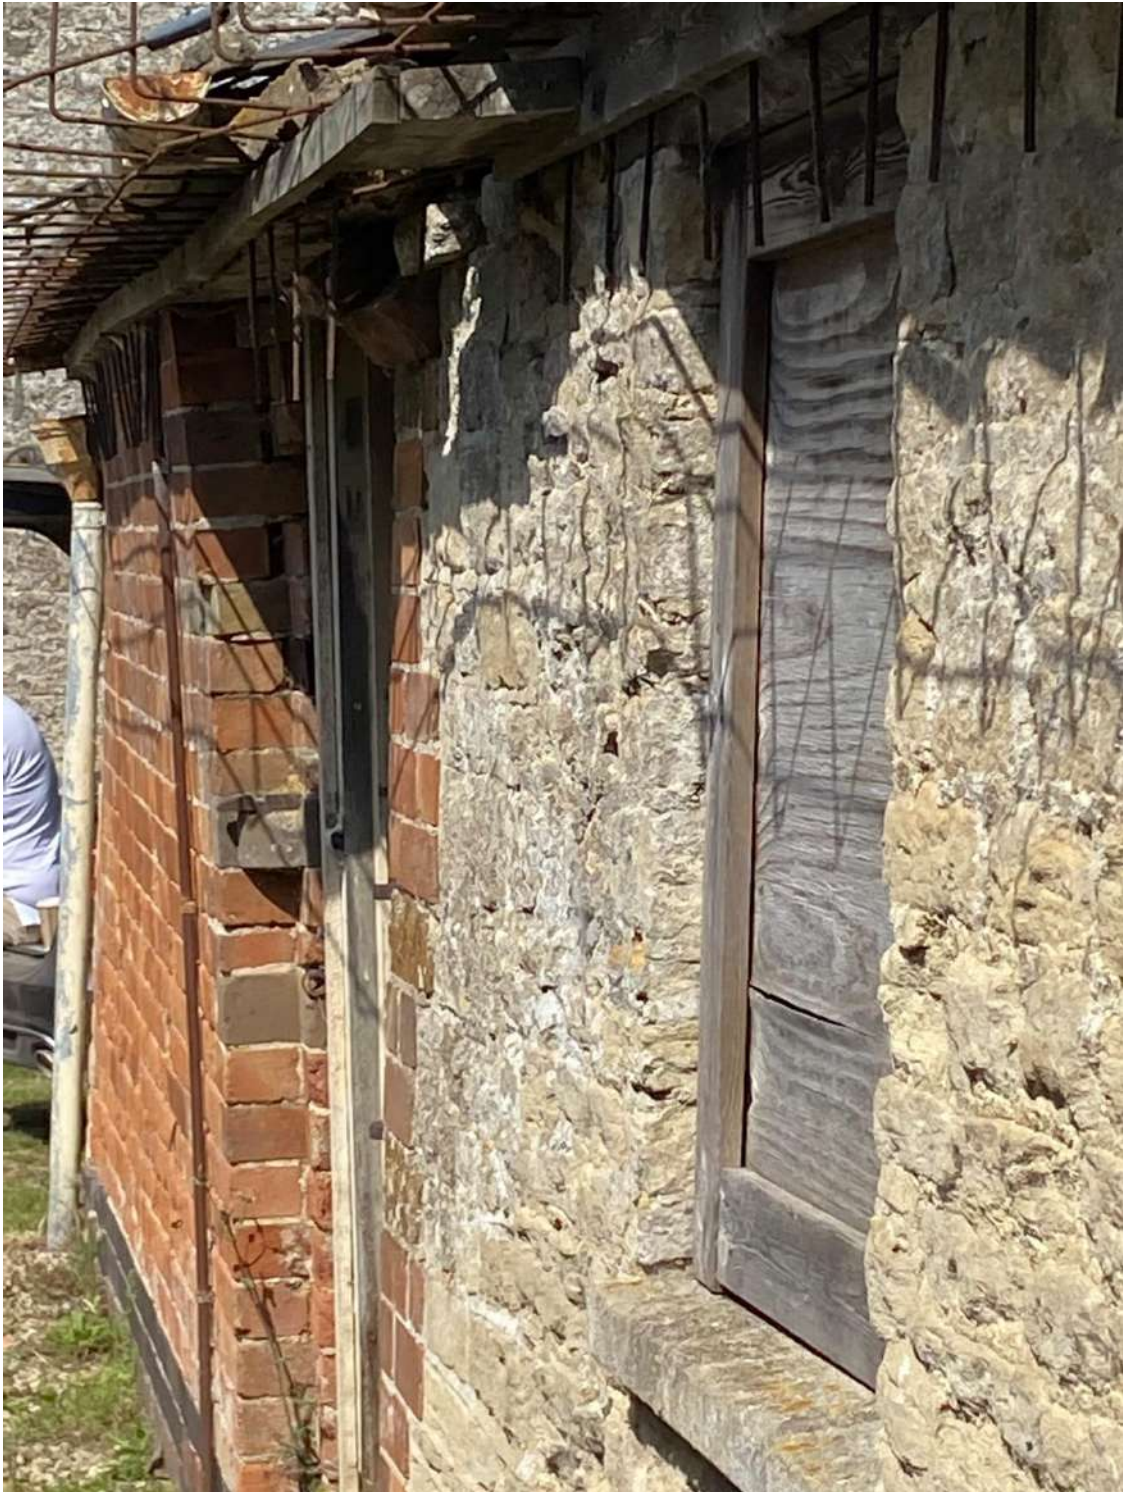
The brick wall is bowing outward by approximately 35mm at the worst point. The cause of the movement is the excessive deflection of the purlins resulting in horizontal loads being applied to the head of the wall.

Figure 6 - Outward Movement of Brick Wall

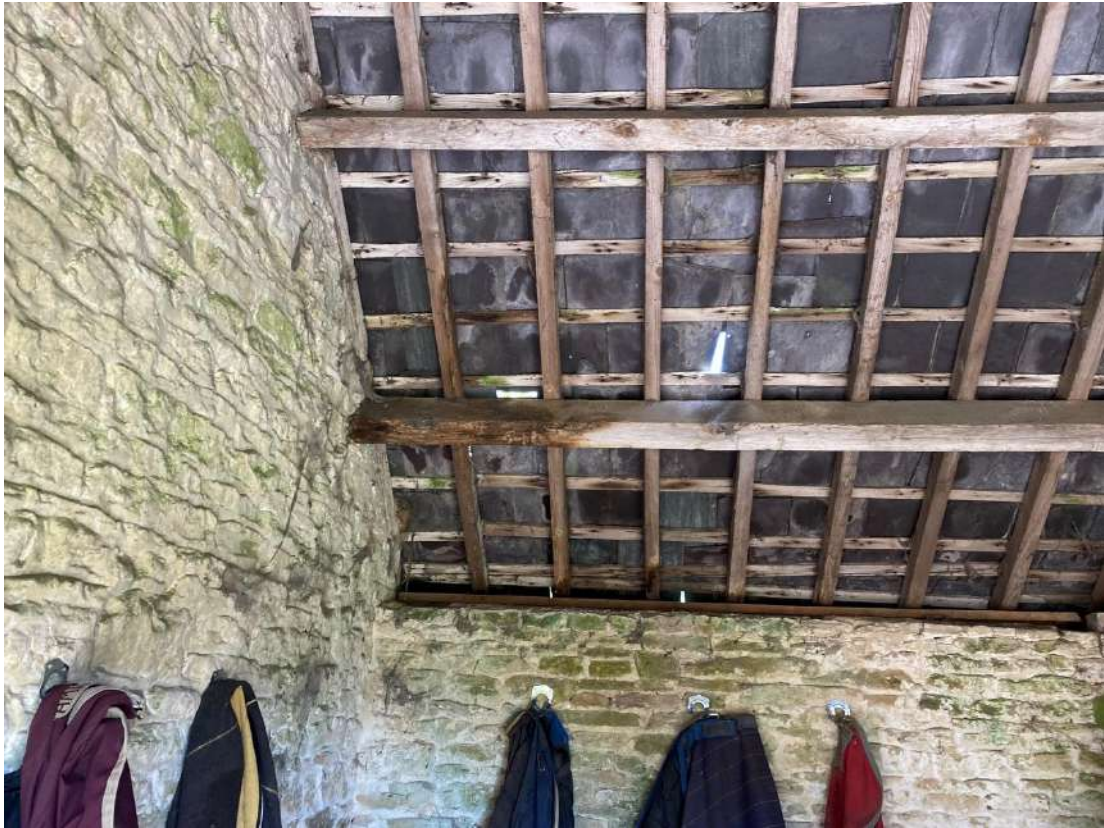
The stable roof is generally free from signs of significant moisture ingress or decay of the timber except for the lower purlin at the left-hand end of the block which appears to be damp although fungal decay does not yet appear to have set in. (Please see Figure 7).

Figure 7 - Moisture Penetration Through Roof and Possible Decay of Purlin

The roof coverings of the stables should be renewed to ensure that the timber roof structure remains dry.

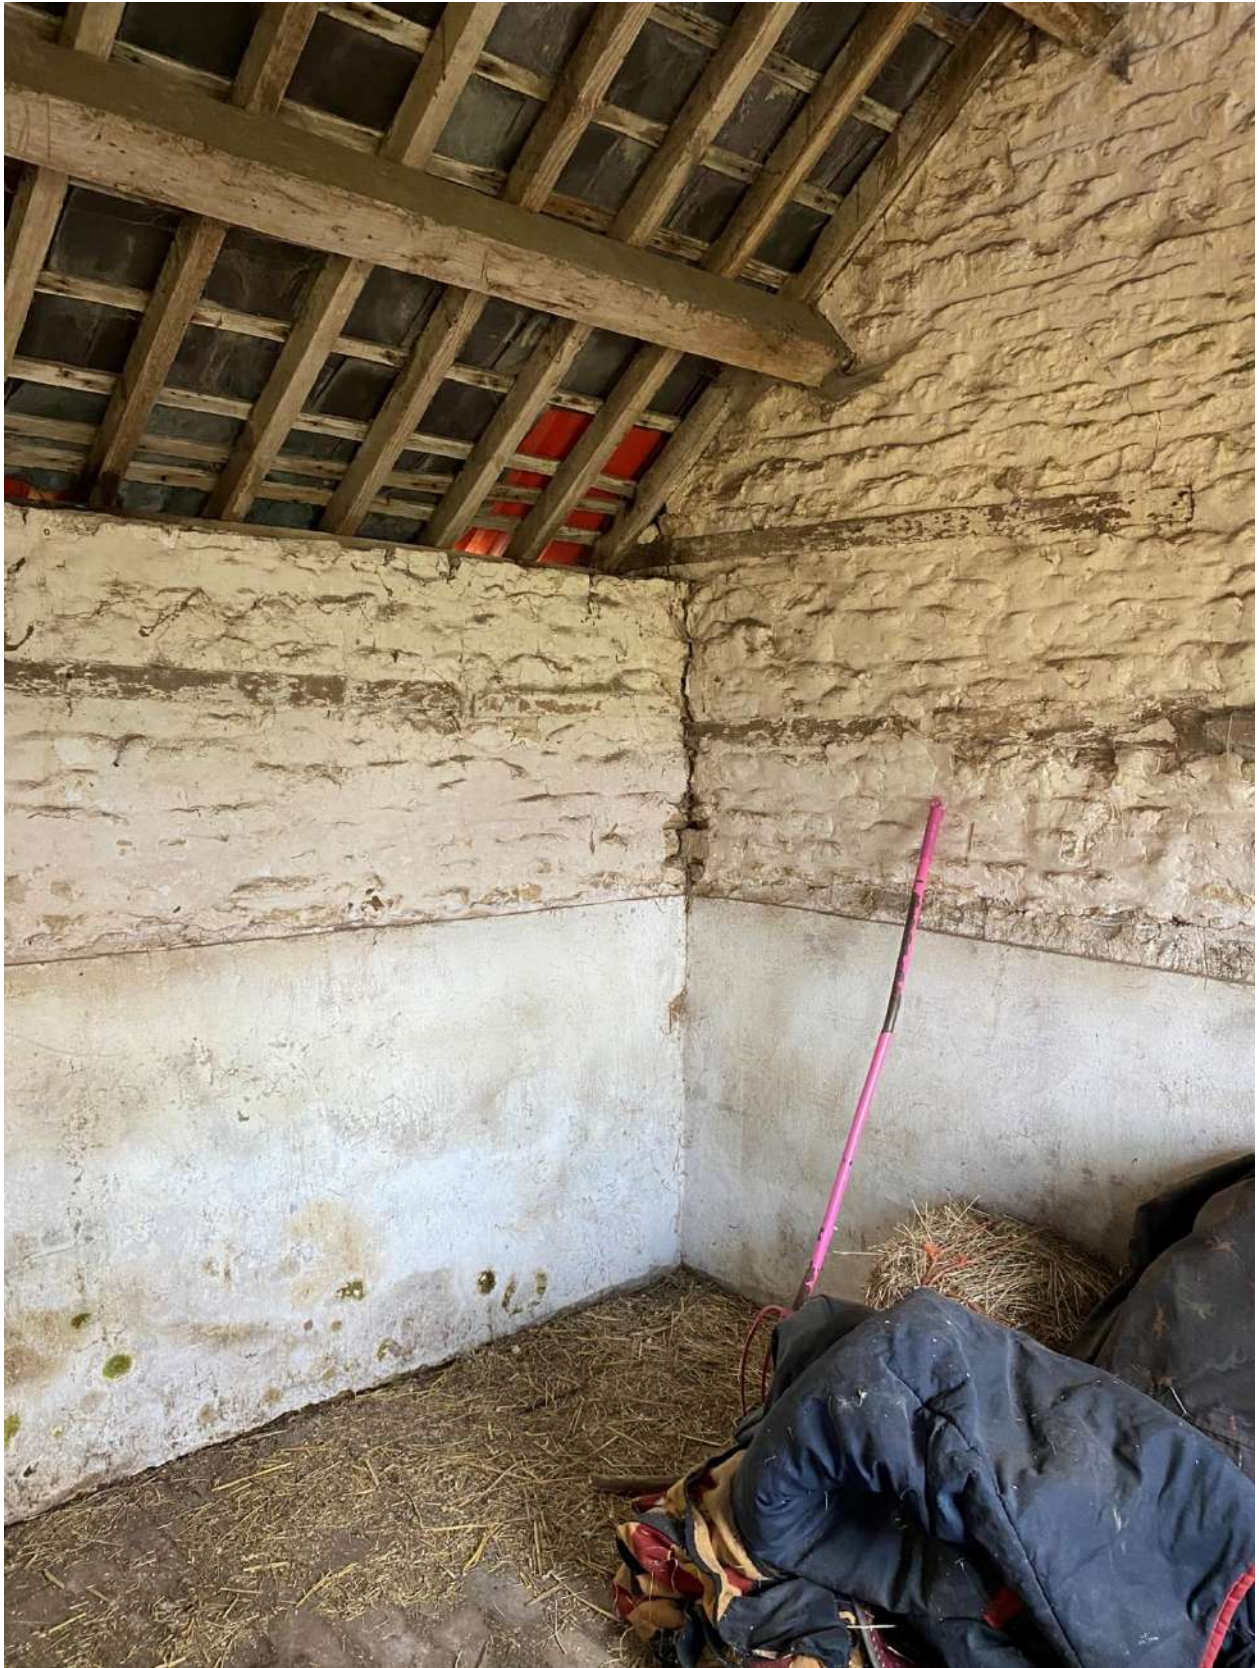
Figure 8 - Separation of Gable Wall From Rear Wall

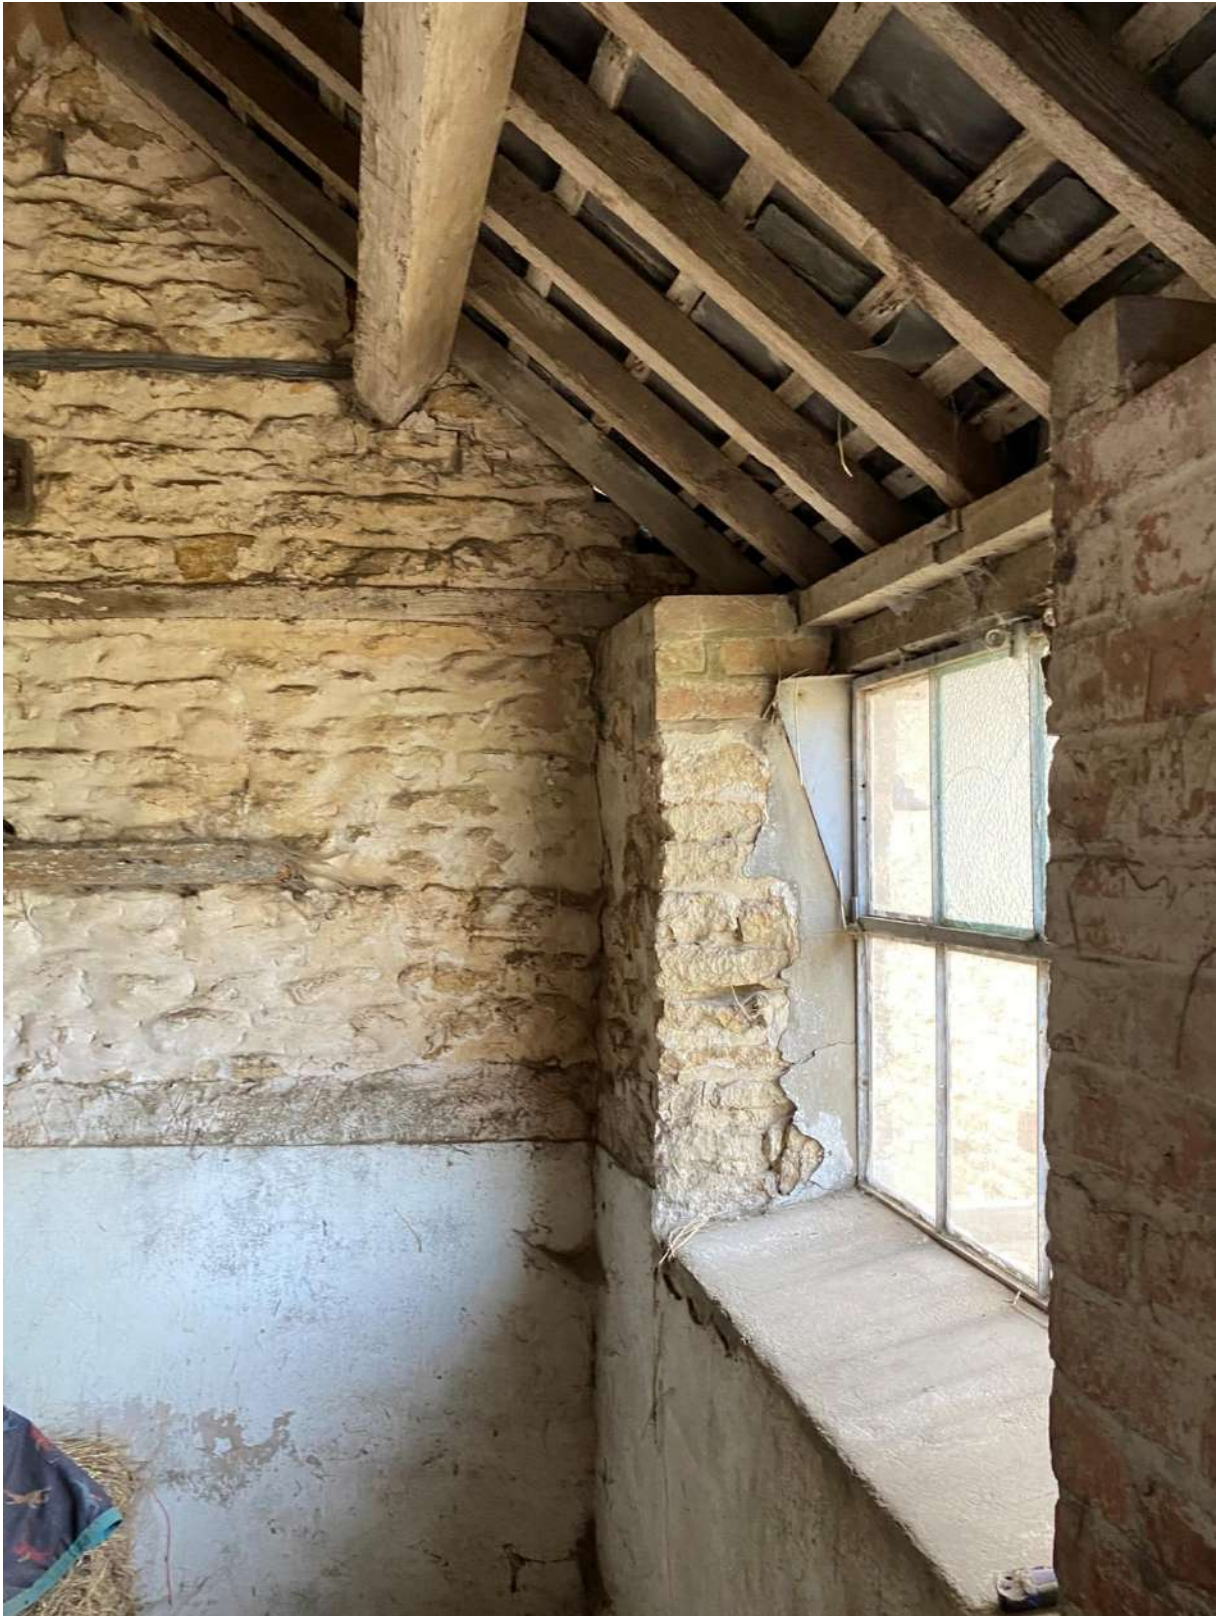
Figure 9 - Separation of Gable Wall From Wall
