# Linton Farms, Cairnfold Farm.

## Tree Report

Harry Wilson  
04/10/2023

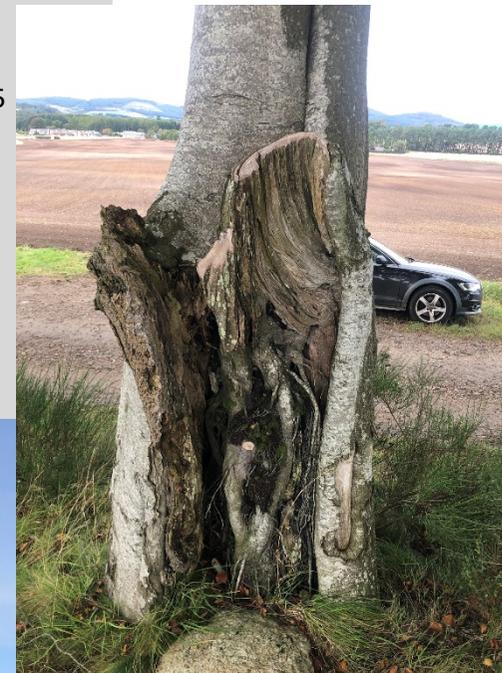
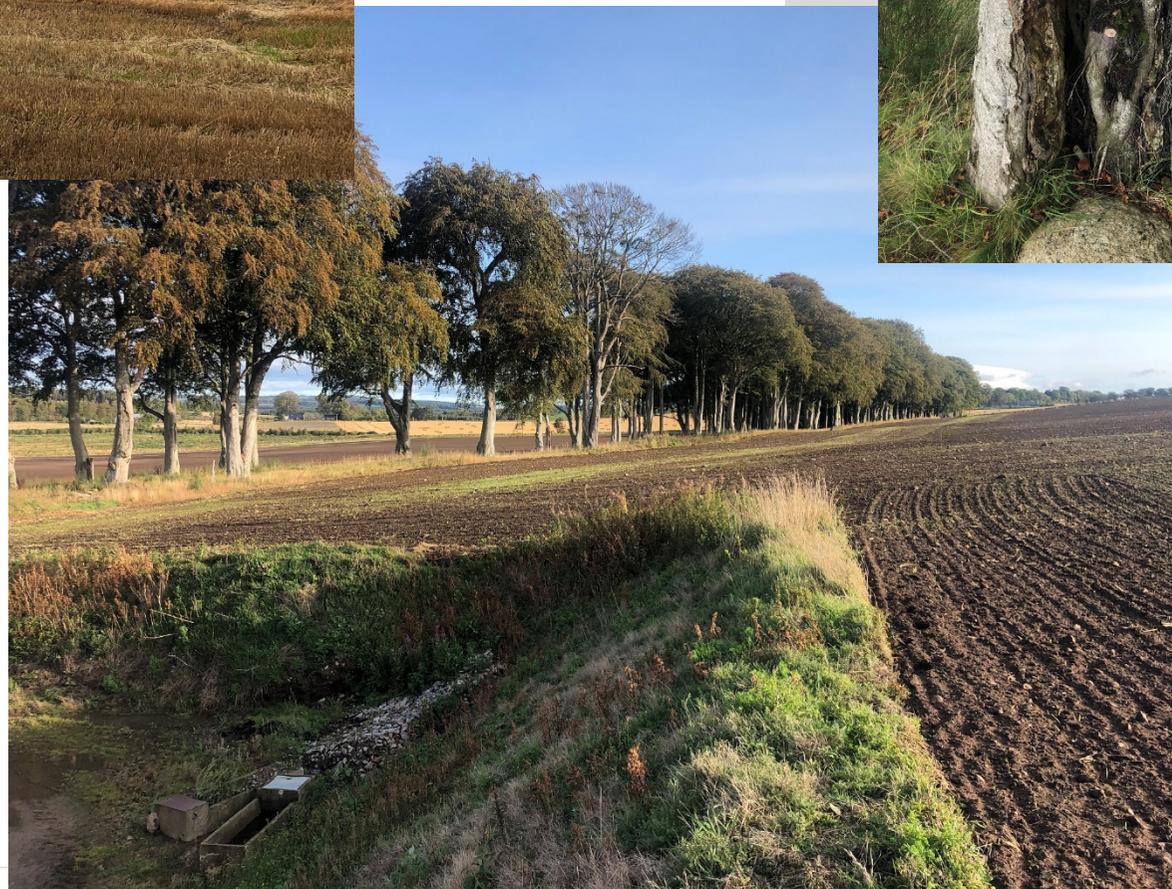
Tree nr 5

5	Beech	21	670	4	0	4	7	10W	M	Medium-sized beech. Large scar at 0m where tree has previously lost a large side stem. Large cavities with decay. Stem strength considerable compromised. Heavy bias over track/path. Crown healthy.	Fell	<10	U	11.5	10	8	no	None
6	Beech	22	730	2	3	5	7	6W	M	Medium/large tree. Scar on east. Pruning stub at 2.5m on west with decay (stub too short). Small percent deadwood in crown. Crowded / squeezed crown (between neighbours) -however overall healthy. Large branch on west overhanging track has decay .	Remove side branch	20+	B2	14.5	12	8.5	no	None
7	Beech	22	780	3	5	3	8	7W	M	Large tree - fairly upright form . Healthy, no decay, several small cavities on west side.	None	20+	B2	20	17.5	9.5	no	None
8	Beech	22	830	7	6	2	8	8W	M	Large, healthy. Unusually clean & straight bole. Large spreading crown. On edge of gap.	None	20+	B2	21.5	20	10	no	None
9	Beech	22	1000						M	Large healthy- many metres from development. No detailed survey.	None	20+	B2	35	30	12	no	None
