# Bradford College Future Technology Centre Flood Risk Assessment

Curtins Ref: 079306-CUR-00-XX-RP-C-002

Issue Date: 06 September 2023

Client Name: Bradford College

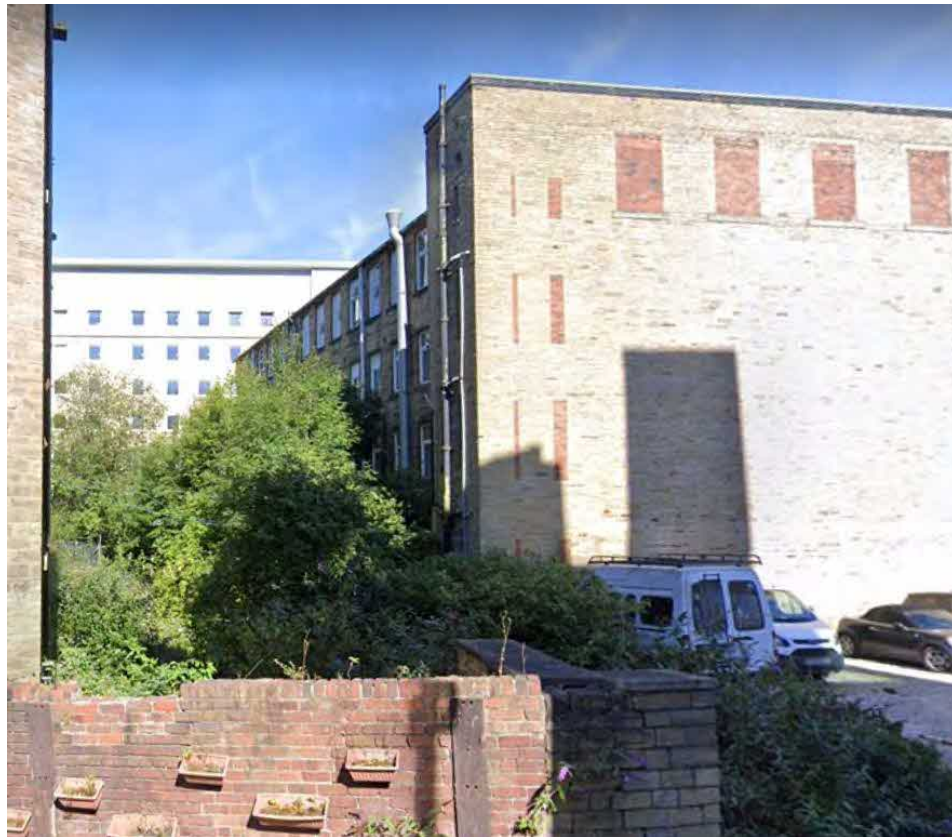
Figure 6-1 Image of Junction Mill building with Bradford Beck under vegetation to left of view

In addition to the drainage survey it should be noted that multiple invert levels are marked on the topographical survey suggesting multiple connections into the river. Access for the drainage survey was not possible owing to existing vegetation as shown in Figure 6-1 but downpipes can be seen in this area.

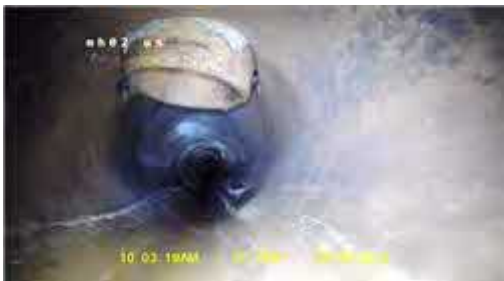
| Pos | Video Ref | Code | Cont. | Description | Image |
|---|---|---|---|---|---|
| 13.9m | 0:00:50 | CXI | | Connection intruding at 12 o'clock: 20% Intrusion : 100mm Diameter - Severity 2 | Image Provided - Ref: 2_4<br> |

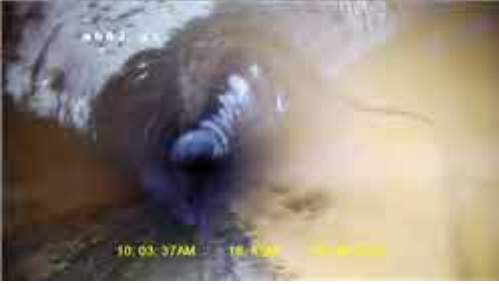
| Pos | Video Ref | Code | Cont. | Description | Image |
|---|---|---|---|--|--|
| 18.5m | 0:01:08 | CC | | Crack, circumferential from 12 o'clock to 06 o'clock - Severity 2 | Image Provided - Ref: 2_6<br> |

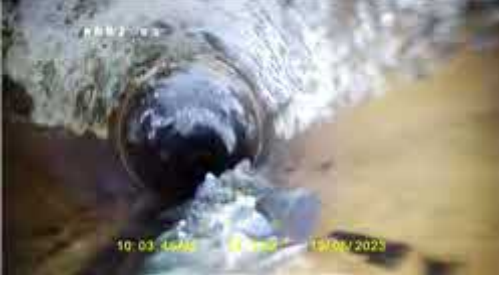
| Pos | Video Ref | Code | Cont. | Description | Image |
|---|---|---|---|--|--|
| 21.4m | 0:01:17 | DEX | | Other settled deposits: 5% cross-sectional area loss - Severity 3<br>Fouling | Image Provided - Ref: 2_7<br> |

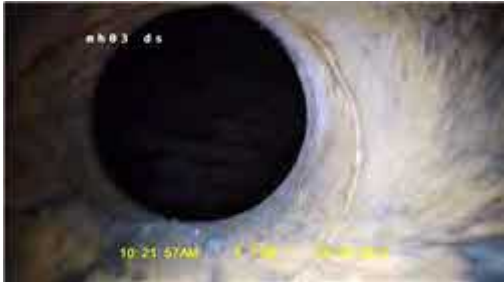
| Pos | Video Ref | Code | Cont. | Description | Image |
|---|---|---|---|---|---|
| 08.7m | 0:00:36 | FC | | Fracture circumferential from 12 o'clock to 12 o'clock - Severity 3 | Image Provided - Ref: 6_6<br> |

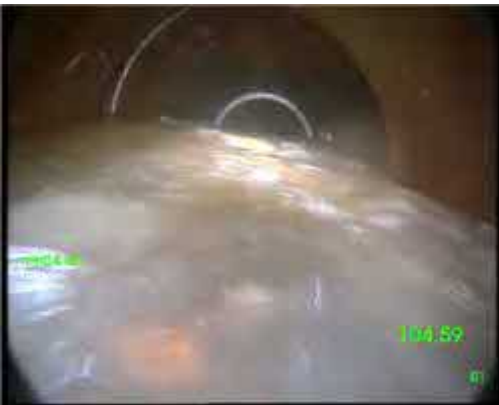
| Pos | Video Ref | Code | Cont. | Description | Image |
|---|---|---|---|--|--|
| 00.0m | | SA | | Survey abandoned<br>Survey Abandoned - Unable To<br>Camera Due To Heavy Flow | <p>Image Provided - Ref: 8_9999</p> |

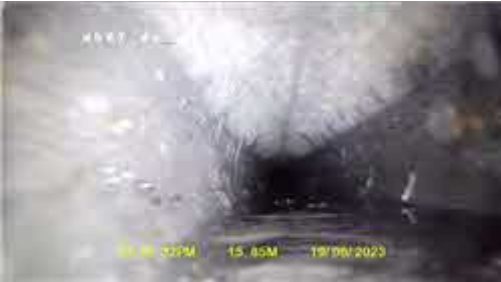
| Pos | Video Ref | Code | Cont. | Description | Image |
|---|---|---|---|--|--|
| 15.8m | 0:01:06 | DES | | Settled deposits fine: 5% cross-sectional area loss - Severity 2 | Image Provided - Ref: 12_3<br> |

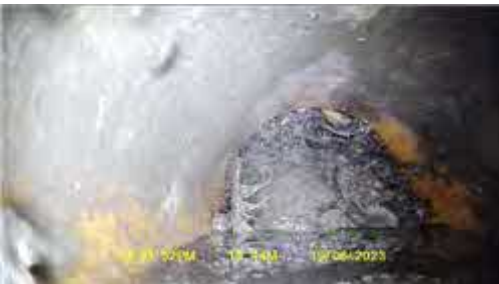
| Pos | Video Ref | Code | Cont. | Description | Image |
|---|---|---|---|--|---|
| 19.5m | 0:01:26 | DES | | Settled deposits fine: 100% cross-sectional area loss - Severity 2 | Image Provided - Ref: 12_4<br> |

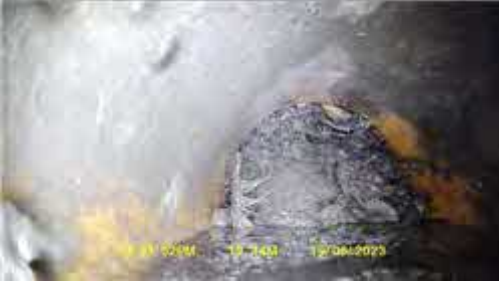
| Pos | Video Ref | Code | Cont. | Description | Image |
|---|---|---|---|--|---|
| 19.5m | | SA | | Survey abandoned<br>Survey Abandoned - Unable To Pass Silt | Image Provided - Ref: 12_9999<br> |

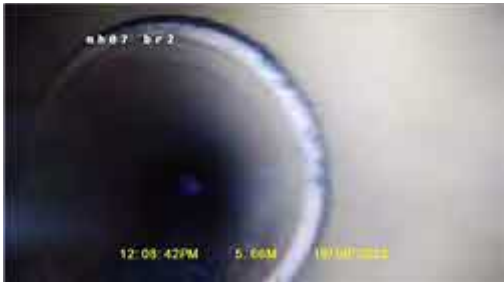
| Pos | Video Ref | Code | Cont. | Description | Image |
|---|---|---|---|---|--|
| 05.7m | 0:00:42 | OJM | | Open joint medium - Severity 2 | Image Provided - Ref: 14_8<br> |

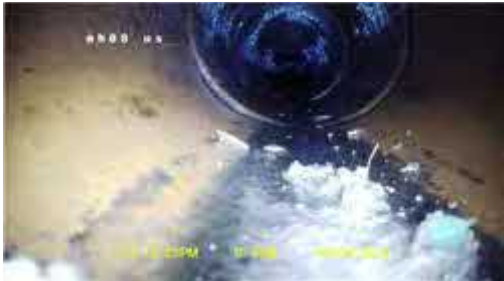
| Pos | Video Ref | Code | Cont. | Description | Image |
|---|---|---|---|--|--|
| 00.2m | 0:00:00 | OJM | | Open joint medium - Severity 2 | Image Provided - Ref: 15_2<br> |

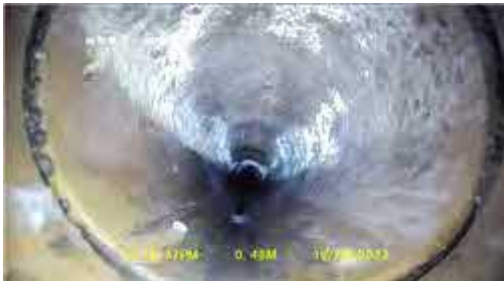
| Pos | Video Ref | Code | Cont. | Description | Image |
|---|---|---|---|--|--|
| 00.5m | 0:00:04 | OJM | | Open joint medium - Severity 2 | Image Provided - Ref: 15_3<br> |

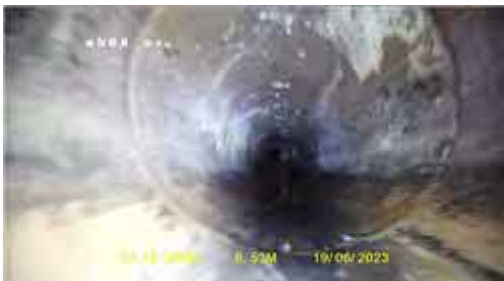
| Pos | Video Ref | Code | Cont. | Description | Image |
|---|---|---|---|--|--|
| 06.6m | 0:00:30 | FL | | Fracture longitudinal at 02 o'clock - Severity 3 | Image Provided - Ref: 15_4<br> |

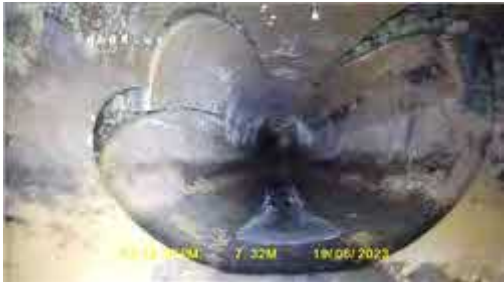
| Pos | Video Ref | Code | Cont. | Description | Image |
|---|---|---|---|---|---|
| 07.4m | 0:00:33 | B | | Broken pipe from 12 o'clock to 12 o'clock - Severity 4 | Image Provided - Ref: 15_5<br> |

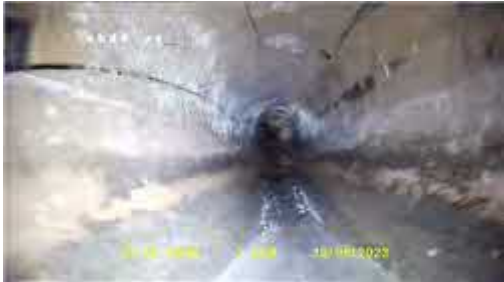
| Pos | Video Ref | Code | Cont. | Description | Image |
|---|---|---|---|---|---|
| 07.5m | 0:00:40 | FL | | Fracture longitudinal at 09 o'clock - Severity 3 | Image Provided - Ref: 15_7<br> |

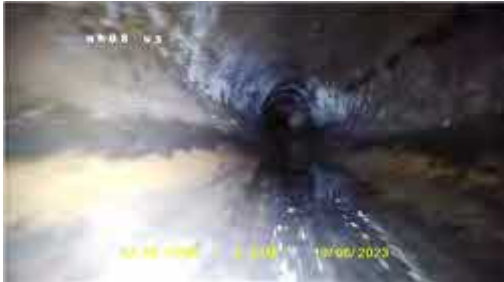
| Pos | Video Ref | Code | Cont. | Description | Image |
|---|---|---|---|---|---|
| 07.6m | 0:00:41 | DEF | S1 | Attached deposits, fouling 7.6m - 9.1m from 05 o'clock to 07 o'clock: 5% cross-sectional area loss - Severity 2 | Image Provided - Ref: 15_6<br> |

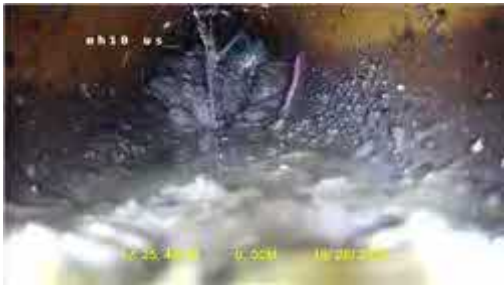
| Pos | Video Ref | Code | Cont. | Description | Image |
|---|---|---|---|--|---|
| 00.2m | 0:00:00 | DEX | | Other settled deposits: 100%<br>cross-sectional area loss -<br>Severity 3<br>Fouling | Image Provided - Ref: 18_3<br> |

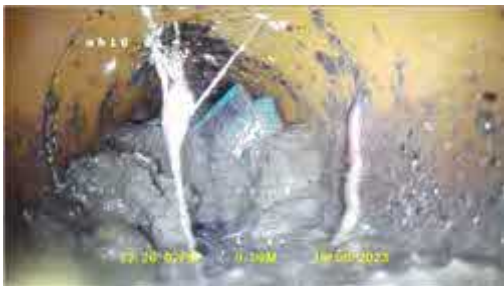
| Pos | Video Ref | Code | Cont. | Description | Image |
|---|---|---|---|--|---|
| 00.2m | | SA | | Survey abandoned<br>Survey Abandoned - Unable To<br>Pass Fouling | Image Provided - Ref: 18_9999<br> |

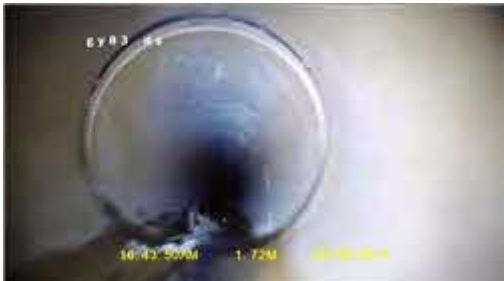
| Pos | Video Ref | Code | Cont. | Description | Image |
|---|---|---|---|--|--|
| 01.8m | 0:00:10 | OJM | | Open joint medium - Severity 2 | Image Provided - Ref: 24_3<br> |

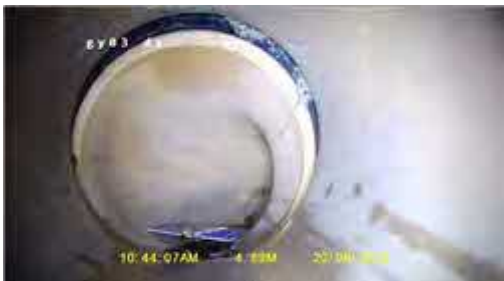
| Pos | Video Ref | Code | Cont. | Description | Image |
|---|---|---|---|--|--|
| 05.0m | 0:00:28 | OJM | | Open joint medium - Severity 2 | Image Provided - Ref: 24_4<br> |

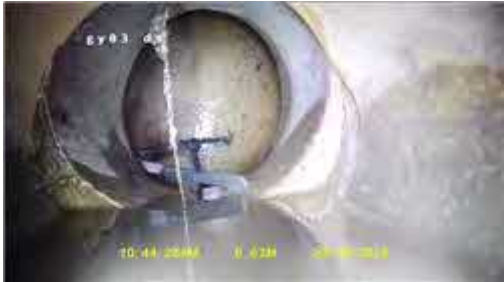
| Pos | Video Ref | Code | Cont. | Description | Image |
|---|---|---|---|---|---|
| 06.6m | 0:00:41 | JDM | | Joint displaced medium - Severity 2 | Image Provided - Ref: 24_7<br> |

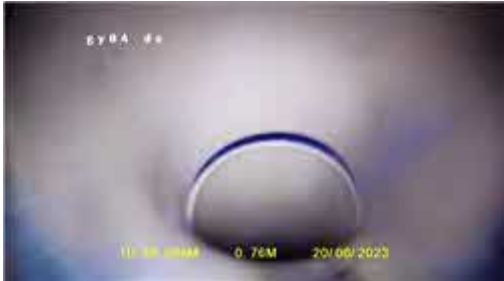
| Pos | Video Ref | Code | Cont. | Description | Image |
|---|---|---|---|---|--|
| 01.0m | 0:00:05 | OJM | | Open joint medium - Severity 2 | Image Provided - Ref: 25_3<br> |

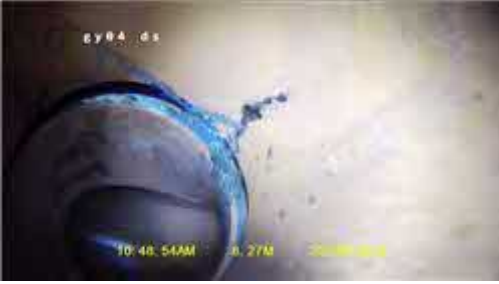
| Pos | Video Ref | Code | Cont. | Description | Image |
|---|---|---|---|---|--|
| 08.4m | 0:00:39 | OJM | | Open joint medium - Severity 2 | Image Provided - Ref: 25_6<br> |
