Replacement windows

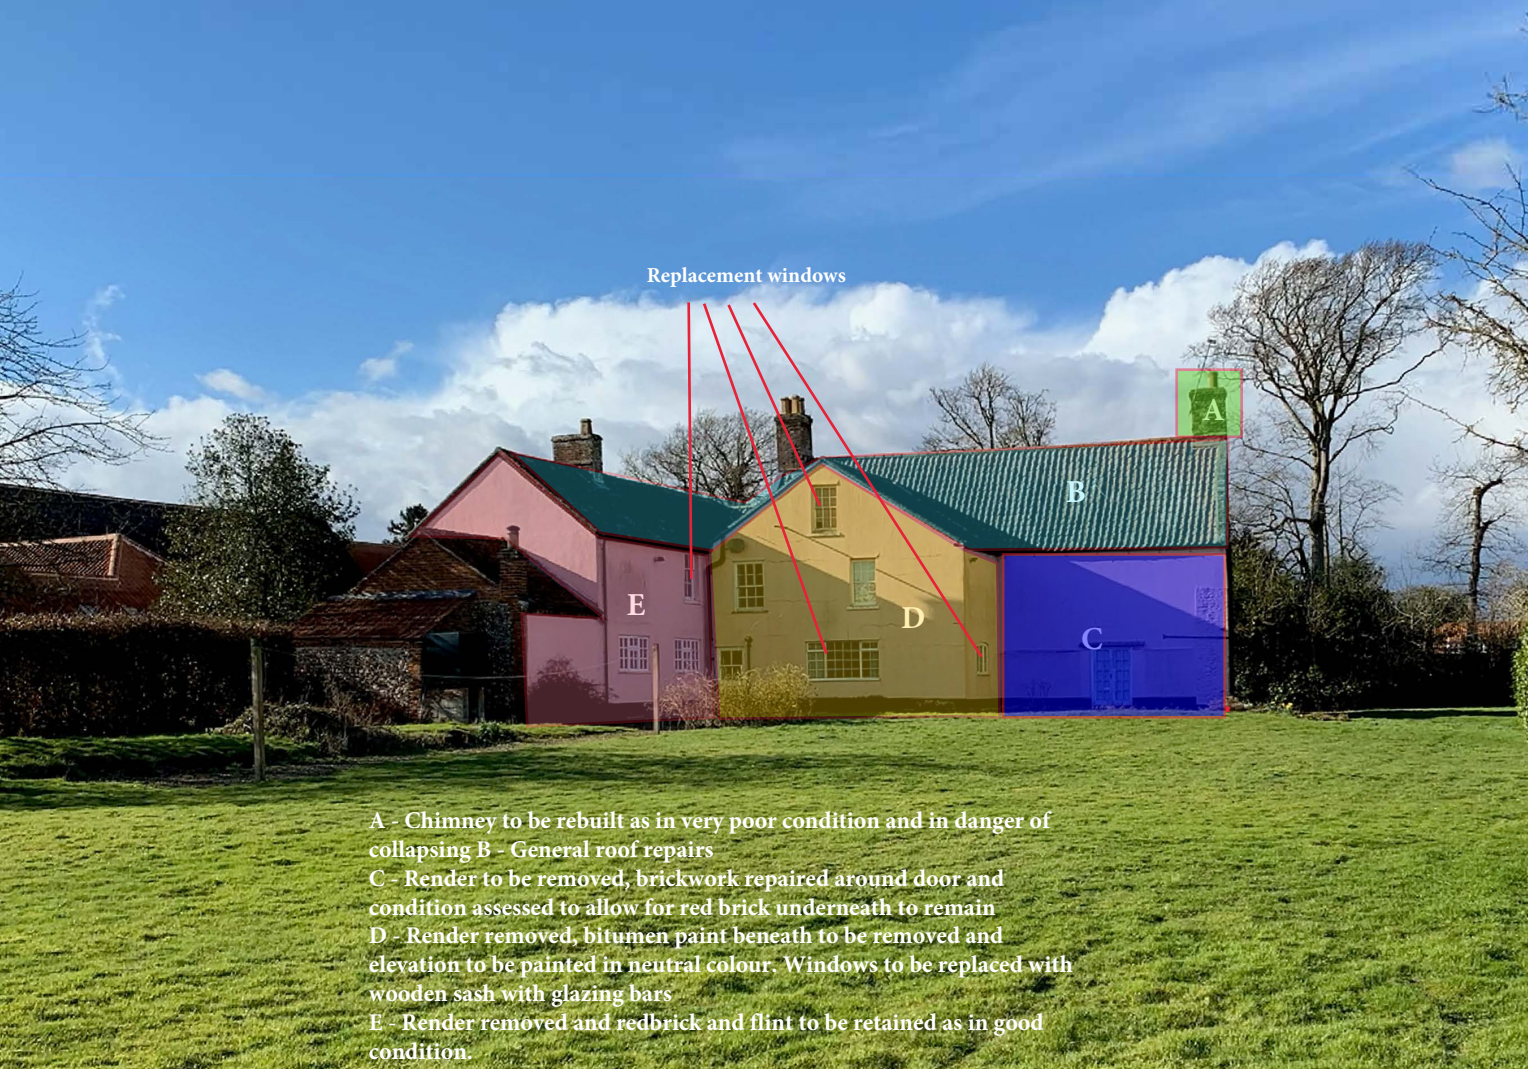
- A - Chimney to be rebuilt as in very poor condition and in danger of collapsing
- B - General roof repairs
- C - Render to be removed, brickwork repaired around door and condition assessed to allow for red brick underneath to remain
- D - Render removed, bitumen paint beneath to be removed and elevation to be painted in neutral colour. Windows to be replaced with wooden sash with glazing bars
- E - Render removed and redbrick and flint to be retained as in good condition.
