s h e d visual structural survey
Flemings Hall barns
Beddingfield, Suffolk

As part of the proposed conversion works to the existing barns and outbuildings at Flemings Hall, Bedingfield, **s h e d** undertook a visual structural survey on the property to inform the planning submission and overall development proposals.

s h e d undertook the visual survey in July 2023. Weather conditions were fine and dry.

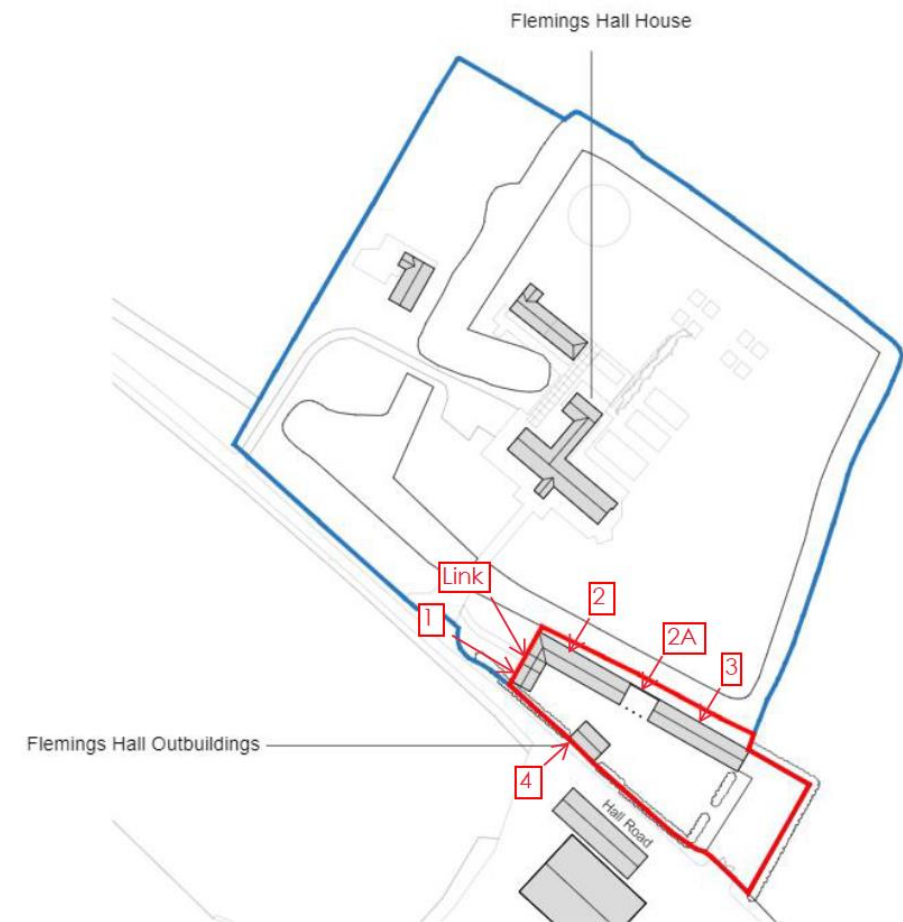
Fig.2 outbuilding/barn refs.

The existing structures comprise a number of outbuildings including an 18th century barn. Each structure is described with reference to fig.2 as follows:

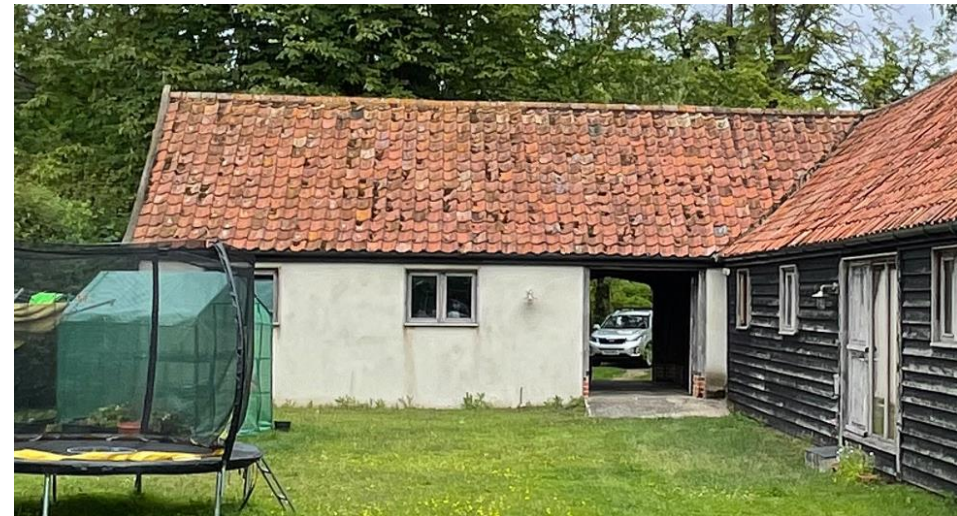
The barn is a single storey structure with visible oak structure internally forming a traditional pitched roof, likely supported off a concealed timber frame structure with low level brick walls, which are clad externally with both rough sawn timber boards and rendered panels. The structure appears to have been constructed later than the 18th century thatched barn and substantial repair and re-building works are likely to have been undertaken from the visible condition noted. The visible timbers appear to be in good condition and appear to have been sensitively replaced, likely during the previous conversion works. There are some exposed timbers to the covered external link sat on low level brick piers which appear to be in good condition.

The barn has been previously converted to provide living accommodation, currently utilised as storage. There are no visible signs of movement or structural distress to the structure, and walls appear stable. Given its current state, there are no concerns with the ability of the structure to be upgraded as required to suit current building performance requirements.

Fig.3 rendered elevation to courtyard

If the proposals include any amendments to existing cladding/render, appropriate care should be taken to consider future damp penetration to any exposed timber members.

- Amendments to cladding (if required) to be considered in relation to avoiding any future damp penetration to exposed timbers.

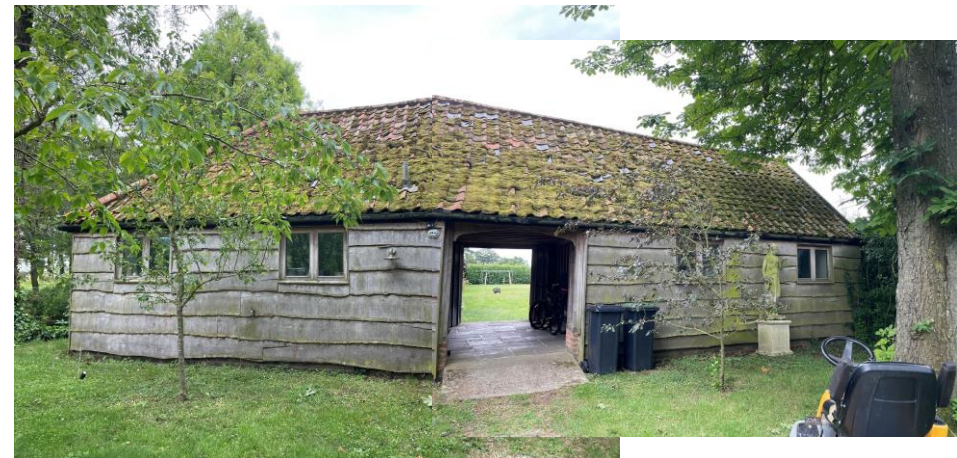
Fig.4 timber clad elevation to north-west

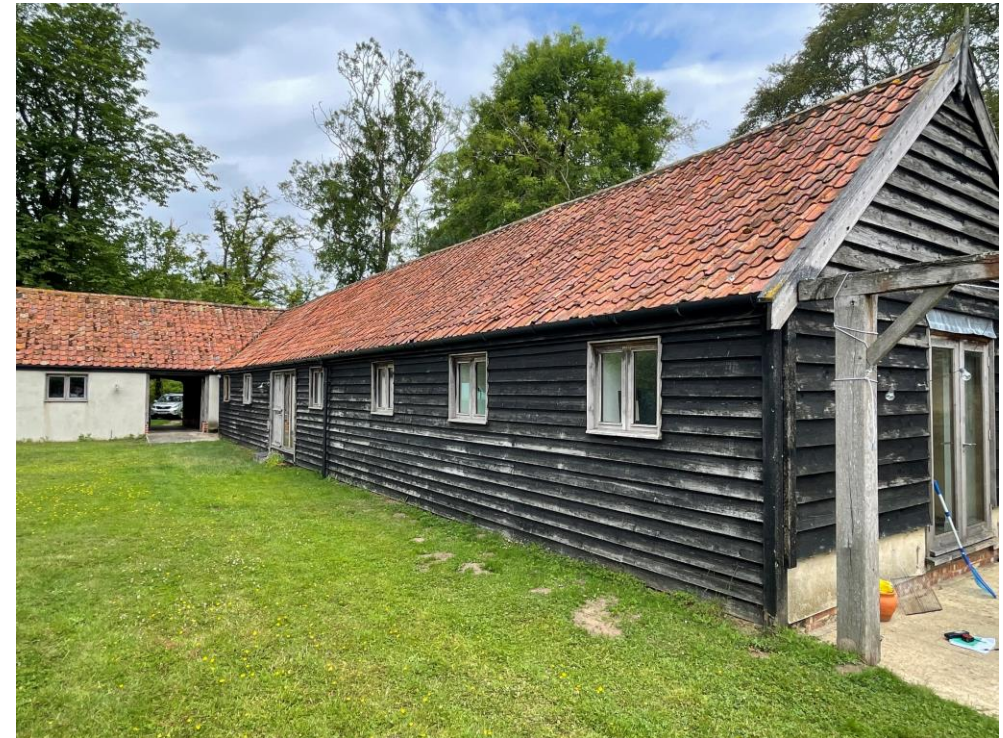
The structure forms a continuation of structure 1 and link and is a previously converted single storey barn. Similarly, to structure 1, there is visible oak structure internally forming a traditional pitched roof, likely supported directly off a concealed timber frame to one side, clad externally to the courtyard facing elevation with black stained timber cladding and exposed facing brick on the north elevation facing the moat. Here this appears to have comprised an original brick garden wall although this appears to have been repaired, likely when the barn was converted into habitable accommodation. No issues were noted to this section of the wall. Substantial repair and re-building works are likely to have been undertaken from the visible condition noted generally of the timber roof structure with visible timbers in good condition. These appear to have been sensitively replaced, likely during the previous conversion works.

The barn has been previously converted to provide living accommodation. There are no visible signs of movement or structural distress to the structure, and walls appear stable. Given its current state, there are no concerns with the ability of the structure to be upgraded as required to suit current building performance requirements.

Fig.5 timber clad elevation to courtyard

If the proposals include any amendments to existing cladding/render, appropriate care should be taken to consider future damp penetration to any exposed timber members.

- Amendments to cladding (if required) to be considered in relation to avoiding any future damp penetration to exposed timbers.

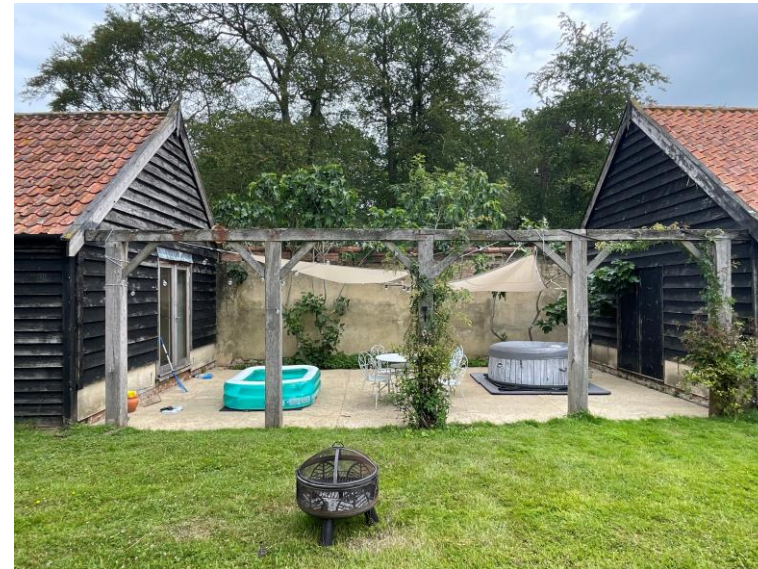
The structure comprises a standalone timber frame likely original to this section of the barn given there is a similar entrance arrangement to structure 3. There is no roof structure although it is likely this would have been present as a continuation of structure 2 with the roof supported from the brick garden wall. Given they are fully exposed with no protection from wetting, the timbers are in reasonable condition. There is some splitting noted and UV damage, but this would be expected for externally exposed timber and is not considered to be causing any loss of structural integrity. The timbers are supported above ground level from plinths and there does not appear to be any localised issues as a result of damp.

Fig.6 exposed timber frame

It would be advisable as part of any redevelopment works to provide a UV protective coating but overall, the timbers appear adequate and would likely be sufficient to support a reinstated roof structure if of similar construction to the existing, without any further strengthening.

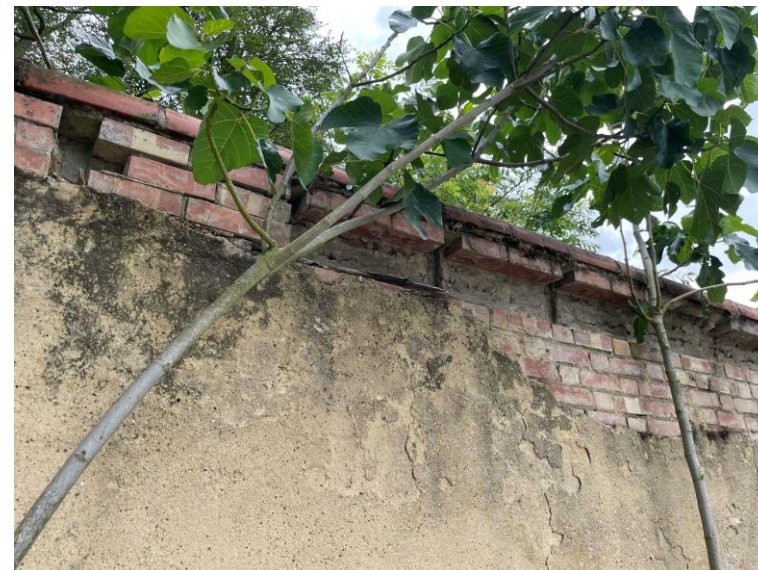
The exposed brick garden wall appears to be in its original state and there are localised issues which should be addressed. The wall has been rendered on one side but is past its lifespan and has spalled off in places. This has likely caused the brickwork itself to spall, exacerbated at original rafter/truss and wallplate locations visible, and there are a number of brick courses with missing bricks and mortar loss as a result. It is advised that this is removed, and the brickwork infilled and re-pointed to reinstate structural integrity of the wall. If rendered, then a breathable render should be provided. The exposed brickwork face towards the moat is of similar condition, albeit with substantial lime bloom noted. There has been some historic movement of the wall and patching undertaken but substantial piers are in place on the moat side at each end of the wall panel which appear adequate and in good condition. It is advised that vegetation growing adjacent to the wall on the courtyard side are removed to mitigate against future damage and movement to the wall.

Fig.7 garden wall condition

Render facing courtyard, bricks missing, vegetation

- The exposed timbers should be treated as part of any redevelopment works to mitigate against ongoing exposure to the elements.
- The existing brick garden wall has localised issues which should be addressed including removal of the existing render, infilling of brickwork and re-pointing.
- Should this area become an internal space then damp penetration would need to be considered as part of the proposals.

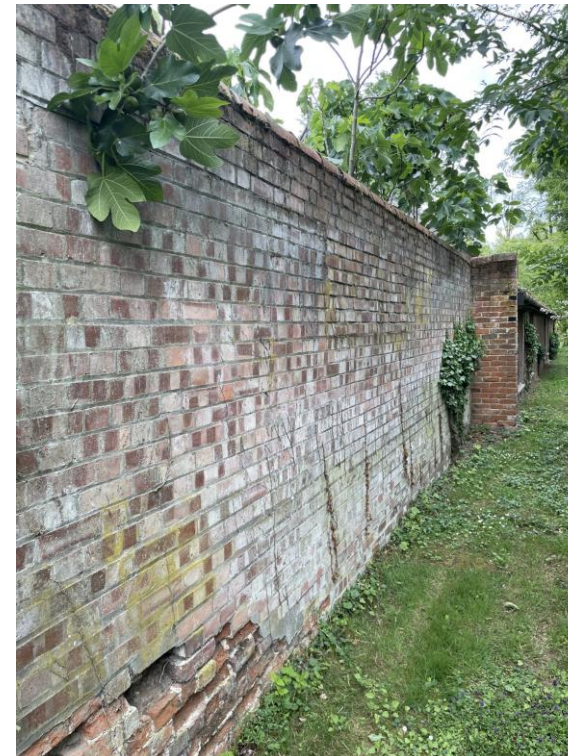
There is 1 no. small area noted with mortar loss and missing bricks which will require repair (shown on fig.8). Overall, the wall appears structurally substantial for its purpose but should be repaired as noted with brickwork reinstated and repointing throughout. A flexible mortar is recommended and damp protection to internal areas as part of any redevelopment would need to be considered. If the original roof structure was to be reinstated, then this would be of benefit providing further restraint to the top of wall as ties could be incorporated.

Fig.8 brickwork condition to elevation facing moat

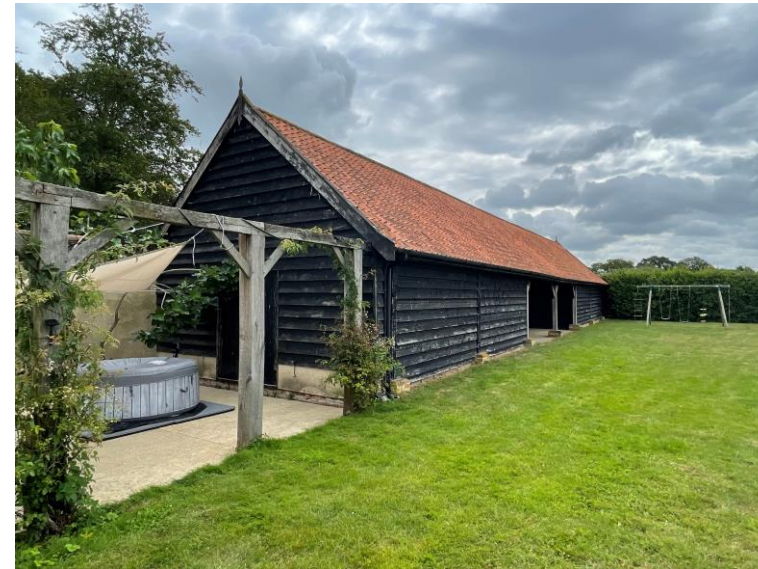
The visible timber appears forming the traditional cut roof and the framing elements to the courtyard facing elevation appear to be in good condition and it is thought the members have been substantially and sensitively replaced likely during the conversion works of the adjacent structures. standalone forms a continuation of. There was some localised splitting of the timbers noted (fig. 13) but this is not unusual in timber structures, and the frame is uninsulated and so not thermally protected. There are no concerns over this structurally.

Fig.9 general view

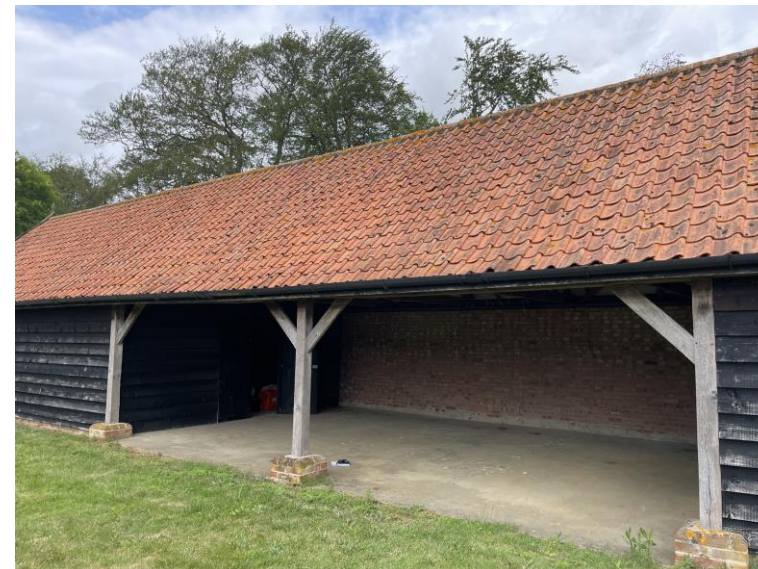
The exposed timbers at the covered entrance area are protected from direct wetting from above and do not appear to be showing any issues as a result of water damage either at the head or at the base where they are supported on raised plinths.

Fig.10 covered entrance area

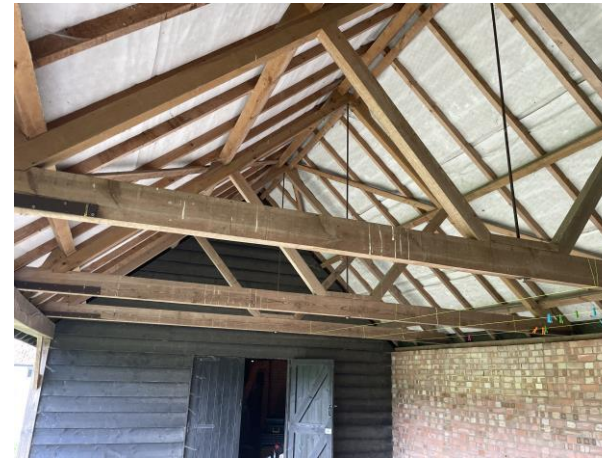
Fig.11 general view - roof condition over covered external area

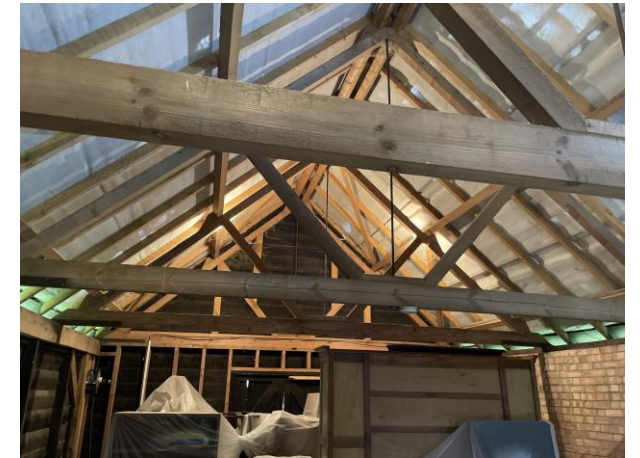
Fig.12 general view - internal roof condition

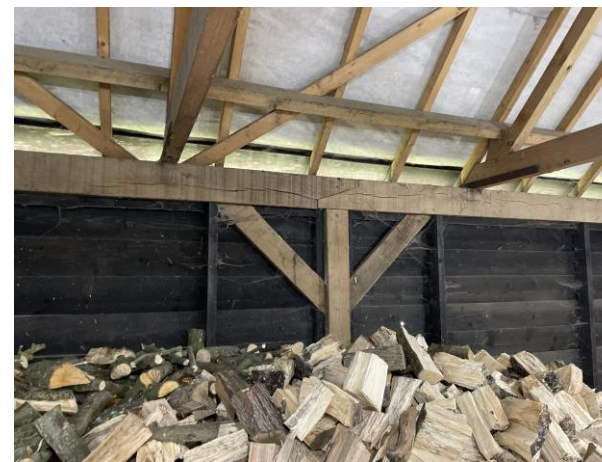
Fig.13 general view - visible timber frame

- Amendments to cladding and proposed wall build-ups to be considered in relation to avoiding any future damp penetration to the timber framing and exposed timbers.
- Ground floor build-ups would need to consider the existing concrete slab levels and adjacent ground levels, also to ensure there is no potential for damp penetration to the base of the timber framing.

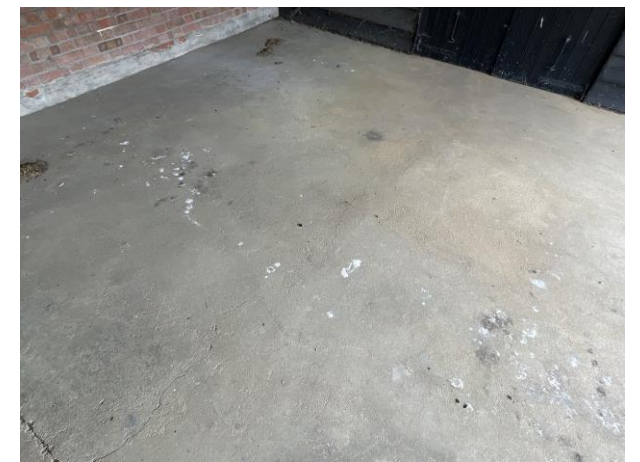
The current floor comprises a cast in-situ concrete slab. This is not original. Its condition appears reasonable consistent with its usage and trafficking. It appears to have been cast in sections with joints visible however some localised surface cracking was noted. This is most likely apparent as a result of shrinkage cracking and is not of structural concern. The build-up and levels of a proposed ground floor if converted would need to be considered in relation to the existing slab levels and adjacent ground levels.

Fig.14 general view - concrete floor slab

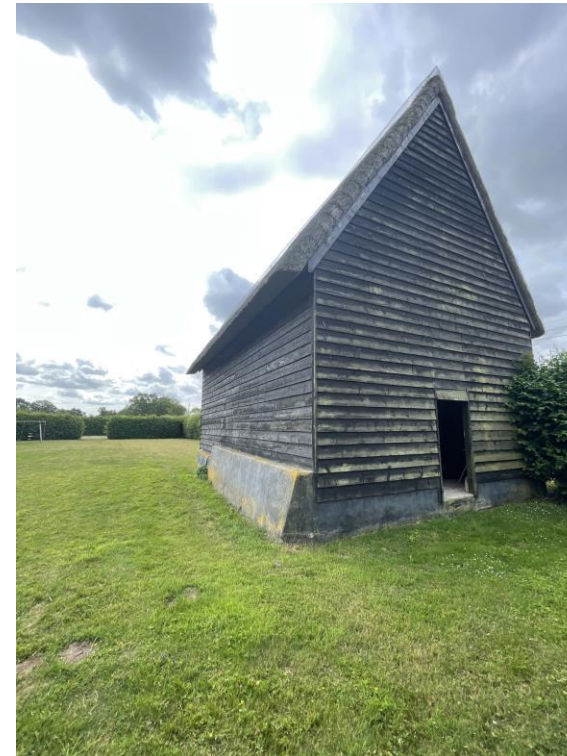
Fig.15 general external view

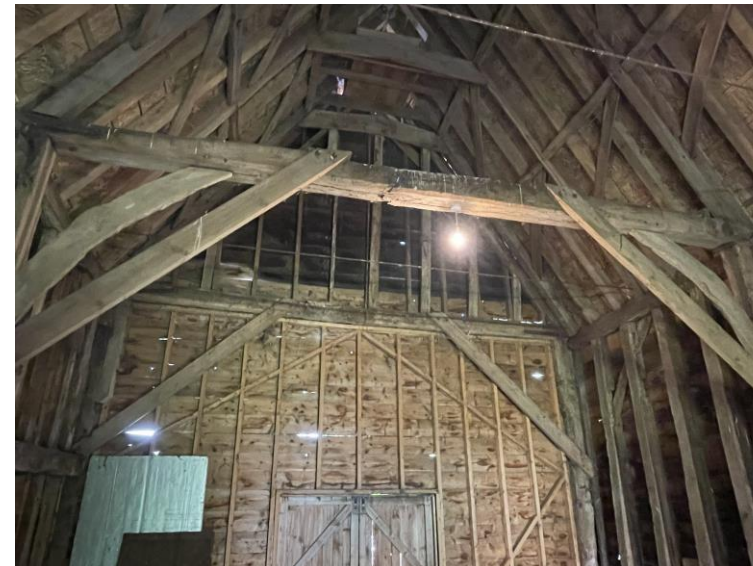
The barn frame comprises 4 no. primary frames, noted as F1-F4 on the structural sketch arrangement included in the appendix. The frames comprise a pitched braced portal arrangement with a horizontal eaves tie with sloping principal rafter members above in lieu of a separate truss, which in turn support cut timber rafters on purlins. The long elevations include diagonal braces between adjacent frames forming stability in this direction. Between the frames loose verticals are present spanning from the top of a raised perimeter concrete plinth to eaves level supporting the horizontal black stained cladding.

Fig.16 general internal frame view

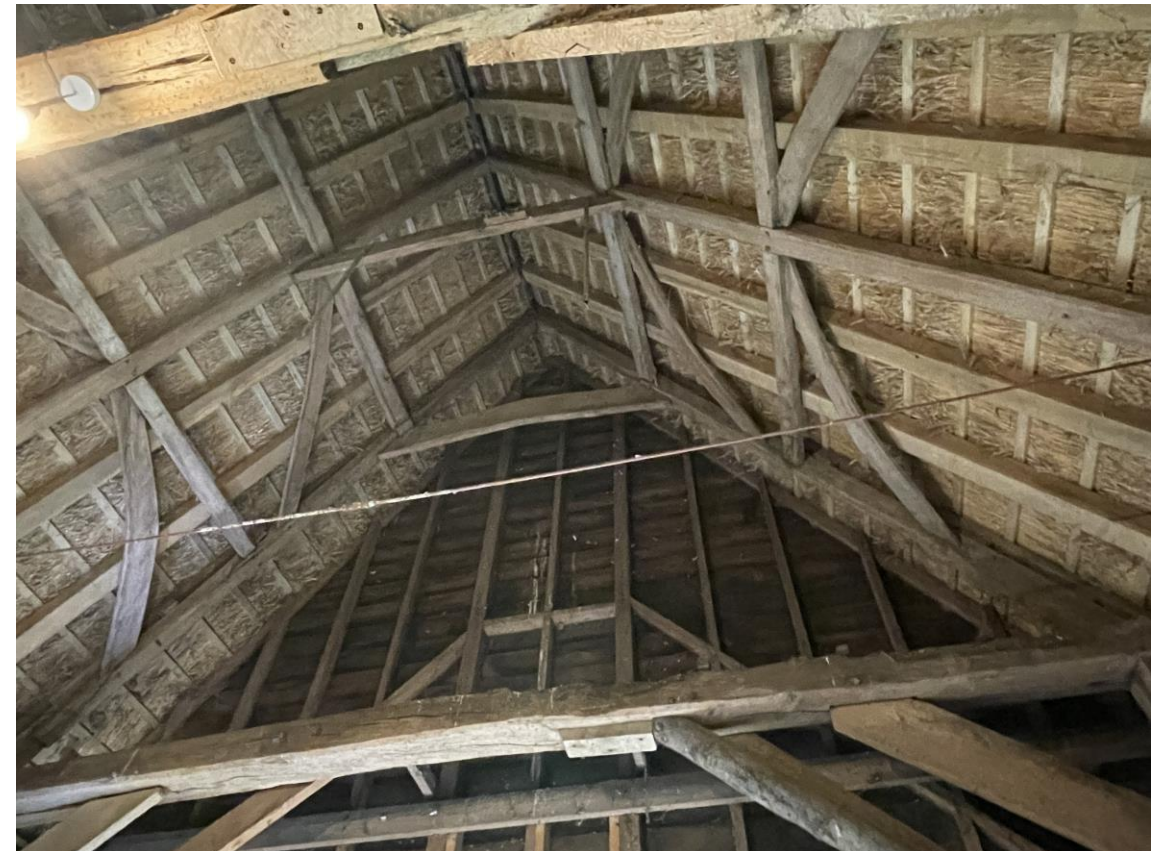
Overall, the roof structure appears to be in the most reasonable condition of the whole structure. Previous works have been undertaken to re-thatch the roof, and it appears that the majority of the original sloping structure has been replaced above eaves level. The timbers appear to be in good condition of high-quality timber, likely undertaken on a like for like basis with oak used throughout. The battens have also been replaced and appear sound. Both the cut rafters and principal rafters have been replaced and therefore currently the roof structure is performing adequately and stable. Timbers to the gables do not appear to have been replaced, refer to discussion on gable walls for comments.

Fig.17 general roof structure

For conversion works, upgrades to the roof build-up internally i.e insulation and finishes should be considered in relation to the capacity of the existing roof structure however this is not thought to be of concern as the members throughout appear substantial and the roof structure is adequately tied. If found to be required, localised strengthening could be incorporated with additional timbers of similar grade and quality to reinforce the frame locally as required. This would not be detrimental to the structure.

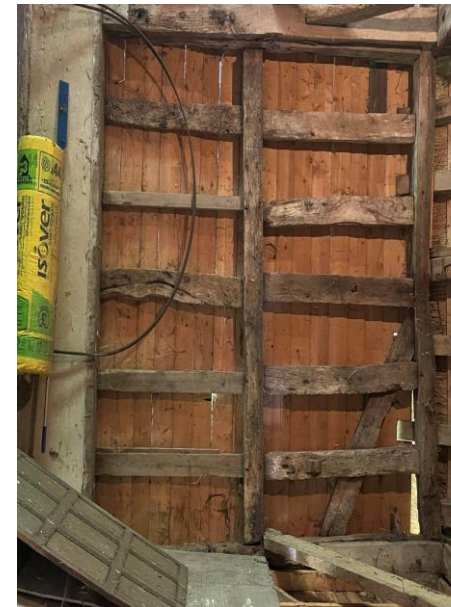
The walls comprise original vertical timbers spanning from a low level concrete plinth to eaves level. There are typically 4-5 between each primary frame with some knee braces incorporated at eaves level and some surface fixed diagonals - as general image shown.

Fig.18 general wall elevation

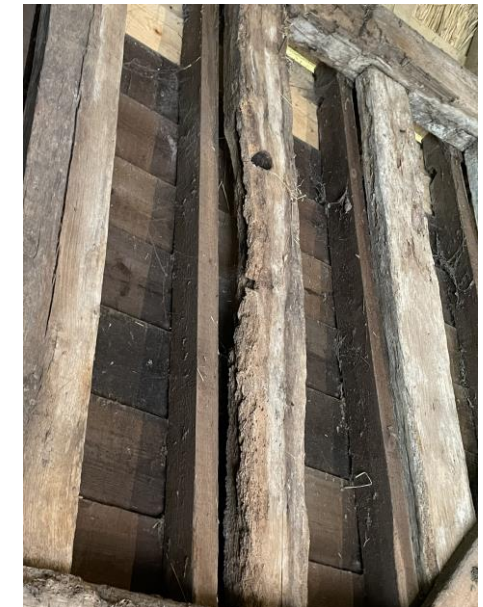
These timbers are original and are in poor condition. These have been subject to extensive insect damage and long term deformation, with loss of section in numerous locations. In some locations there is little contact between base of member and the existing soleplate (fig. 20-21). The external cladding has been more recently replaced however it does not appear any of the existing frame or wall verticals were repaired or replaced. To provide support to the cladding the verticals have been supplemented by additional vertical timbers of varying depth to accommodate the alignment vertically of the original frame, which appear to be treated softwood, and are in reasonable condition. These are in places fixed to the existing verticals and currently provide the majority of support and integrity to the cladding.

Fig.19 supplementary cladding supports

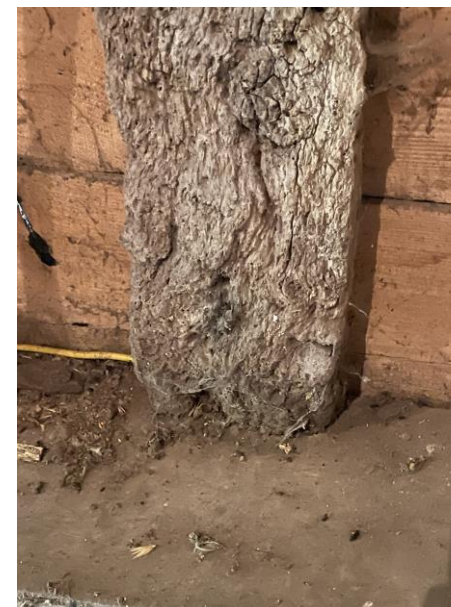
Fig.20 insect damage

The original verticals and diagonals form part of the overall stability of the frame and by virtue of the supplementary timbers are currently stable, however, to reinstate structural integrity to the frame these should be replaced where insufficient. Each member will need to be reviewed on a case by case basis. The majority will require attention with either complete replacement or significant sections cutting out and replaced with timber on a like for like basis. If this is adopted then suitable joints should be utilised. Some members will require complete replacement. A suitable method statement should be provided by the contractor to advise on replacement to coordinate with any upgrades to the building fabric as required to facilitate conversion. Replacement on a one-by-one basis is advised to maintain stability of the frame. This also applies to the principle verticals of frame F1-F4. For these, temporary bracing may be required to prop the eaves members whilst replacement is undertaken.

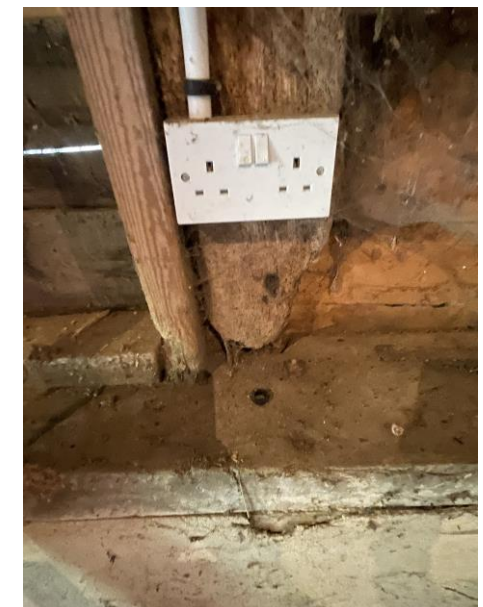
Fig.21 loss of base section

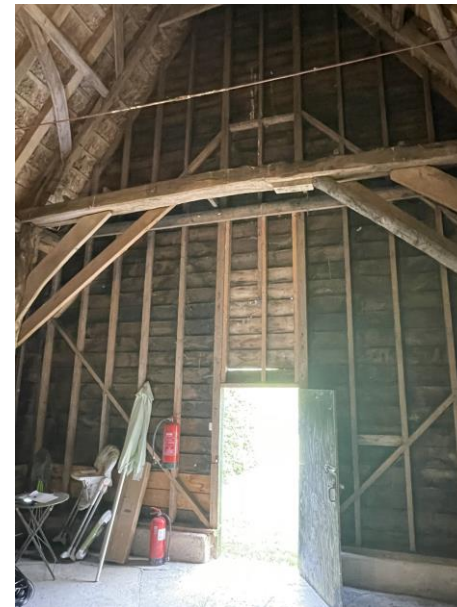
The gable walls comprise infill timbers, original above eaves tie level which do not appear to have been replaced or repaired as part of previous cladding works. The timbers visually appear in reasonable condition although loss of section and insect damage was noted to various members particularly along the sloping rafter lines. A similar strategy to the walls should be used to maintain long term integrity of the structure, with either complete replacement or localised sections cut out and replaced on a like for like basis.

Below eaves tie level, each gable end has been infilled. It is likely the structure may have originally been open or substantial doors present. Currently, softwood infills have been provided comprising verticals to provide cladding support, trimmed around a doorway at each end. One infill appears to have been provided at the same time as the cladding repairs as the timbers are similar, and is of reasonable quality and performing adequately. The southern gable has a more recent infill comprising smaller sections of treated softwood. The sections do not appear adequate and despite some diagonal bracing are not sufficient. The trimming arrangement around the opening is not adequate resulting in the lintel member sagging and doors unable to open easily. These are not structural integral to the frame and could be omitted to facilitate conversion. Doing so would allow opportunity for additional strengthening in the plane of the gable to provide additional long term support to the frame.

Fig.22 northern gable

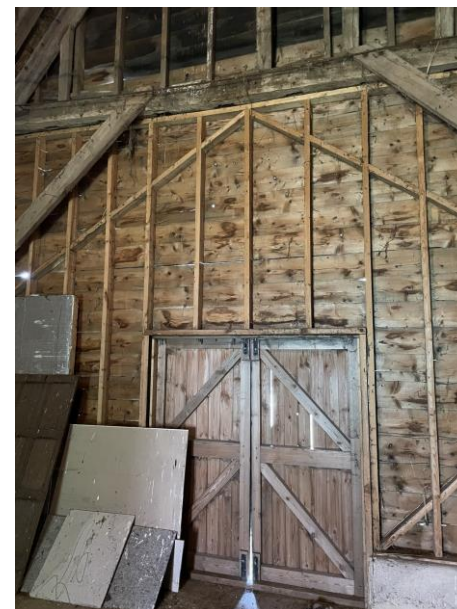
Fig.23 southern gable

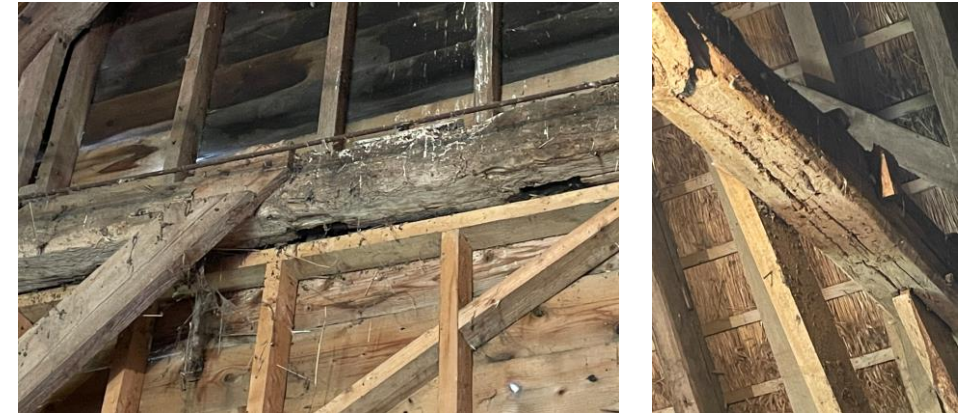
Condition of the vertical members was mentioned above, however the horizontals and diagonal braces are of similar condition, notably F2-F4 where considerable section has been lost to the horizontals with cracking and insect damage visible. F2 and F3 have had at some point additional braces provided to supplement original members, these appear to be performing adequately. Those members to F3 are raw timber and so their structural grade will be variable. It is recommended that where this occurs these are replaced with timber of known grade.

Fig.24 left - F4 insect damage, right - cracking and loss of section to F3

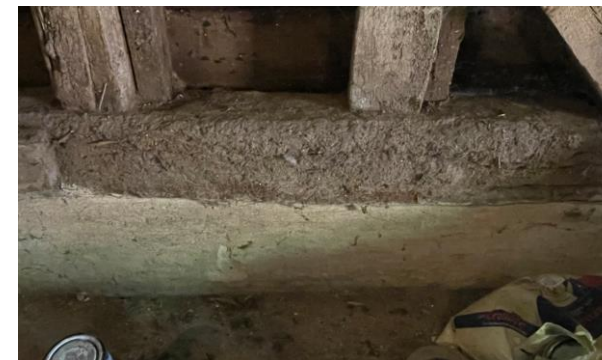
The base of the timber frame is supported from an original timber soleplate off a concrete plinth that has at some point been inserted to lift the timber off the ground. The soleplate is variable in condition with sections subject to insect attack. To maintain long term integrity sections should be cut out and replaced.

Fig.25 soleplate section with significant insect damage

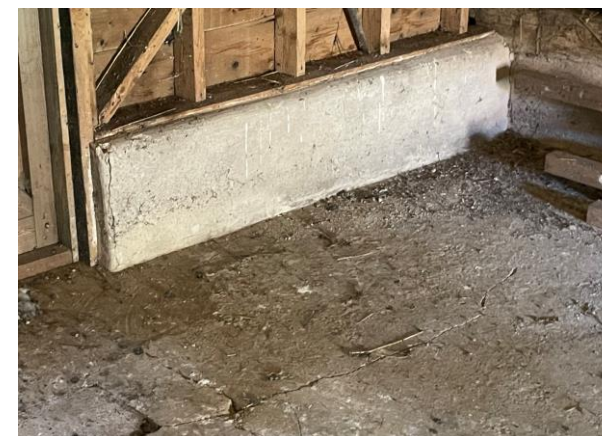
The concrete plinth itself is in reasonable condition with only some localised cracking noted near openings which would be anticipated (fig. 26).

Fig.26 plinth and floor slab cracking

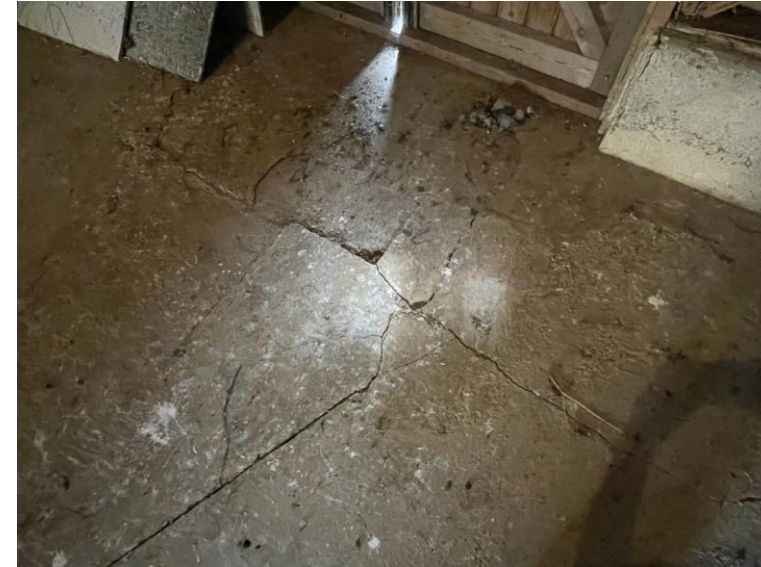
There is considerable cracking across the floor which in itself may not be an issue as the surface was adequate for its intended agricultural use however may only comprise unreinforced concrete without joints and therefore has been subject to shrinkage over time. The level is variable however and the north-west corner slopes down which indicates likely settlement of the ground beneath. Externally, the condition of the perimeter plinth visible appears good, with cracking noted to the western elevation particularly at the north-west corner (fig.28). This appears to be localised only and given the relatively light loading from the timber frame not likely to be progressive. It would be advised however that any redevelopment works incorporated stabilisation in the form of local underpinning to this corner. It is likely any conversion would require insulation to the ground floor. The existing surface could be utilised with insulation and a flexible finish provided, although a better long term solution may be to remove the cracked slab, compact any soft spots below and provide a new levelled concrete slab. This would need to be considered in sequence to avoid compromising the perimeter plinth structure.

Fig.27 slab cracking

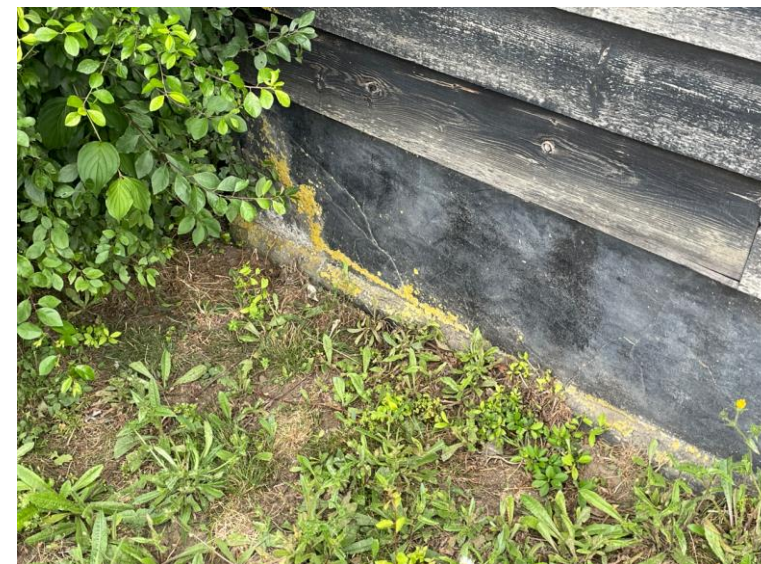
Fig.28 external plinth cracking
