# Single site survey

**Location description:** Bettws Newydd, Usk NP15 1JN

**Tree location:** T1 on west gate external boundary. T2 inside gate to east of drive.

**Tree species:** T1 Beech. T2 Cherry.

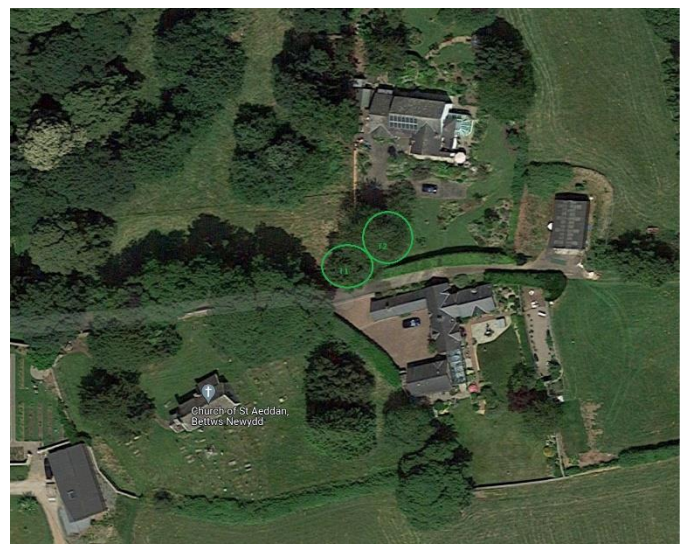
T1 has a slightly phototropic form to the south and east due to a previous tree being located to the west. T1 is outgrowing the one-sided form and will self-optimize its crown form. Normal resonance test. No overall concerns with tree health. T2 also has a phototropic crown to the north and east. Historical pruning is noted.

- Low foliage tips over drive.
- Squirrel damaged branches.
- Rubbing branches.

- Rubbing branches.
- Deadwood sections.
- Crown extension to north and east.

1. Lift low foliage tips over drive to 3.5-4m using natural target pruning.
2. Climb tree and check for excessively damaged branches and prune out/reduce sections as required.
3. Re balance crown density.
4. Remove any dead wood sections.

1. Remove dead wood and rubbing branches.
2. Reduce low east limb tips by up to 3m at suitable lateral branches to maintain natural silhouette.
3. Potential minor crown tip reduction required to balance tree silhouette.
