BARN CONVERSION
DOVECOTE RISE, SOUTH RAUCEBY
STRUCTURAL APPRAISAL REPORT

Commissioned by Mr A Hastings

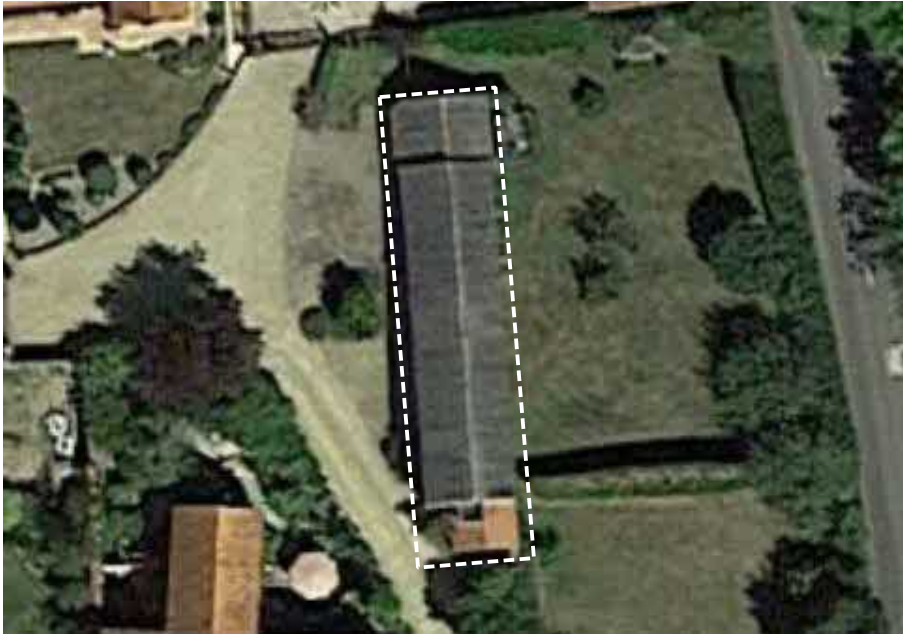
Aerial view of the site with inspected part of the building outlined (© 2023 Google).

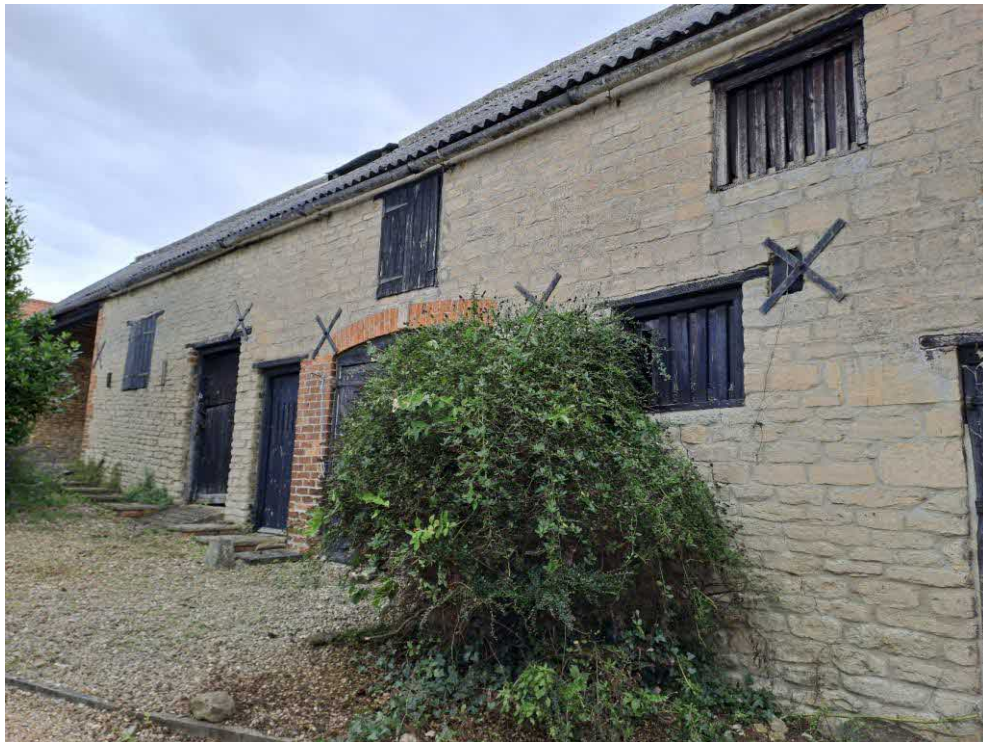
- 1 West elevation. Stone masonry in good condition. Roof cover of asbestos cement sheets. Minor deflection to the ridge in the centre of the building, with one of the ridge covers displaced. Five cross-shaped anchor plates for ties.

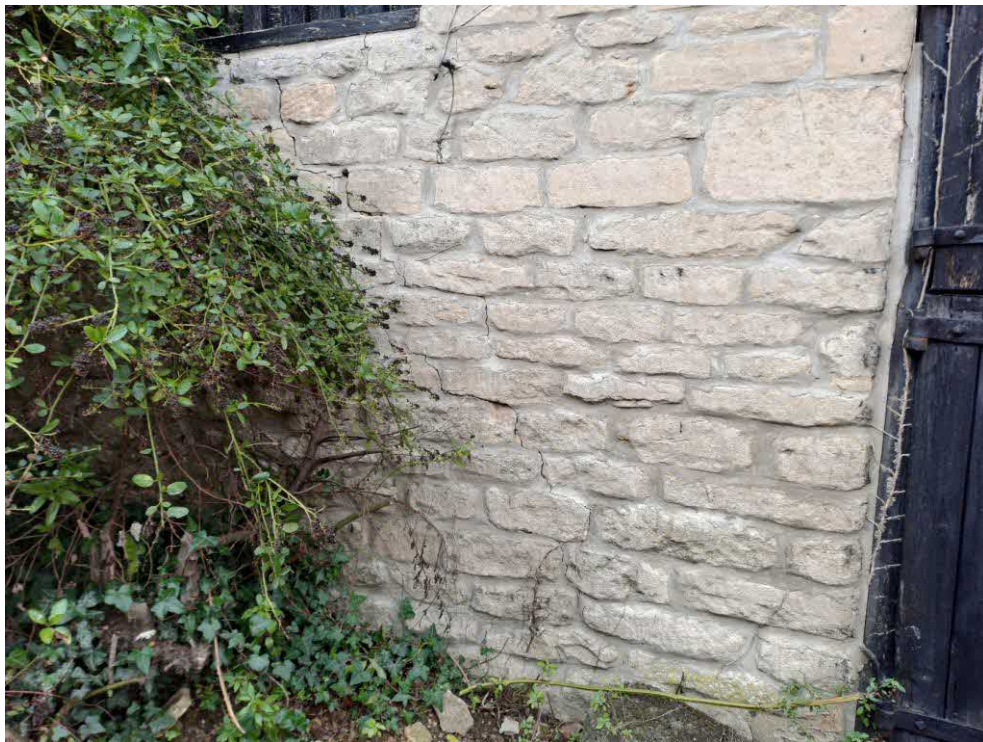
- 2 West elevation. Fine to slight diagonal stepped crack, under the ground-floor window of Barn 3.

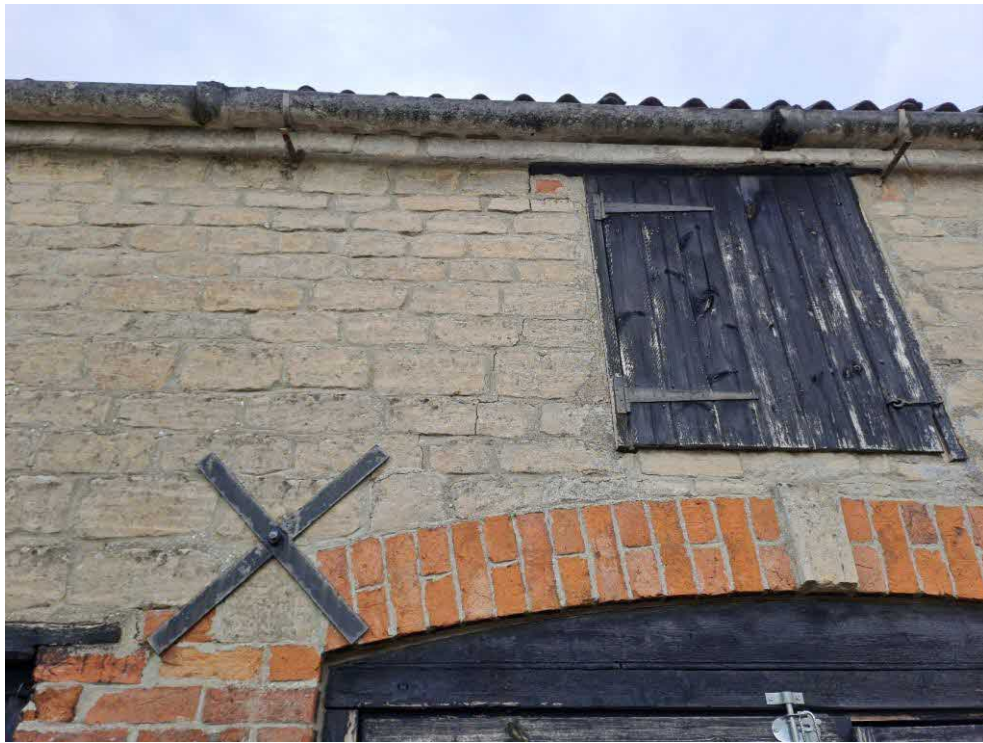
3 West elevation. Fine diagonal crack from the first-floor window in Store 2 to the cross-shaped plate.

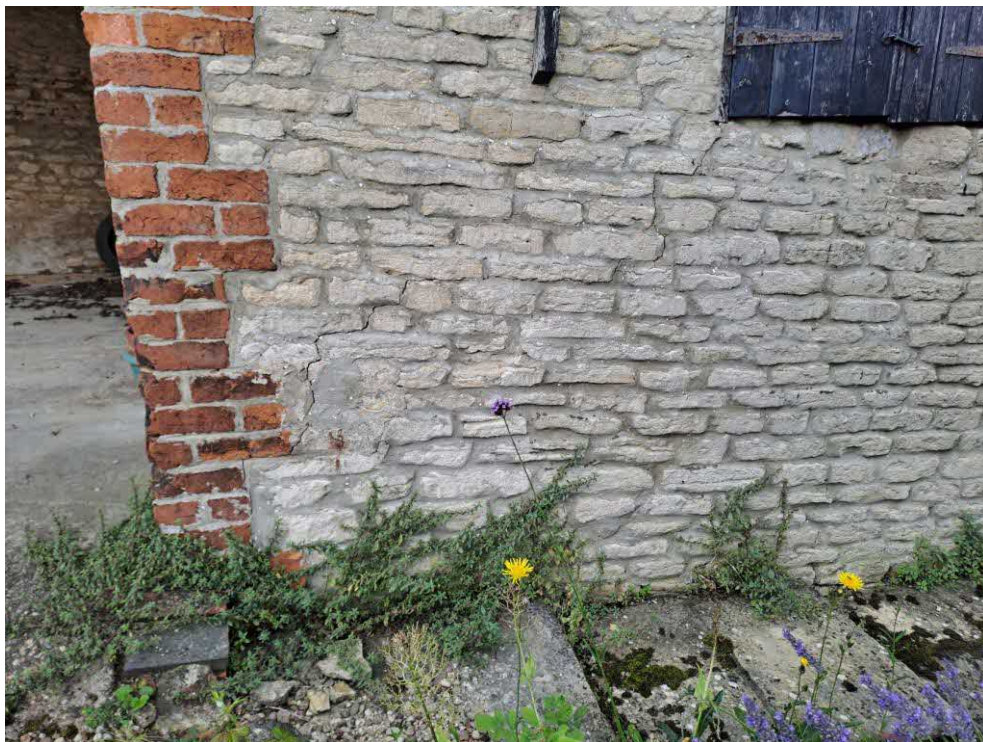
4 West elevation. Fine diagonal and bed joint crack from the corner of the window in Barn 1 to the base of the brick wall.

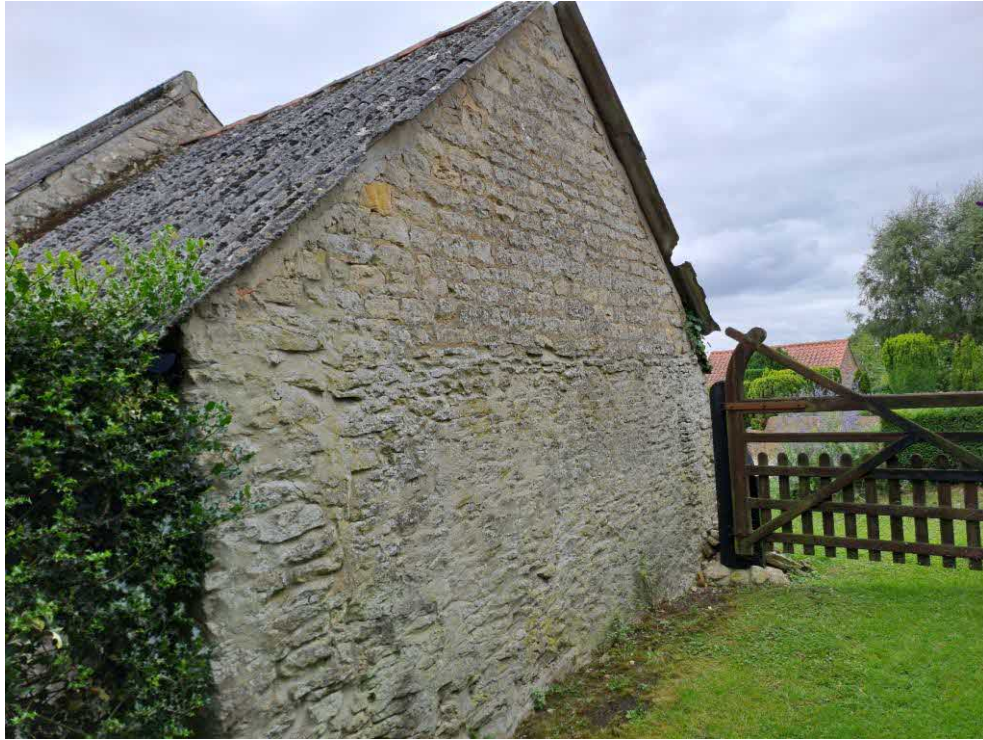
5 North elevation. Distinct stonework from possible different periods of construction. Vegetation growth to the top of the northeast corner.

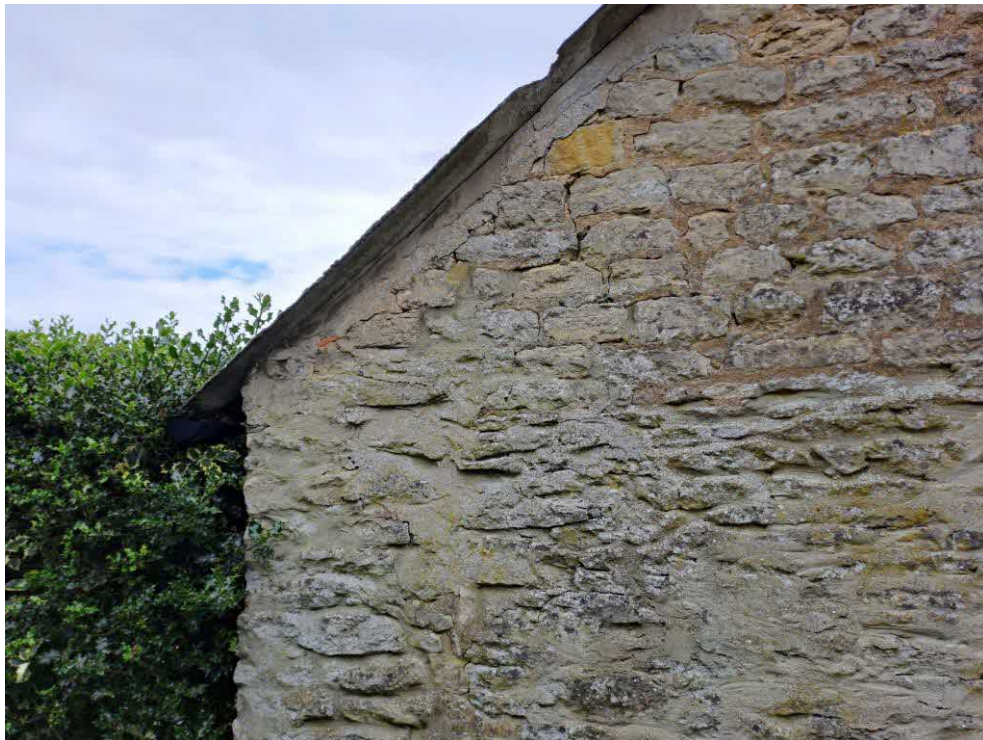
6 North elevation. Fine cracking and open joints close to eaves and connection with east and west elevations.

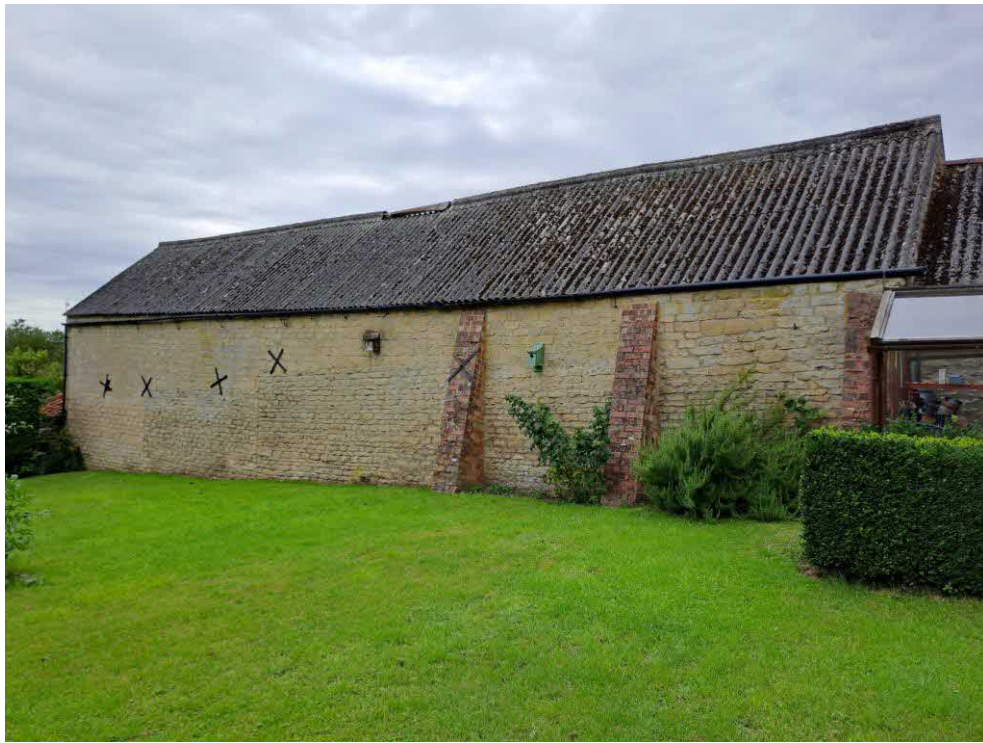
- 7 East elevation. Distinct stonework from different periods of construction. Three brick buttresses with full height of wall and tie anchor plates. Minor outward lean to the top.

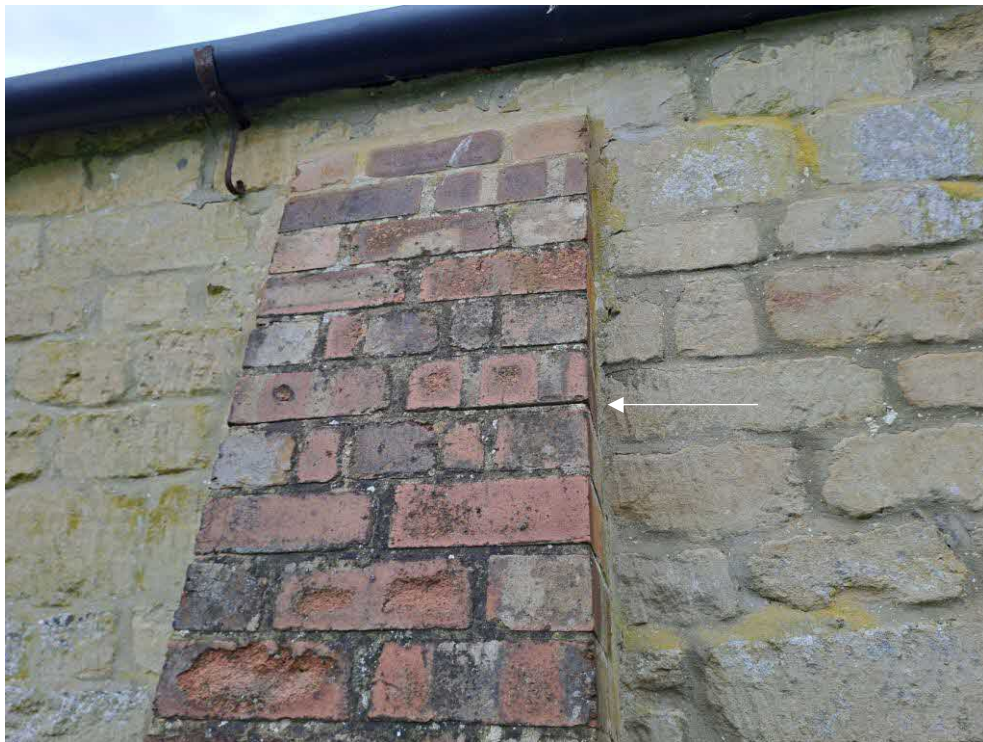
- 8 East elevation. Bed joint cracking at the top of the middle buttress.

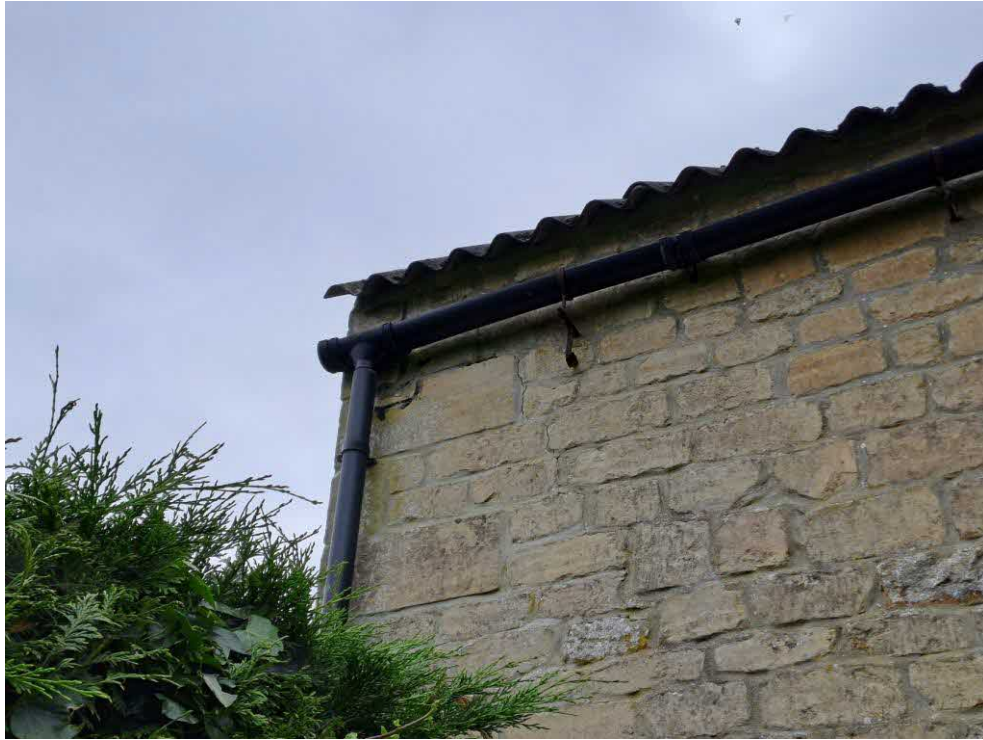
9 East elevation. Fine cracks to the wall starting from the kneeler.

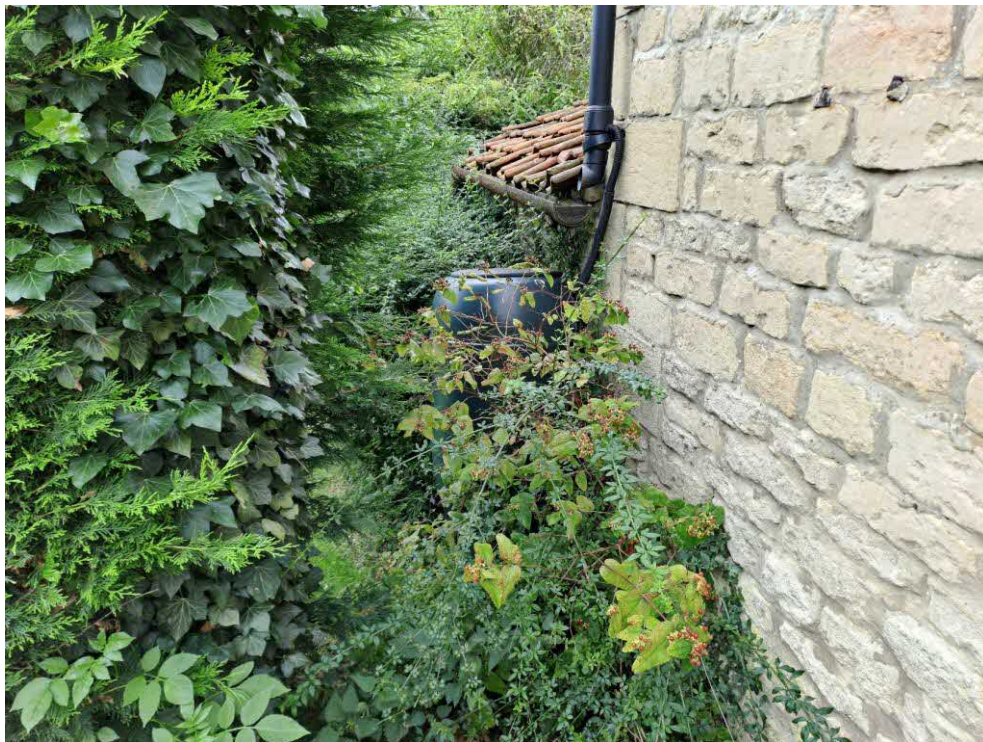
10 East elevation. Vegetation growth close to the wall. Interrupted drainage system.

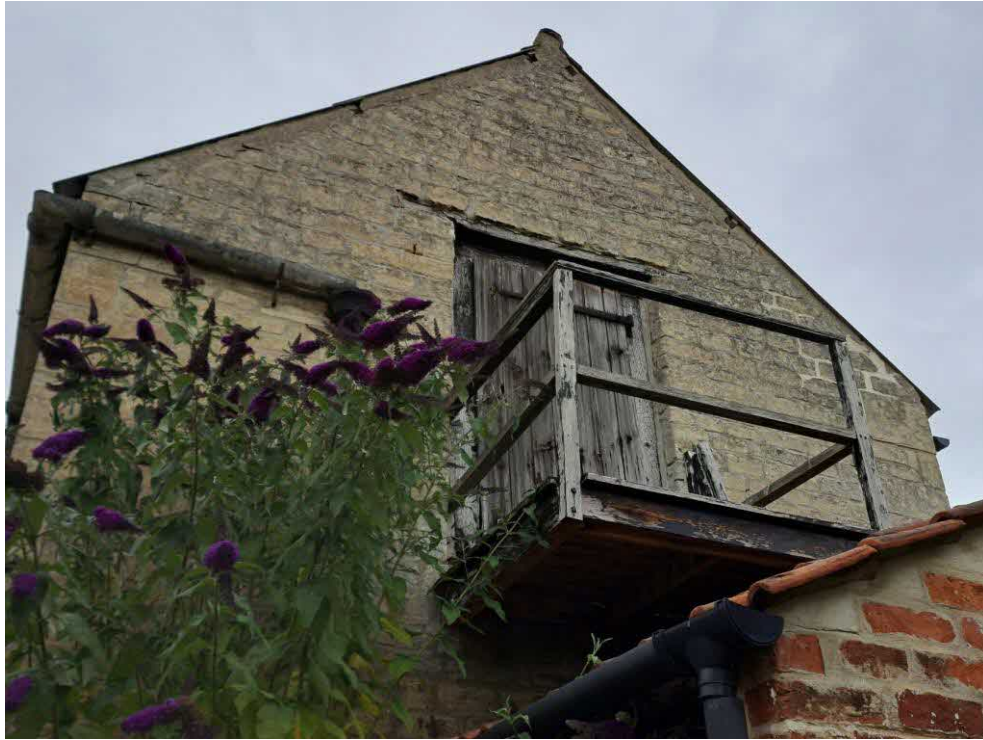
11 South elevation. Fine cracks to top of gable along eaves and west kneeler. Previous repairs around the east kneeler.

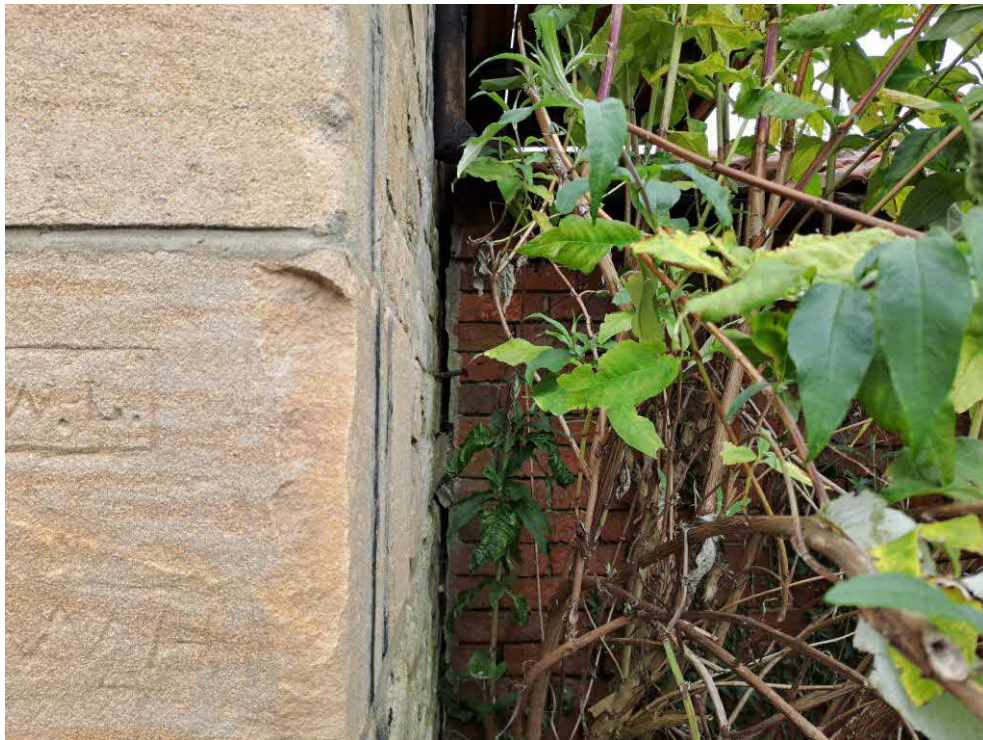
12 South elevation. Separation between the brick wall of Store 1 and the stone wall of Barn 3. Vegetation growth close to the walls.

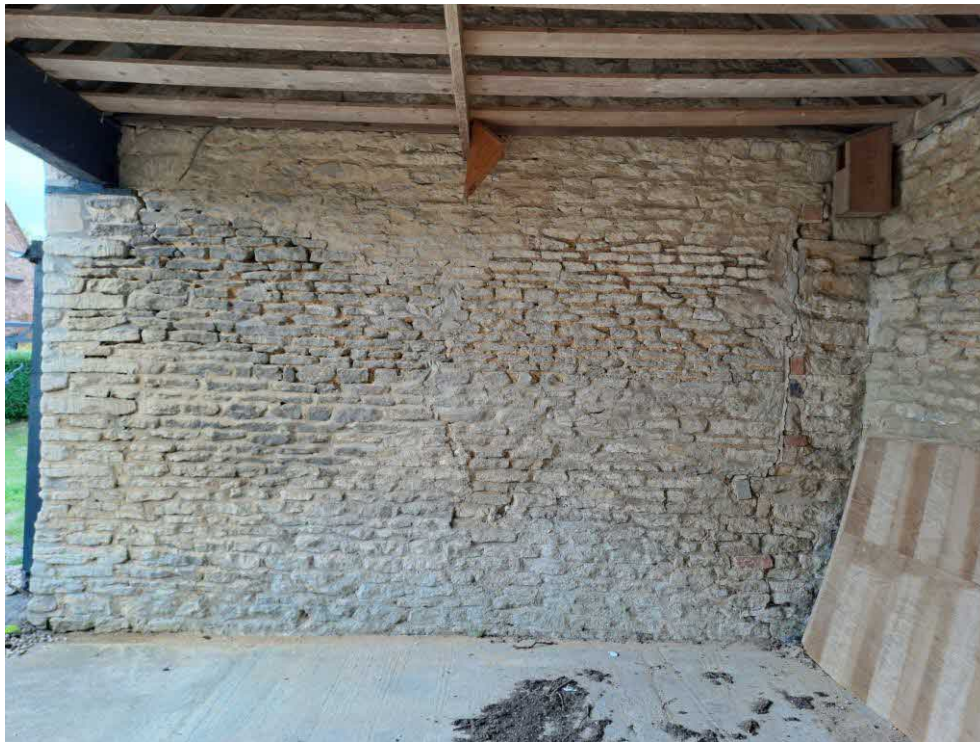
- 13 Car port. Open joints to top half of wall and bearing of stained black timber beam. Open joints and cracking to connection between pre-1824 wall and 1824-1888 wall. Connection previously infilled.

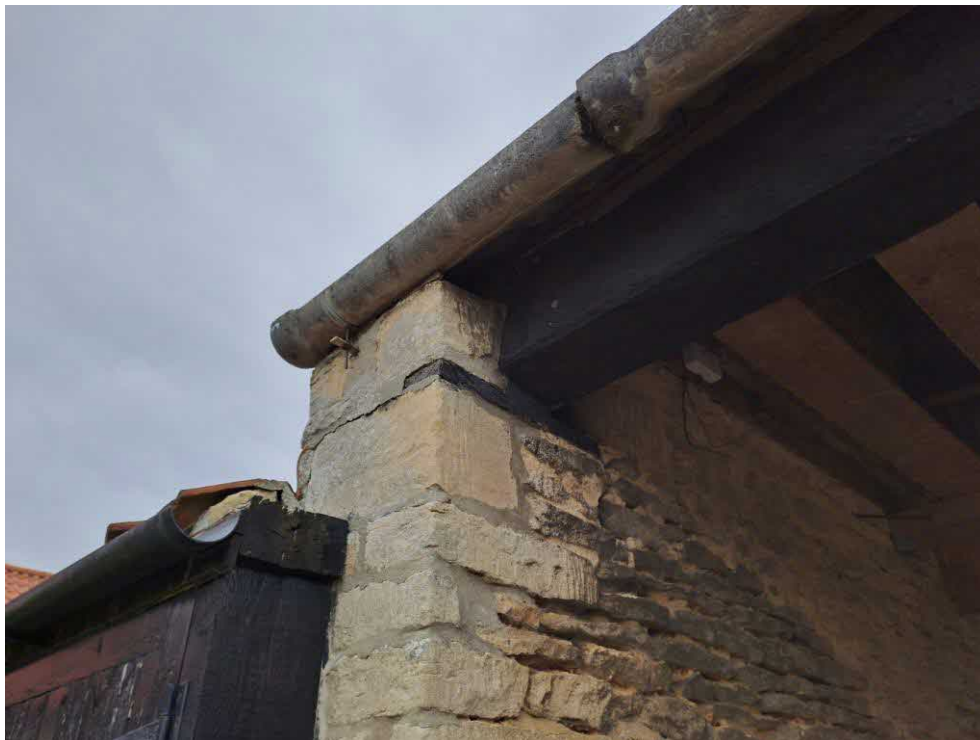
- 14 Car port. Rotation of timber beam with fine bed joint cracking to top course. No visible cracking or deflection to beam.

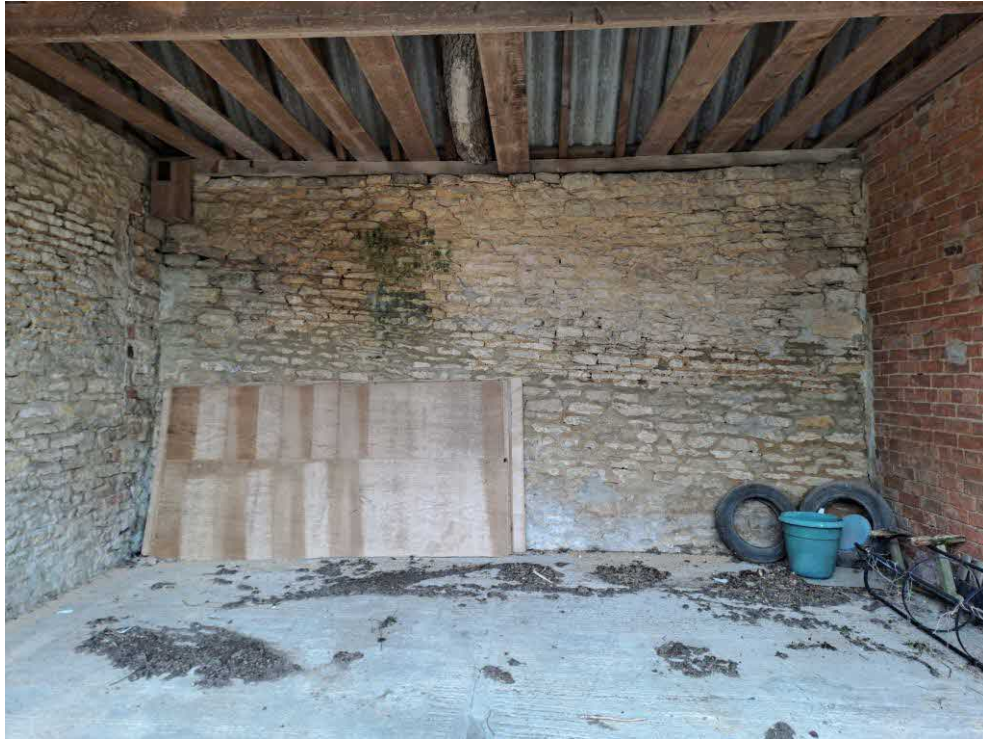
15 Car port. Wall with stonework from different construction periods (bottom pre-1824) and top from 1824-1888. Severe outward lean to wall.

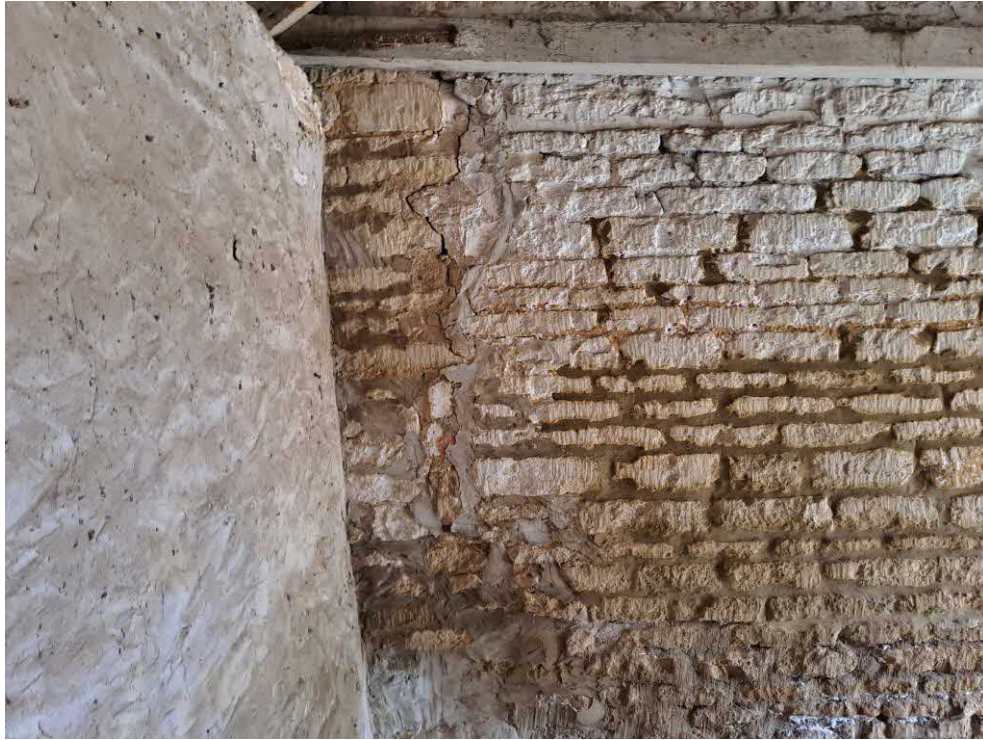
17 Garage. Open joints and cracking to connection between pre 1824 wall and 1824-1888 wall. Connection previously repaired.

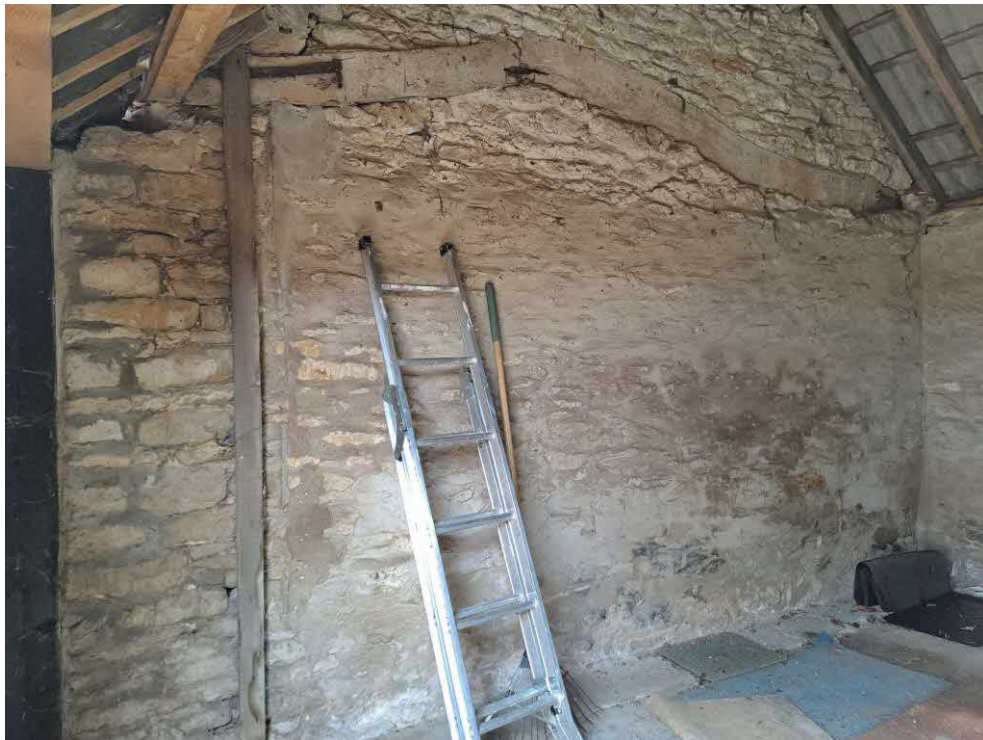
18 Garage. Historic bent tie beam with iron ties embedded in the north wall. Fine vertical crack, full height, at the northeast corner.

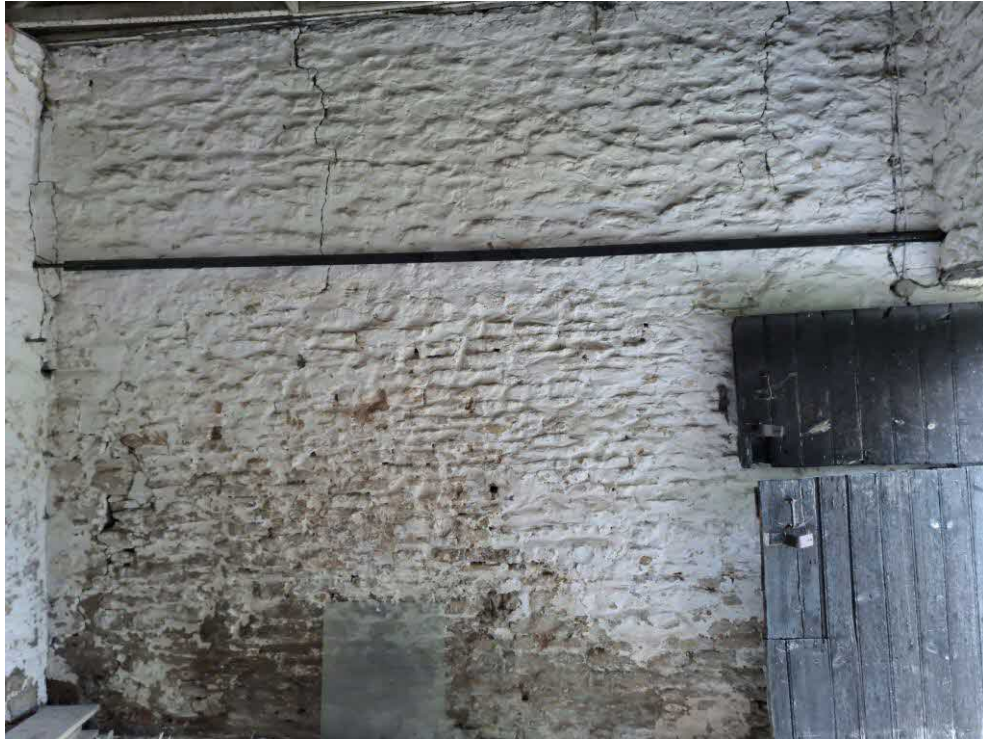
19 Barn 1. Slight vertical cracks to the top half of the wall. Steel tie anchored to the west and east walls.

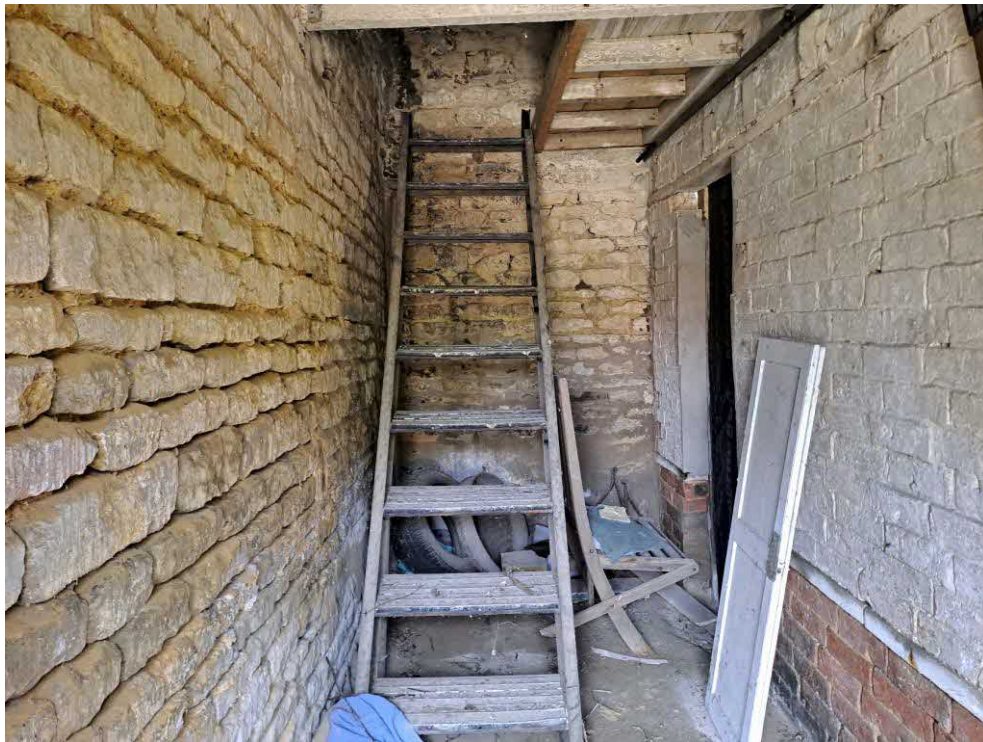
20 Stair. Deep recessed open joints to the wall at left. Steel tie anchored to the west and east walls.

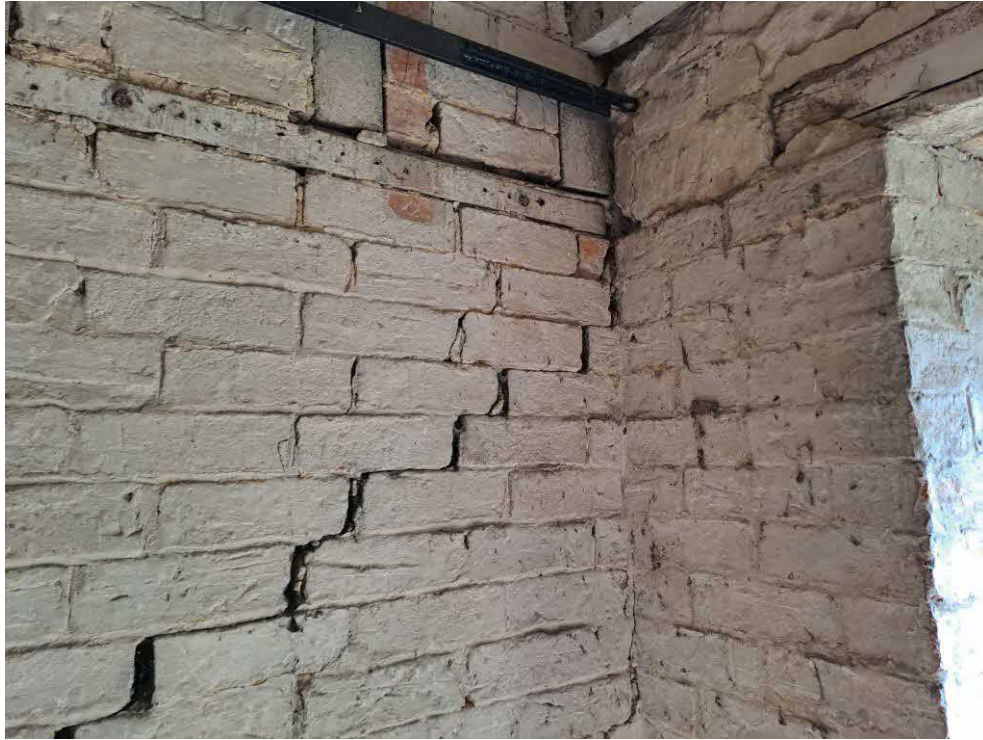
21 Stair. Diagonal fine stepped cracks and moderate open joints (full height) to brick wall. Detail of the tie end: threaded bar bolted to flat plate.

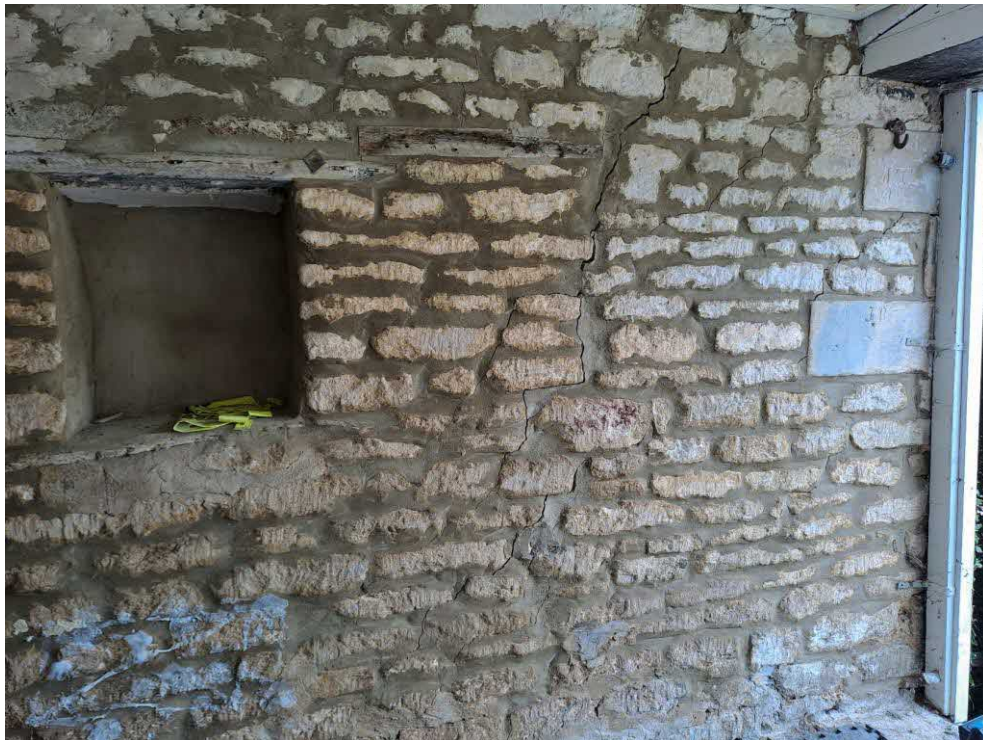
22 Barn 2. Fine to slight diagonal cracks, full height. Joints previously infilled.

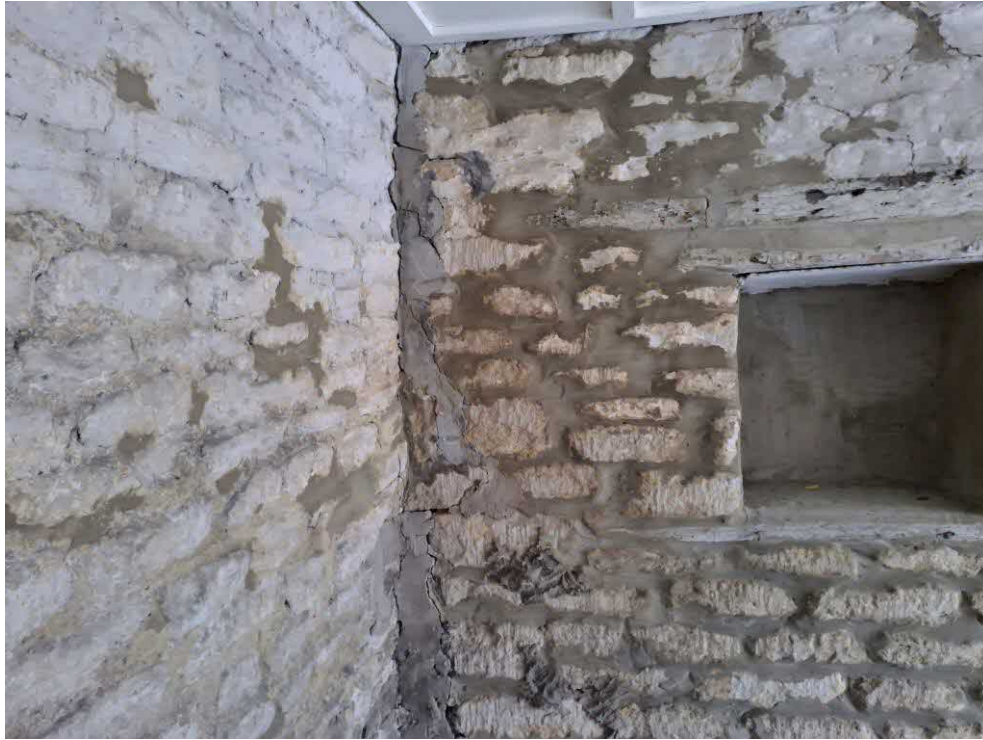
23 Barn 2. Fine to slight diagonal cracks, full height, to previously infilled joints.

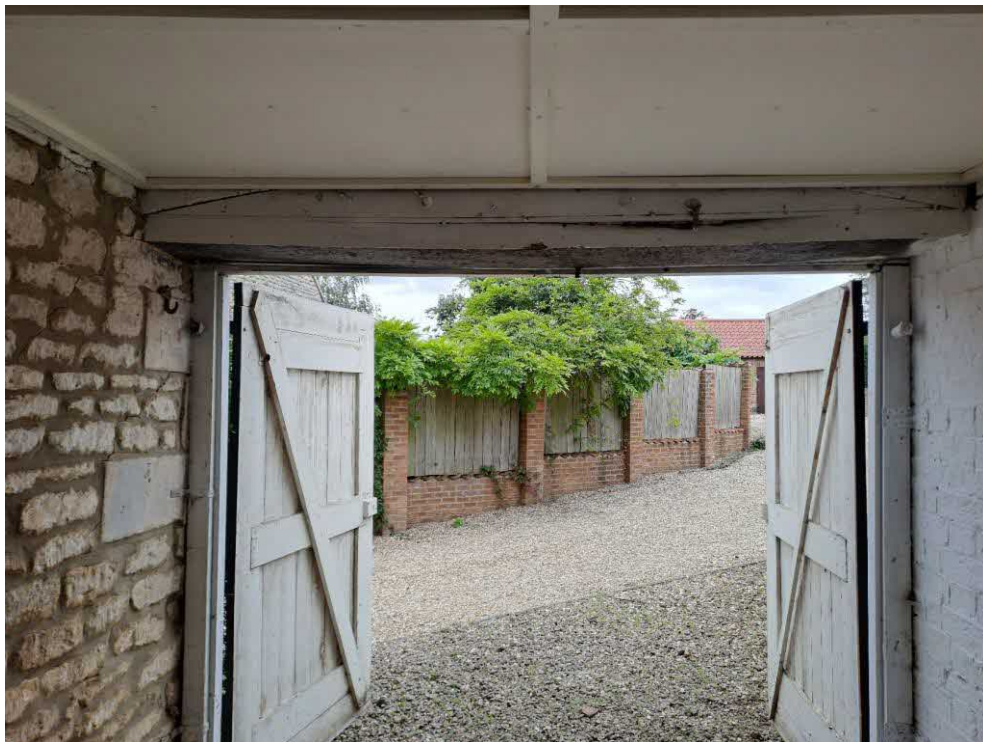
24 Barn 2. Minor deflection to timber lintel.

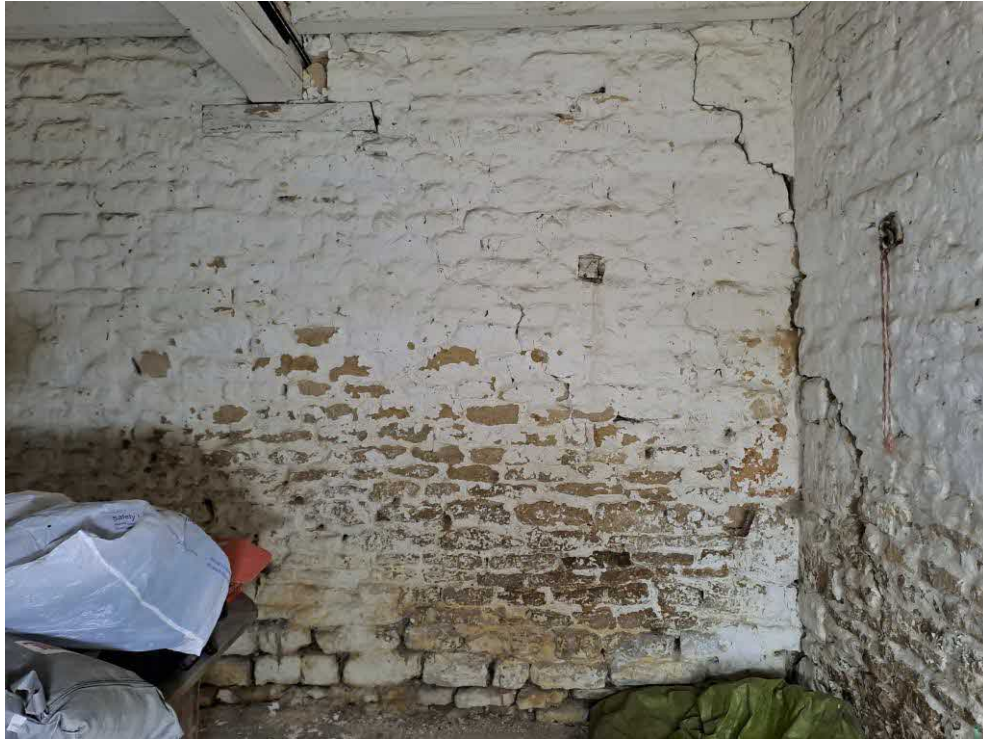
25 Barn 3. Fine to slight diagonal stepped cracks to east wall. Severe open joints to south wall and connection to east wall. Deep recessed open joints to the base of the walls.

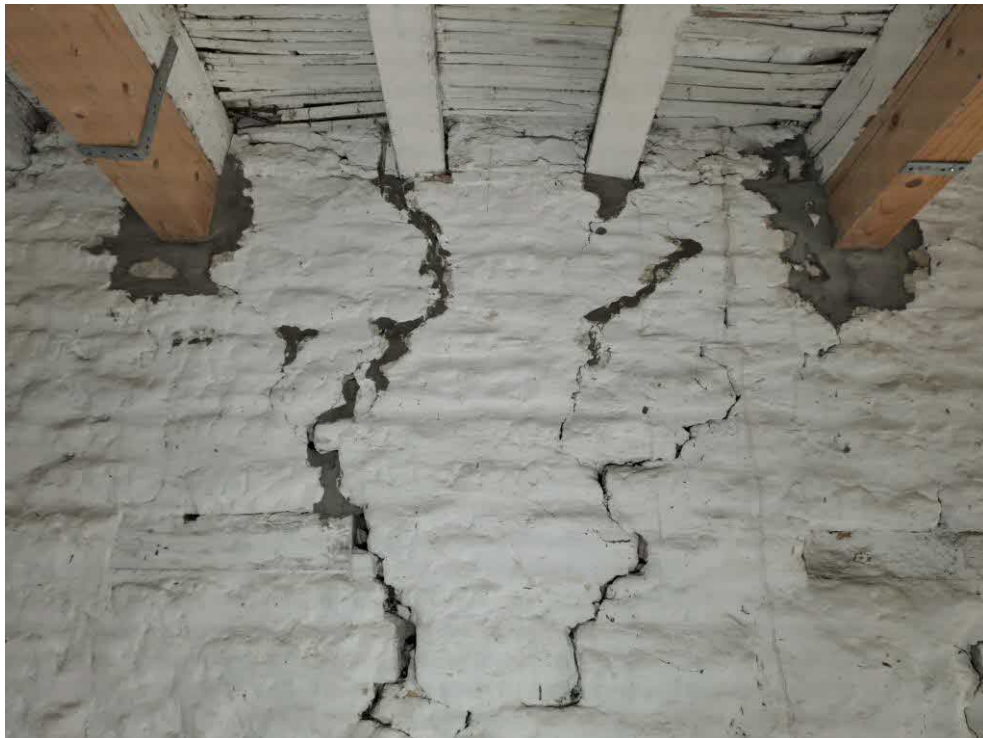
26 Barn 3. Vertical moderate open joints at the centre of the wall. New timbers added to existing joists. Infill at bearings and cracks with cement mortar. Twisting of joists.

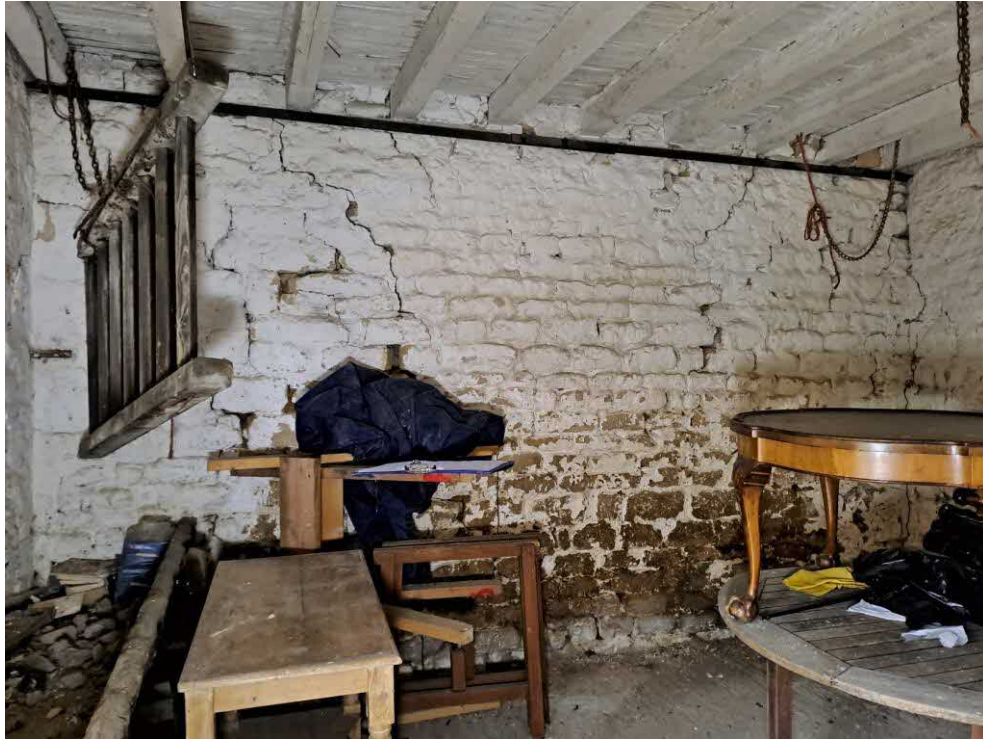
27 Barn 3. Fine to slight diagonal cracks and open joints to wall on the north side. Deep recessed open joints to the base of the west wall.

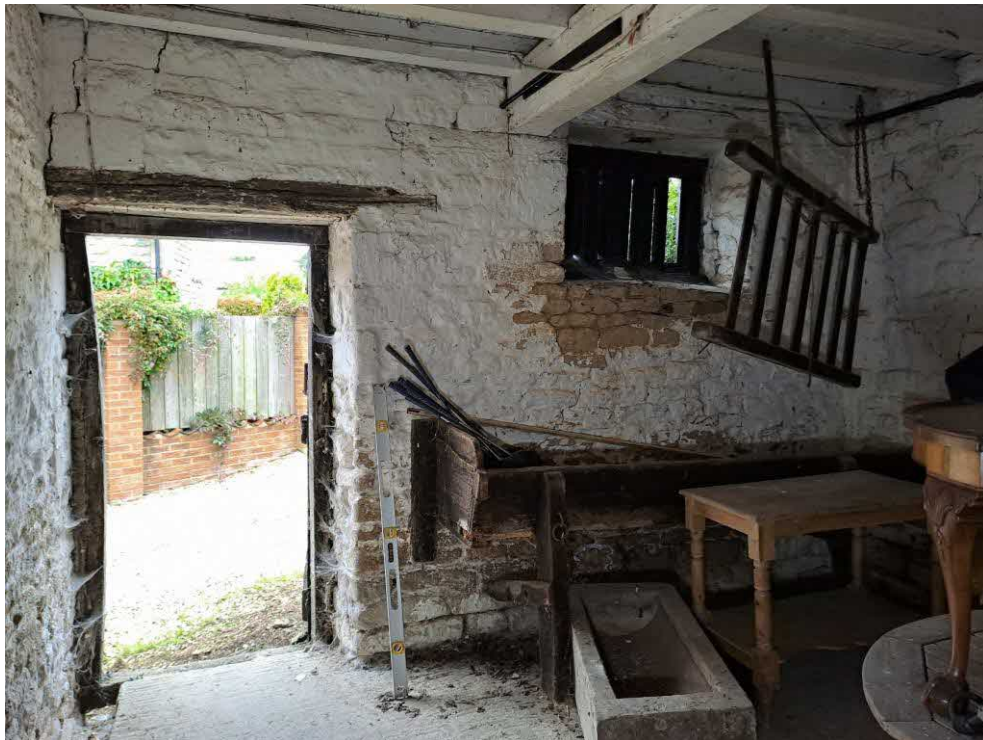
28 Barn 3. Fine diagonal cracks below and above window. Slight diagonal crack above the lintel. Deep recessed open joints and efflorescences to base of the west wall.

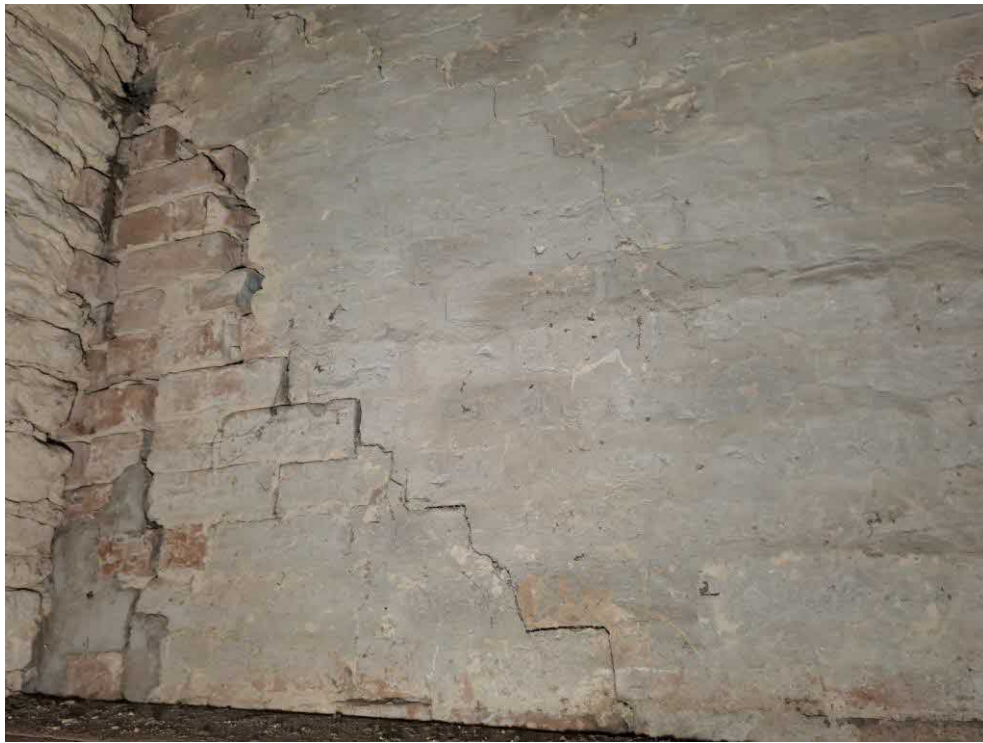
29 Stair 1st floor. Diagonal fine stepped cracks, very severe open joints, and fractured bricks to second-floor brick wall. Complete separation of east wall.

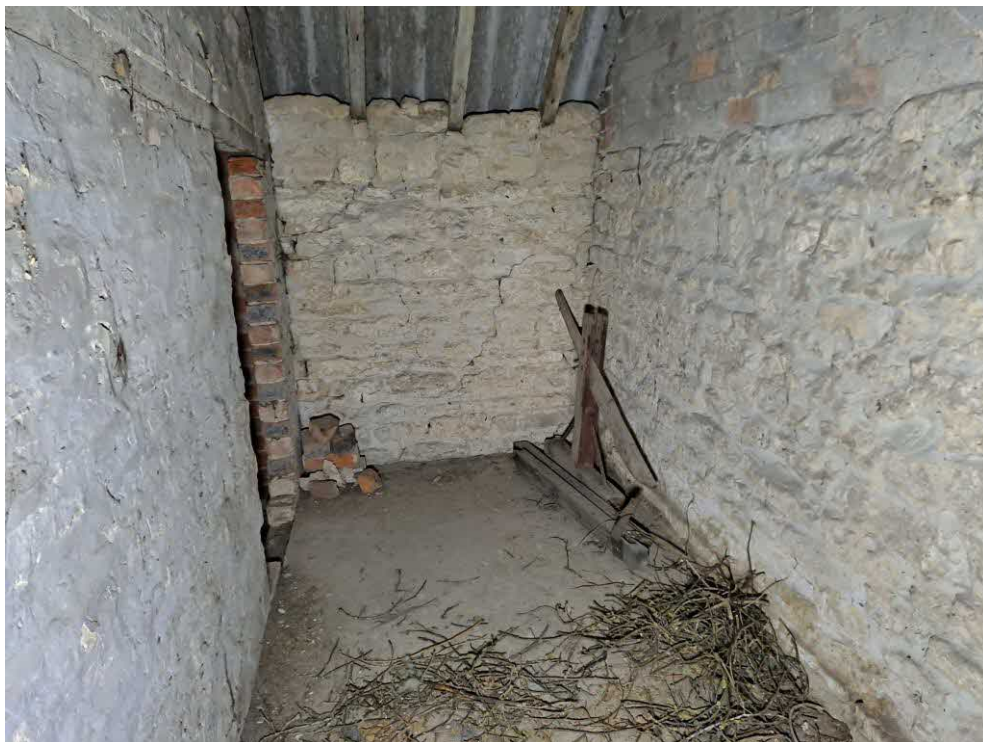
30 Stair 1st floor. Diagonal fine cracks to the inner face of the west wall.
