BARN CONVERSION
DOVECOTE RISE, SOUTH RAUCEBY
STRUCTURAL APPRAISAL REPORT

Commissioned by Mr A Hastings

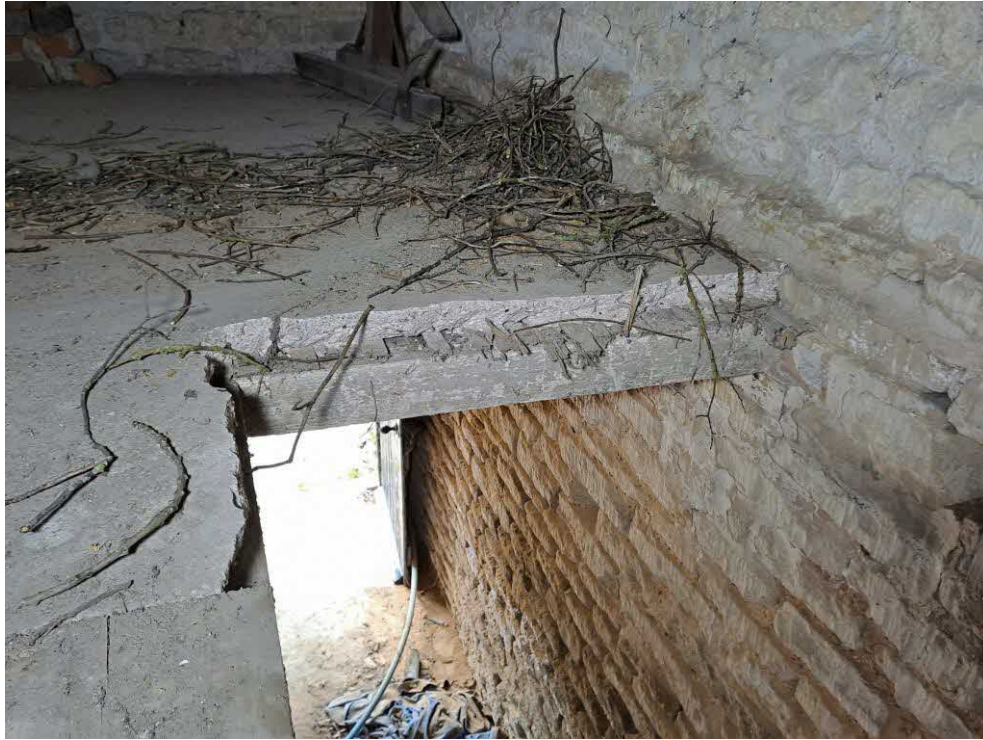
31 Barn 2. Lime-ash floor on the first floor.

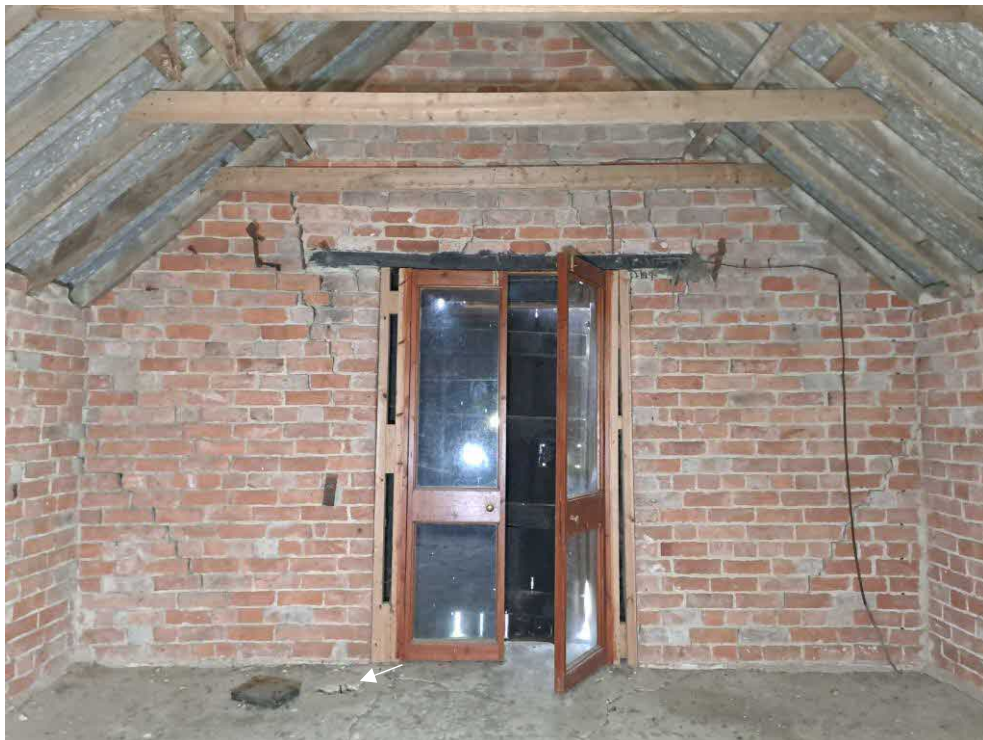
32 Store 2. Moderate to severe diagonal open joints to brick inner leaf of south gable. Fractured lime-ash floor with small hole near the door.

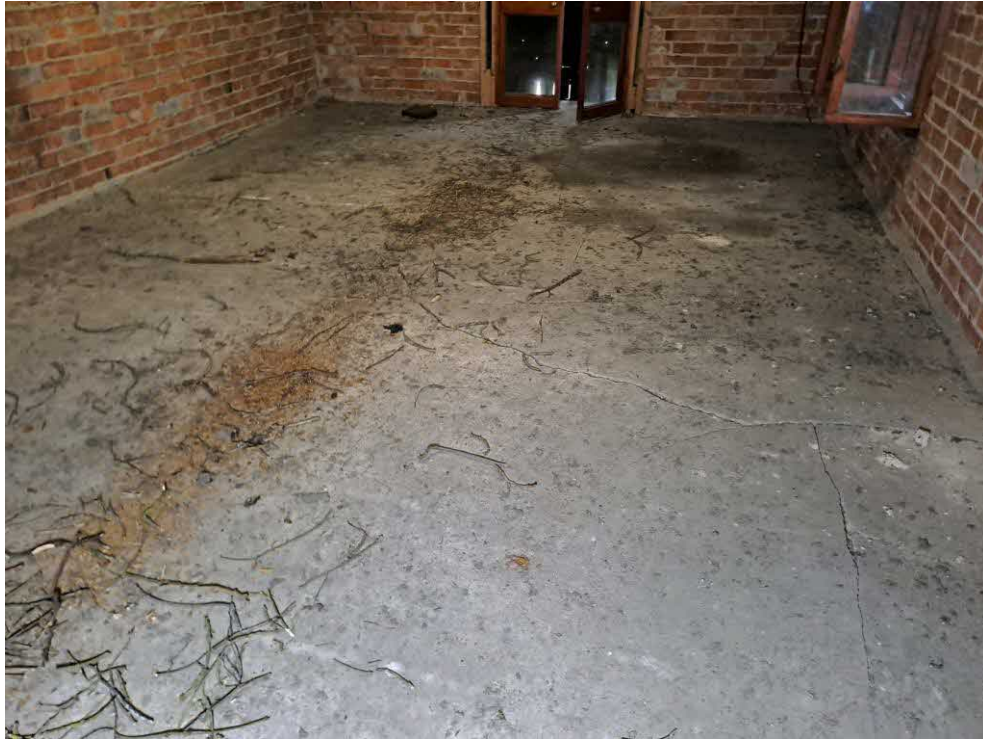
- 33 Store 2. Generalised cracking of lime-ash floor with moderate deflection from the centre to the east wall.

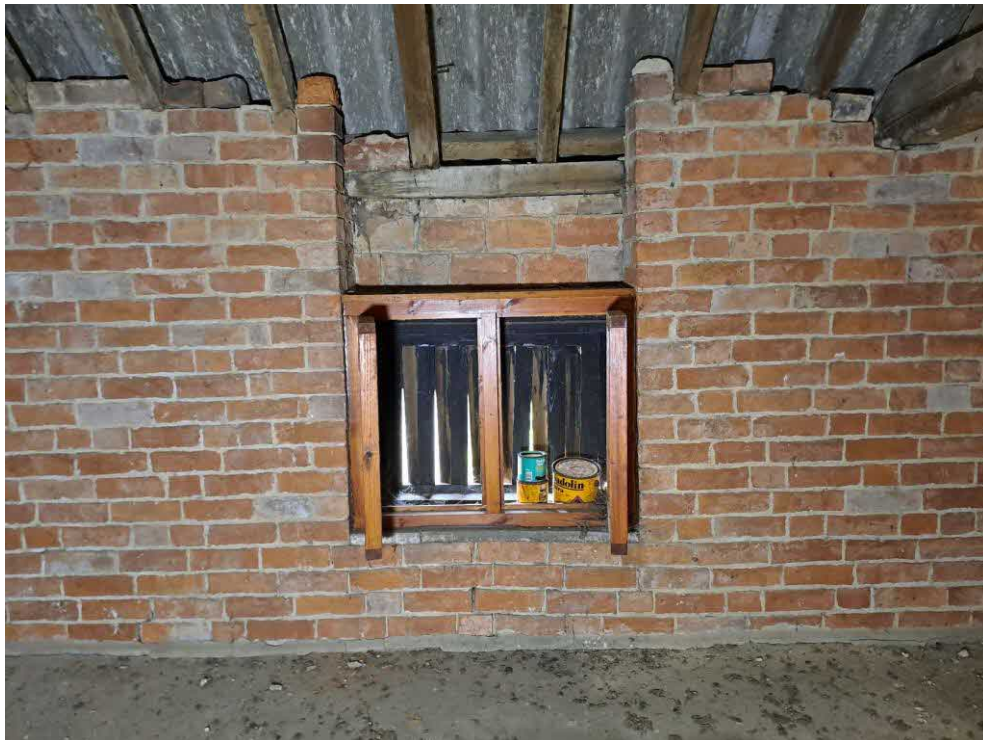
- 34 Store 2. Minor deflection of the floor. Vertical open joints to the west wall inner face, below the window (over the floor timber beam in Barn 3). Window frame skewed. Missing units to the top of wall. Wall-plate with water staining.

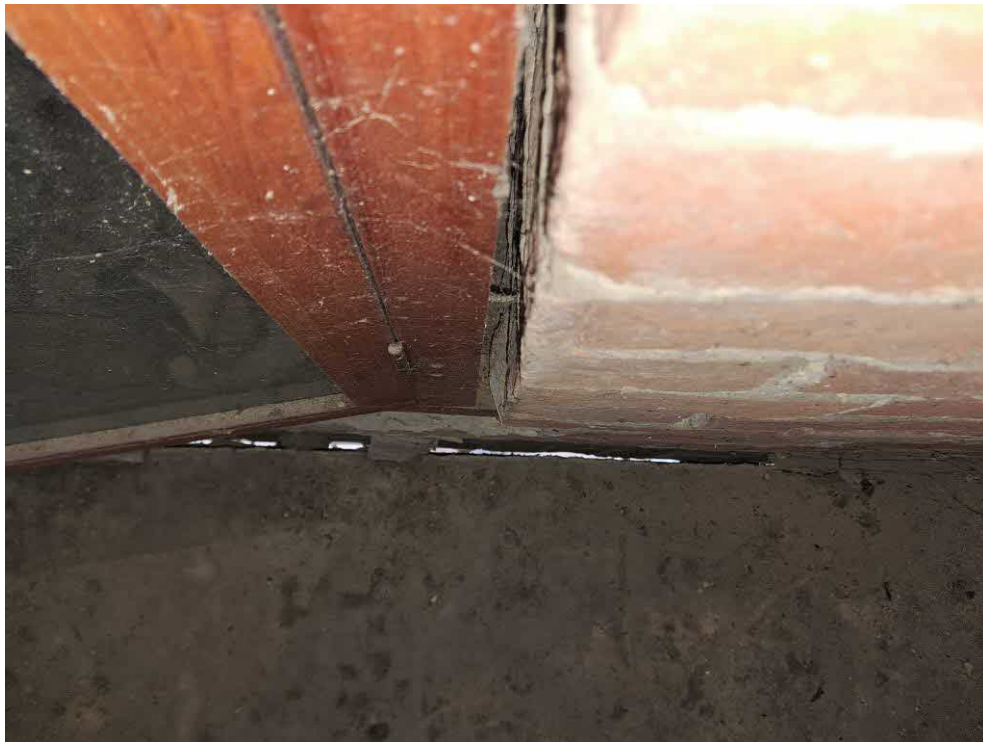
35 Store 2. Separation between the floor and west wall. Separation between window timber frame and brick inner leaf.

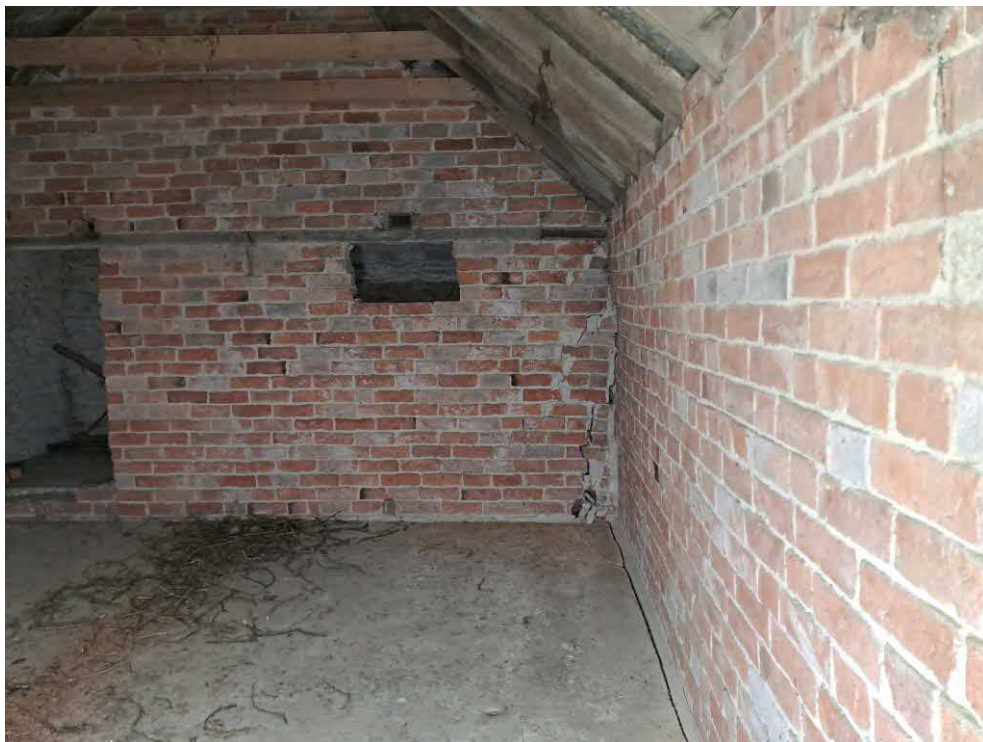
36 Store 2. Separation between the floor and east wall. Moderate deflection from the centre to the east wall. Inwards displacement of top three courses. Diagonal fine stepped cracks, very severe open joints, and fractured bricks to second-floor brick wall.

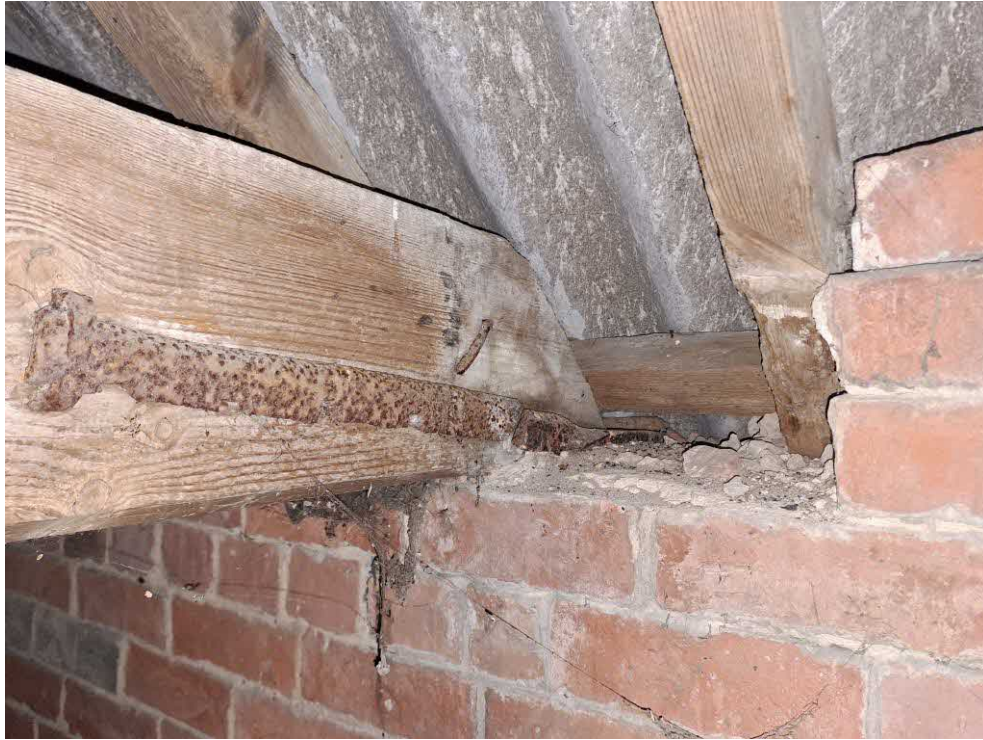
37 Store 2. Tie beam bearing on the east wall. Fractured iron tie. Reduced section to rafter foot.

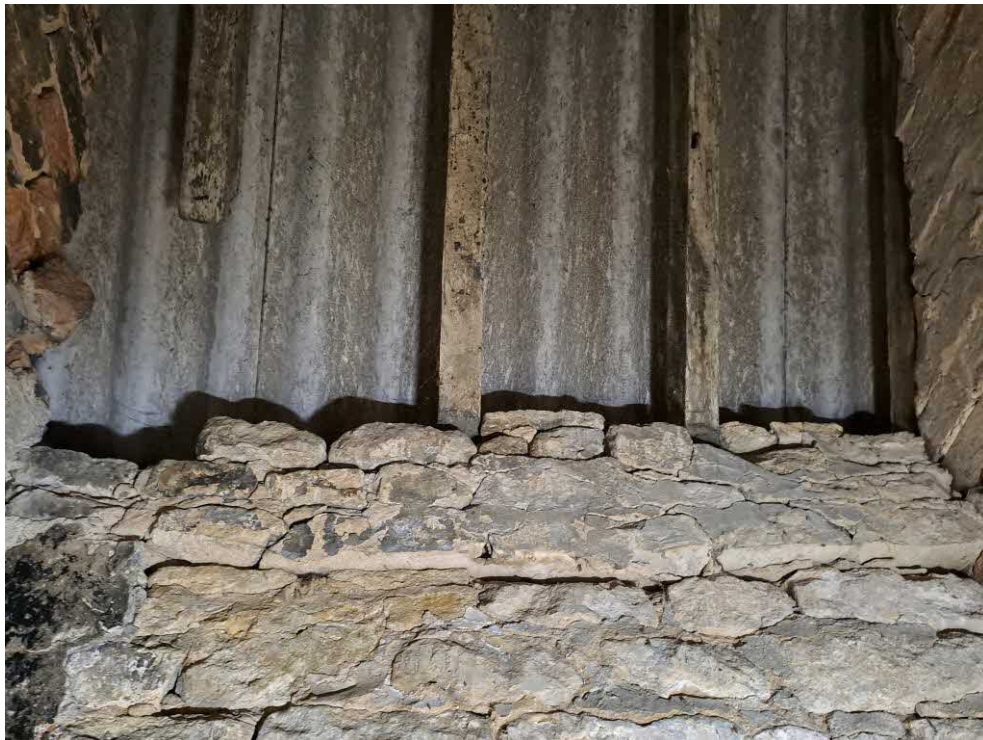
38 Stair roof. Three top courses displaced inwards. Missing rafter end to wall.

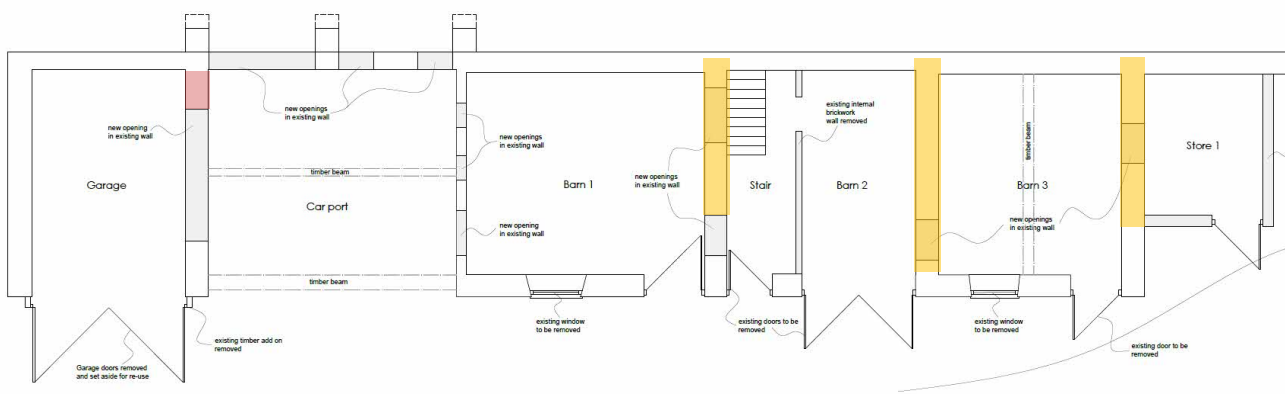
Existing ground floor plan with areas of intervention

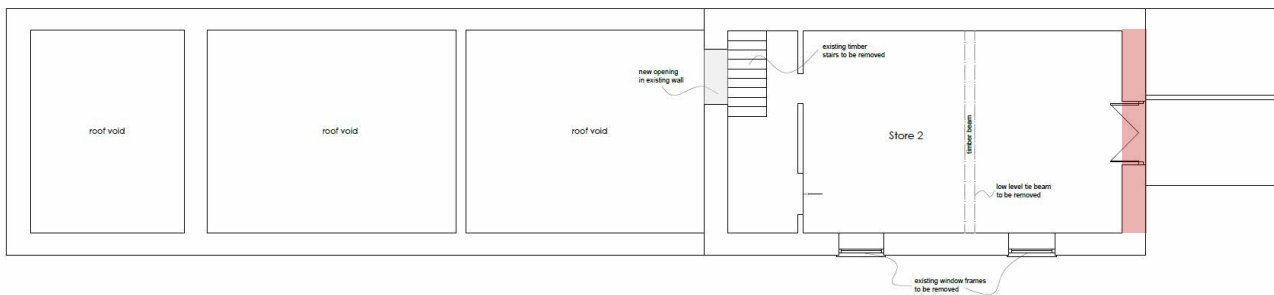
Existing first-floor plan with areas of intervention

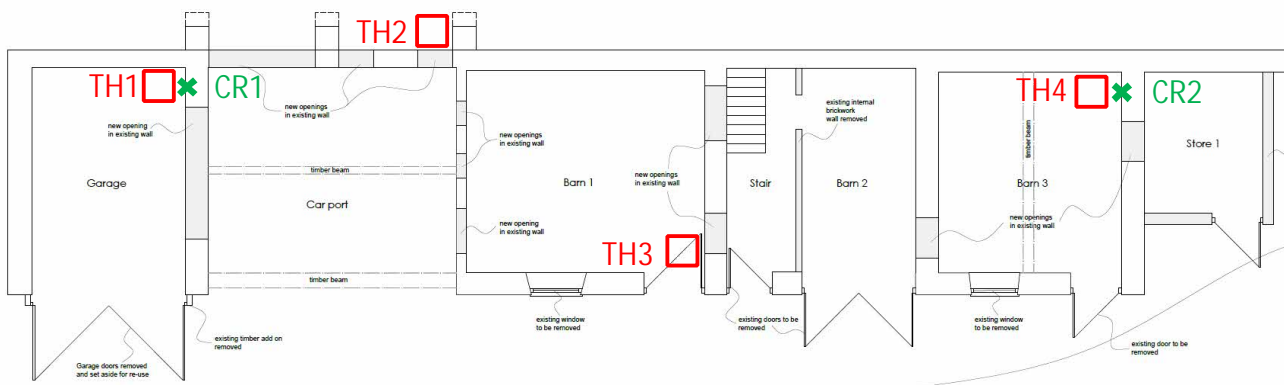
- 5.3 Replace and/or repair the existing rainwater drainage system to effectively discharge from roofs and redirect the water away from the building.
- 5.4 Careful removal of all cement pointing, and repointing in lime of all walls.

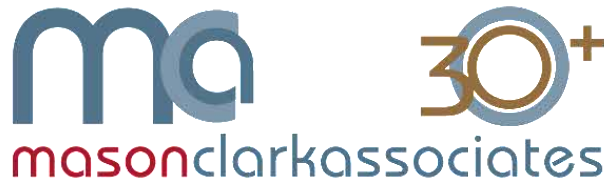
- 6.10 The inspection and report will not include any liability in respect of Advice/Design in fire safety to the structure and/or any liability whatsoever in respect of any losses (whether direct or indirect) arising from combustibility of cladding in delivery of our Services. We shall not be liable for that part of any claim which relates to loss of profits, loss of use, loss of production, loss of contract, liquidated damages or for any cost of decamping or rehousing.
- 6.11 This report is limited to structural matters. The client should obtain their own advice on any specialist surveys that need to be undertaken.
