Preliminary Ecological Appraisal
Stone Barn
Dovecote Rise
South Rauceby
Lincolnshire
NGR TF02532 45640

Report prepared by: C J Barker CEnv	Date Issued 23 May 2023
Reviewed by: KB	CBE Consulting, Highbank, 5 Grantham Road, Navenby, LN5 0JJ
Report ref: P2763 / 0523 / 01

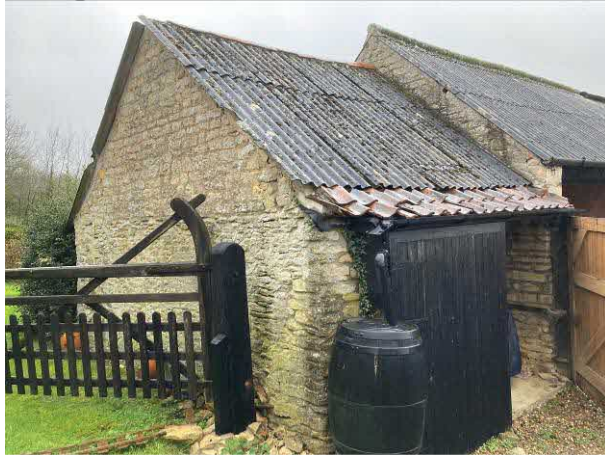
Front and north gable end

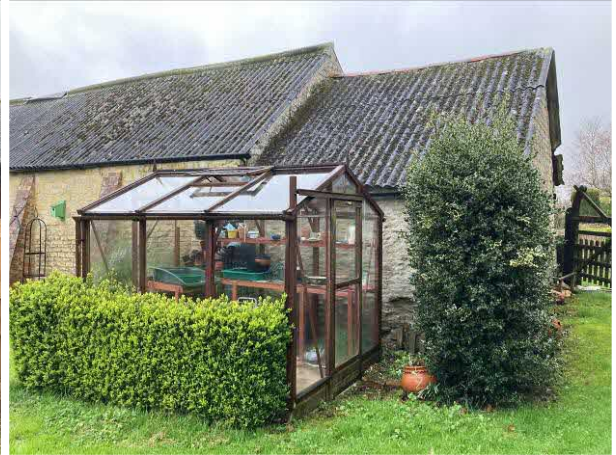
Rear of garage

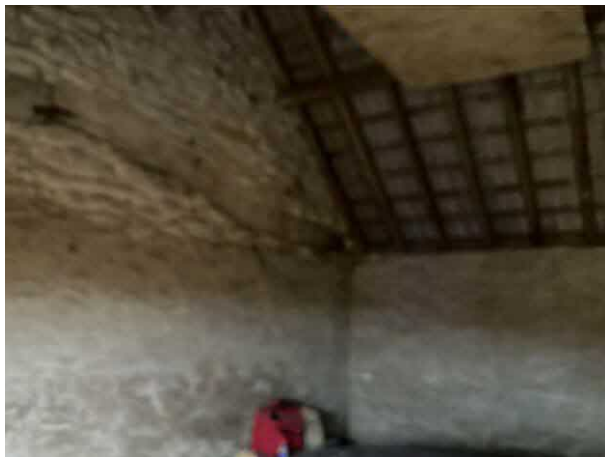
Interior of garage

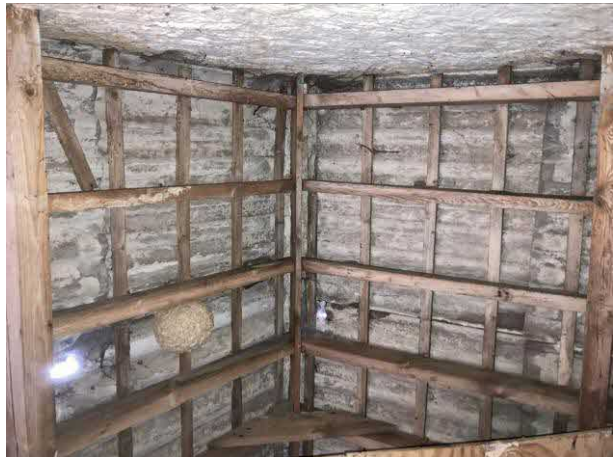
Underside of roof (note wasp nest)

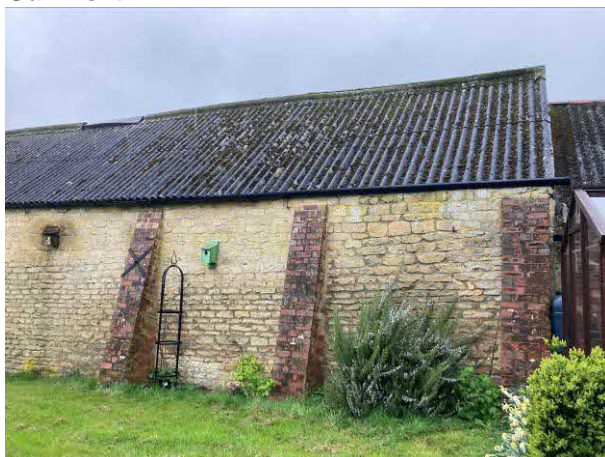
Rear face of car port

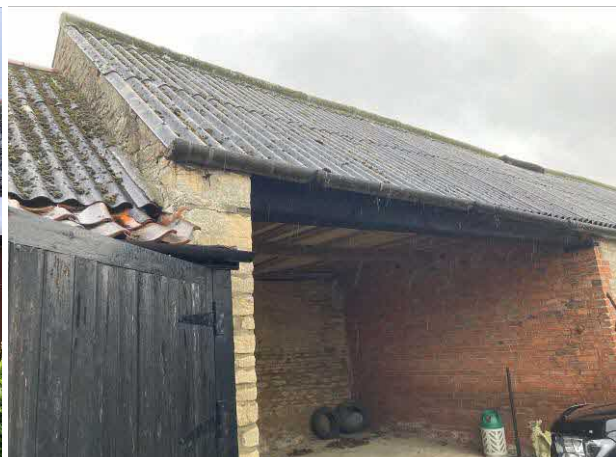
Front of car port

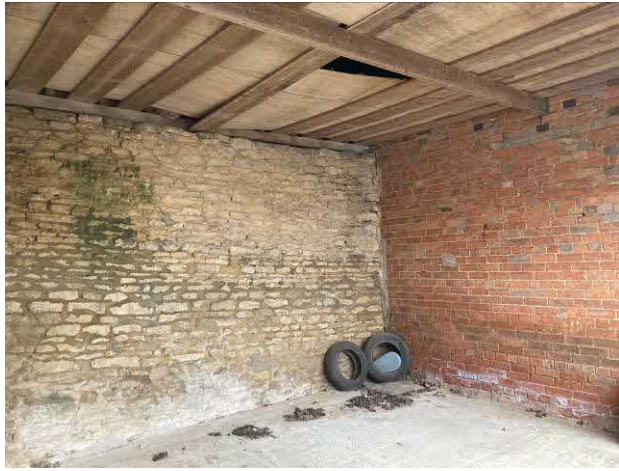
Interior of car port

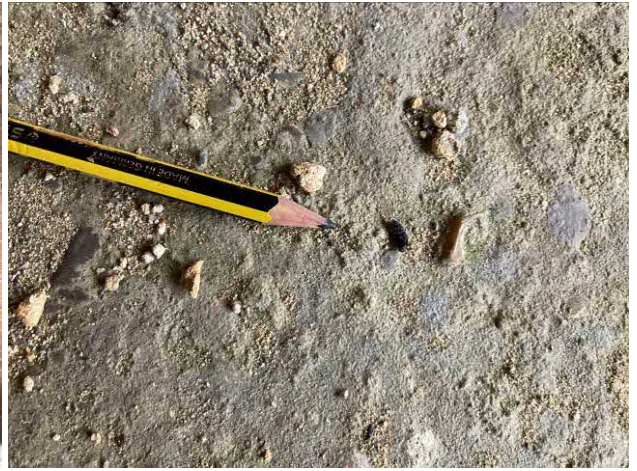
The car port is open-fronted and one solitary medium sized bat dropping was found within the interior of this section of the building on the concrete floor. There are no other indications of bat activity and the walls and ceiling structure do not present any significant potential for bats to hide away to roost where it is dark and draft free. It is considered the dropping is a result of a flying bat exploring the open fronted car port.

Single bat dropping in car port

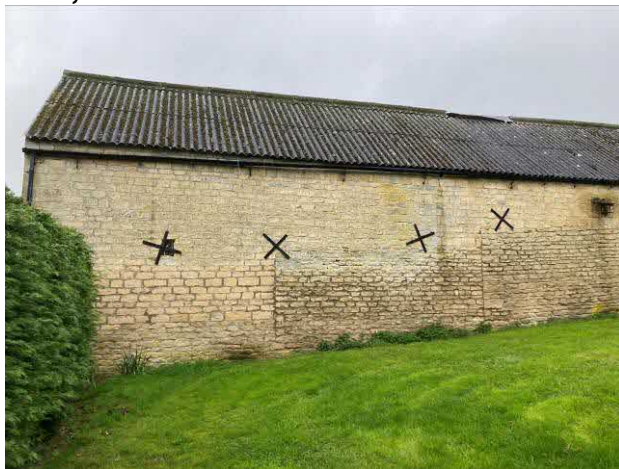
Rear of building

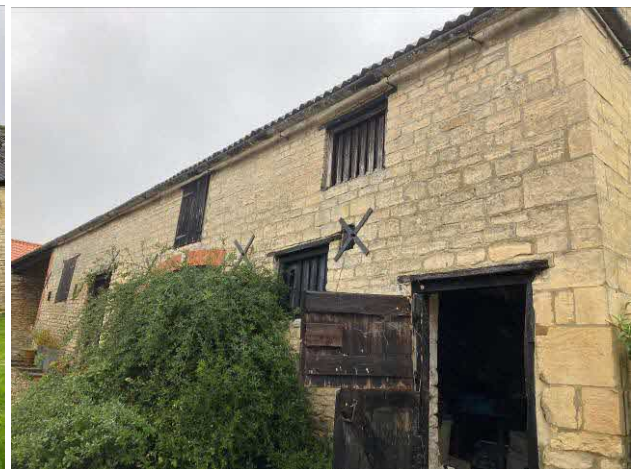
Front of building

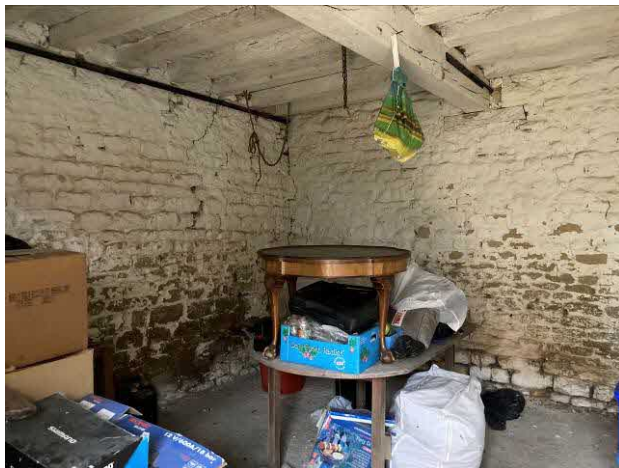
Interior ground floor of barn

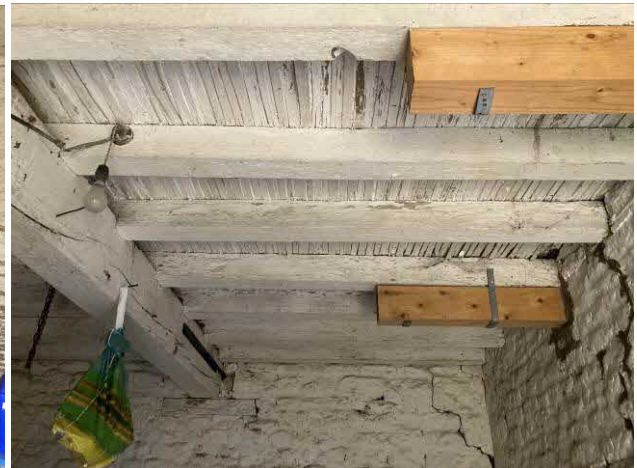
Exposed ceiling beams

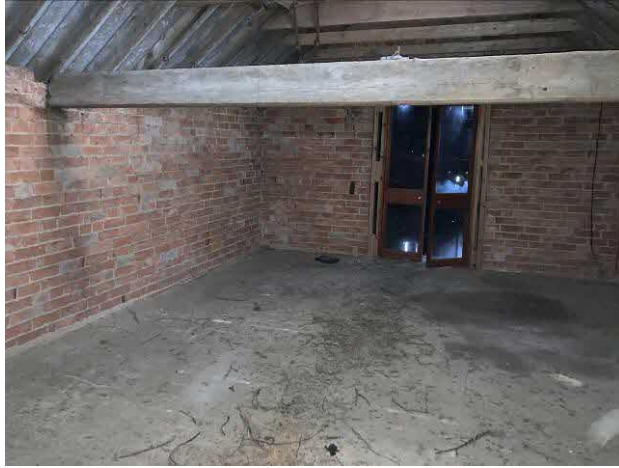
Interior of first-floor granary room

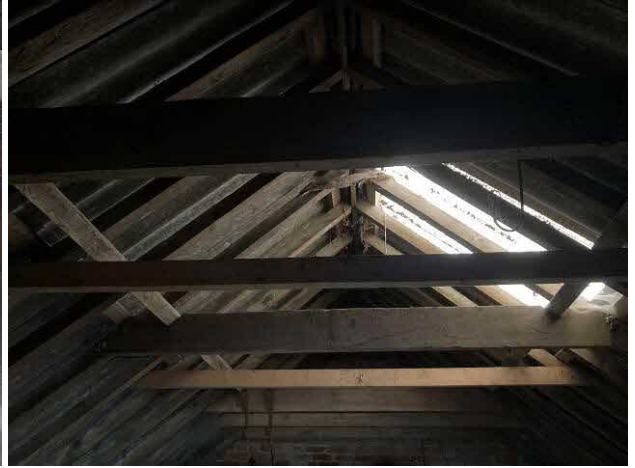
Underside of roof and light panels

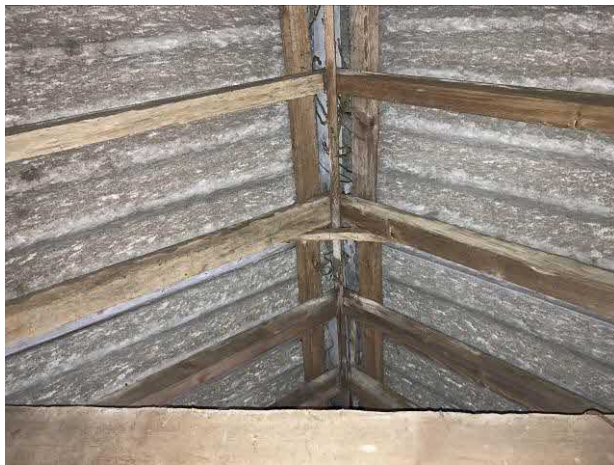
Underside of pitched roof

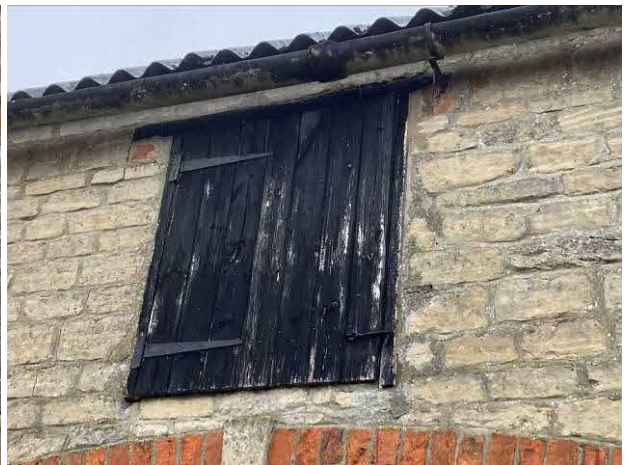
The timber doors to the remainder of the main section of the building are quite tightly fitting but the boarded timber windows to the first-floor granary room have significant gaps around the edges and the roof edges are not sealed. This could allow access into this room within the interior of the roof by bats and small birds. However, no evidence of bat or nesting bird activity was found within the interior of the granary within the interior of the roof or the other buildings on the ground floor.

Boarded windows to the granary room

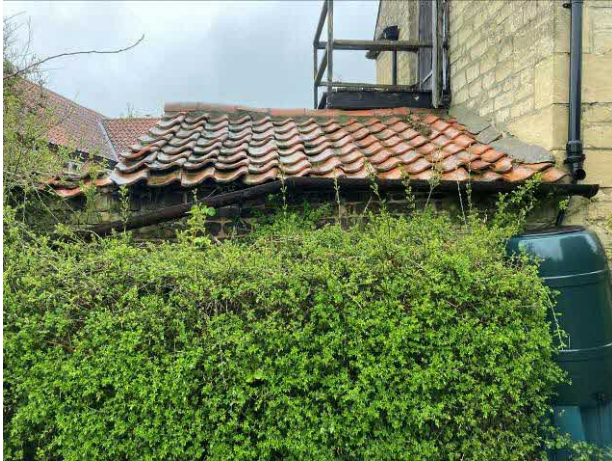
Rear roof of store

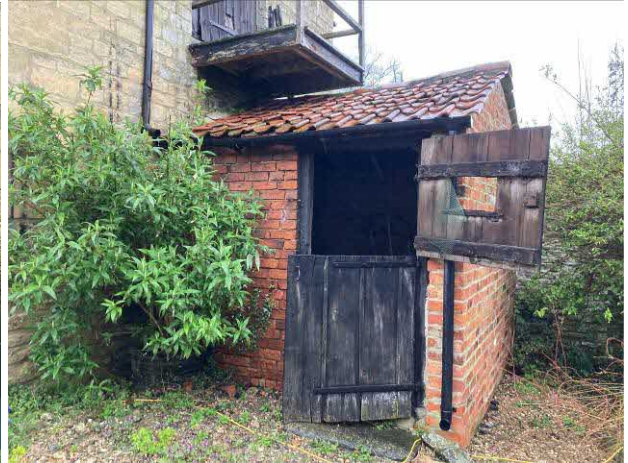
Front of store attached to south gable

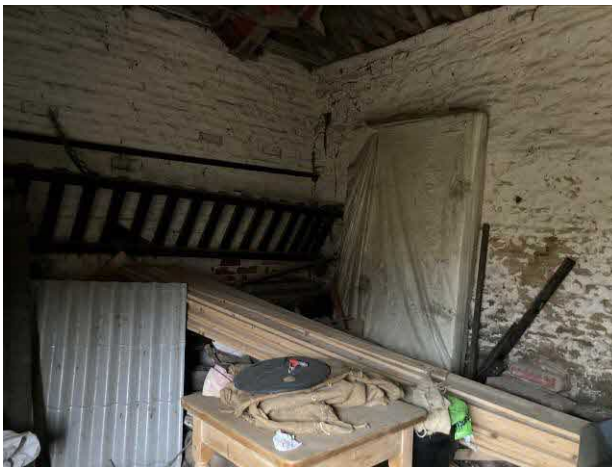
Interior of store

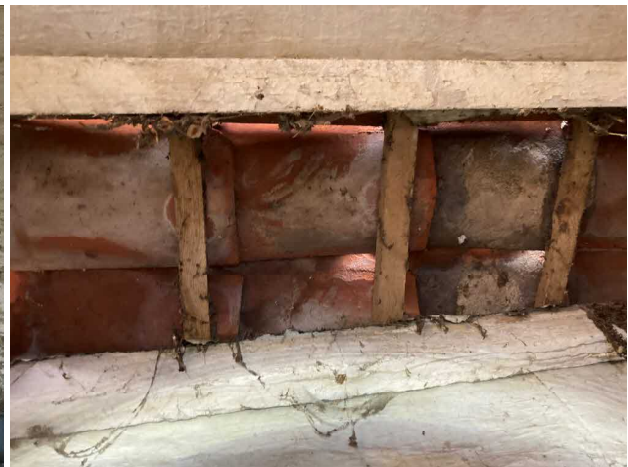
Underside of pantiles exposed
