Tree Survey at Banchory Lodge Caravan Park Tree Management

Client:	Donna Duncan
Drawing No:	BLCP-2310-DR
Issue Date:	16th October 2023
Drawn by:	LW
Checked by:	NA/EP
Revision:	A
Rev Date:	14/11/2023
Scale:	1:600 at A2

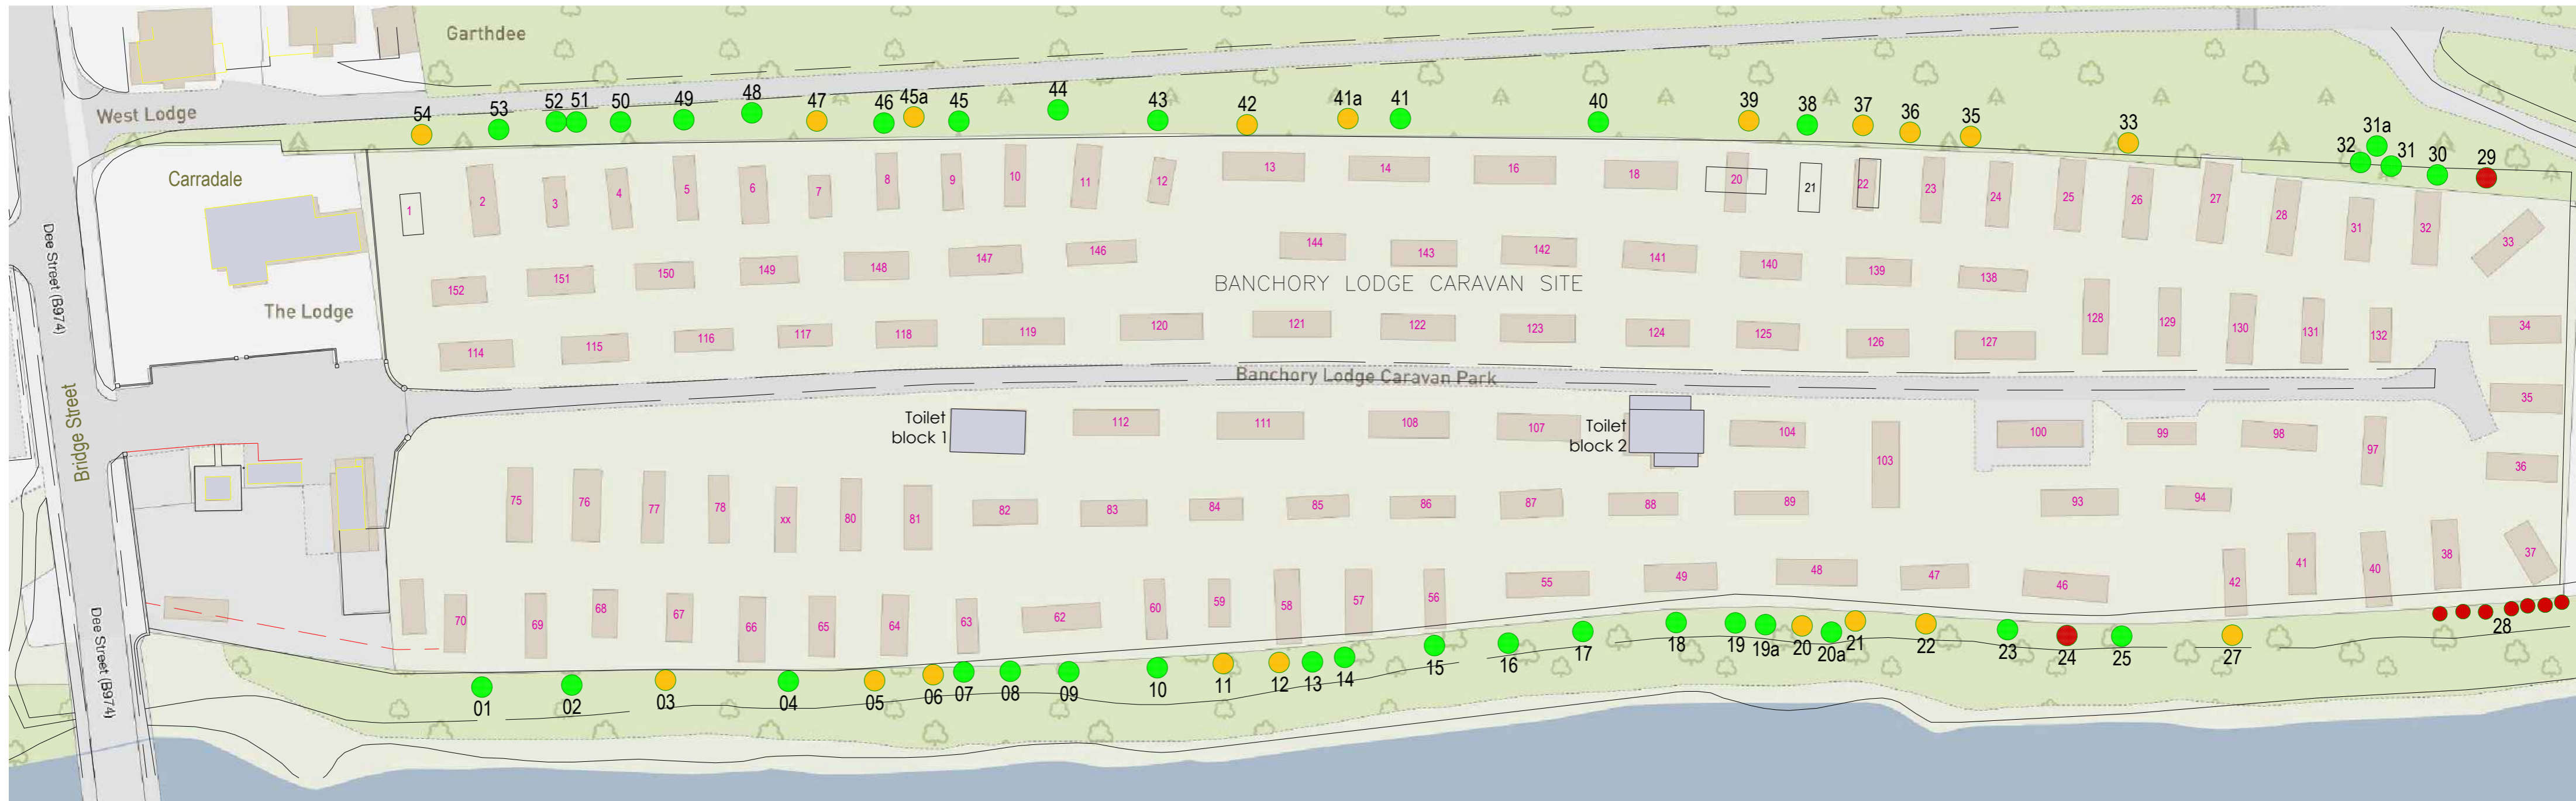
No	Species	Description	Action
1	Beech	Mature tree has severe lean toward northwest.	Retain at present.
2	Beech	Three-stemmed, mature tree.	Retain at present.
3	Beech	Mature tree with slight lean over caravan 67.	Cut ivy at base of tree to prevent it becoming dominant in crown.
4	Oak	Mature tree, appears healthy.	Retain at present.
5	Oak	Mature tree, appears healthy.	Remove branch over caravan 66 and lift crown.
6	Oak	Twin-stemmed, with tree appearing healthy.	Thin canopy over crown to reduce weight on divergence angle.
7	Beech	Twin-stemmed tree, appears healthy.	Retain at present.
8	Lime	Three-stemmed tree.	Retain at present.
9	Spruce	Three trees adjacent to caravans 60 and 62.	Retain and inspect at regular intervals.
10	Spruce	Three trees, appear healthy.	Retain and inspect at regular intervals.
11	Oak	Mature tree, twin-stemmed at 7m.	Lift crown over caravan 59.
12	Spruce	Three trees.	East tree has divergence angle with slight split developing. Reduce height by 3m and thin canopy.

13	Beech	Twin-stemmed, mature tree. Appears healthy.	Retain at present.
14	Beech	Large stem has been removed in part, no rot evident.	Retain at present.
15	Beech	Tree appears healthy.	Retain at present.
16	Beech	Twin-stemmed tree. Limb has been removed in past. Appears healthy.	Retain and inspect at regular intervals.
17	Birch	Tree has canopy with deadwood. Branches are thinning.	Retain and inspect at regular intervals.
18	Birch	Tree appears healthy.	Retain at present.

No	Species	Description	Action
19	Beech	Limb has been ripped off toward river in past.	Retain and inspect at regular intervals.
20	Oak	Tree appears healthy.	Thin branches away from caravan 48.
20a	Pine	Tree appears healthy.	Retain at present.
21	Spruce	Tree appears healthy.	Thin 20% to reduce 'sail' effect.
22	Beech	Mature tree.	Remove limb to northeast over caravan 47.
23	Beech	Mature tree, three-stemmed.	Retain and inspect at regular intervals.
24	Spruce	Four mature trees. Growing too large for proximity to caravan.	Fell.
25	Beech	Mature tree. Appears healthy.	Retain at present.
27	Horse chestnut	Mature tree.	Remove limb toward caravan 42, growing to northeast.
28b	Sitka spruce	Seven trees along northeast boundary close to pitch 37 and 38. Tall thin trees, with canopy at height. Trees appear healthy, but are shallow rooting and prone to windblow.	Fell due to safety concerns and to remove suppression of mature oak tree behind them.

29	Ash	Tree is dying.	Fell.
30	Ash	Mature tree.	Retain at present.
31	Ash	Mature tree. Topped in past at 11/12m.	Retain and inspect at regular intervals.
31a	Ash	Mature tree. Topped in past at 11/12m.	Retain at present.
32	Norway maple	Pollarded tree	Retain and inspect at regular intervals.
33	Oak	Tree has had branches removed over caravans 24 and 25 in the past.	Remove further branch over caravans.
35	Fir	Tree appears healthy.	Thin canopy to remove larger overhanging branches.

No	Species	Description	Action
36	Fir	Tree appears healthy.	Thin canopy to remove larger overhanging branches.
37	Oak	Tree appears healthy.	Crown lift to clear caravan 22.
38	Sycamore	Tree appears healthy.	Retain at present
39	Oak	Tree appears healthy.	Crown lift by removing one branch.
40	Lime	Tree appears healthy.	Retain at present.
41	Ash	Rot at 8 - 9m. Tree has been pollarded above rot.	Retain at present.
41a	Oak	Tree appears healthy.	Remove branch growing over caravan 14.
42	Holly	Tree appears healthy.	Trim.
43	Oak	Tree appears healthy.	Retain at present.
44	Lime	Tree appears healthy.	Retain at present.
45	Beech	Tree appears healthy.	Retain at present.
45a	Fir	Adjacent to caravan 8, growing into canopy of neighbouring beech.	Reduce by 3m.
46	Sweet chestnut	Tree appears healthy.	Retain at present.
47	Sweet chestnut	Tree appears healthy.	Remove branch over caravan 8 and two branches at height growing to south.

48	Cherry	Tall, thin tree on bank.	Retain and inspect at regular intervals.
48a	Lime	Mature tree, appears healthy.	Retain at present.
49	Oak	Tree appears healthy.	Retain at present.
50	Oak	Tree appears healthy.	Retain at present.
51	Cherry	Tree appears healthy.	Retain at present.
52	Cherry	Tree appears healthy.	Retain at present.
53	Sweet chestnut	Multi-stemmed, semi-mature tree, leans toward caravans 2 and 3.	Retain at present.
54	Oak	Tree appears healthy.	Thin 30% of large limb over caravan hard standing 21 (as in 2022).
