SASH & CASE WINDOW REPORT Mr & Mrs Lambert Kilbucho Place Broughton, ML12-6JQ

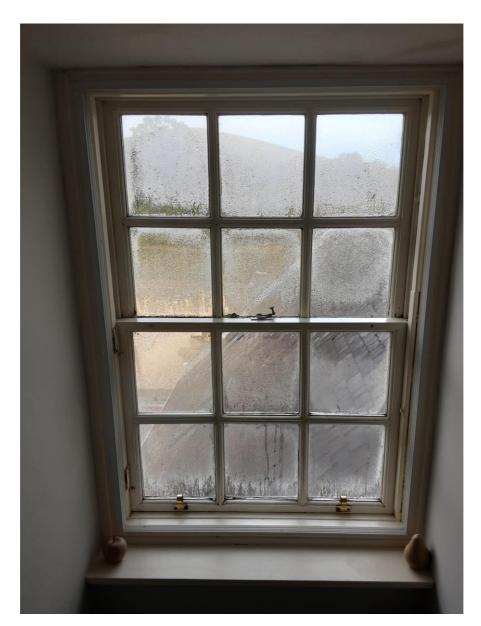
TIMBER DECAY

• Timber decay was noted in all of the sills, pulley stiles and the end grain of the bottom rails of bottom sashes. There were several open Tenon joints letting in moisture.

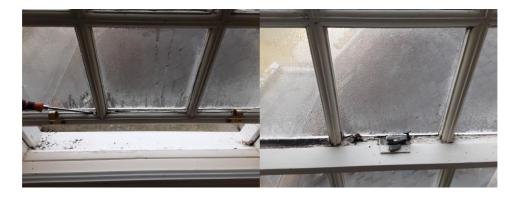
• Equally, interior has been affected by condensation, especially the rooms used as bedrooms, leaving soft spots on the profiles.

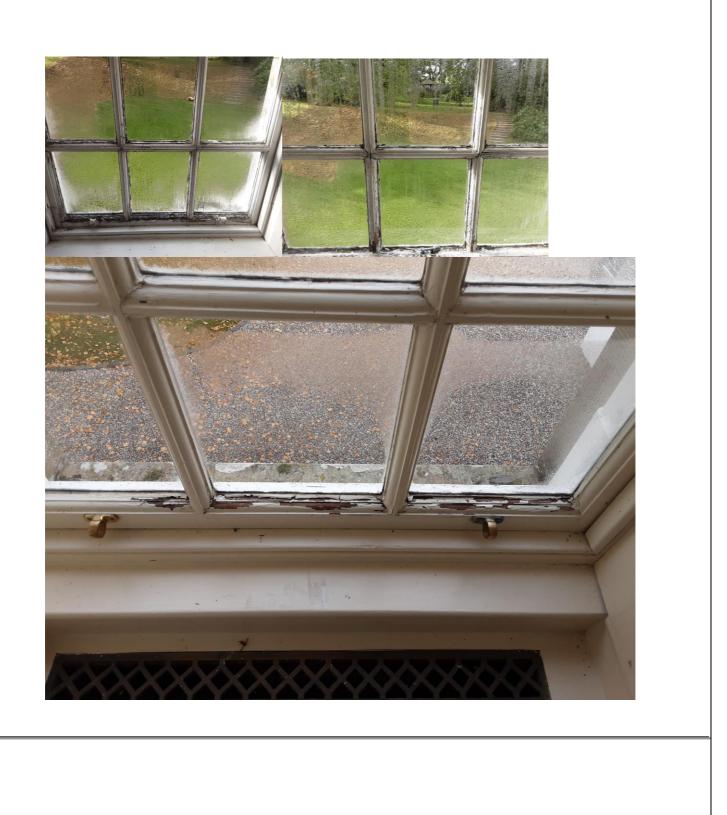
• The majority of putty on the mid-rails of the top sashes is in poor condition or missing, and the bottom rails of the bottom sashes are missing, allowing moisture to penetrate the timber which results in rot and water ingress.

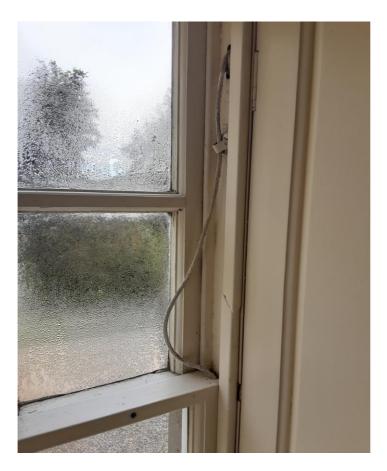
Operation

- The Top Sashes are screwed Shut or painted shut.
- None of the top sashes in the house operate, this then results in poor ventilation which causes condensation and the associated problems of moisture.
- Of the bottom sashes that do operate they do not run smoothly due to over painting, missing weights, stuck cords, and defective joints.
- All of sashes are on cords, which all have several coats of paint on them. Due to this there is not enough clearance for the cords to go through the pulley wheel adding to the difficult operation of the window.

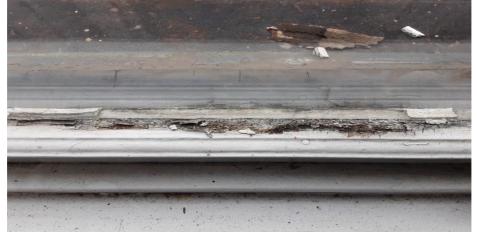
GLAZING

- The Glazing is made up of 4mm float Glass on all sashes and there is NO historical glass present in the top and bottom sashes of the windows. This is due to the windows not being original and having been replaced over time.
- Putty on the upper part of the windows is in reasonable condition, but putty on the lower parts is coming away from the glass allowing moisture to get in behind which in turn will cause further problems.
