**STRUCTURAL INSPECTION  
OF  
THE STABLES  
AT  
PILGRIMS' FARM  
WHITE HILL ROAD  
OVERTON  
RG25 3DS**

**221224 Rev A- JUNE 2023**

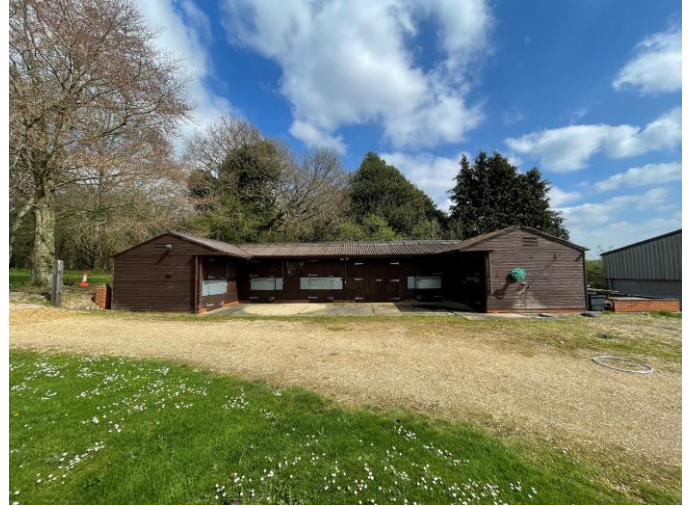
- 2.1 The stables comprised single storey, lightweight timber sheds with weather board cladding and shallow pitched roofs covered with profiled roof sheets (see photograph 2).
- 2.2 The timber structure appeared to have been constructed on a 2 brick plinth, on a ground bearing concrete slab; we have not excavated trial pits, but it is unlikely that there are any significant foundations.
- 2.3 The stables are located on the east side of the farm with a number of mature trees on the site boundary at the rear.
- 2.4 The stables are west facing, and the ground level gently falls from north to south.
- 2.5 Further details of the layout and condition can be gleaned from the appended survey photographs and drawings.

2. West Elevation

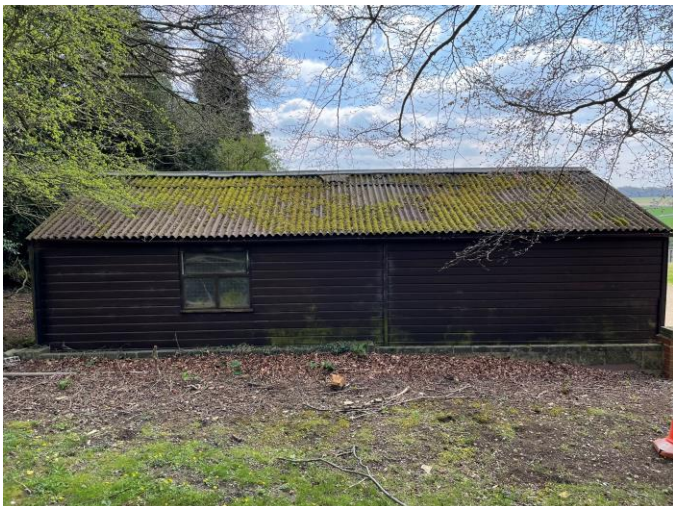
3.3 The roof was covered with profiled steel roof sheets that were in poor condition. There was extensive moss and lichen growth and the flashings and dressings were poor (see photographs 3 and 4).

3. North Elevation. Note the profiled roof sheets and block plinth

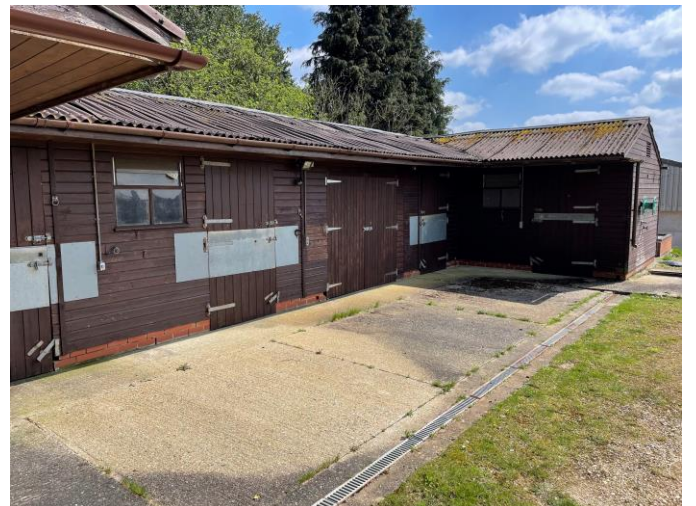
3.12 There was a drainage channel across the front of the hardstanding. We assume this drains to a soakaway but will need to be investigated(see photographs 4 and 5 ).

4. Front concrete hardstanding. Note the joints in the slab and drainage channel

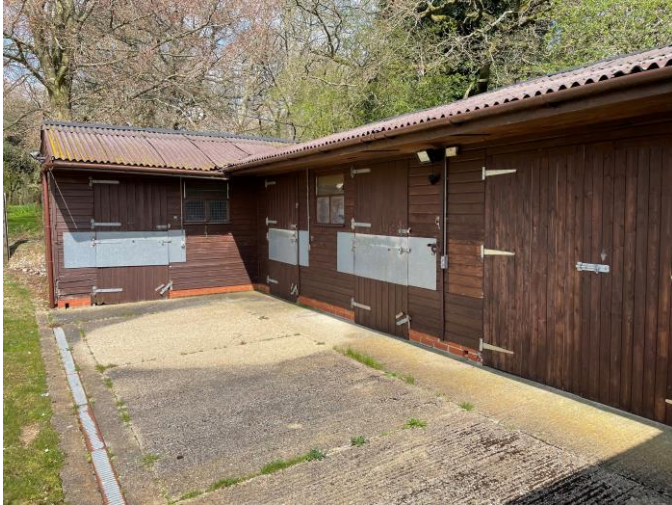
5. Front Hardstanding

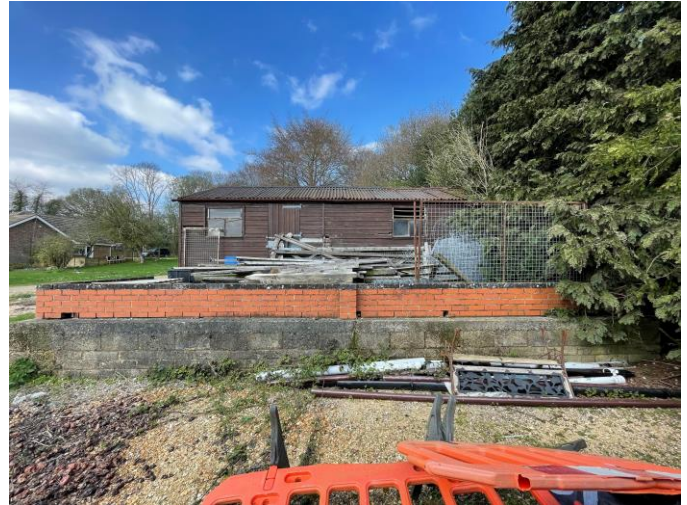
3.8 The south wall was in particularly poor condition with rotten boarding, poor windows, and was moved by light hand pressure (see photograph 6).

6. South Elevation. Note the retaining wall, change in levels, and poor condition of the windows and cladding

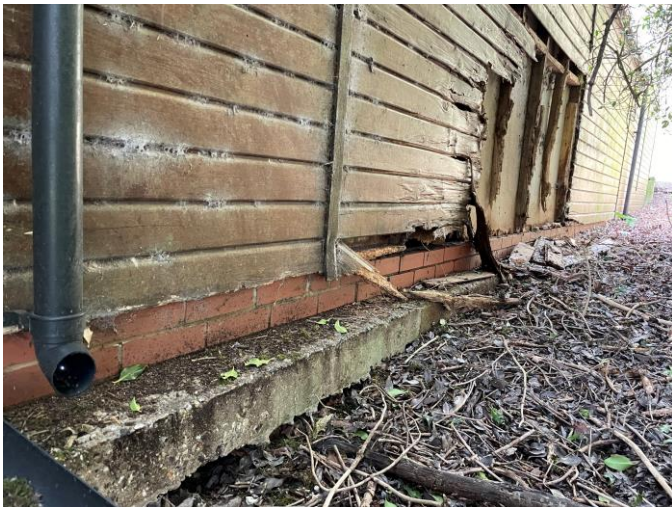
3.7 The timber studwork at the rear was exposed in part and severely damaged by moisture (see photograph 7). There was some visual evidence of fungal and insect infestation.

7. Rotten studwork and cladding on East side.  
Note the undermining of the slab

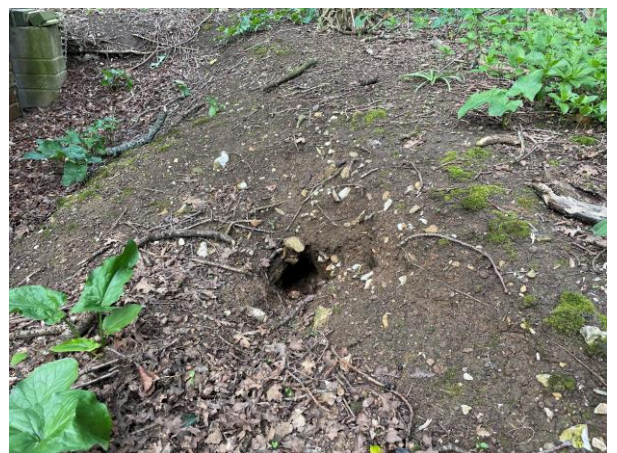
3.10 There were a number of holes in the ground around the perimeter and some undermining of the concrete ground slab. This may have been caused by rabbits or foxes (see photograph 8).

8. Badger or rabbit warren on East side?

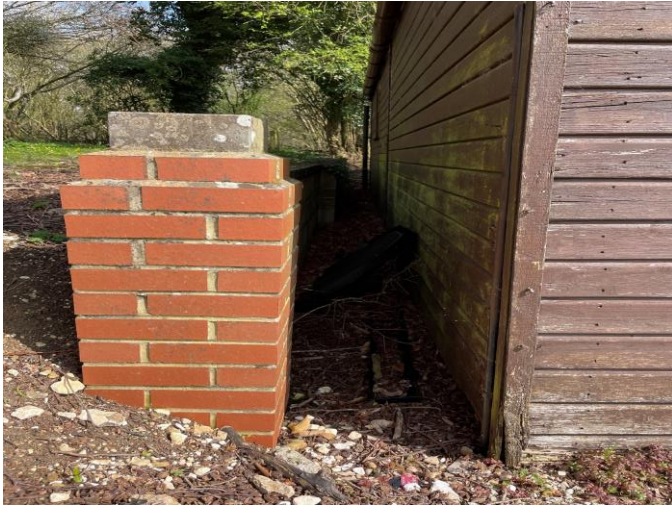
3.4 There is a low level brick retaining wall on the west side of the stable. The wall was in poor condition and was leaning towards the stable wall. At the rear the wall was of blockwork construction and clearly bowed along its length (see photographs 9 and 10).

9. Retaining wall to north elevation

1. Undertake geotechnical investigation to determine depths of foundation.
2. Undertake local authority drainage search and CCTV drainage investigation
3. Grade the external levels to expose the brick plinth.
4. Remove all roof and wall cladding
5. Temporary works to hold the base 'frame' in place
6. Temporarily lift the frame, remove the existing ground slab and construct a new substructure including foundations, and insulated ground slab.
7. Repair the existing frame members
8. Lower the existing frame on to a new raised plinth
9. Construct new brick and flint external leaf
10. Amend timber walls to accommodate insulation and line as required.
11. Strengthen timber roof structure
12. Replace the retaining wall on the west side of the stable

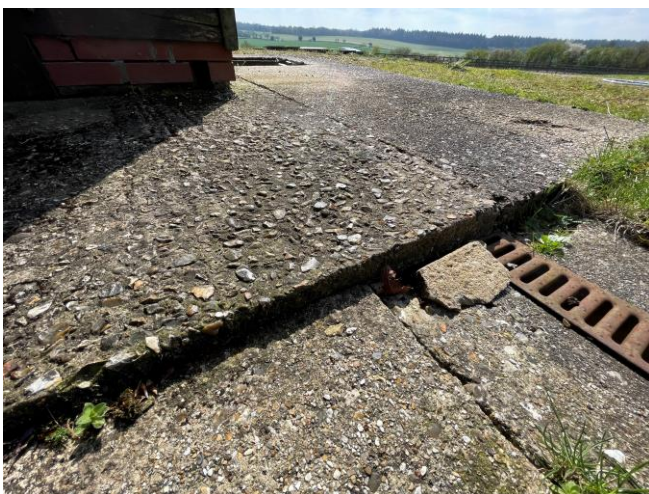
11. Differential movement of concrete slab

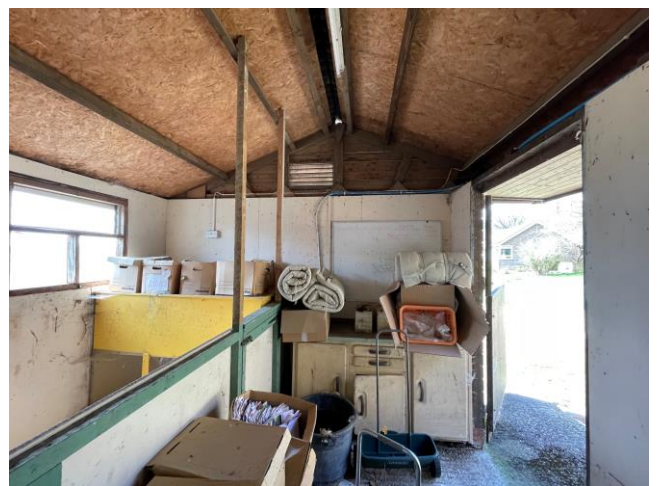
- 3.14 The structure of the stables was lightweight timber framing with simple roof trusses, some with ply gusset plate connections (see photographs 12-19).

12. Internal structure. Note the Stirling board roof sheeting

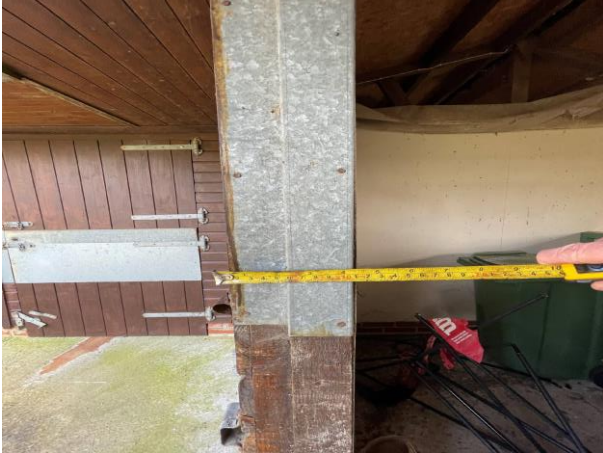
13. Overall wall thickness ~ 100mm

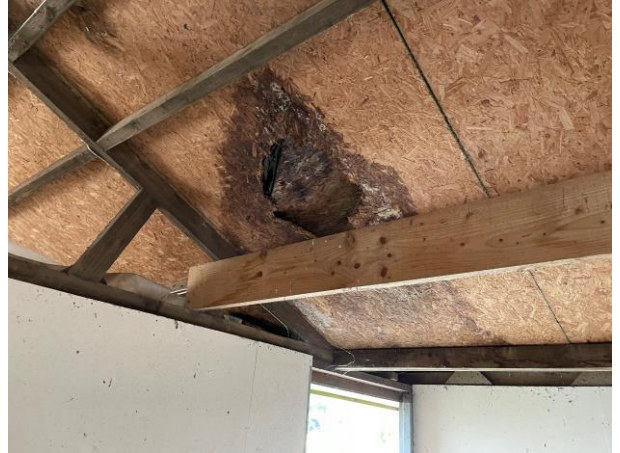
- 3.16 The walls were clad internally and again the boarding was damp and in poor condition, particularly at low level(see photograph 14).
- 3.17 Some of the walls were poorly fixed to the plinth at ground level and were easily moved by light force.

14. Leaking roof damaging the roof boarding and remedial propping

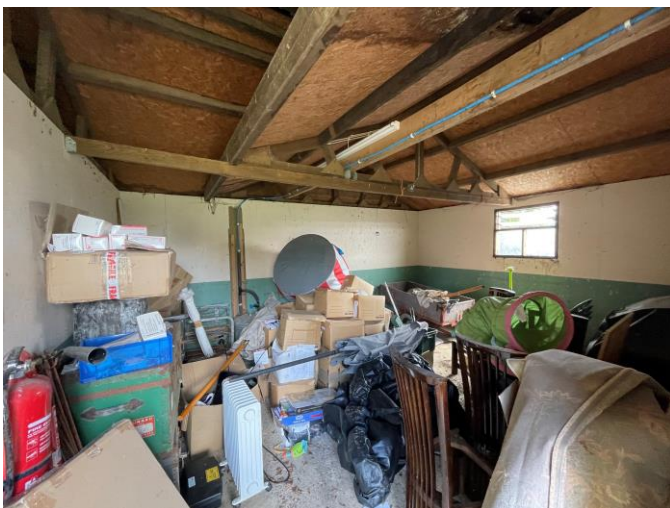
15. Lightweight timber roof structure and wall boarding

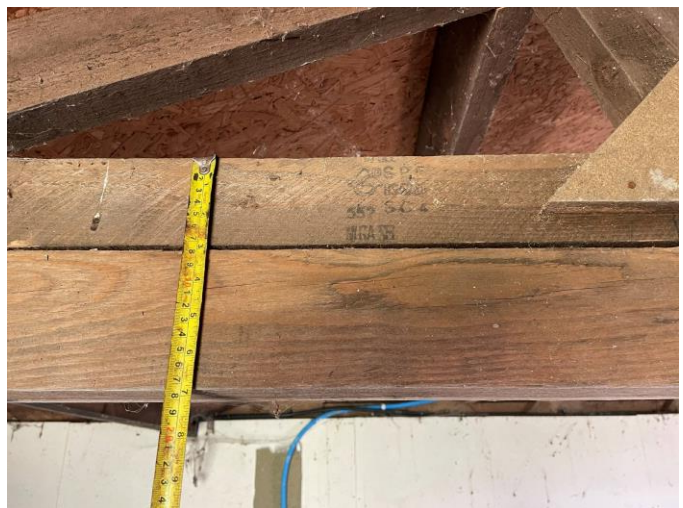
16. Small section roof trusses (75mm) and supporting joist

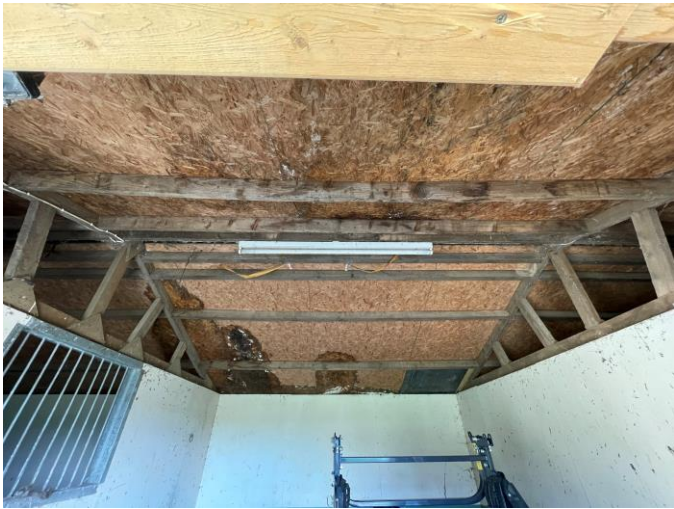
17. Lightweight purlins and damaged roof boarding.

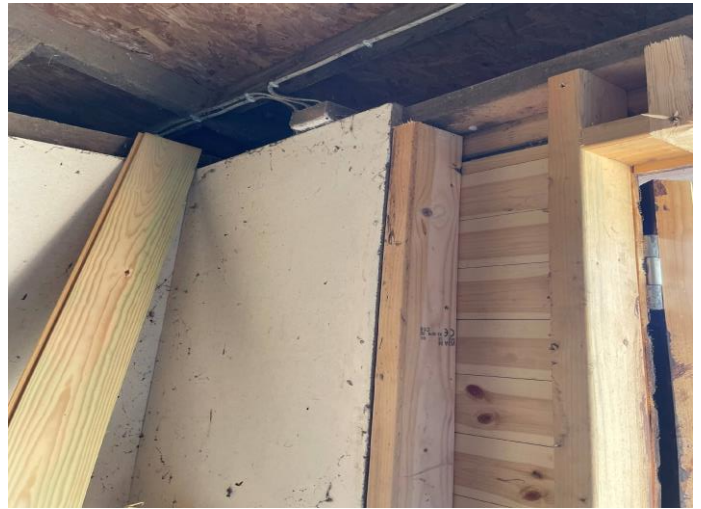
- 3.18 Some of the stud walls had been repaired in the recent past (see photograph 18).
- 3.19 The stables had been in use for many years, and had not been well protected from the horses washing down and contamination etc (see photograph 20).

18. Replacement timber wall studding

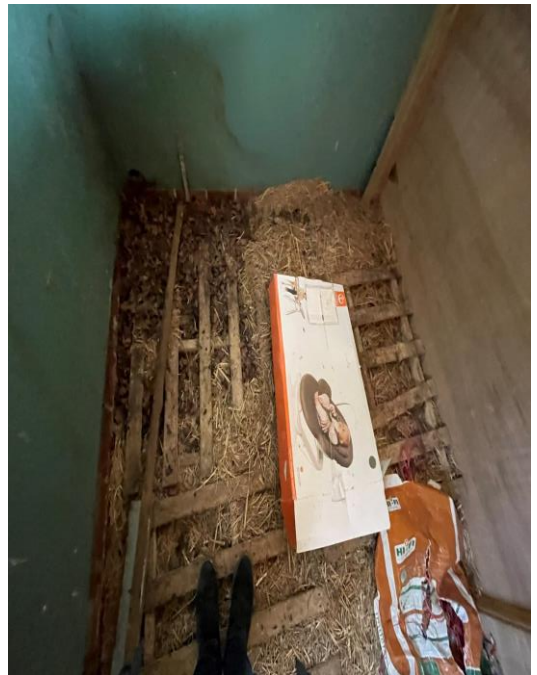
20. Damp walls and floor

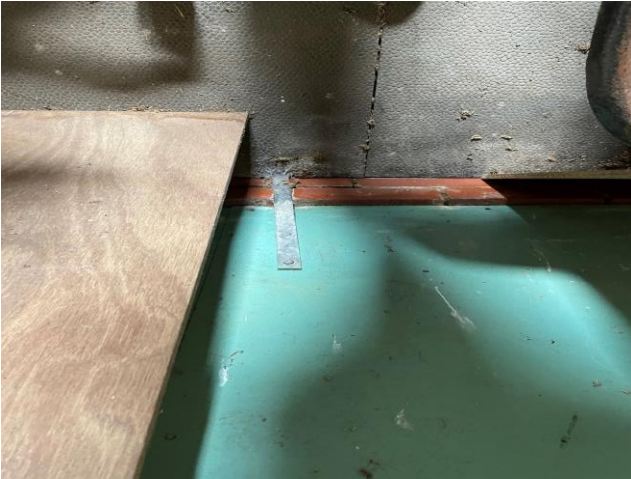
21. Typical strapping of wall to floor.

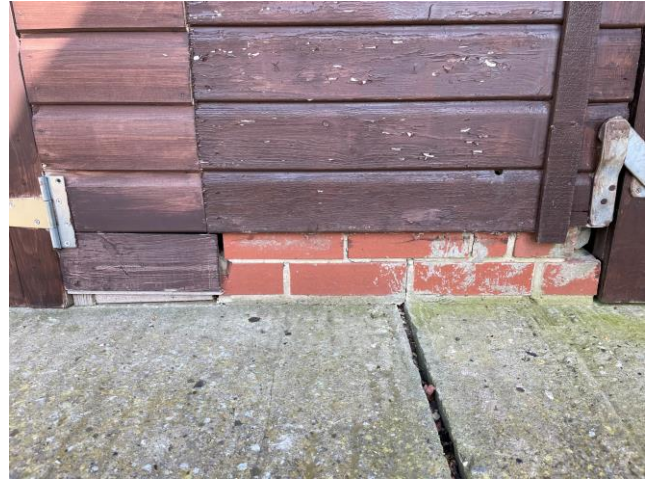
3.11 The concrete ground slab was cast in small bays and there was differential movement between the slabs. This had affected the brickwork plinth where it bridged the joint in the slabs(see photograph 22).

22. Cracking of brick plinth constructed over a joint in the concrete slab.
