# STRUCTURAL APPRAISAL

OCTOBER 2023

**BICTON MANOR BARN, BICTON ROAD, PENSILVA, LISKEARD  
CORNWALL, PL14 5RF.**

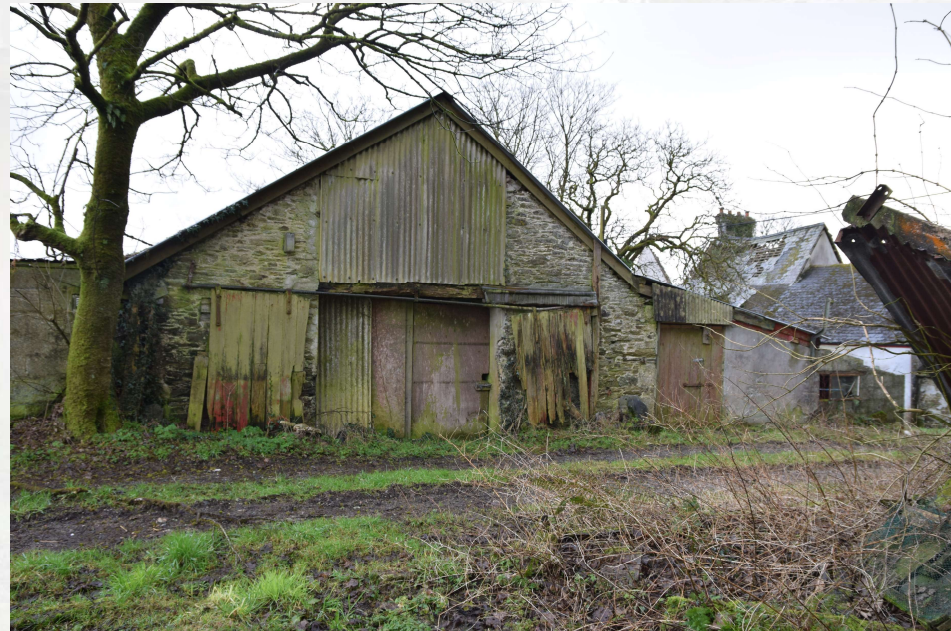
Image 1. Redundant Barn, Bicton Manor, Bicton Road, Pensilva, PL14 5RF
