Project:	Charles Gordon House	Project No:	03129
Prepared By:	Linsey Chambers	Date:	03/10/2023
Present:	Linsey Chambers	Weather:	Dry, sunny, mild

Purpose of the Inspection:

1. To inspect the decayed timber beam that has been uncovered in the basement.
2. To inspect the front steps and basement wall externally.

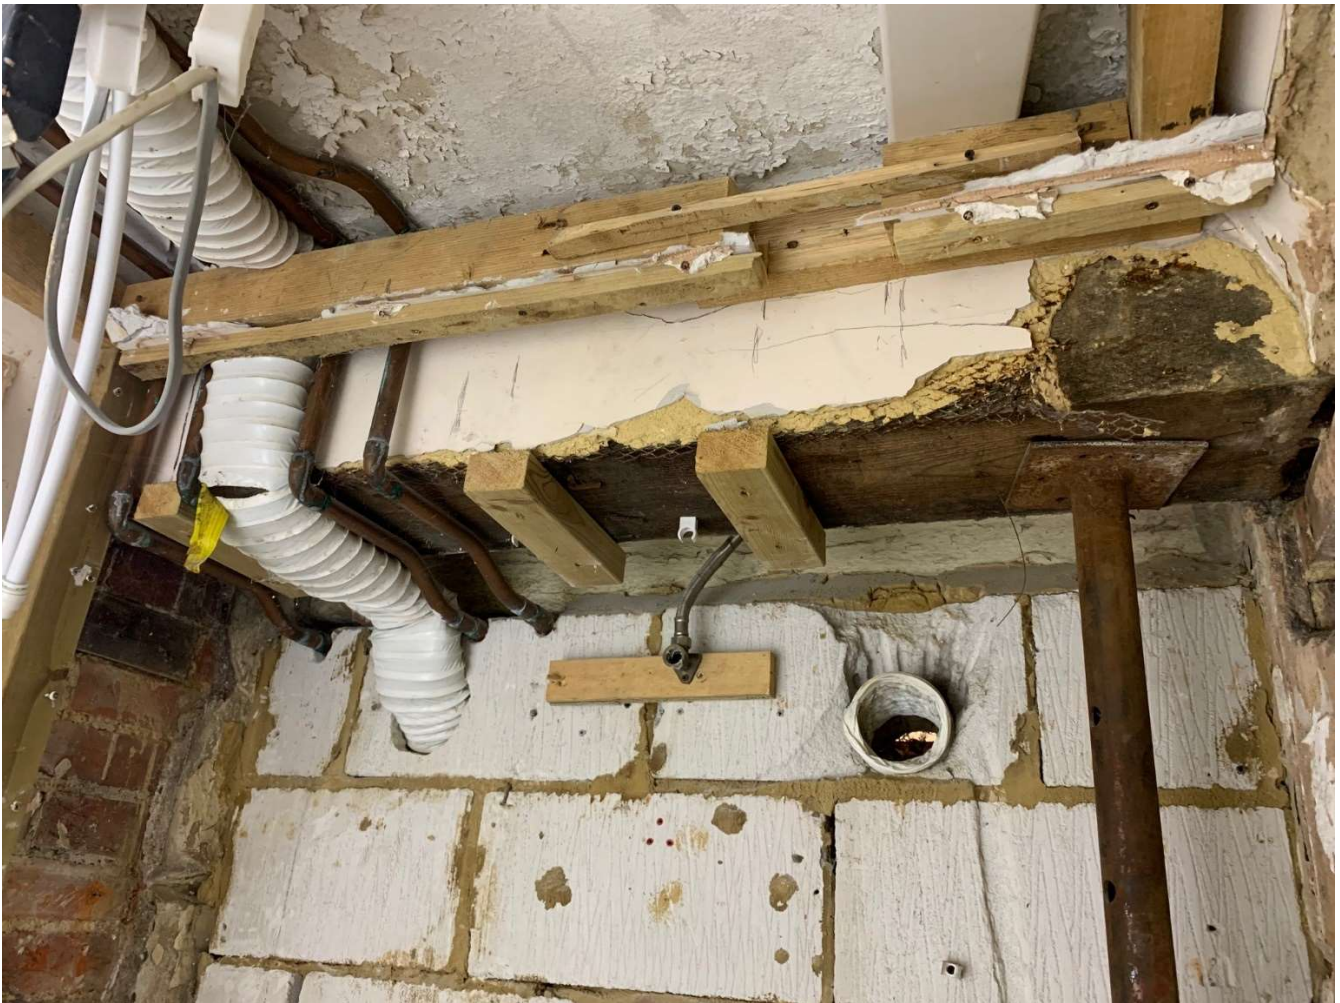
The room below the ground floor entrance hall, in line with the external front steps, has been stripped of finishes exposing a decayed timber beam at high level. Facing south towards the front of the building, the timber beam can be seen at high level spanning 1.35m between masonry walls. The beam is 220mm wide and at least 140mm deep. It was not possible to confirm the depth of the beam due to the presence of plaster finishes and timber studwork (see figure a).

Figure a. High level timber beam in basement with blockwork infill beyond.

1. Moss and vegetation should be cleared out of the gaps between the steps and the bases of the side walls and gaps filled with a suitable lime mortar to prevent further water ingress.
2. Gutters higher up the building should be checked and cleared to ensure rainwater does not overspill and run down the face of the building.
3. Blistering paintwork should be scraped off. Stucco should be repaired either side of and beneath the steps as necessary and locally repainted. Repairs and paint finish should be compatible with the age and type of stucco.
4. Decayed timber beam should be replaced. This could be a like for like replacement or, to avoid the problem of decay in the future, a concrete lintel such as Naylor Lintel type ER8 is recommended. See sketch below:

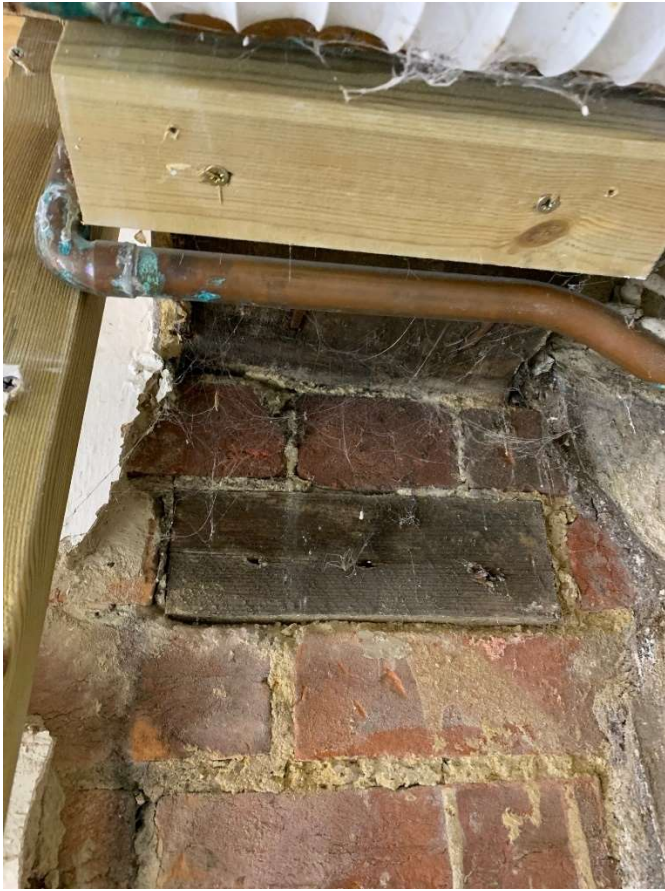
The LH end of the beam extends into the masonry wall and is intact (see figure b). The RH end extends into the opposite masonry wall but has visibly decayed on the underside and is being temporarily supported on an acro prop (see figure c).

Figure b. Wall supporting LH end of beam with timber bonding brick under.

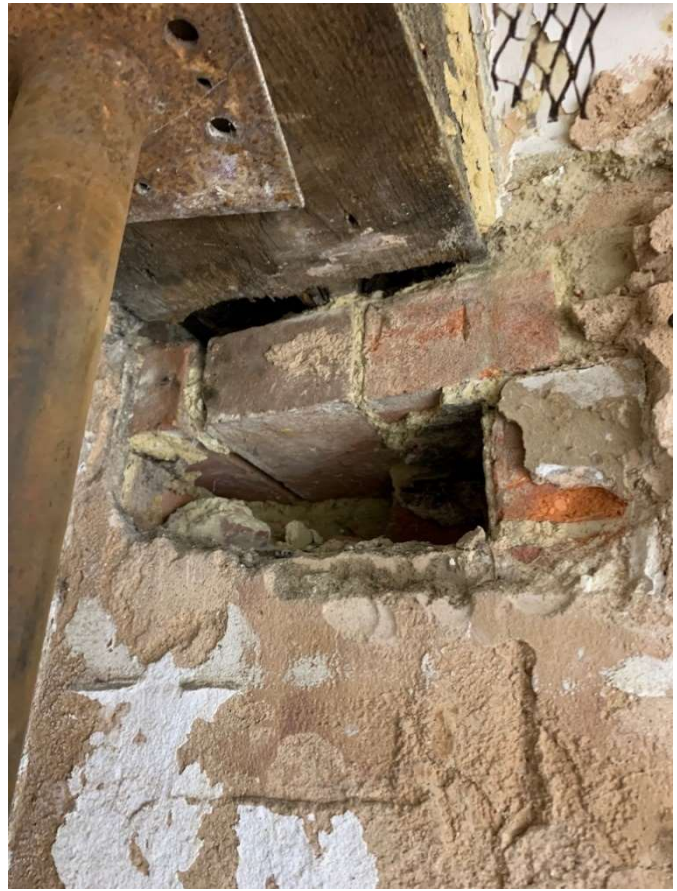
Figure c. Wall supporting RH end of beam with timber bonding brick missing.

The source of water ingress that has caused the beam to decay is not clear but given that the RH end of the beam within the wall is the most severely decayed it suggests that there is moisture in the wall at this end possibly caused by cracks in the stucco on the front elevation of the building or a weakness at the interface between the front wall and the steps.

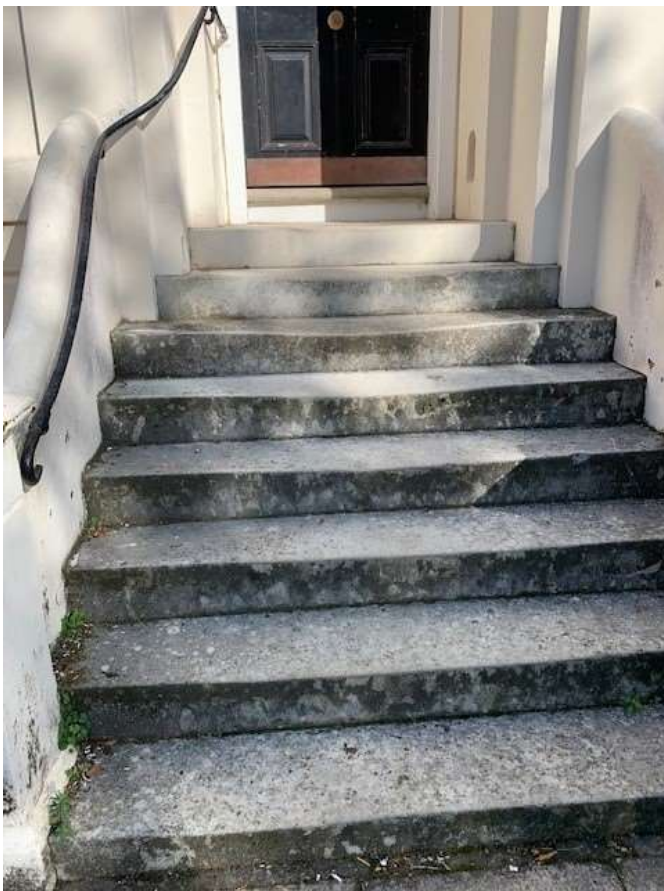
The front steps appear to be the original stone steps which span parallel to the face of the building between supporting beams that bridge across the basement lightwell. The steps appear to be in reasonable condition. There is some moss and vegetation growth evident between the ends of the steps and the base of the side walls (see figure d). These gaps could be a potential route for water to track down into the main front wall of the building.

Figure d. Front steps

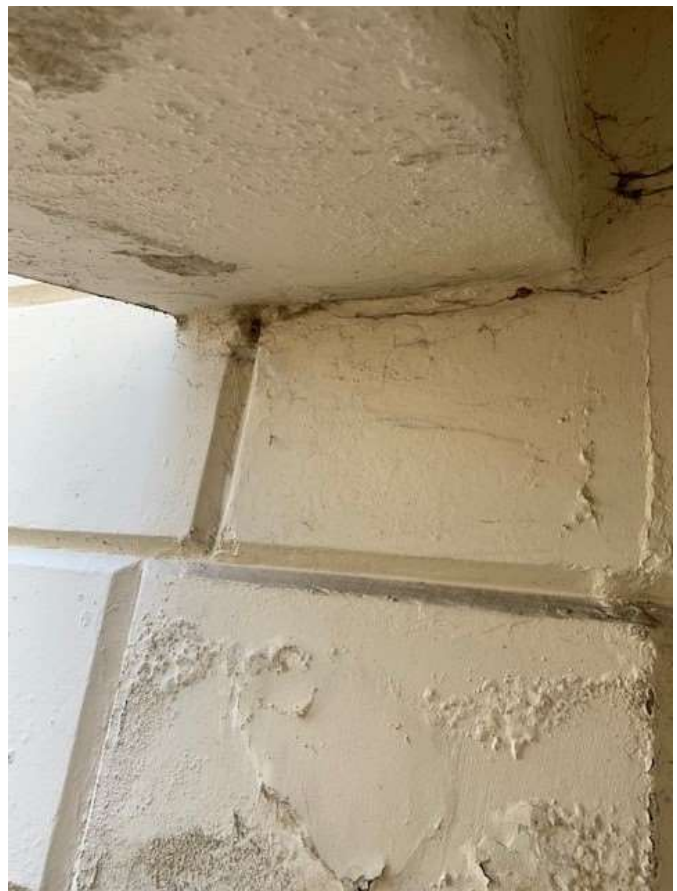
The basement wall below the front steps has a stucco finish. The area that corresponds to the end of the decayed timber beam viewed internally, shows signs of blistering (see figure e). This is due to efflorescence, which is a build-up of expanding salts below the painted surface of the stucco wall, caused by moisture in the stucco.

Figure e. Blistering of paint finish on stucco beneath steps
