Flat 28, 22 Woodlands Terrace, Glasgow G3 6DF

We propose replacing the existing sash and case window with newly manufactured timber sash and case windows that will be manufactured in a like for like formation. Horn detail would be lifted from the existing windows on the building to reinstate the established style.

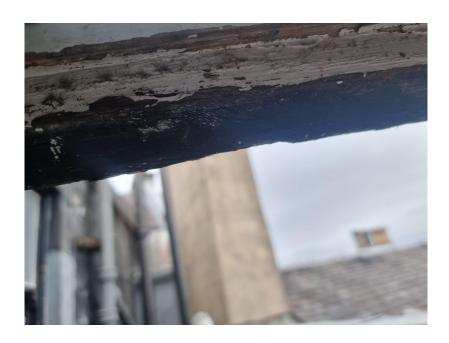
Rotting parting beads, sills and casement woodwork.

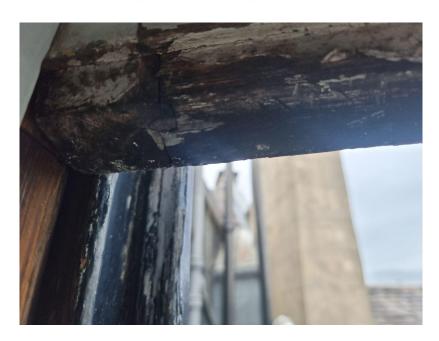
Rotting and water damaged bottom rail.
