- 1.1.1 This arboricultural report is required by our client as part of an investigation into soil shrinkage subsidence damage at:
  - 2 Convent Avenue, South Kirby, Pontefract, West Yorkshire, WF9 3NX.

2.1.1 The site was surveyed during January 2022 by **Charles Cocking** FdSc (Arboriculture), MArborA.

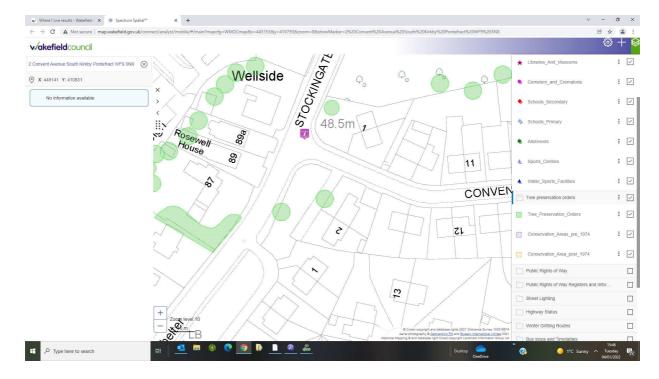
- 4.2 According to this plan (above), there are two protected trees in the locations of the surveyed trees, although **T1** is incorrectly labelled as a Sycamore online. However, it is likely to be the Oak tree surveyed and as such we believe both **T1** and **T2** are protected by individual TPO's.
- 4.3 Before any tree works are undertaken to protected trees, written consent from the Local Authority must first be obtained. An application for tree works form must therefore be completed and submitted to the Local Authority outlining all the proposed works along with a suitable justification. A waiting period of eight weeks is then required.
- 4.4 No work must be done to protected trees until permission has been granted.

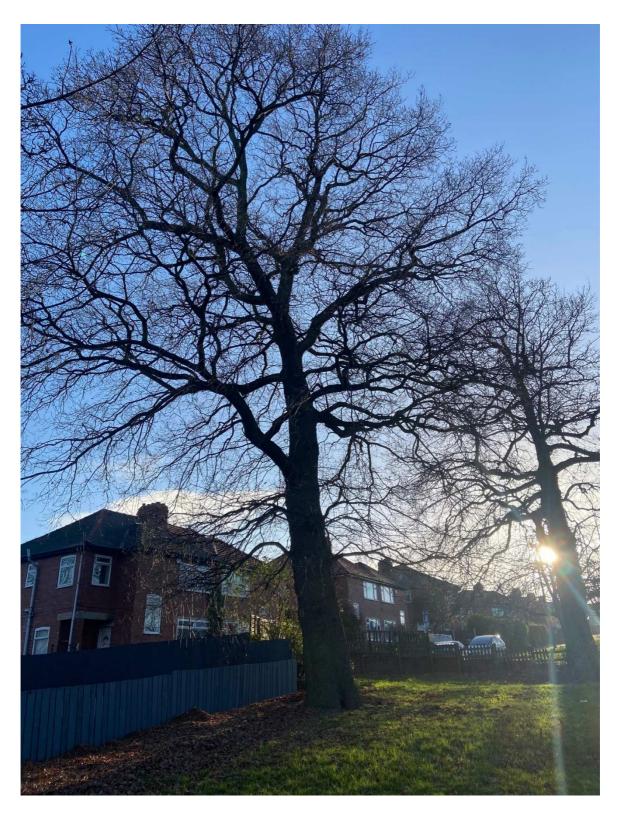
3.4.7 The root identification is a match to the vegetation identified as **T1** in this report. As such it is highly likely that the roots found emanate from this tree.

- 6.1 Having made a detailed survey of the site and having given due consideration to the other information supplied, it is likely that in this case some subsidence damage may have occurred as a result of drying shrinkage caused by **T1**, as identified in this report.

Photo 1: Showing T1 (English Oak).

- We have therefore recommended that **T1** be removed to ground level, and that the stumps be treated to prevent regrowth. In order to negate its influence, the only vegetation management option available is to remove the tree and treat its stump to prevent regrowth, if all other causal factors have been discounted.
