Engineers Report

Risk Address 2 Convent Avenue
South Kirkby
Pontefract
West Yorkshire
WF9 3NX

360 Reference DLG-SN-21-003542
Insurer Reference 079598843
Policy Holder Miss Claire Hibbert

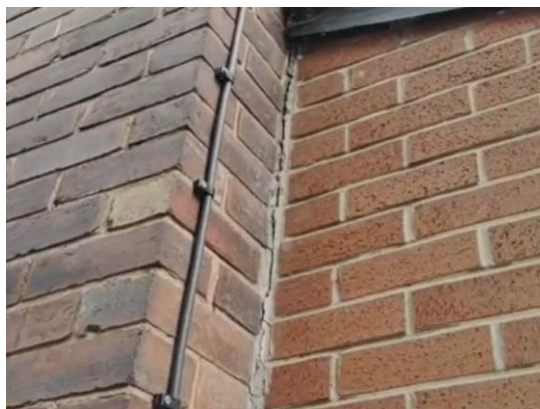
To the front there is 2mm wide stepped and vertical cracking to the mortar joints of the brickwork adjacent to the top right corner of the front entrance door. There is a 5mm wide vertical separation crack at the joint between the garage and the right-hand gable elevation of the main building which becomes wider with height indicating that the garage has rotated away to the right.

Picture 1: Crack between house and garage

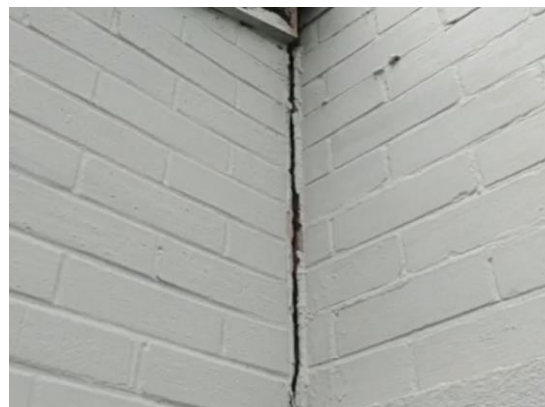
To the rear there is 3mm wide stepped cracking to the mortar joints of the brickwork to the rear of the garage, whilst there is a 10mm wide vertical separation crack at the joint between the garage and the right-hand gable elevation of the main building which becomes wider with height indicating that the garage has rotated away to the right. There are 3mm wide stepped cracks above the kitchen window. The boundary garden wall to the right-hand side has also sustained movement and is out of alignment in various areas.

Picture 2: Crack between house and garage

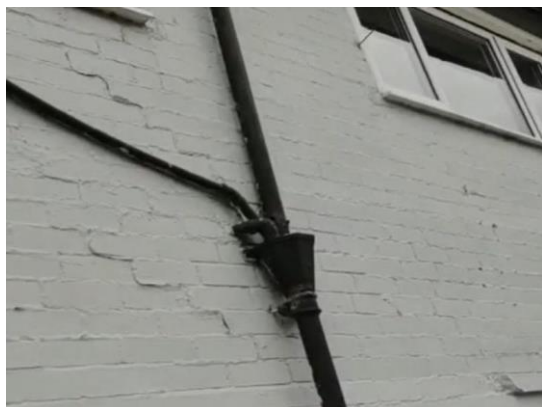
Picture 3: Cracking to rear elevation

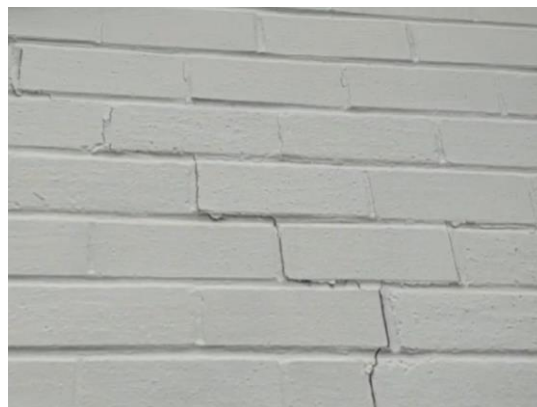
Picture 4: Cracking to rear of garage
