**Subsidence
Monitoring
Services**

Monitoring visit 9 of 9

Monitoring Plus Report

Owners name	Miss Claire Hibbert	Suspected cause	to be advised	Monitoring type	levels
Address	2 Convent Ave South Kirkby Pontefract West Yorks WF9 3NX	Principal area of damage	to be advised	Installed	21/01/2022
		Damage category	to be advised	Frequency (weeks)	8.7
		Surface geology	to be advised	Completion date

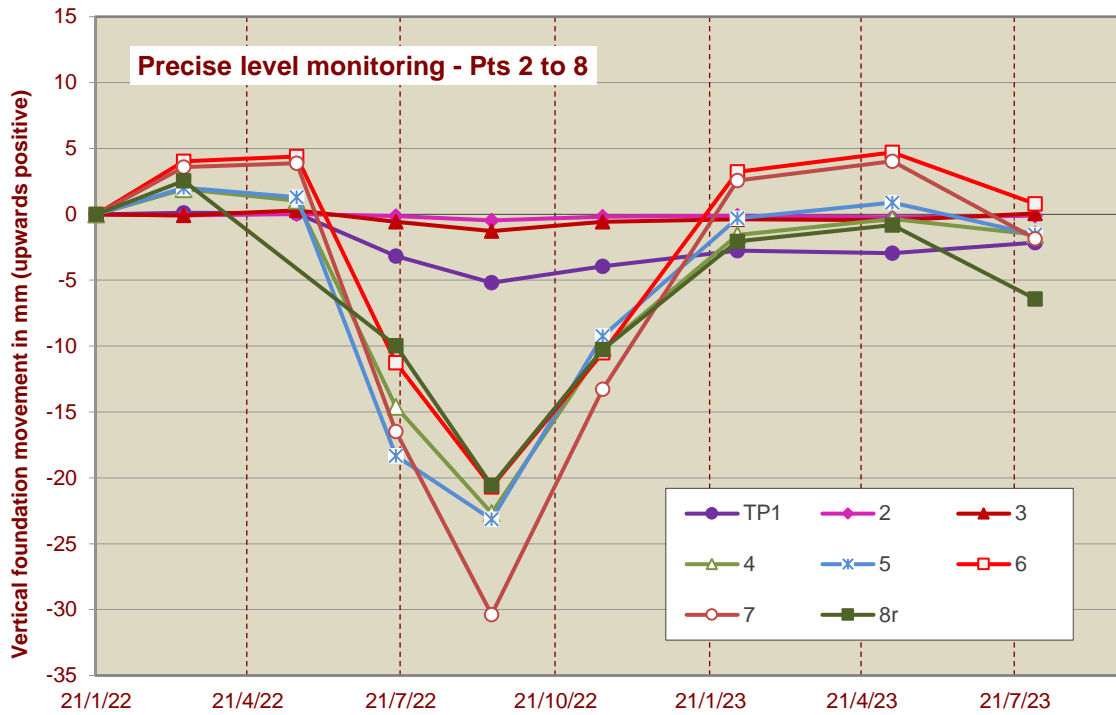
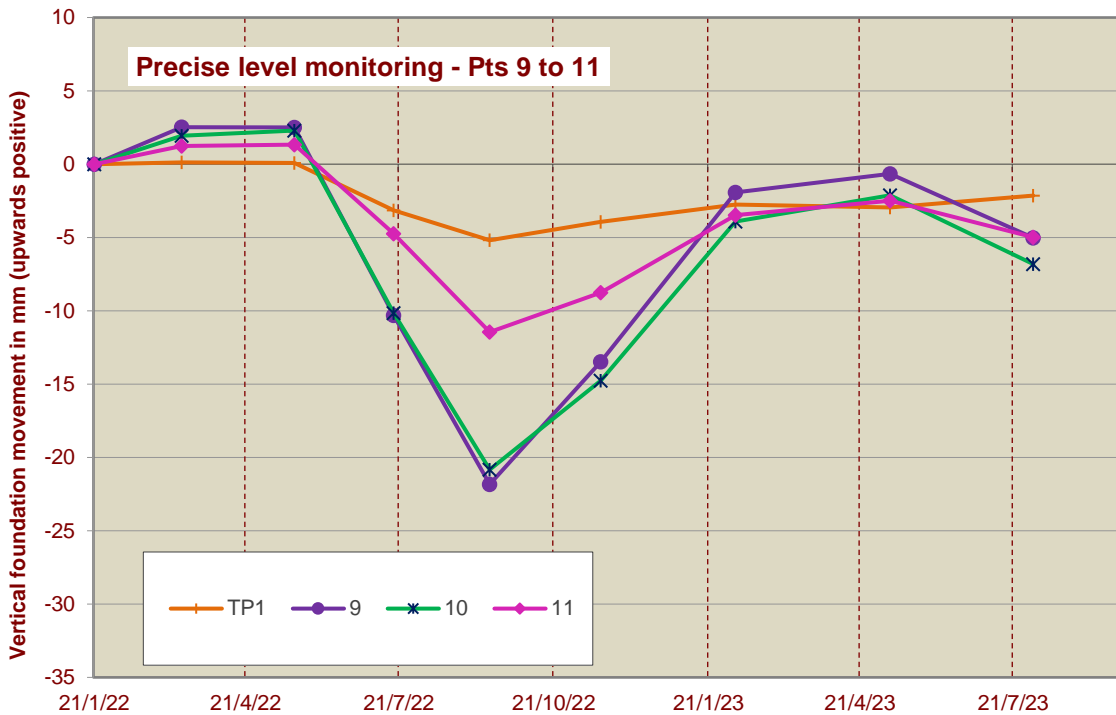
Precise level monitoring related to Point 1

Comment		Feedback from last visit		Status	completed
Max movement	34.4 mm	no feedback for this visit			
Focal area	Pts 4, 5, 6, 7, 8r, 9, 10,				
02/08/2023 - Instructed visits completed.		Sketch showing location of monitoring points			
		<p>The sketch shows a front elevation of a building with several monitoring points marked with arrows and numbers. Points 1, 2, 3, 4, and 5 are on the top edge of the building. Points 6, 7, 8, 9, 10, and 11 are on the bottom edge. A tree is shown to the right of the building. A label 'TP1' is located near the bottom left corner of the sketch.</p>
