**CCTV REPORT FOR: 2 CONVENT AVENUE  
SOUTH KIRKBY  
PONTEFRACT  
WEST YORKSHIRE  
WF9 3NX**

**Insured:** Miss Claire Hibbert  
**Reference:** DLG-SN-21-003542 Ins Ref: 079598843

**Site Visit:** 04-Nov-21  
**Report Date:** 24-Nov-21

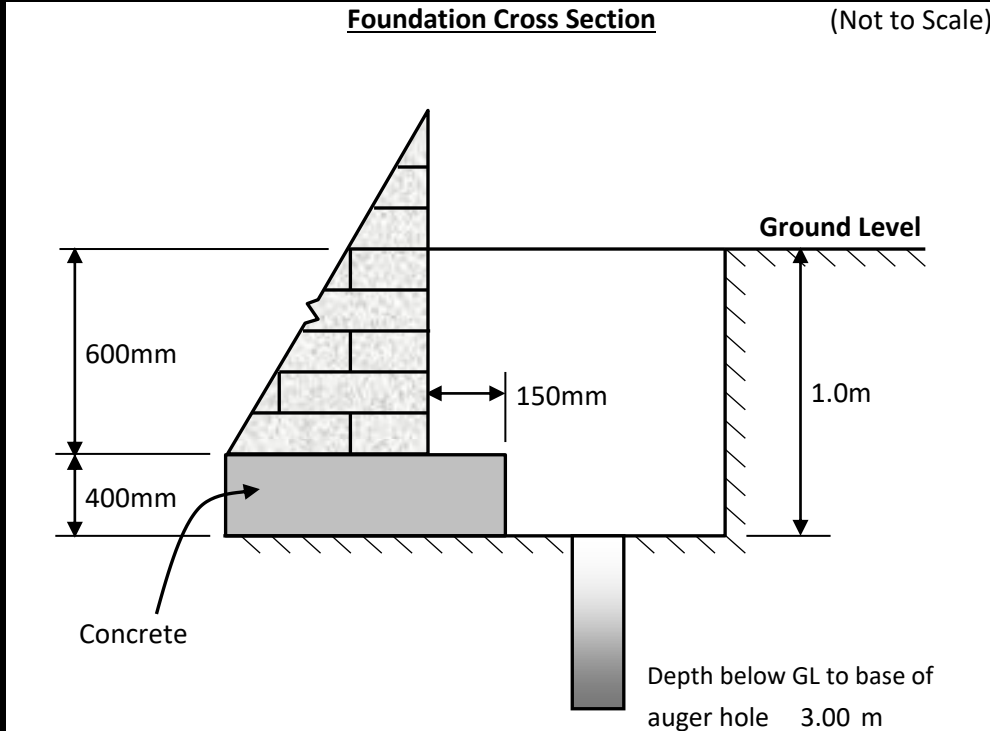
Location: <b>Front elevation</b>	T/H No. <b>1</b>
Ground Surface: <b>Dry</b>	Weather: <b>Dry</b>
	Date: <b>04-Nov-21</b>

Roots Depth & Diameter:
From 1.0m
Down to 2.0m
up to 3mm diameter
Water Depth Hit & Rise:
None observed on site
Reason for Termination :
Encountered obstruction
Compact sand

Depth (m)	Soil Descriptions <i>(NB: Field crew description only)</i>	Test Type	Depth (m)	
			From	To
G.L.				
1.00	Stiff brown CLAY	V(n) 72	1.000	
2.00	Stiff brown slightly sandy CLAY	V(n) 75	1.500	
3.00	End of Borehole

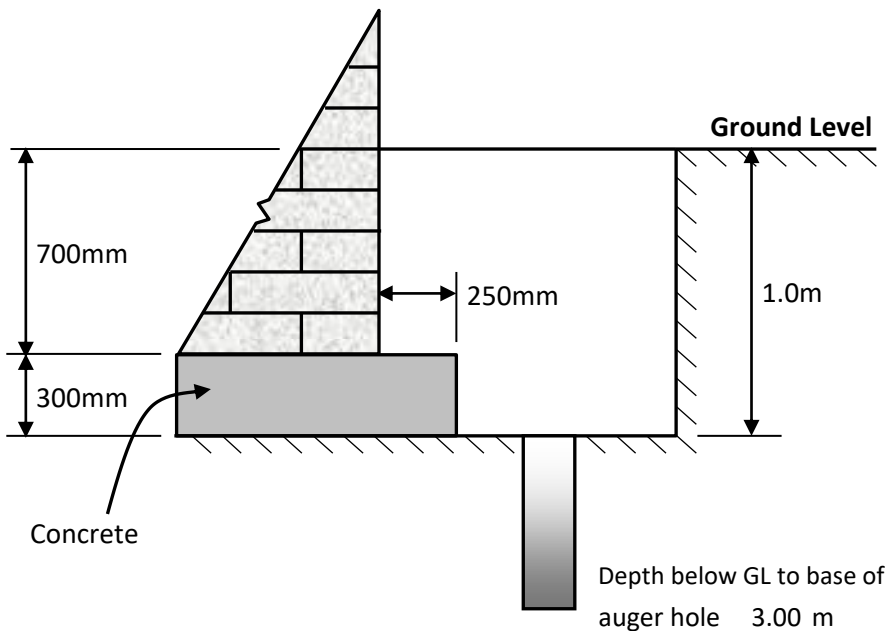
Location: **Rear elevation** T/H No. **2**  
 Ground Surface: **Dry** Weather: **Dry** Date: **04-Nov-21**

Roots Depth & Diameter:  
None observed on site

Water Depth Hit & Rise:  
Hit at 1.8m

Reason for Termination :  
Encountered obstruction  
Compact sand

Depth (m)	Soil Descriptions <i>(NB: Field crew description only)</i>	Test Type	Depth (m)	
			From	To
G.L.				
1.00	Stiff brown mottled grey sandy CLAY	V(n) 47	1.000	
1.50	Stiff brown mottled grey slightly sandy CLAY	V(n) 47	1.500	
3.00	End of Borehole			
<b>Photograph</b>

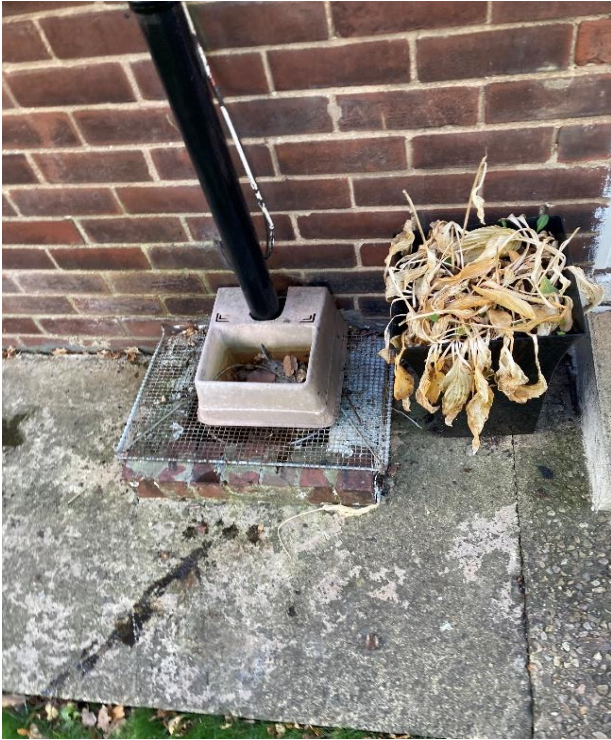
Metres	Faults / Defects	Remarks
0.00		At RWG1
0.40	Medium Open Joint + Displaced Joint	
	Circumferential Crack 12 to 12 o'clock	
0.80	Displaced Joint + Open Joint	
1.80	Circumferential Crack 12 to 12 o'clock	
	Medium Displaced Joint	
3.40	Displaced Joint + Medium Open Joint	
5.10		Past area of concern
		End of survey

Circumferential cracks, medium displaced joints and medium open joints.

Excavate and replace RWG1 allowing for up to 1.0m of pipework downstream.

Carry out high pressure water jetting to prepare pipework for lining. Install a structural liner from excavation downstream for up to 3.0m.

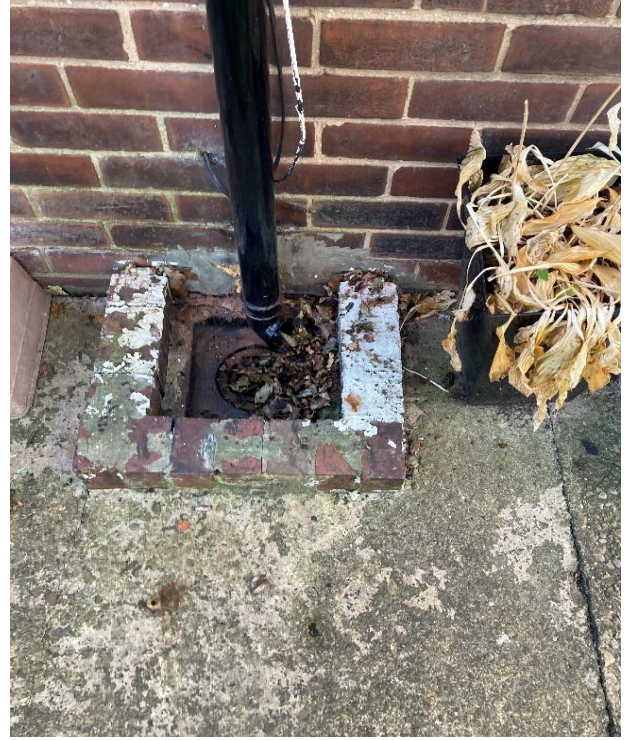
Metres	Faults / Defects	Remarks
0.00		At I/C1
0.20	Medium Displaced Joint	
1.70	Medium Displaced Joint	At R&FWG1
		End of survey

Medium displaced joints.

Excavate and replace FWG1 and remaining pipework downstream to I/C1.

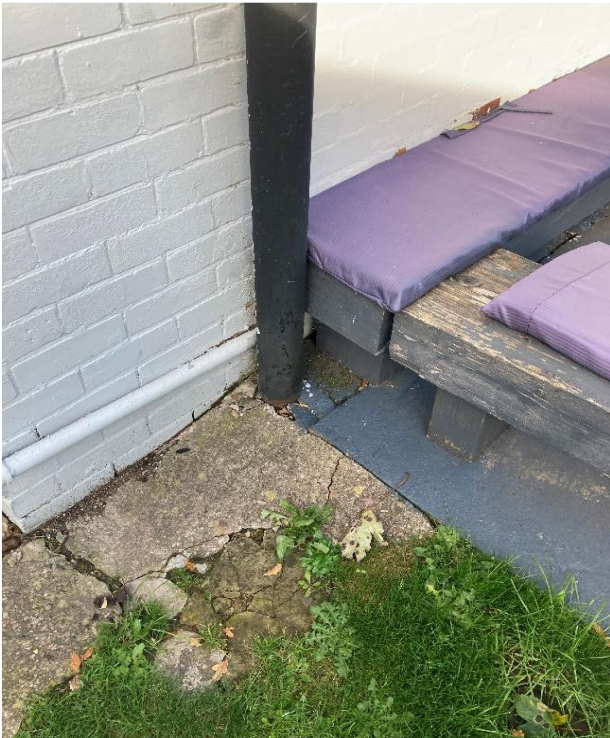
Metres	Faults / Defects	Remarks
0.00		At I/C1
1.60	Medium Displaced Joint	
2.30	Medium Displaced Joint	
2.90	Displaced Joint + Medium Open Joint	At SVP1
		End of survey

Medium displaced joints and medium open joint.

Excavate and replace rest bend to SVP1 to allow access for lining.

Carry out high pressure water jetting to prepare pipework for lining. Install a structural liner from I/C1 upstream to SVP1.
