# Tree Survey Report

## Rubislaw Park Care Home Aberdeen

November 2023

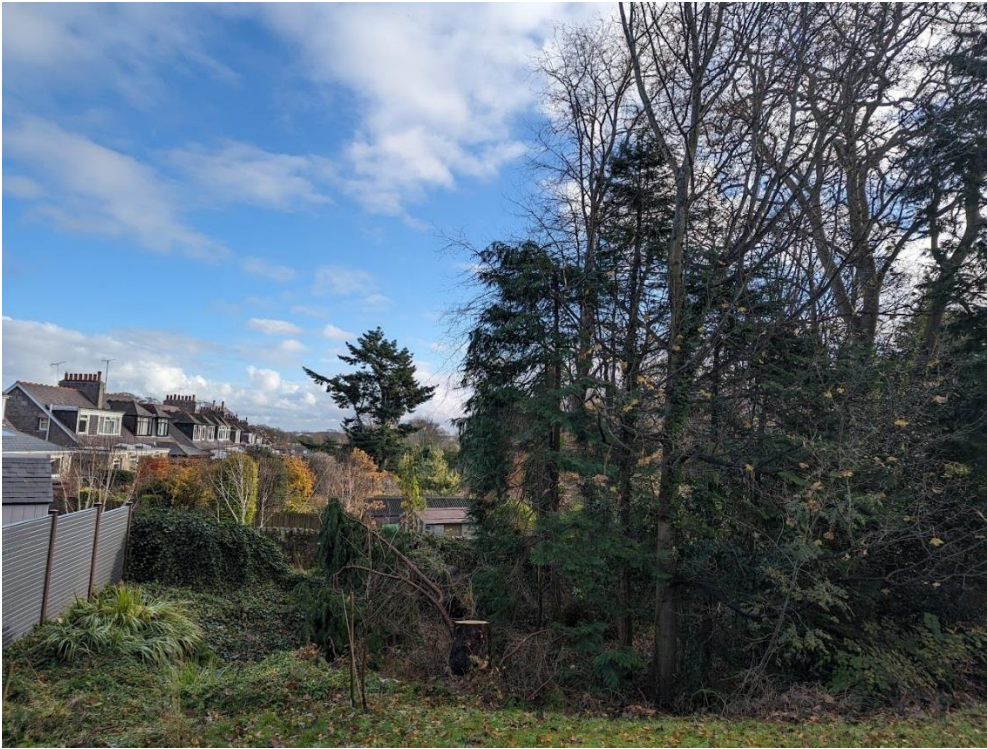
Recently, a 12m tall Lawson cypress at the woodland edge close to the care home building split at a tight fork due to high winds and has been removed to a stump.

**Lawson cypress 2759** has split and been removed to a tall stump. Replacement planting nearby with a silver birch (*Betula pendula*) is recommended to provide trees of an appropriate mature height and increase the species diversity within the site.

Photo 1 – Recently failed Lawson cypress. Cut stump to ground level and replace nearby with silver birch.

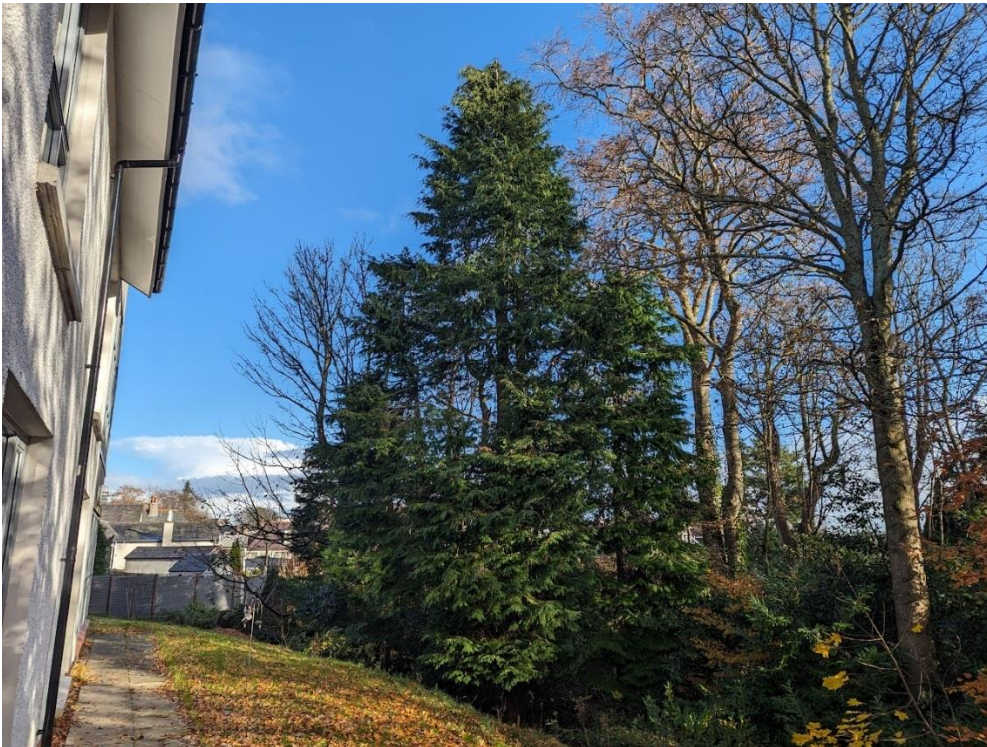
**Lawson cypress 2757** has a dense evergreen crown close to the care home building. Its smaller neighbour 2759 has recently split. Removal of the tree and replacement with a yew (*Taxus baccata*) will increase clearance distance and provide a replacement of long-term potential and smaller mature height.

**Lawson cypress 4777** is a small tree with potential for significant future growth. It forms a single spread with cypress 2757 (noted above). Removal and replacement with yew (*Taxus baccata*) is recommended.

Photo 2 – Lawson cypress 2757 close to care home. Removal of this tree and neighbouring cypress 4777 would provide increased clearance of the care home building. Replacement with yew nearby but at a greater distance from the building is recommended.

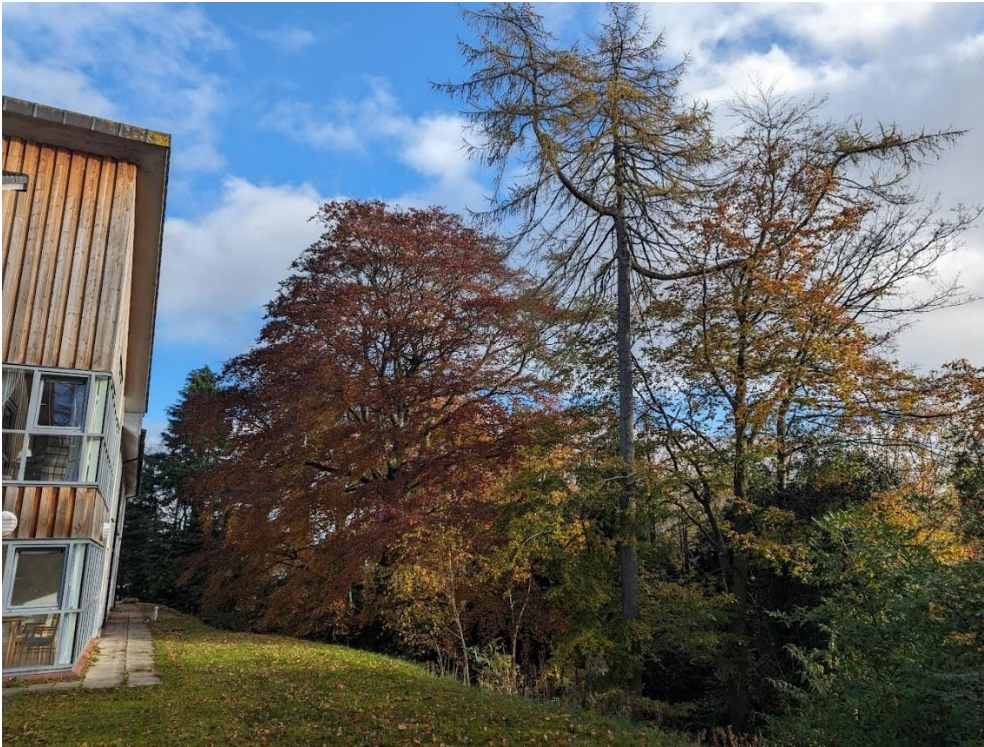
**Larch 2750** is tall and close to the care home. The crown displays lesser form. Removal of the tree will benefit neighbouring beech. Replacement with a yew (*Taxus baccata*) will provide a tree of smaller mature height and long-term potential.

Photo 3 – Copper beech 2748 is a good specimen and appears well formed. The adjacent larch 2750 is of lesser form and has potential for significant further growth. Its removal and replacement with yew is recommended to increase clearance of the building.

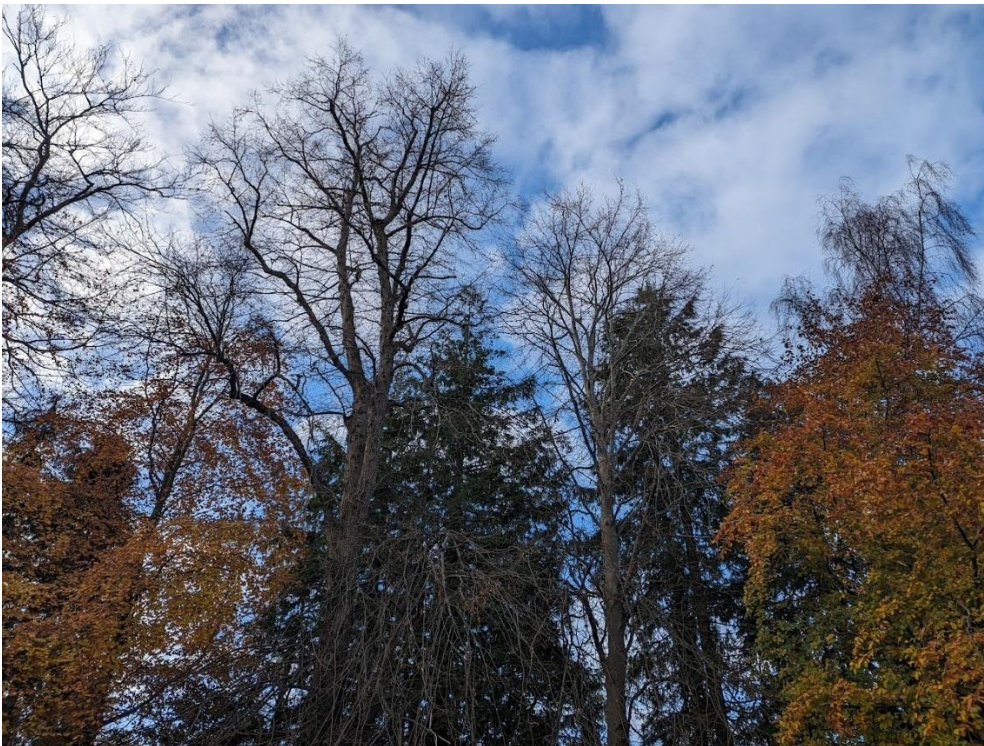
**Lime 644** displays dense basal shoots which should be pruned to provide access to the lower trunk.

**Lime 645** is a larger tree close to the care home. Pruning to reduce the height by around 20%, to that of the neighbouring lime, is recommended. Basal shoots should be pruned to improve access around the base of the tree.

Photo 4 – Lime 644 and 645 occur at the western site boundary close to the care home. Pruning to reduce the height and spread of tree 645 is recommended. Shoot growth at the base of both trees should be pruned to improve access to the lower trunk.

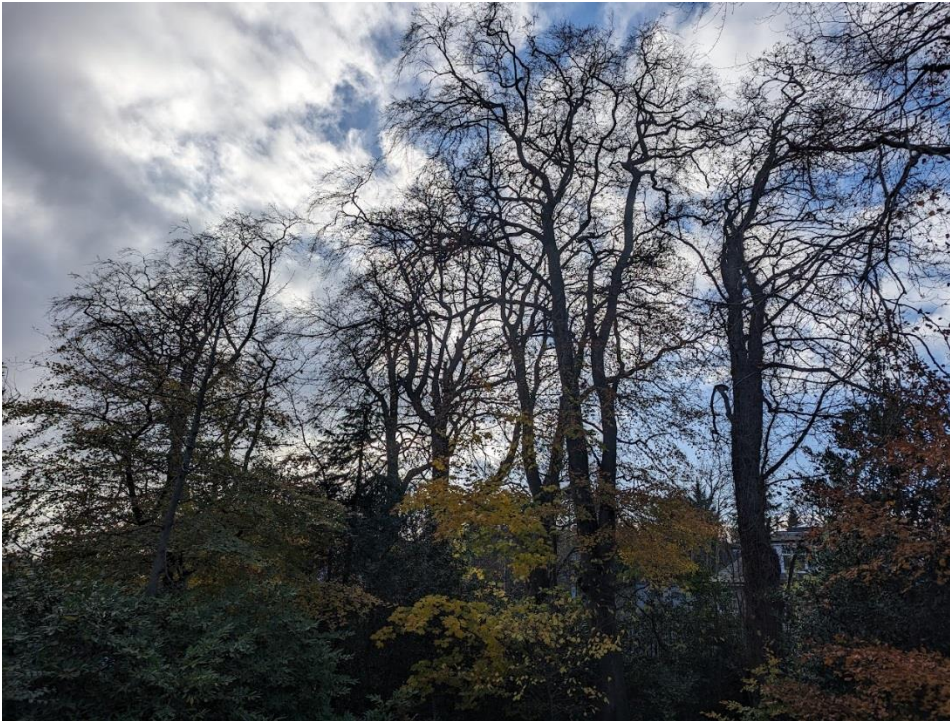
**Sycamore 655** has a pronounced bias towards and overhangs the neighbours garden at the western boundary. Pruning to reduce the overhanging branches by around 20% is recommended.

**Beech 656** is a large tree bias towards and overhanging neighbouring property at the western boundary. Pruning to reduce the overall height and spread above the neighbours garden by around 20% is recommended.

**Sycamore 657** is a large tree bias towards and overhanging neighbouring property at the western boundary. Pruning to reduce the overall height and spread above the neighbours garden by around 20% is recommended.

**Horse chestnut 658** is a large tree bias towards and overhanging neighbouring property at the western boundary. Pruning to reduce the overall height and spread above the neighbours garden by around 20% is recommended.

**Horse chestnut 662** is a large tree bias towards and overhanging neighbouring property at the western boundary. Pruning to reduce the overall height and spread above the neighbours garden by around 20% is recommended.

Photo 5 – Large and old trees 655 to 658, 662 and 663 occur along the southern part of the western boundary. The trees significantly overhang neighbouring property and pruning to reduce height and spread has been recommended.

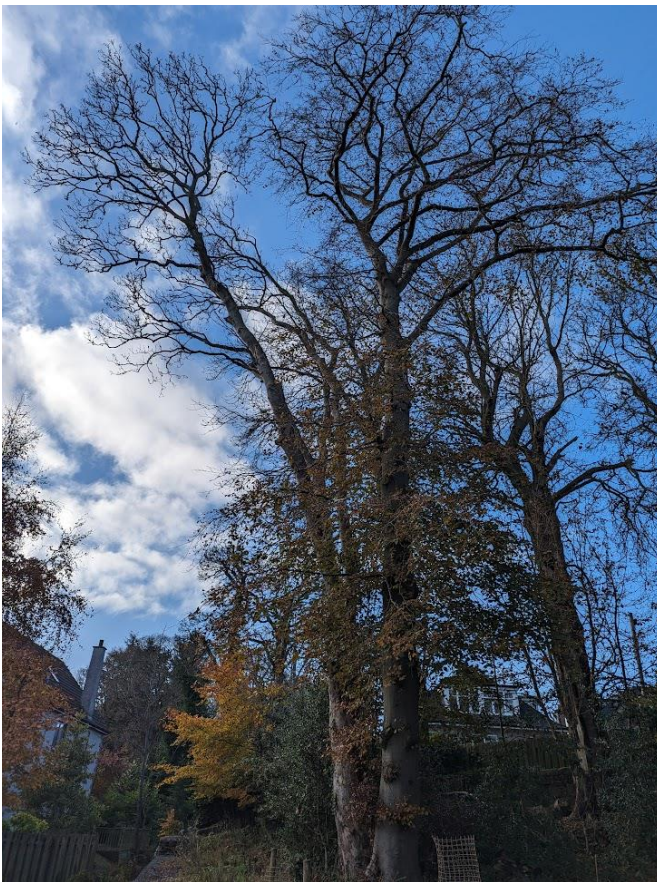
**Sycamore 663** was previously severely pruned, removing all of the lower branches. The remaining upper crown appears sparse and exposed. The tree is of low vigour and its health may have been impacted by the installation of gabions along the water course at the base. Removal of the crown at the forks is recommended. The lower trunk could be retained and may regenerate. The additional space will benefit the improved development of neighbouring beech 664.

Photo 6 – Sycamore 663 displays a sparse crown with a pronounced bias overhanging the neighbour's garden. The tree is in poor condition and removal of the crown at the low fork has been recommended.

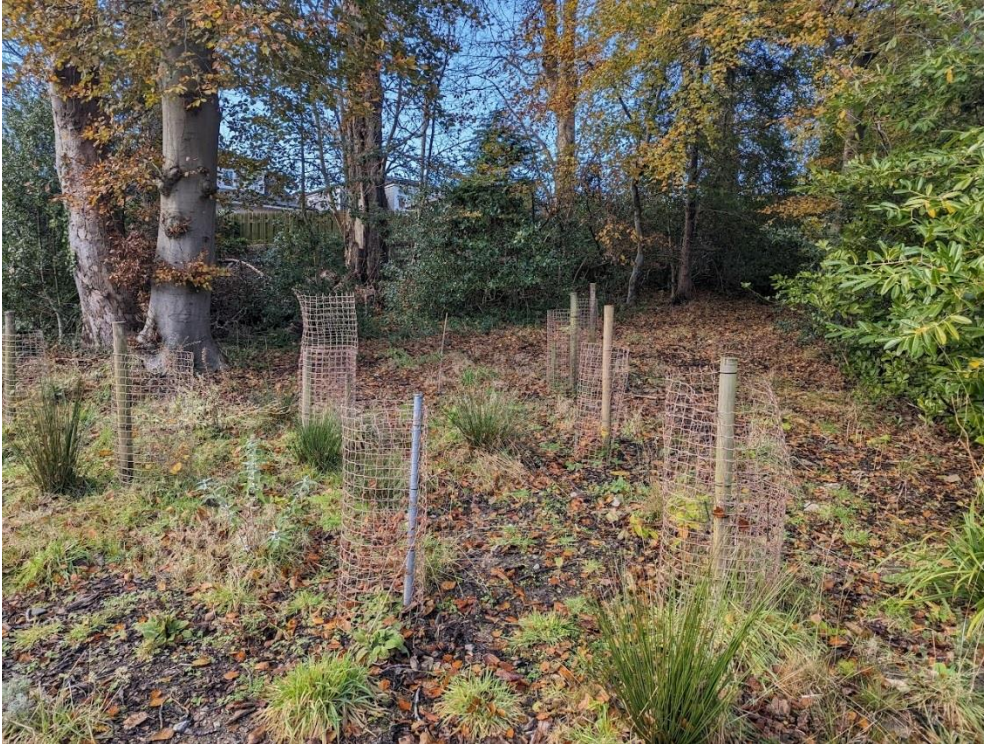
Photo 7 – Recent planting of hazel (*Corylus avellana*) to replace trees removed to accommodate gabion installation.

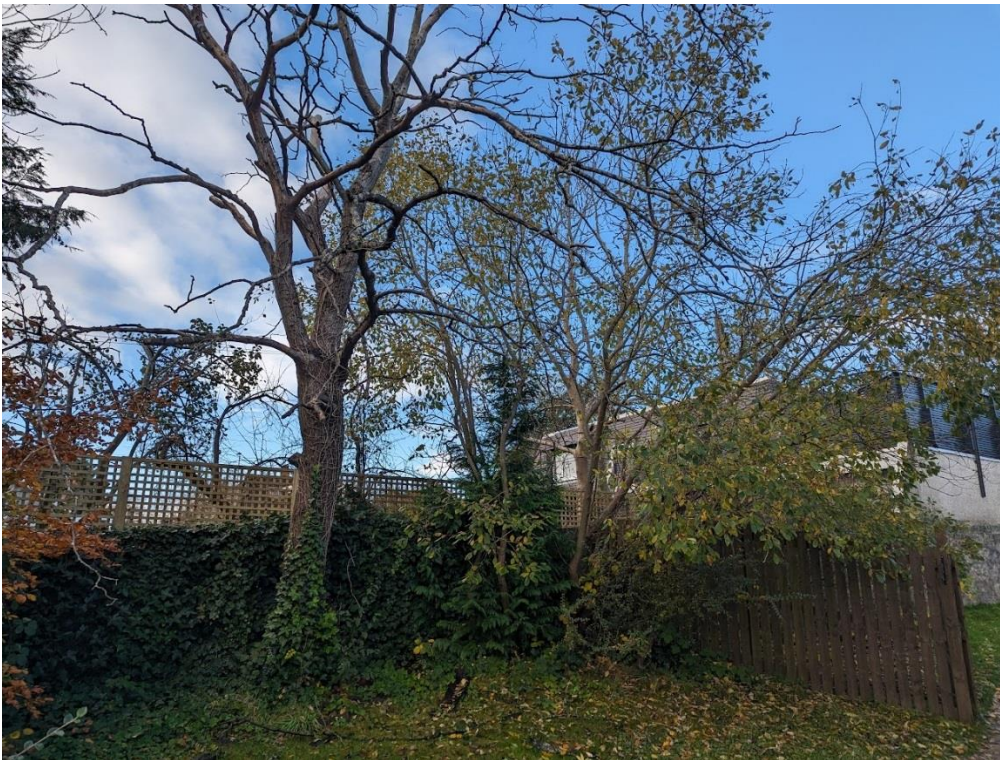
**Tree 630** occurs close to the building and overhangs the neighbouring garden. Removal has been recommended. Trunk wood could be cross-cut and retained on site. Replacement planting with silver birch (*Betula pendula*) is recommended.

**Willow 629** has grown quickly and developed a multi-stemmed form with branches resting on the boundary fence. Pruning to remove these branches at the base is recommended.

Photo 8 – Willow 629 should be pruned to remove branches resting on the fence. Adjacent dead elm 630 should be removed and replaced with a silver birch (*Betula pendula*)
