**Structural Condition Survey for  
Faccenda Farms Ltd, Lower Farm,  
Hillesden, Buckingham, MK18 4BY**

Ref: 230790-CON-ZZ-ZZ-RP-S-0001

Revision: P01

Date: 26 July 2023

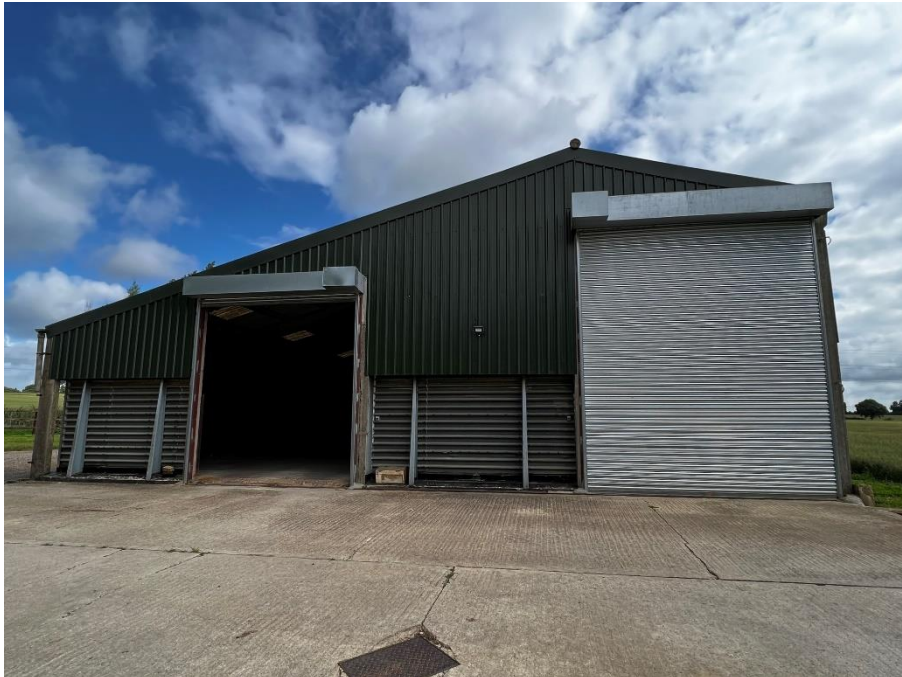
5.2 South elevation

- 3.1 Roof deck is in corrugated asbestos cement sheeting, similarly high level cladding to west, north and east elevations is in the same. High level cladding to the south elevation is corrugated steel sheeting (photos 5.1–5.6).

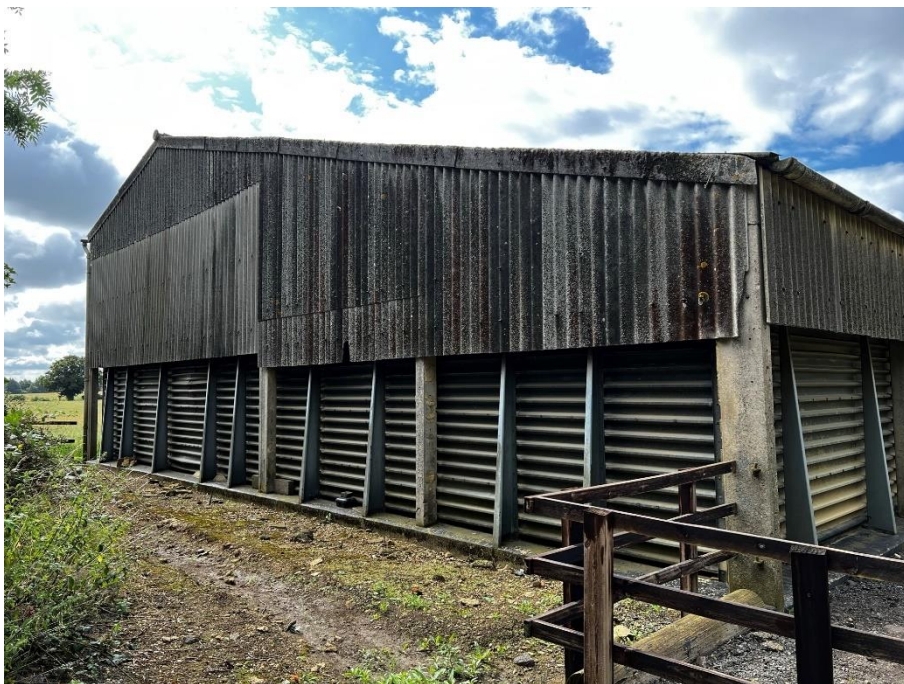
5.4 North elevation

- 3.2 Concrete columns visible externally at low level, head connections visible popping through the high level cladding (photo 5.4).
- 3.3 Low-level cladding to all elevations is in corrugated steel sheeting, spanning between tapered steel cantilever posts with bases cast through the slab edge / ground beam. This acts as a retaining wall for internal grain storage (photo 5.7).

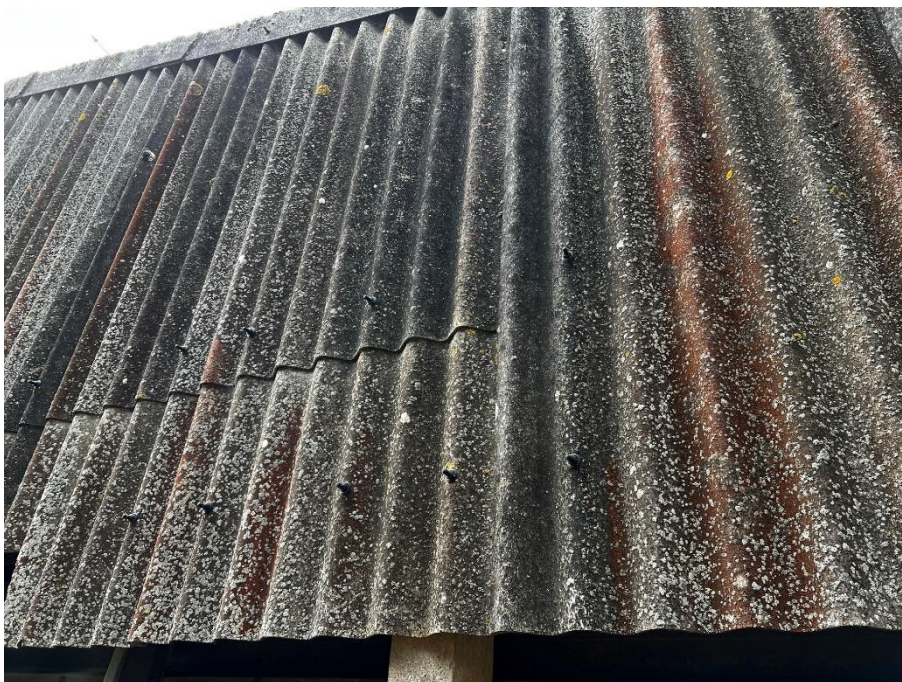
5.6 High level cladding in corrugated asbestos cement sheet

- 4.4 A Refurbishment & Demolition asbestos survey will be required and potential asbestos containing material removed (refer items 3.1 and 3.4). Replacement roofing materials should be no heavier than the existing, otherwise strengthening might be required of existing roof structure.

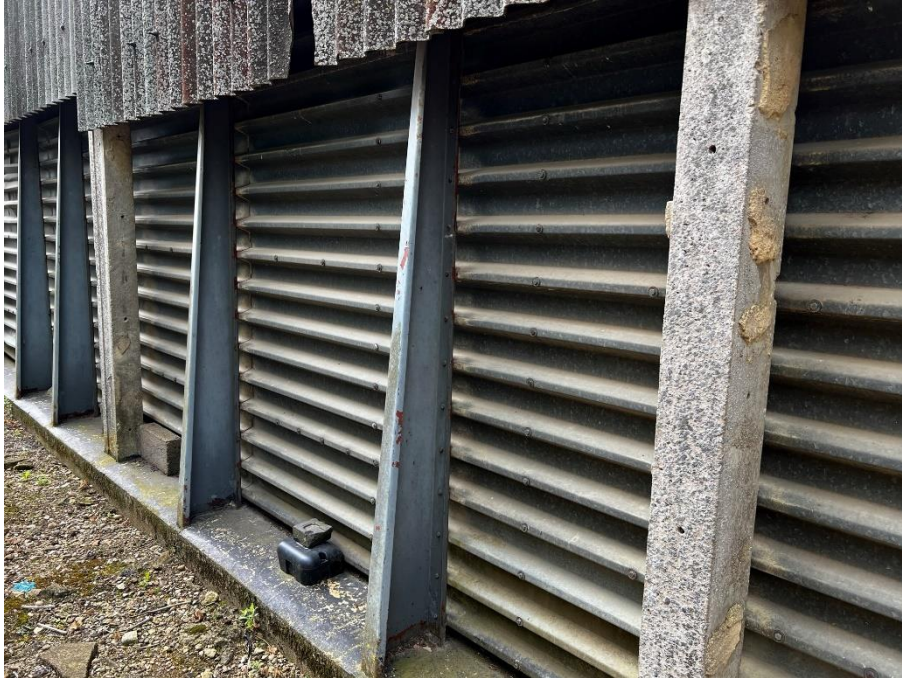
5.7 Steel cladding at low level with tapered support struts with bases cast through concrete edge beam / slab edge – assumed to act as retaining walling for internal grain storage.

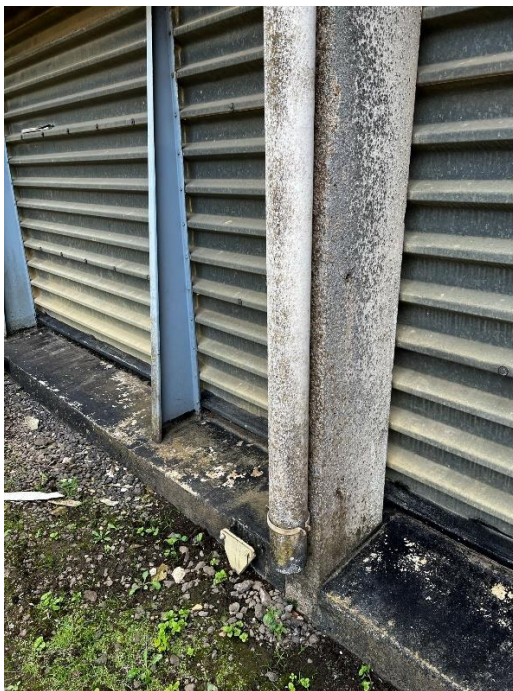
- 3.4 Possible asbestos to guttering and downpipes (photo 5.8).
- 3.5 Precast concrete purlins support the roof sheeting (photo 5.13).
- 3.6 Haunched bolted connections join the portalised framing elements at the eaves and one side of the central column line (photos 5.14-5.16).

5.8 Possible asbestos guttering and downpipes

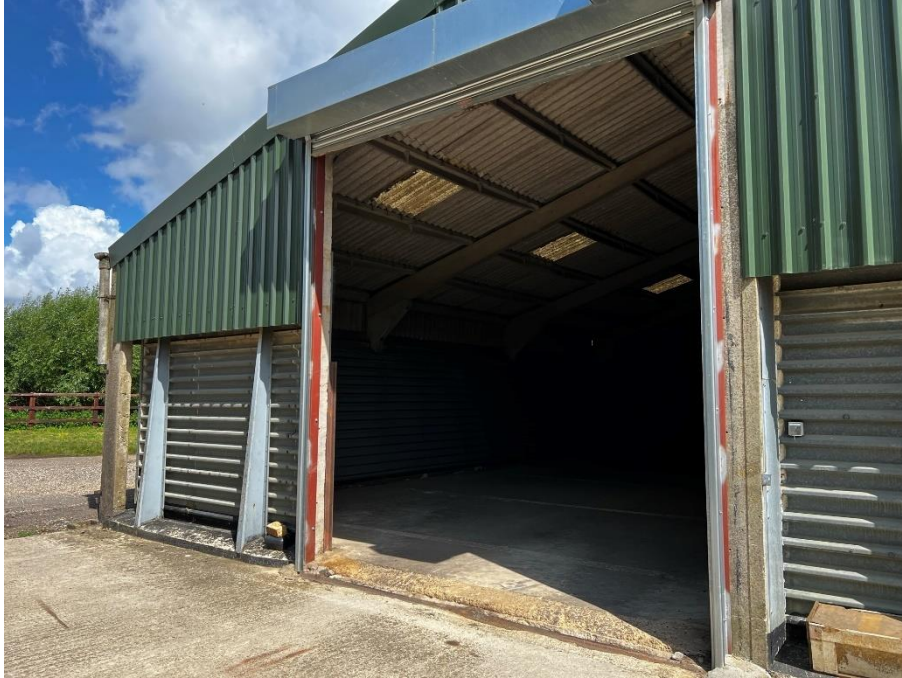
5.9 Steel cladding to south elevation, structural steel trimming in red at roller shutter doors

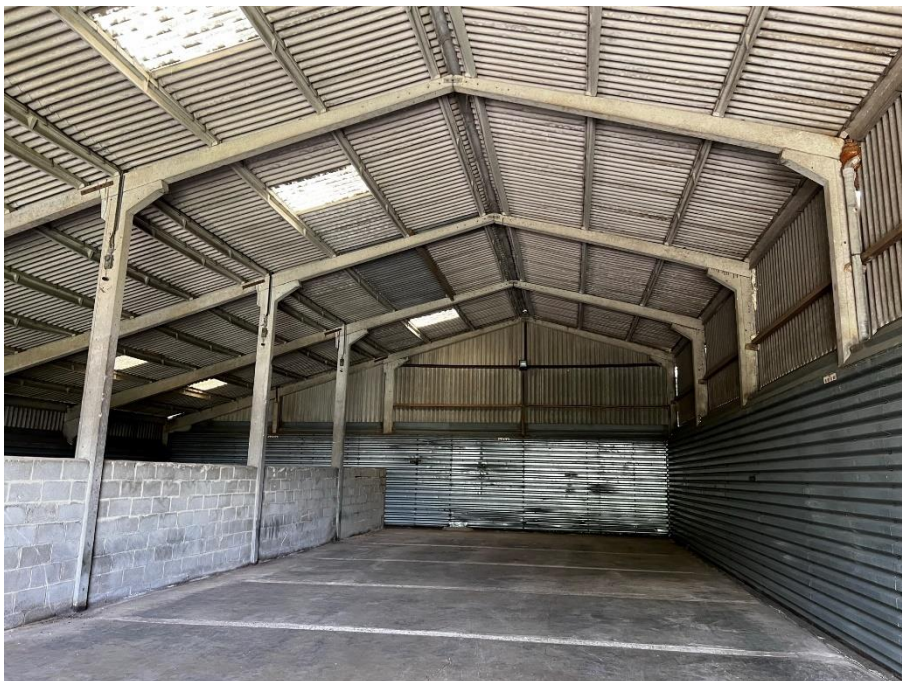
5.10 Barn internal – precast concrete portal frames spans the larger, taller area to a central column with dividing low level wall line

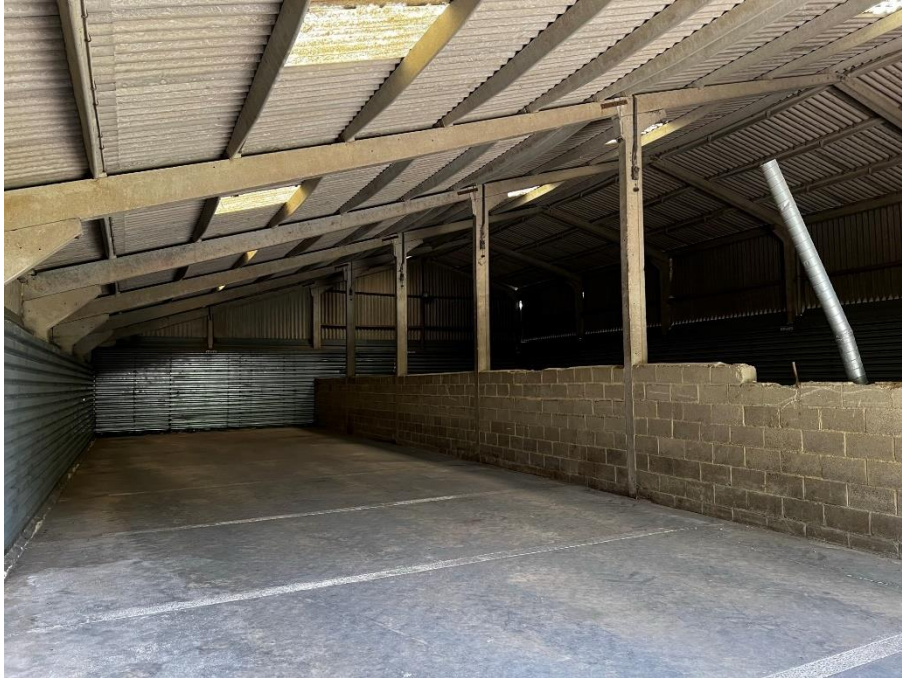
5.11 Barn internal – precast portal concrete frame lean-to framing supports the lower, smaller barn area roof; steel plated connection to shared central column

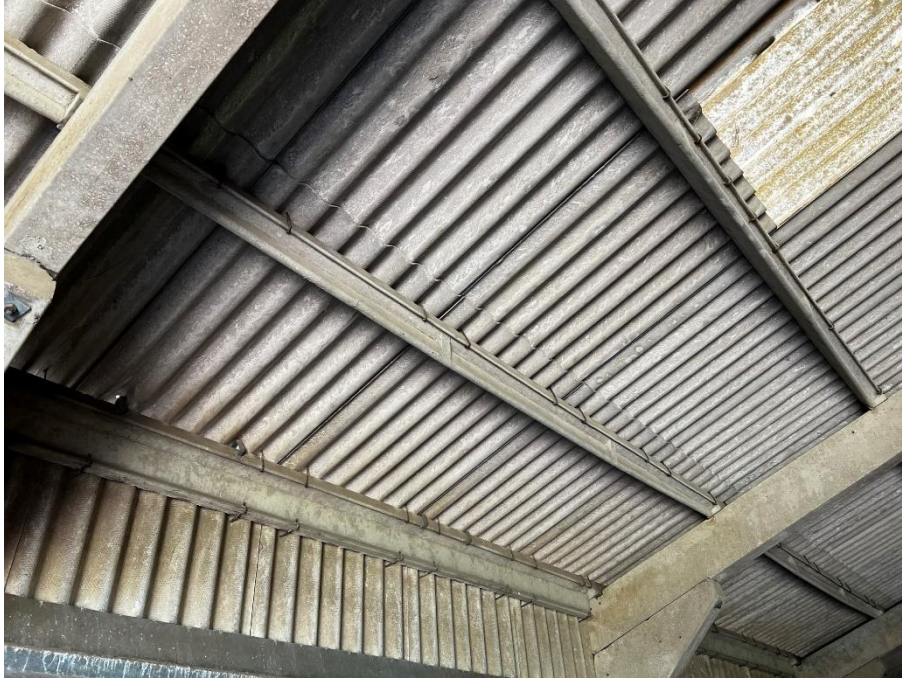
5.13 Corrugated asbestos cement roof sheeting spanning between precast concrete purlins

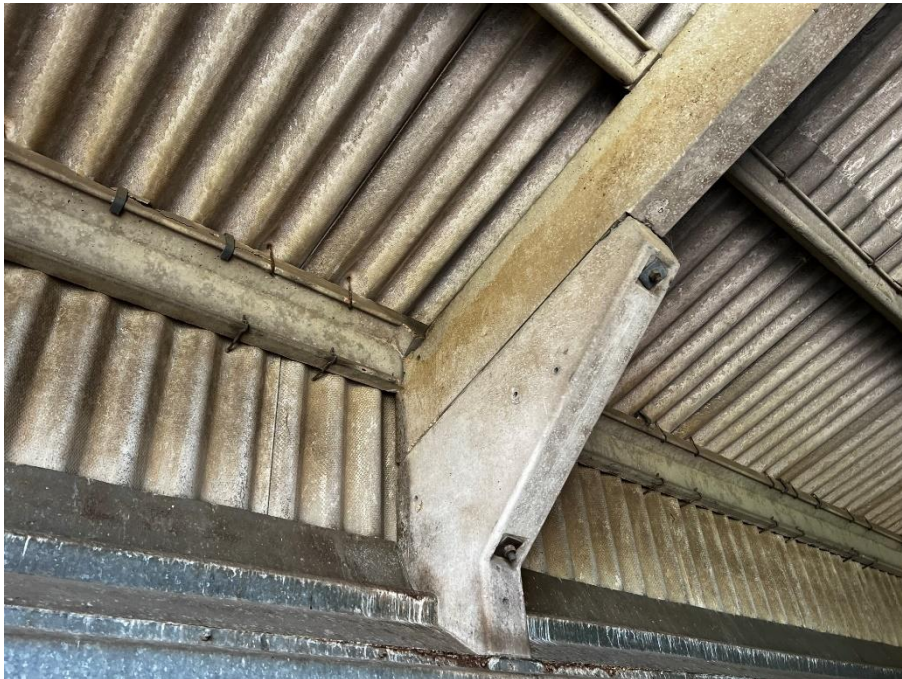
5.14 Portal bolted haunched eaves connection at west elevation

- 4.3 Primary framing connections should be inspected closely to check for any degradation of bolts or concrete elements (ref item 3.9). Basic checks should also be undertaken to ensure sufficient capacity of these connections (refer items 3.6-3.8).

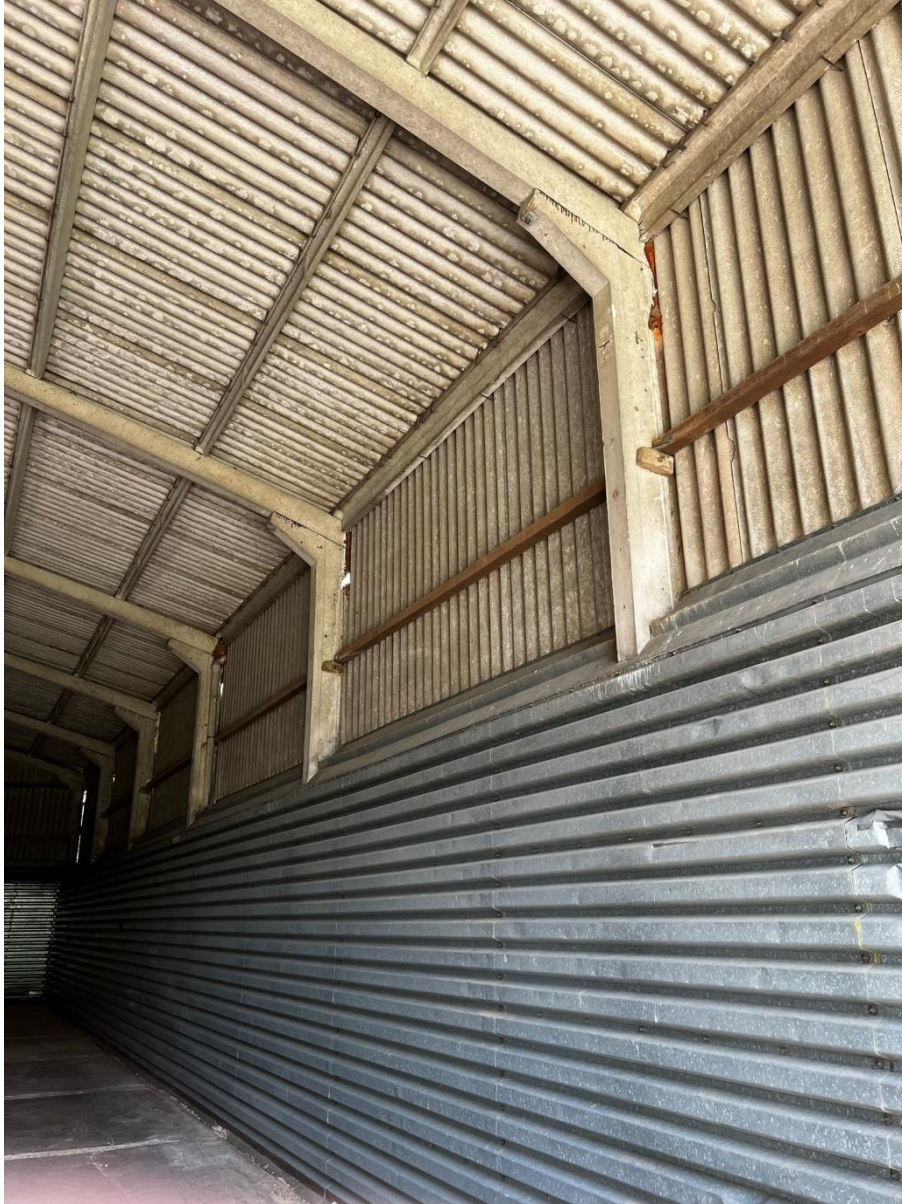
5.15 Portal bolted haunched connection to east elevation, timber cladding rails, steel corrugated sheeting retaining wall at low level

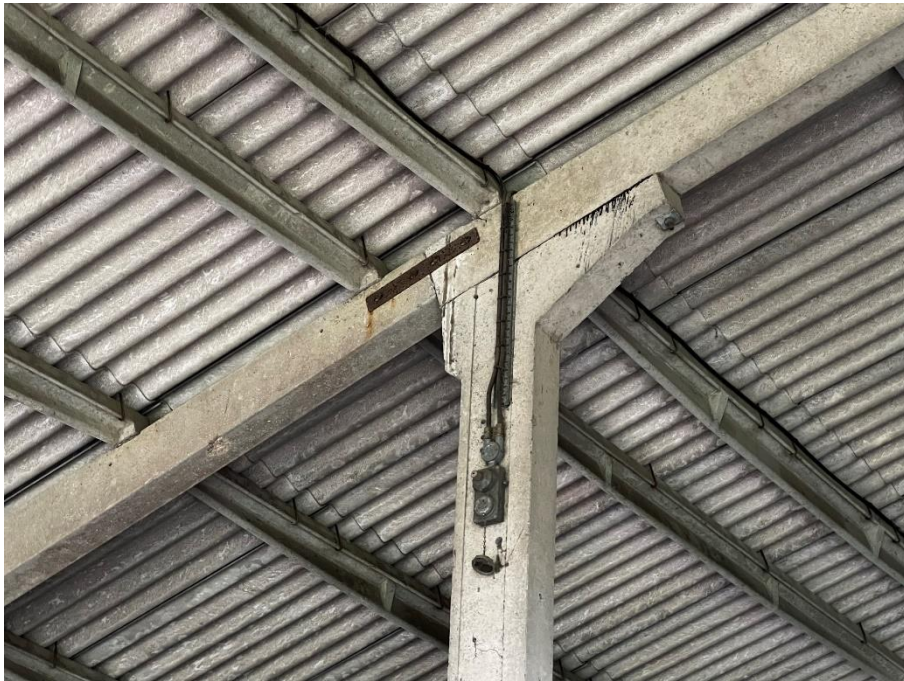
- 3.7 The framing of the smaller west area appears to be a lean-to against the taller complete portal frame of the larger barn area to the east. A simple steel plated bolted connection joins the lean-to rafter to the taller portal rafter (photo 5.16).

5.16 Central column line head connection

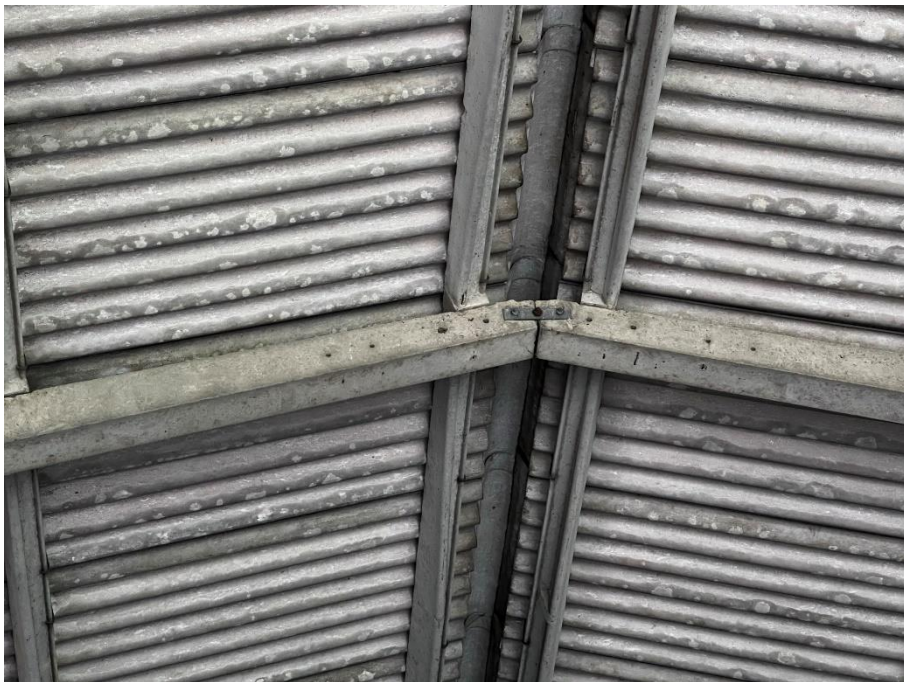
- 3.8 A simple steel plated bolted connection also joins the taller portal rafters at the ridge (photo 5.17).
- 3.9 Possible cracking to one ridge bolted connection (photo 5.18).

5.17 Ridge line bolted connection

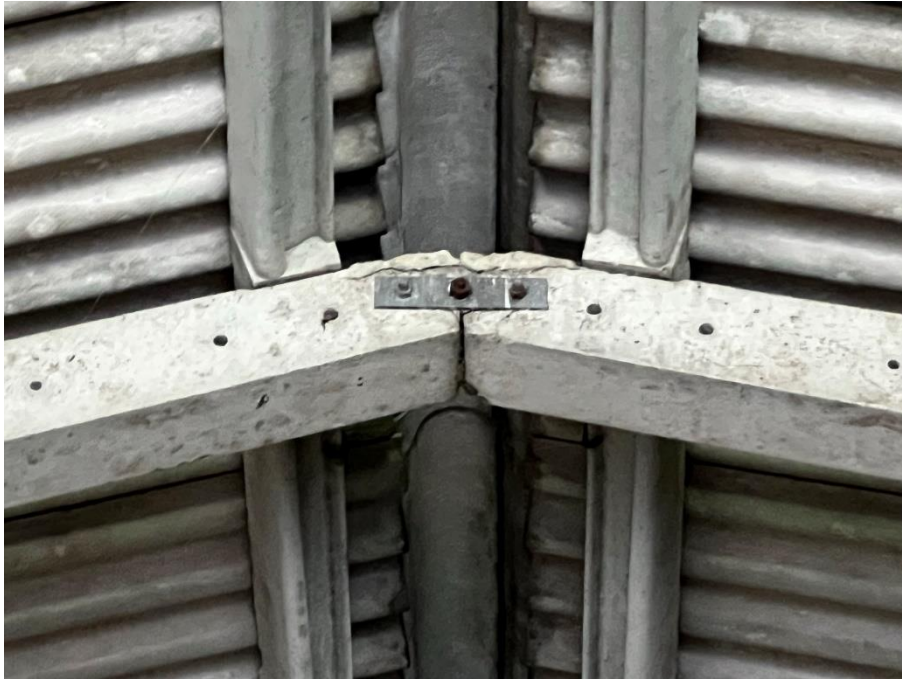
5.18 Ridge line connection – possible cracking

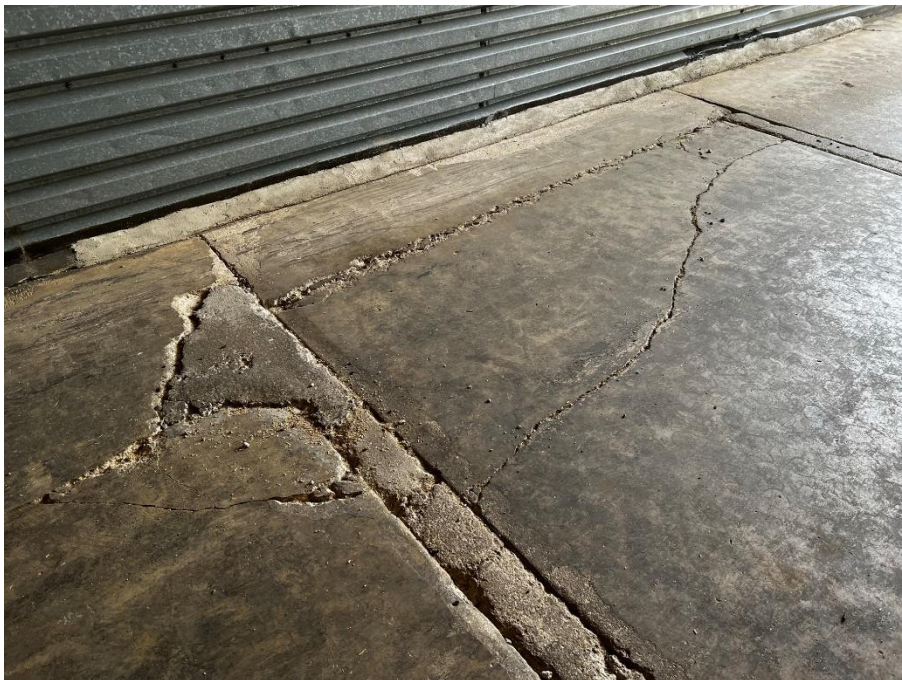
5.19 Cracking to ground bearing slab

- 4.6 Localised repairs should be made to cracked areas of the ground floor slab, introduction of additional joints with tolerance for movement should be considered (ref item 3.10).

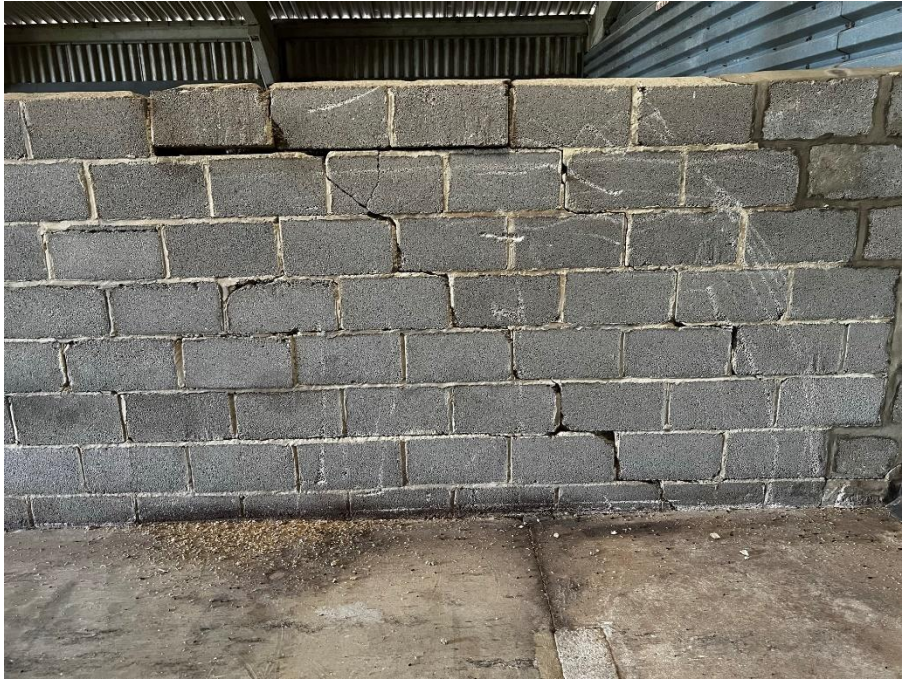
5.20 Movement and cracking to internal blockwork dividing wall

- 4.7 If central blockwork wall is to be retained, localised patch repairs are required to cracked and moved areas; introduction of soft joints to primary framing should be considered to avoid further cracking (ref item 3.11).

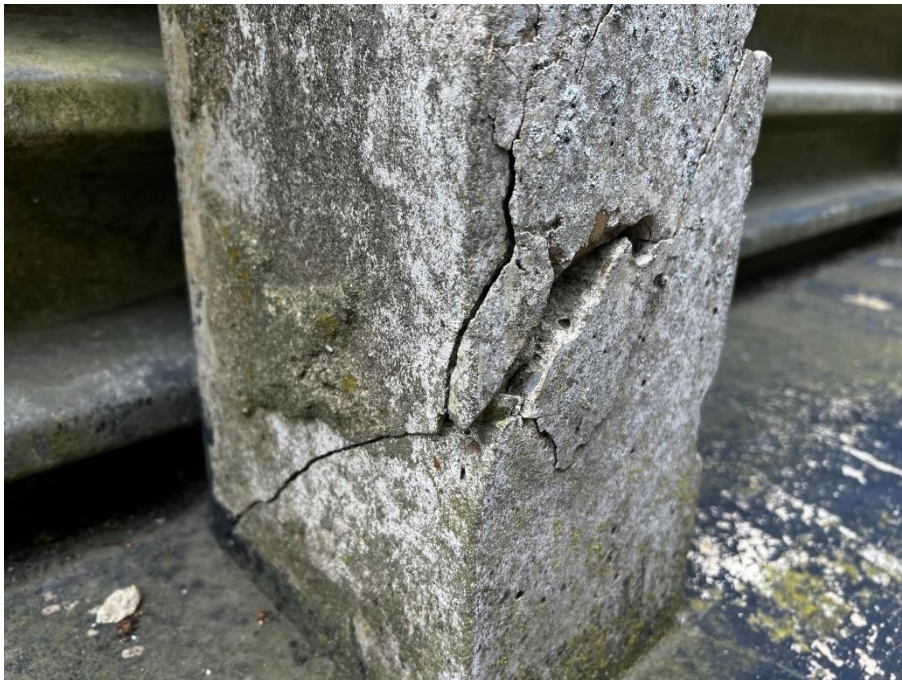
5.21 Cracking to gable column on north elevation at low level

- 4.8 Localised concrete repair required to north gable column externally at low level (ref item 5.21).
