# Arboricultural Consultancy for Aviva

Insured	Mr Antony Lewis	Address	12 The Causeway, Burwell, Cambridge, CB25 0DU		
Client	Subsidence Management Services	Contact	Ian Walters	Claim No.	IFS-AVI-SUB-23-0107600
ES Ref	SA-253201	Consultant	Keith Burgess	Contact No.	0330 380 1036
Report Date	16/06/2023

# GEOTECHNICAL

12 The Causeway, Burwell, Cambridge, CB25 0DU

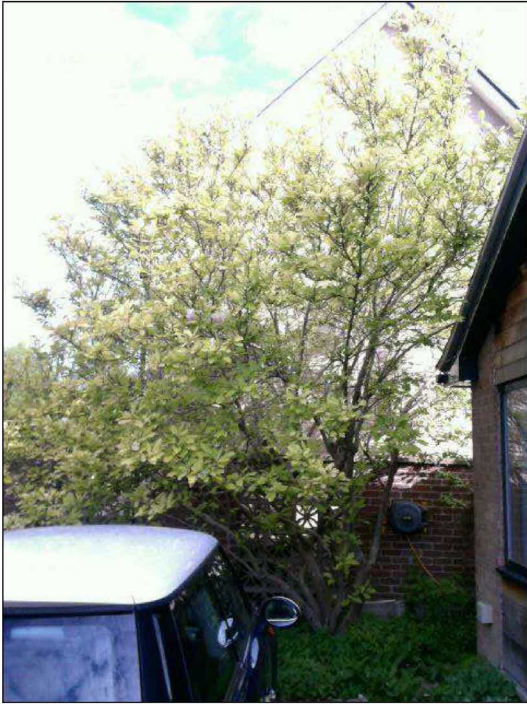
T1 - Magnolia

With due regards to species profile, size and proximity, the Magnolia (T1) is considered the dominant feature proximate to the focal area(s) of movement and accordingly, where vegetation is confirmed as being causal, we have identified it as the primary cause of the current subsidence damage.

The size and proximity of the above vegetation is consistent with the advised location(s) of damage and it is our opinion, on balance of probability, that roots from the above vegetation will be in proximity to the footings of the insured property.

Tree No.	Species	Age Cat	Approx. Height (m)	Distance to Building (m) *	Ownership	Action	Requirement
T1	Magnolia	1	5.5	1.2	C - Insured	Remove	Remove close to ground level and treat stump to inhibit regrowth.

Consequently, we have advocated the complete removal of T1 as it will offer the most certain arboricultural solution likely to restore long-term stability.

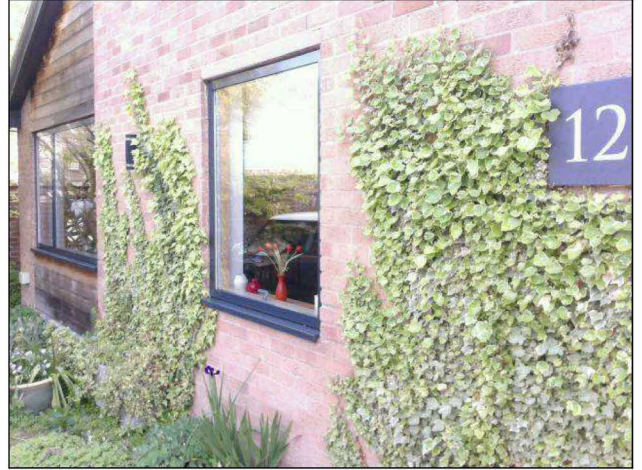
CG1 - Ivy

Please note that the footing of the insured property fall within the anticipated rooting distance of additional vegetation which we believe presents a foreseeable risk of future damage and accordingly we have made recommendations in respect of this.

Tree No.	Species	Age Cat	Approx. Height (m)	Distance to Building (m) *	Ownership	Action	Requirement
CG1	Ivy	1	2	0.1	C - Insured	Action to avoid future risk	Maintain at broadly current dimensions by way of regular pruning.
S1	Philadelphus	1	5	2.3	C - Insured	Action to avoid future risk	Maintain at, or below current dimensions by way of regular pruning.
T2	Pine	1	2	3.7	C - Insured	Action to avoid future risk	Maintain at broadly current dimensions by way of regular pruning.
T3	Apple (Crab)	1	4	6.2	C - Insured	Action to avoid future risk	Maintain at broadly current dimensions by way of regular pruning.
T4	Cherry	1	3	8.6	C - Insured	Action to avoid future risk	Maintain at broadly current dimensions by way of regular pruning.
T5	Willow (Goat)	1	4.5	12.0	C - Insured	Action to avoid future risk	Maintain at broadly current dimensions by way of regular pruning.

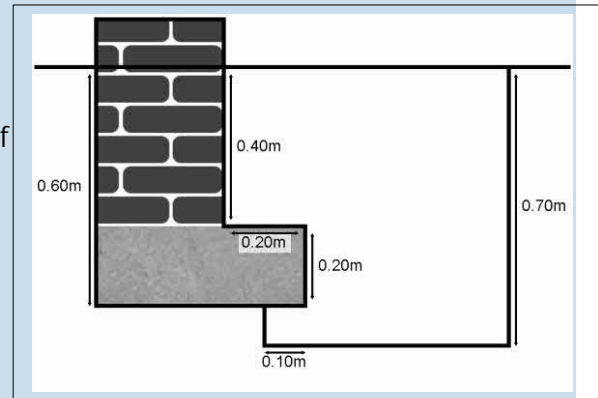
TP/BH1 Foundation Detail and Borehole Log

House foundation comprised of brick wall to 400mm bgl, bearing on concrete to 600mm bgl with a total projection of 200mm from the elevation. Underside of foundation (USF) was exposed to 100mm back from the face of the foundation and probed 400mm back from the face of the foundation.

WS	Samples		Tests		Legend	Stratum Description and Observations
	Type	Depth (m)	Type	Depth (m)		
					0	TOPSOIL.
					0.5	MADE GROUND: brown mottled grey gravelly CLAY with occasional fine to medium brick. Gravel is fine to medium. ...at 0.10m to 0.60m bgl numerous roots of live appearance encountered
	D R	0.60 - 1.10 0.60 - 1.60	PEN	0.60	HP=4.3 (4.5,4.5,4.0,4.0,4.5)	Hard grey mottled brown cobbly CLAY. Cobbles are fine to coarse chalk. ...at 0.60m bgl UNDERSIDE OF HOUSE FOUNDATION. ...at 0.60m to 1.60m bgl numerous roots of live appearance encountered and sampled. ...at 0.70m bgl base of hand excavated trial pit.
	D	1.10 - 1.60	PEN	1.10	HP=4.7 (4.5,5.0,5.0,4.5,4.5)	
	D	1.60 - 2.10	PEN	1.60	HP=4.5 (4.5,4.5,4.0,4.5,5.0)	...at 1.60m to 2.10m bgl no roots encountered. Extensive inspection of soil samples encountered no roots. ...at 2.10m bgl unable to retrieve further sample due to friable soils (mudstone) preventing sample recovery

-- End of borehole at 2.10m --  
 PEN = Hand Penetrometer (kg/sq cm). Groundwater strikes not encountered. Roots encountered to 1.10m bgl. Borehole completed by hand held percussive window sampler. Trial pit excavated to 0.70m bgl. Borehole completed by hand held percussive window sampler.

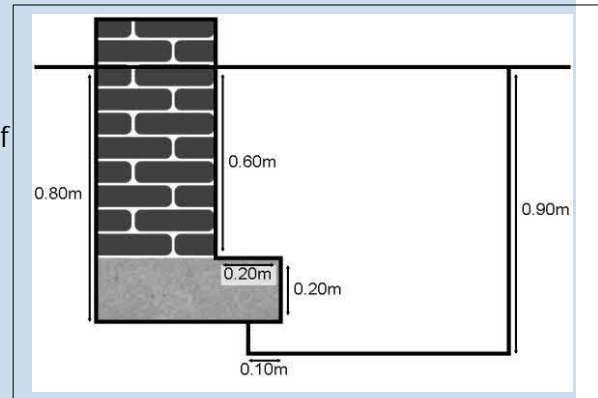
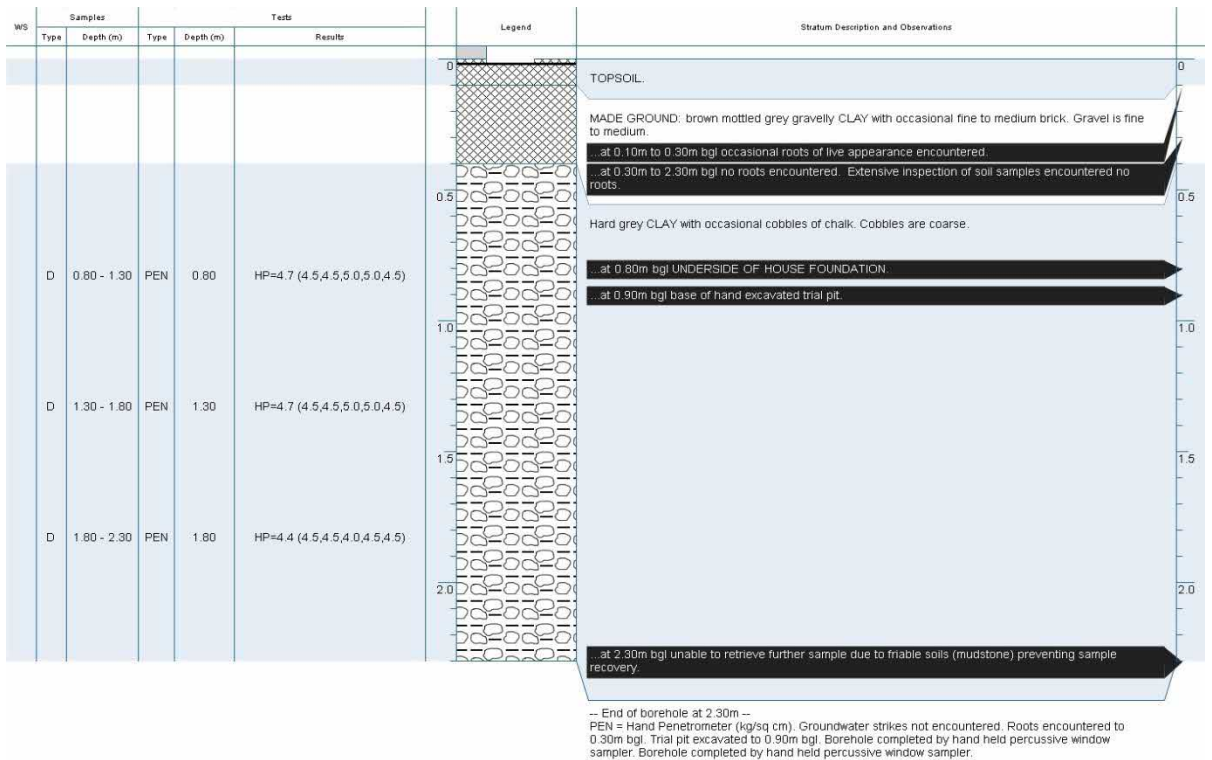
TP/BH2 Foundation Detail and Borehole Log

House foundation comprised of brick wall to 600mm bgl, bearing on concrete to 800mm bgl with a total projection of 200mm from the elevation. Underside of foundation (USF) was exposed to 100mm back from the face of the foundation and probed 400mm back from the face of the foundation.

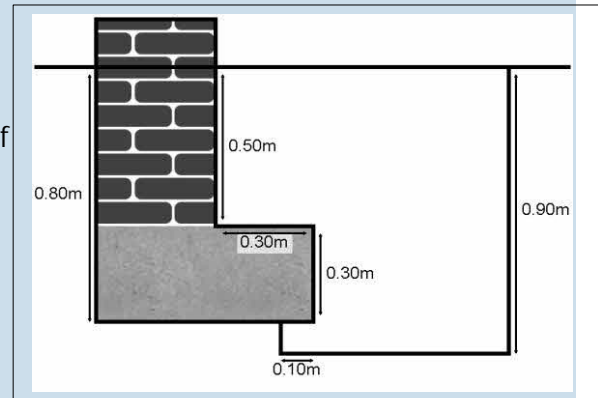
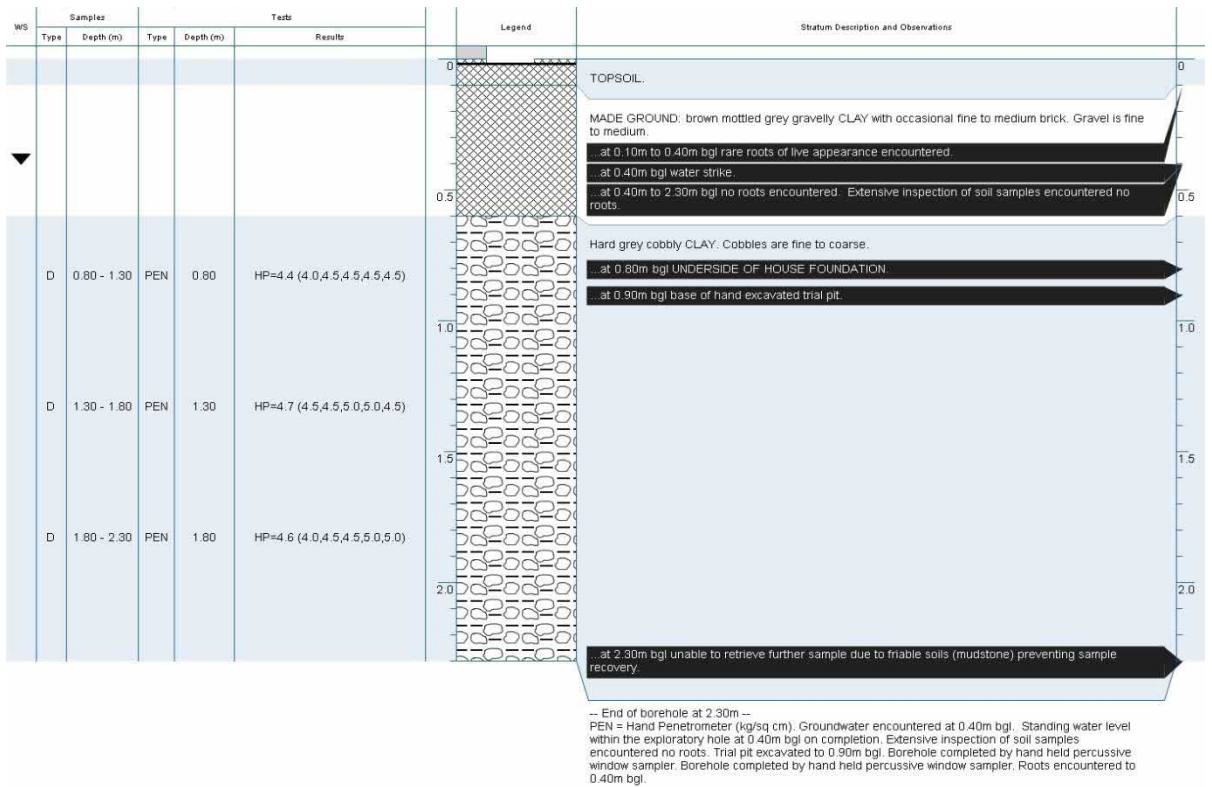
TP/BH3 Foundation Detail and Borehole Log

House foundation comprised of brick wall to 500mm bgl, bearing on concrete to 800mm bgl with a total projection of 300mm from the elevation. Underside of foundation (USF) was exposed to 100mm back from the face of the foundation and probed 400mm back from the face of the foundation.
